**Second Five-Year Review Report
Blue Ridge Plating Site
Arden, Buncombe County, North Carolina
US EPA ID: NCD 044 447 589**

**Prepared by
North Carolina Department of Environmental Quality
Raleigh, North Carolina**

This is the second FYR for the Blue Ridge Plating Site (BRP Site or Site). The triggering action for this statutory review is the completion date of the previous FYR, September 26, 2012. A FYR has been prepared due to the fact that hazardous substances, pollutants, or contaminants remain at the Site above levels that allow for unlimited use and unrestricted exposure. The Site consists of one operable unit (OU), which is addressed in this FYR. The OU addressed both contaminated soil and groundwater.

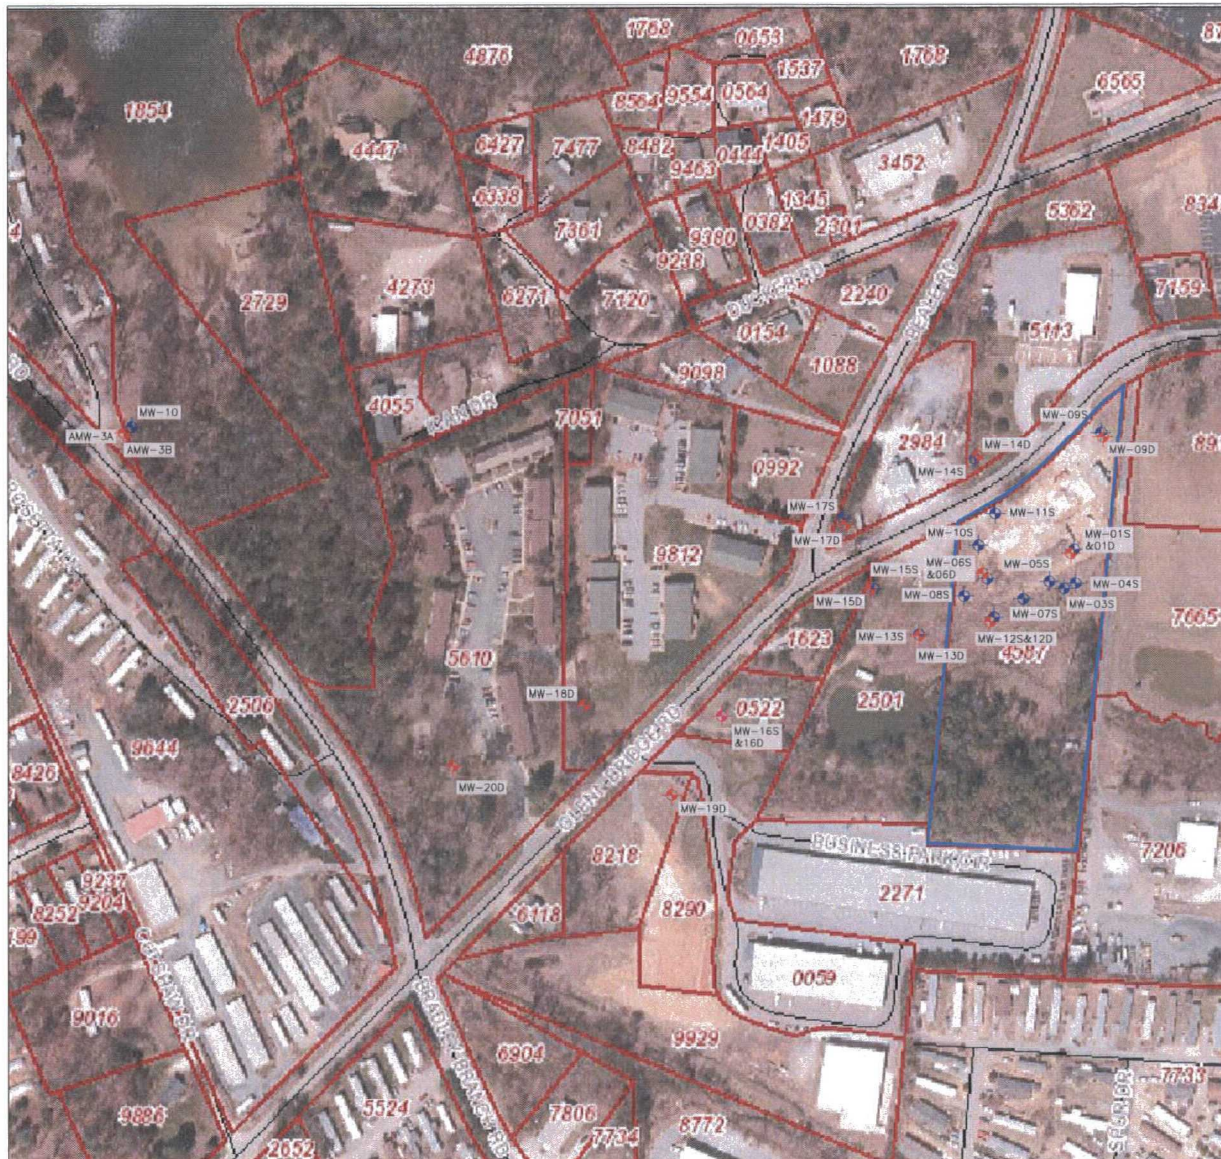
Figure 4
Monitoring Well
Locations

MW17D, MW18D, MW19D, AND MW20D. The “S” indicates a monitoring well screened in the shallow region of the underlying aquifer and the “D” indicates a monitoring well screened in the deeper zone of the underlying aquifer. MW19D, an off-Site well, was not sampled as the well was destroyed during construction activities at the well location. In addition, three off-Site wells (AMW-3A, AMW-3B, and MW-10), which are owned and maintained by Duke Energy, were sampled in the 2016 sampling event. See Appendix D Figure 4 for a monitoring well location map. Appendix G, 2016 Data Evaluation Report, Table 3-1 is a table of all the Groundwater Analytical Data Summary from September 2007 through June 2016.

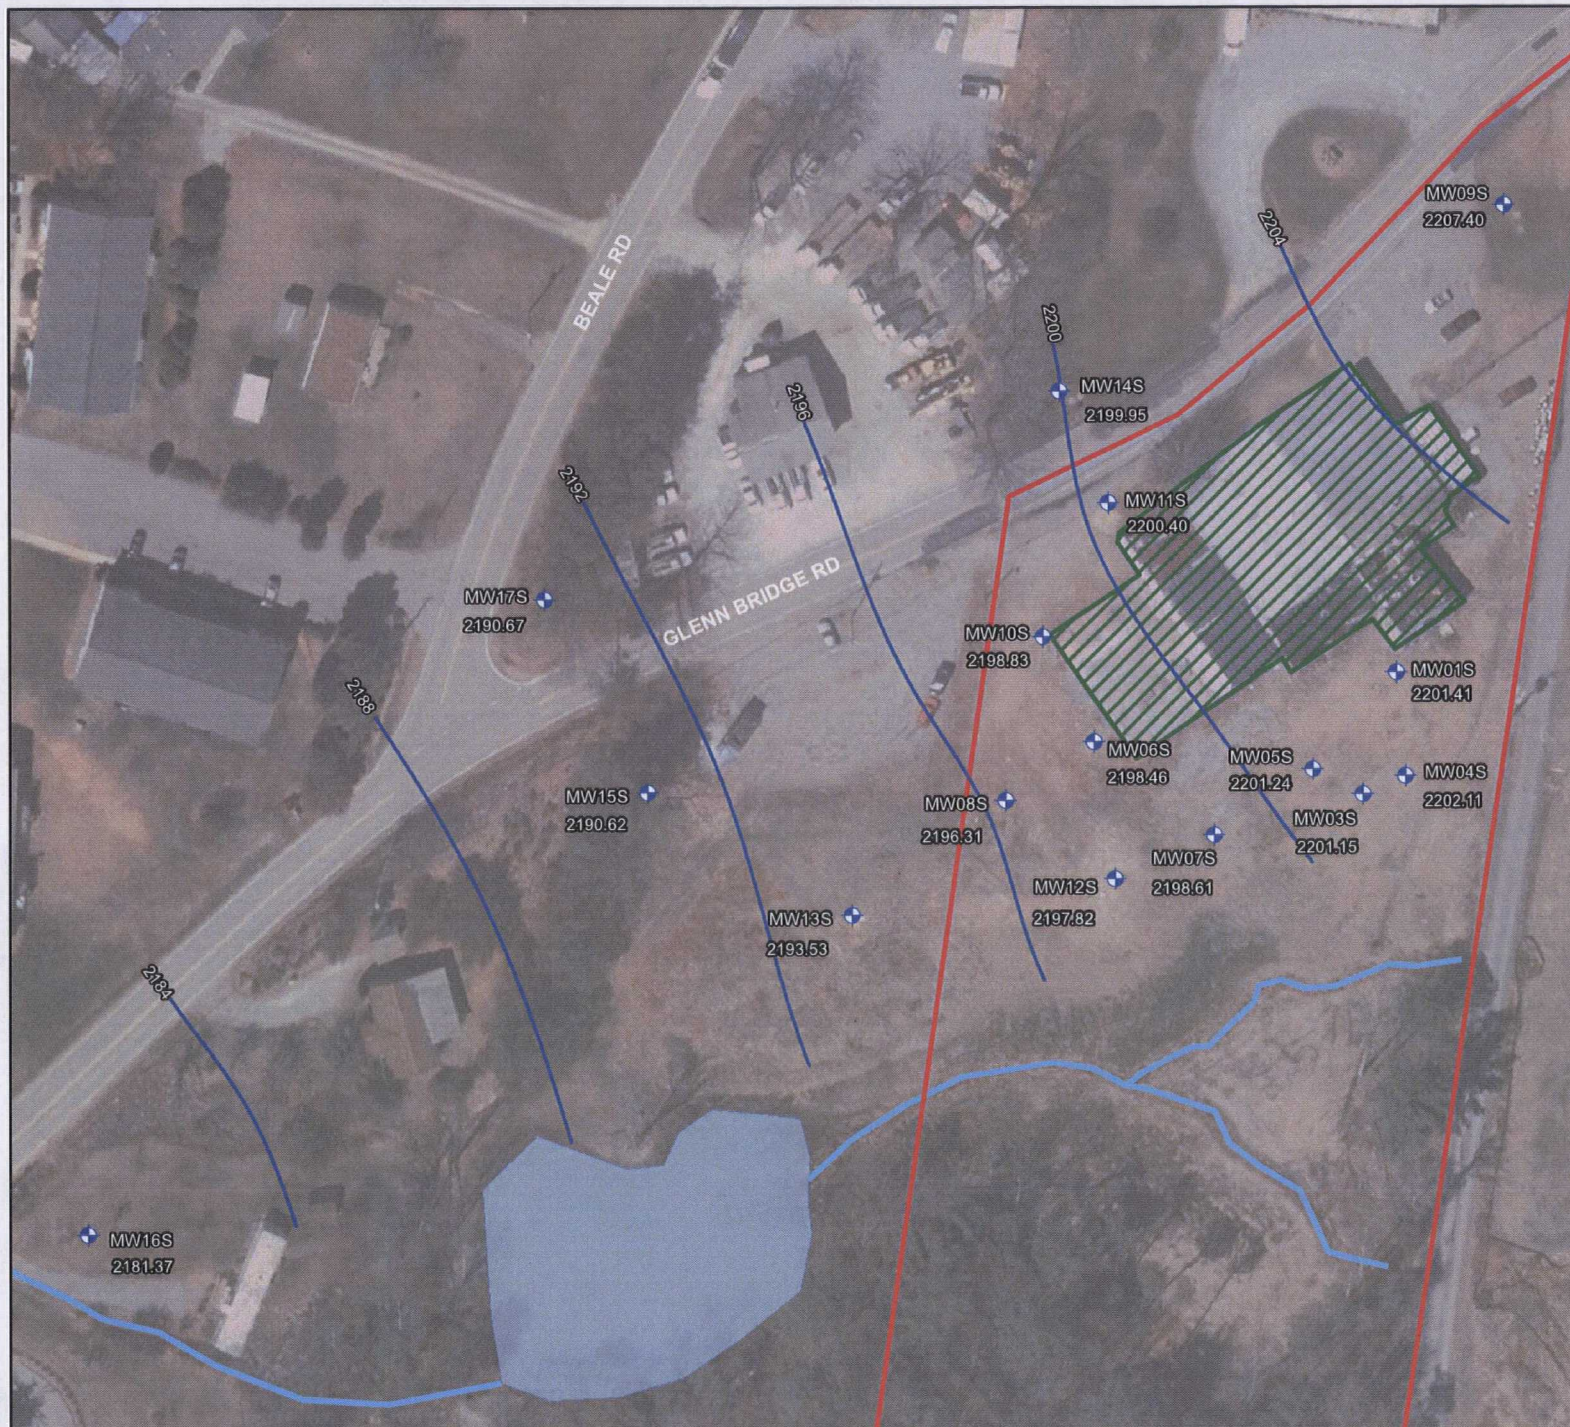
Figure 3-1
Groundwater Elevation
Contour Map June 2016
(Shallow)

- Shallow Well
- Groundwater Elevation Contour (in feet)
- Property Line
- Streams
- Former Building (Demolished)
- Lake/Pond

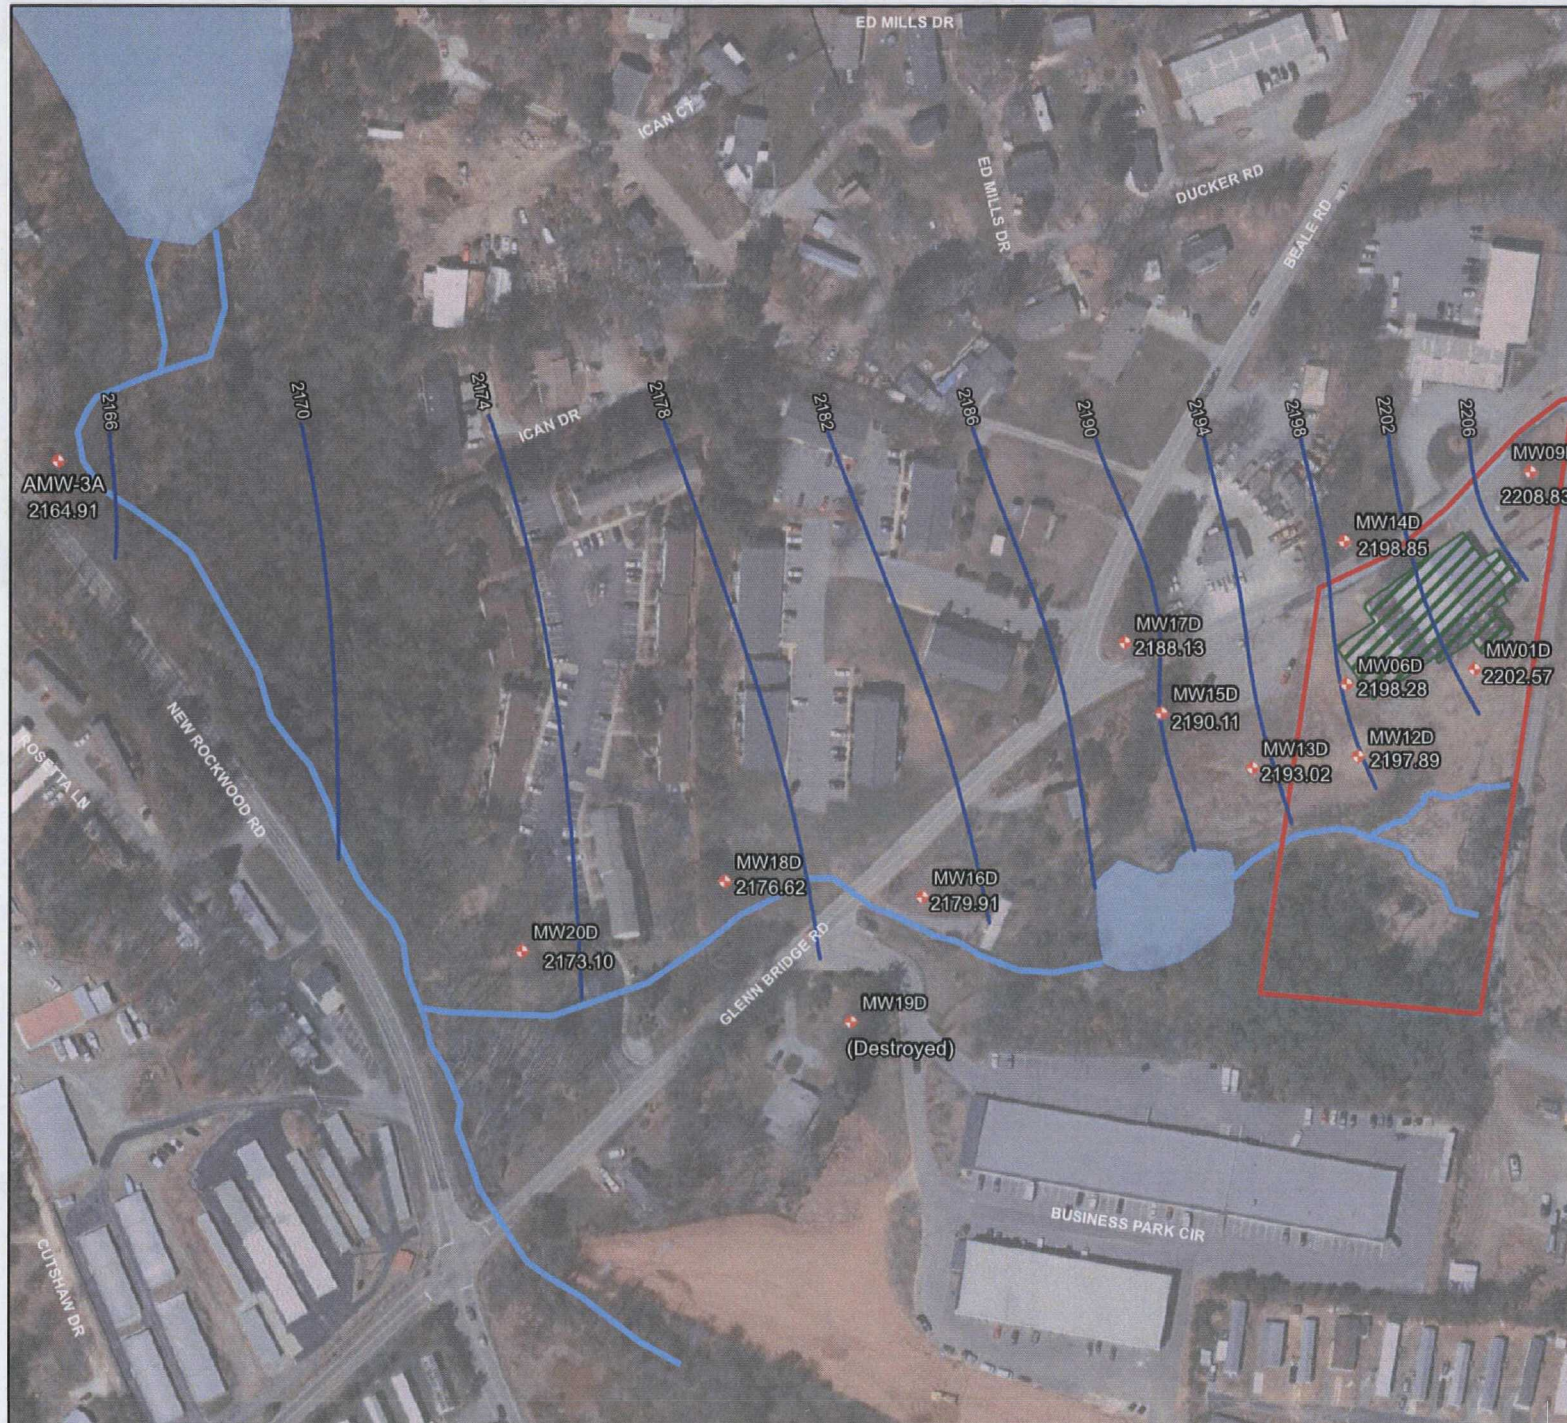
Groundwater elevations measured on June 21, 2016 (listed in Table 2-1) were used to create groundwater elevation contour maps for the shallow and deep zones of the saprolite aquifer. Figures 3-1 and 3-2 show the groundwater elevation contours for the shallow and deep zones, respectively. Groundwater flow direction in June 2016 was to the west-southwest in both zones. Horizontal groundwater gradients in the shallow and deep zones were approximately 0.033 and 0.029, respectively. Vertical gradients, as evaluated by comparing groundwater elevations at paired shallow and deep well locations, were downward from the shallow zone to the deep zone at seven of the ten nested well pairs (at all except the MW01, MW09, and MW12 pairs). Groundwater flow directions, horizontal gradients, and vertical gradients observed in June 2016 were consistent with those observed during previous sampling events.
