**FIRST FIVE-YEAR REVIEW REPORT FOR  
SIGMON'S SEPTIC TANK SERVICE SUPERFUND SITE  
IREDELL COUNTY, NORTH CAROLINA**

**AUGUST 2018**

**U.S. Environmental Protection Agency  
Region 4  
Atlanta, Georgia**

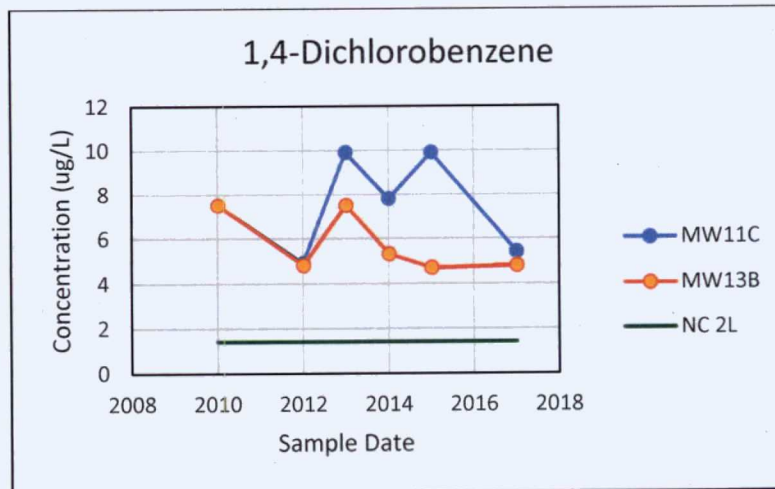
**Figure 4: 1,4-Dichlorobenzene in MW11C and MW-13B**

In 2017, ROD action level exceedances for 1,4-dichlorobenzene occurred in MW11C and MW13B. These wells have historically had the highest concentrations of 1,4-dichlorobenzene. The 2017 concentration in MW11C was almost half the 2015 concentration; the concentration stayed essentially the same in MW13B. No overall trend was noted for 1,4-dichlorobenzene since MNA began in 2009 concentrations have declined from historical levels but remained between 4 µg/L and 10 µg/L over the past eight years. In June 2018, 1,4-dichlorobenzene levels were below ROD action levels in MW11C and MW13B.

MNA monitoring of groundwater is ongoing. ROD exceedances of 1,4-dichlorobenzene continue in MW-11C and MW-13B; manganese exceedances were observed in four wells. An O&M plan with MNA goals should be developed to better assess the remedy in the future.

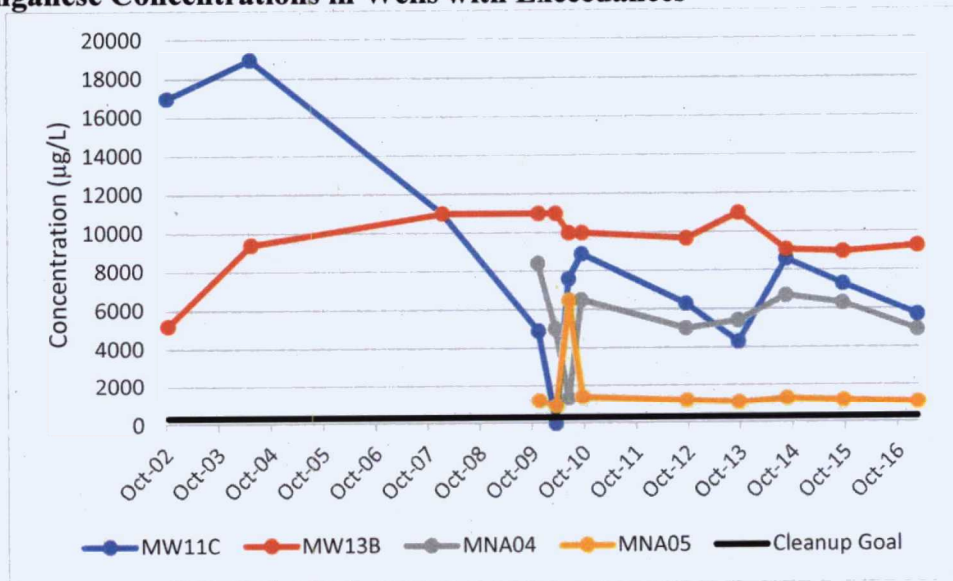
**Figure 5: Manganese Concentrations in Wells with Exceedances**

In 2017, manganese was detected above the ROD action level (300 µg/L) in MNA04, MNA05, MW11C and MW13B; concentrations ranged from 1,100 µg/L to 9,300 µg/L (Figure 5). Iron was below the ROD action level (11,000 µg/L) in 2014, but above the ROD action level in MNA05 during 2015 (13,000 µg/L) and 2017 (12,000 µg/L). Arsenic was detected in three wells during 2017 (MNA05, MW11C and MW16C) but concentrations were below the ROD action level of 10 µg/L. In June 2018, manganese, iron and arsenic were detected below ROD action levels in wells.

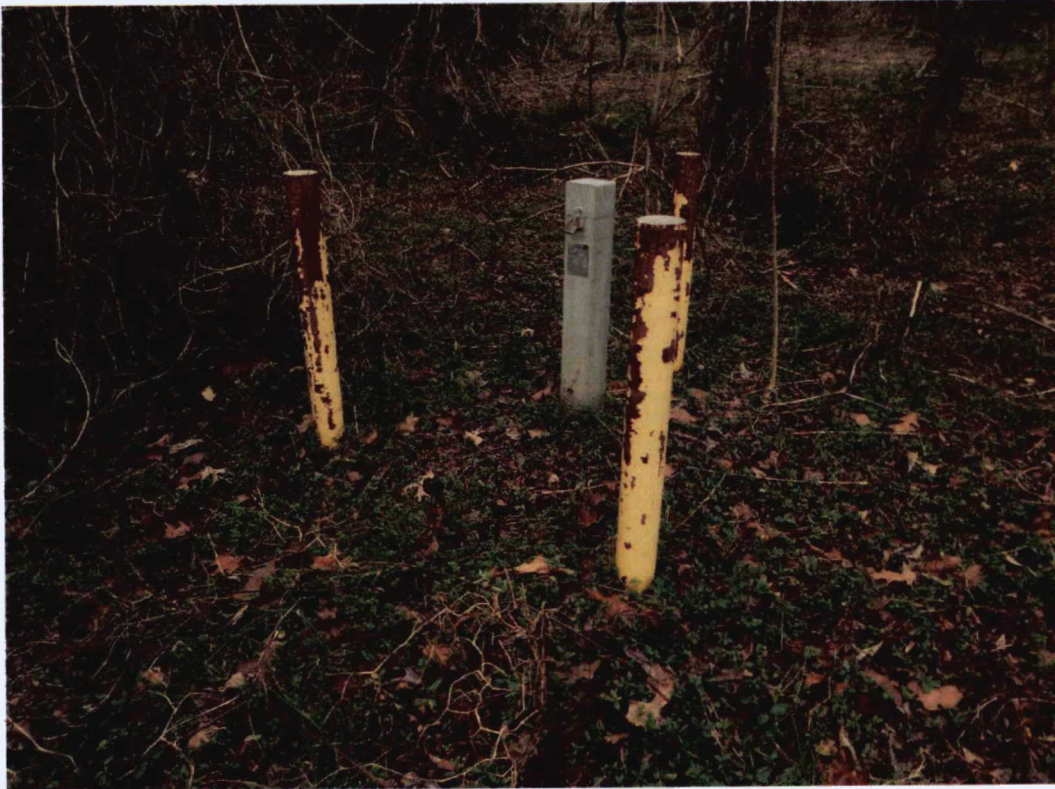
MW-11c

Site inspection participants met at the Site to discuss the status of the property and conduct the site inspection. Participants accessed the southern removal area via the northern and middle private properties, which were formerly part of the Sigmon’s parcel. Several vehicles were parked at the northern end of the southern parcel; they appeared to be abandoned. On the Sigmon’s parcel, participants noted four large septic tanks; a large tree was growing through one tank, indicating the tanks might remain from historical operations. There was no evidence of trespassing or dumping in the soil stockpile area of the southern parcel. Observed monitoring wells were locked and labelled.

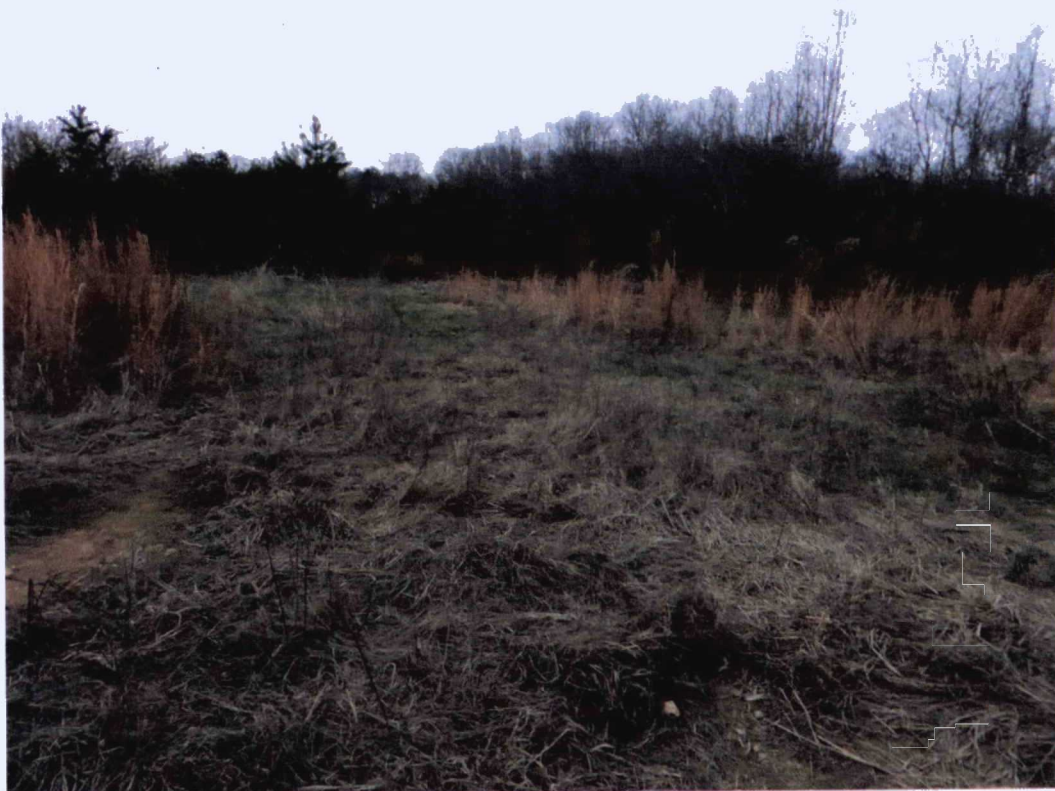
Area of former waste pile on the southern end of the site property

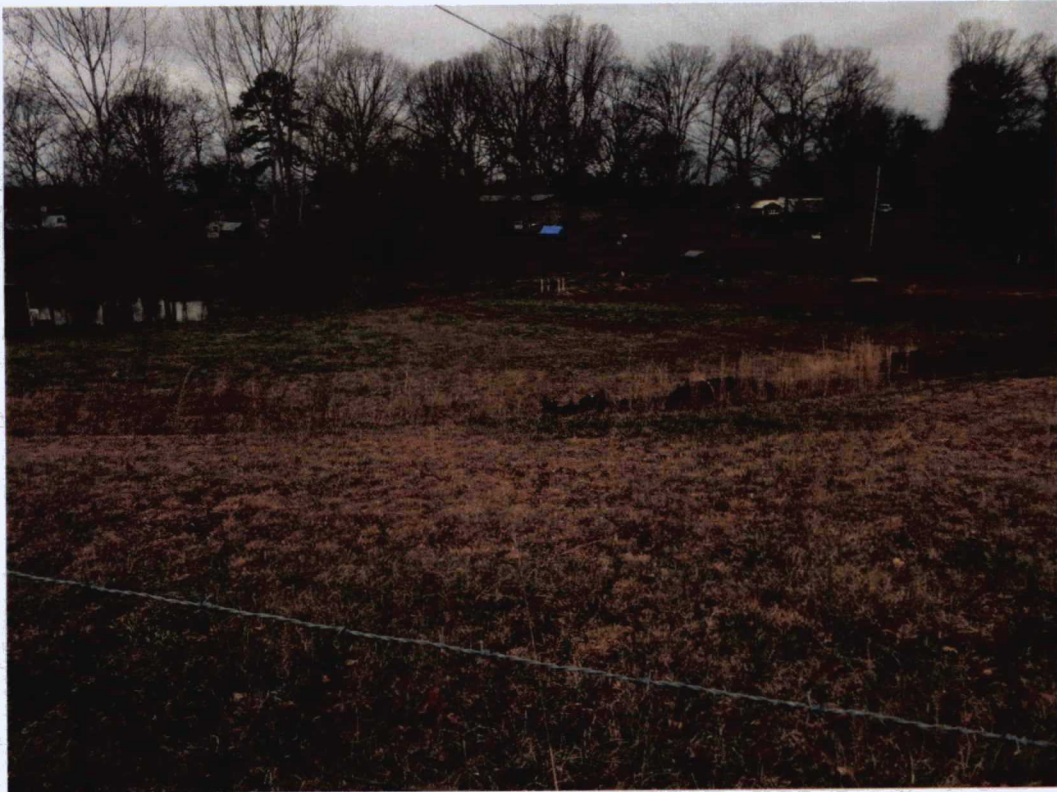
Northern portion of the site property with pond and wells

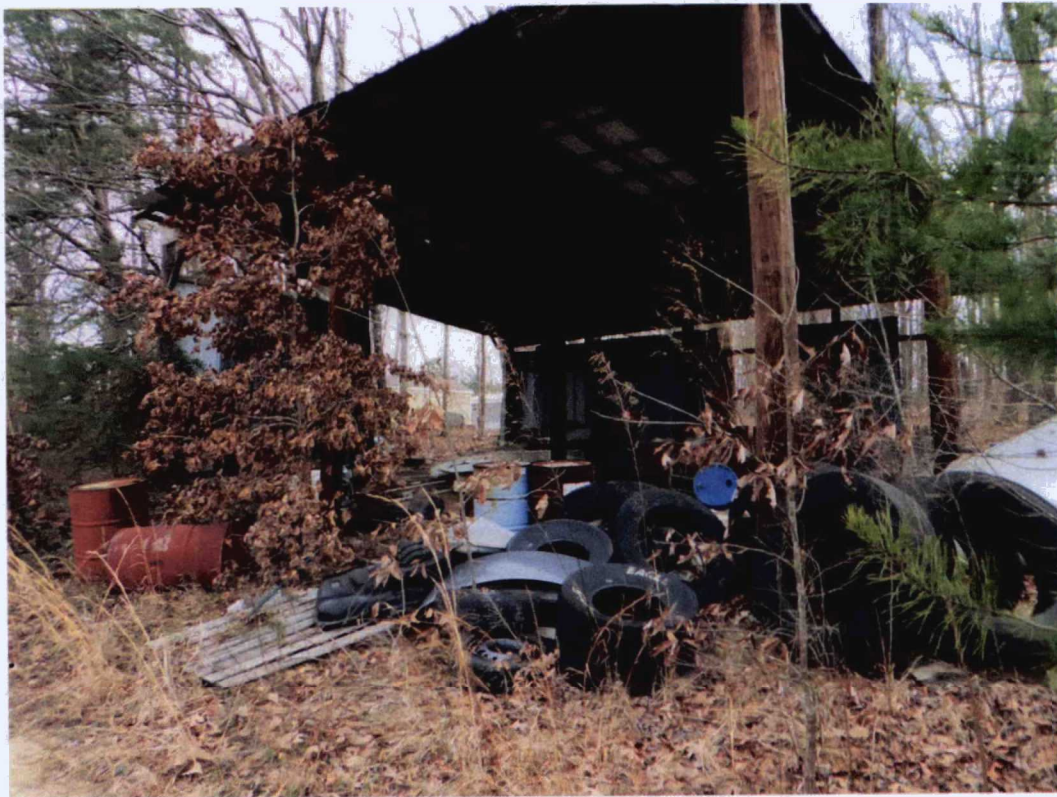
Dumping on the eastern edge of the Site

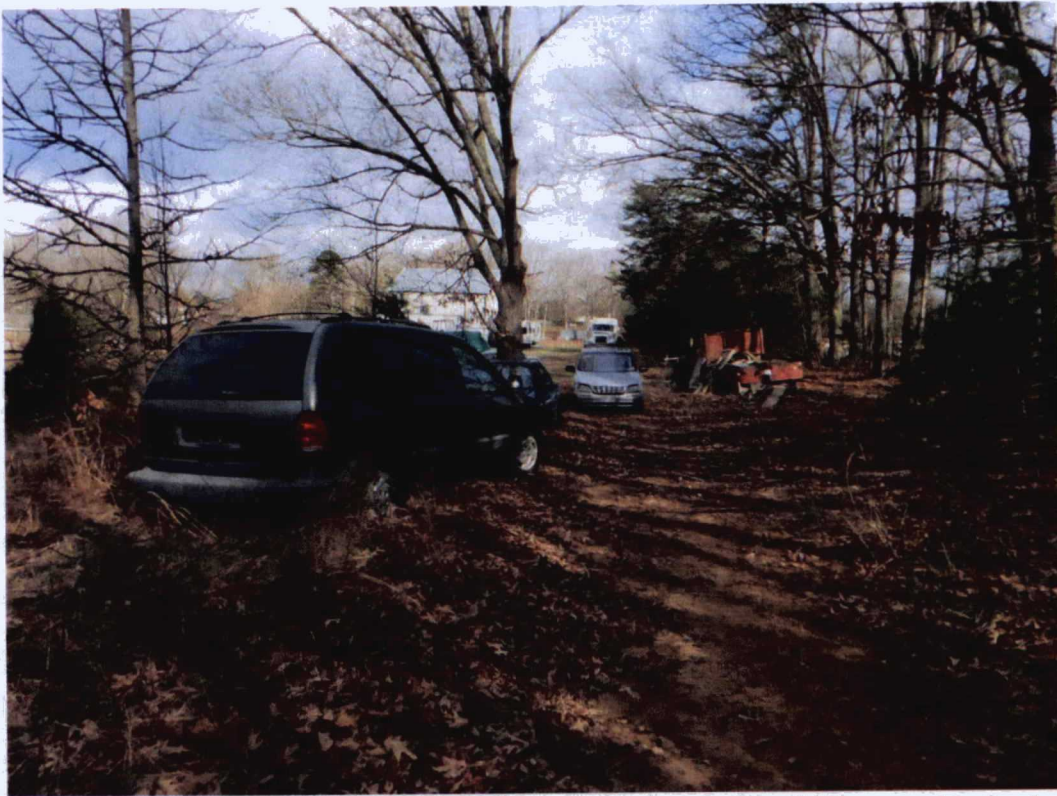
Cars stored on the eastern side of the Site, with private garage on middle parcel in background

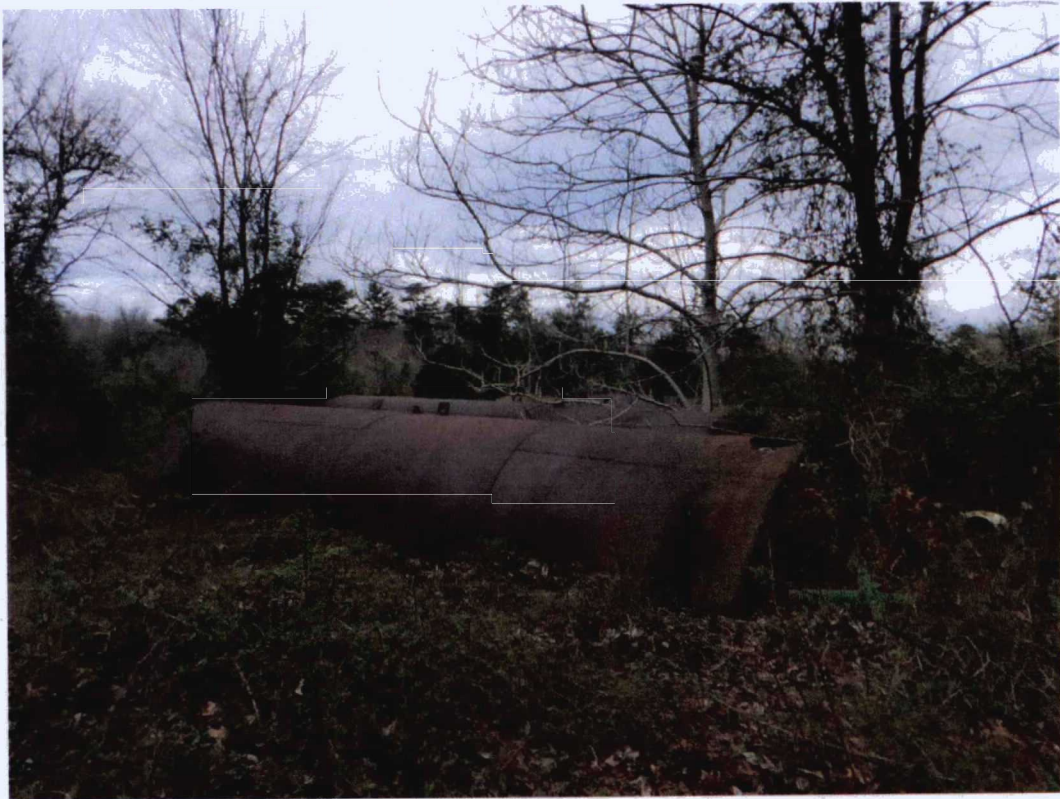
During the site inspection, four large septic tanks were noted on the southern parcel, north of the delineated soil excavation area. The RA Completion Report does not mention observation or removal of tanks.

Tanks left on the southern parcel
