**CY 2018 Five-Year Review for  
Remedial Actions  
at the Paducah Gaseous Diffusion Plant,  
Paducah, Kentucky  
(Fourth Synchronized Five-Year Review)**

(Fourth Synchronized Five-Year Review)

Date Issued—May 2019

Prepared by  
FOUR RIVERS NUCLEAR PARTNERSHIP, LLC,  
managing the  
Deactivation and Remediation Project at the  
Paducah Gaseous Diffusion Plant  
under Contract DE-EM0004895

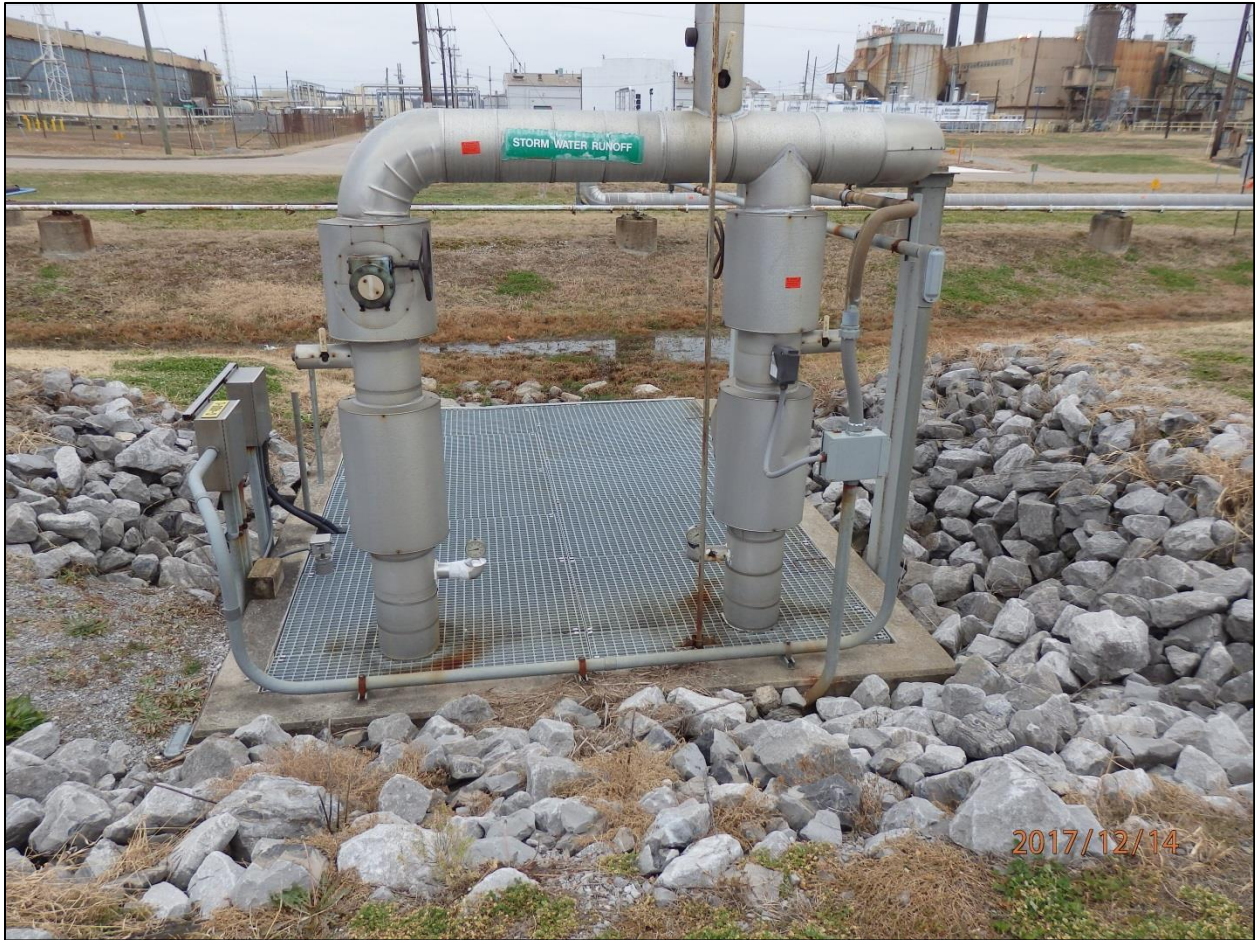
**Figure 11.2. C-400-L Lift Station**

On December 14, 2017, a site inspection of the following facilities associated with the NSDD IRA was conducted by a team supporting the five-year review preparation: (1) the C-400-L Lift Station and associated piping (Figure 11.2), (2) the C-616-L Lift Station and associated piping (Figure 11.3), and (3) the gabion installed at the C-615-K Lift Station (Figure 11.4). The signs that had been posted along the southern reaches of the ditch were removed after the remedial response for Sections 1 and 2 (Chapter 12) was completed. There was no excessive debris over the gabion screens. The aboveground piping was in good condition, the insulation was intact, and the metal jacket covering was not rusted or deteriorated. The lift stations appear to be functioning properly. The facility manager participated as part of the inspection team and did not have any concerns.

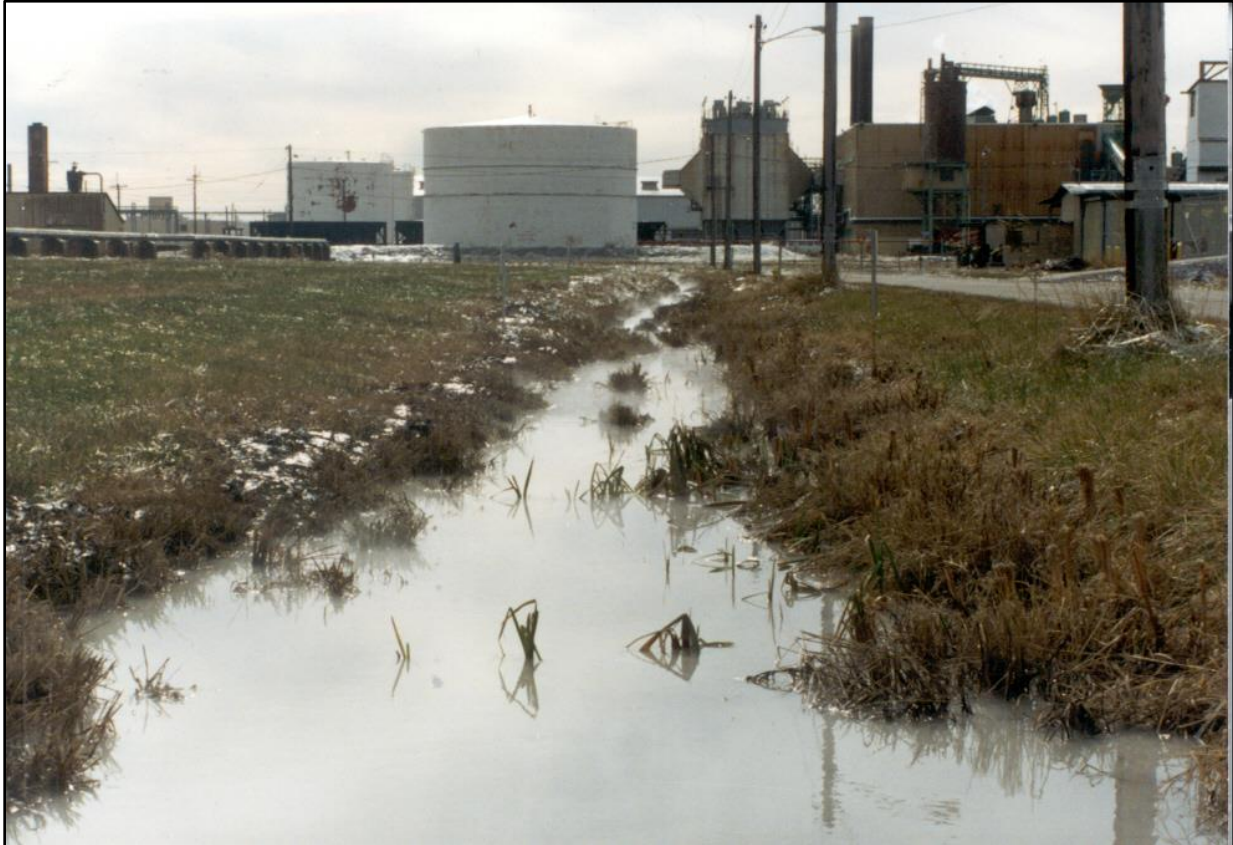
**Figure 12.2. NSDD Sections 1 and 2 before Remedial Action**

Figures 12.2 and 12.3 show “before and after” views of the NSDD Sections 1 and 2. The total cost of excavation of Sections 1 and 2, construction of the detention basin, and disposal of approximately 3,200 yd<sup>3</sup> of soil in the C-746-U Landfill was \$12.2M, according to the *Remedial Action Completion Report for the North-South Diversion Ditch Sections 1 and 2 at the Paducah Gaseous Diffusion Plant, Paducah Kentucky*, DOE/OR/07-2195&D2 (DOE 2005d).

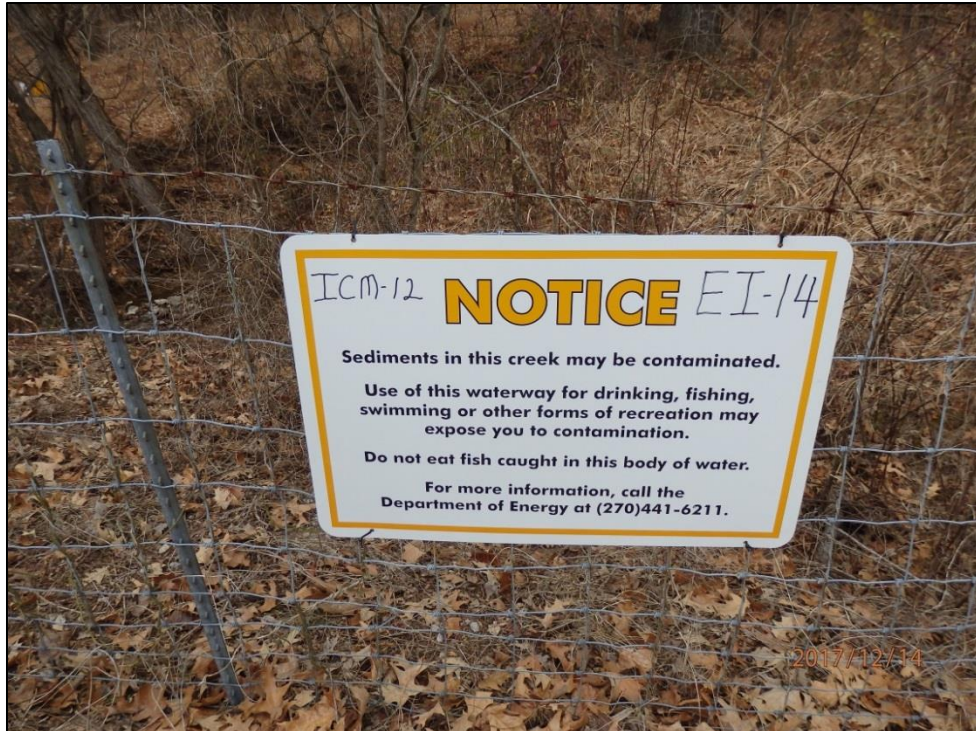
Figure 15.3. Sign and Fencing Installed for the Surface Water ICM

The locations of the signs and fences were inspected on December 13, 2017, by the Five-Year Review team and the facility manager (see Figure 15.2–Figure 15.4 for examples). The ICM signs all were legible. Also, at all locations the Surface Water ICM signs were posted along with “KEEP OUT,” “NO TRESPASSING,” and radiological warning signs. The fences at all locations were in place.

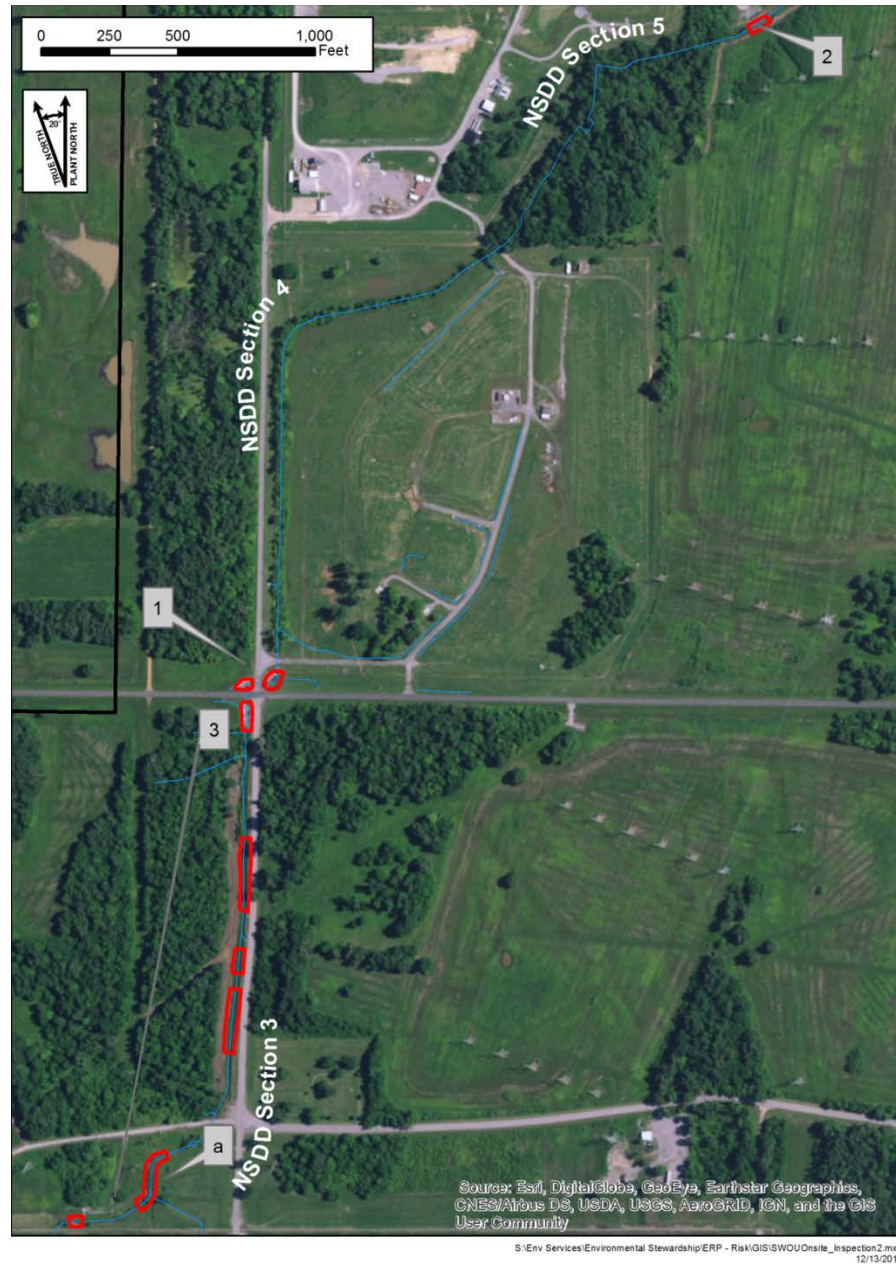
Area 1: drive-by inspection—rip rap appears to be holding well, some standing water
