ST. LOUIS SMELTING AND REFINING  
MADISON COUNTY  
COLLINSVILLE, ILLINOIS  
ILD980607006  
LPC# 1194280014  
SUPERFUND/ HRS

## REASSESSMENT

Illinois Environmental  
Protection Agency

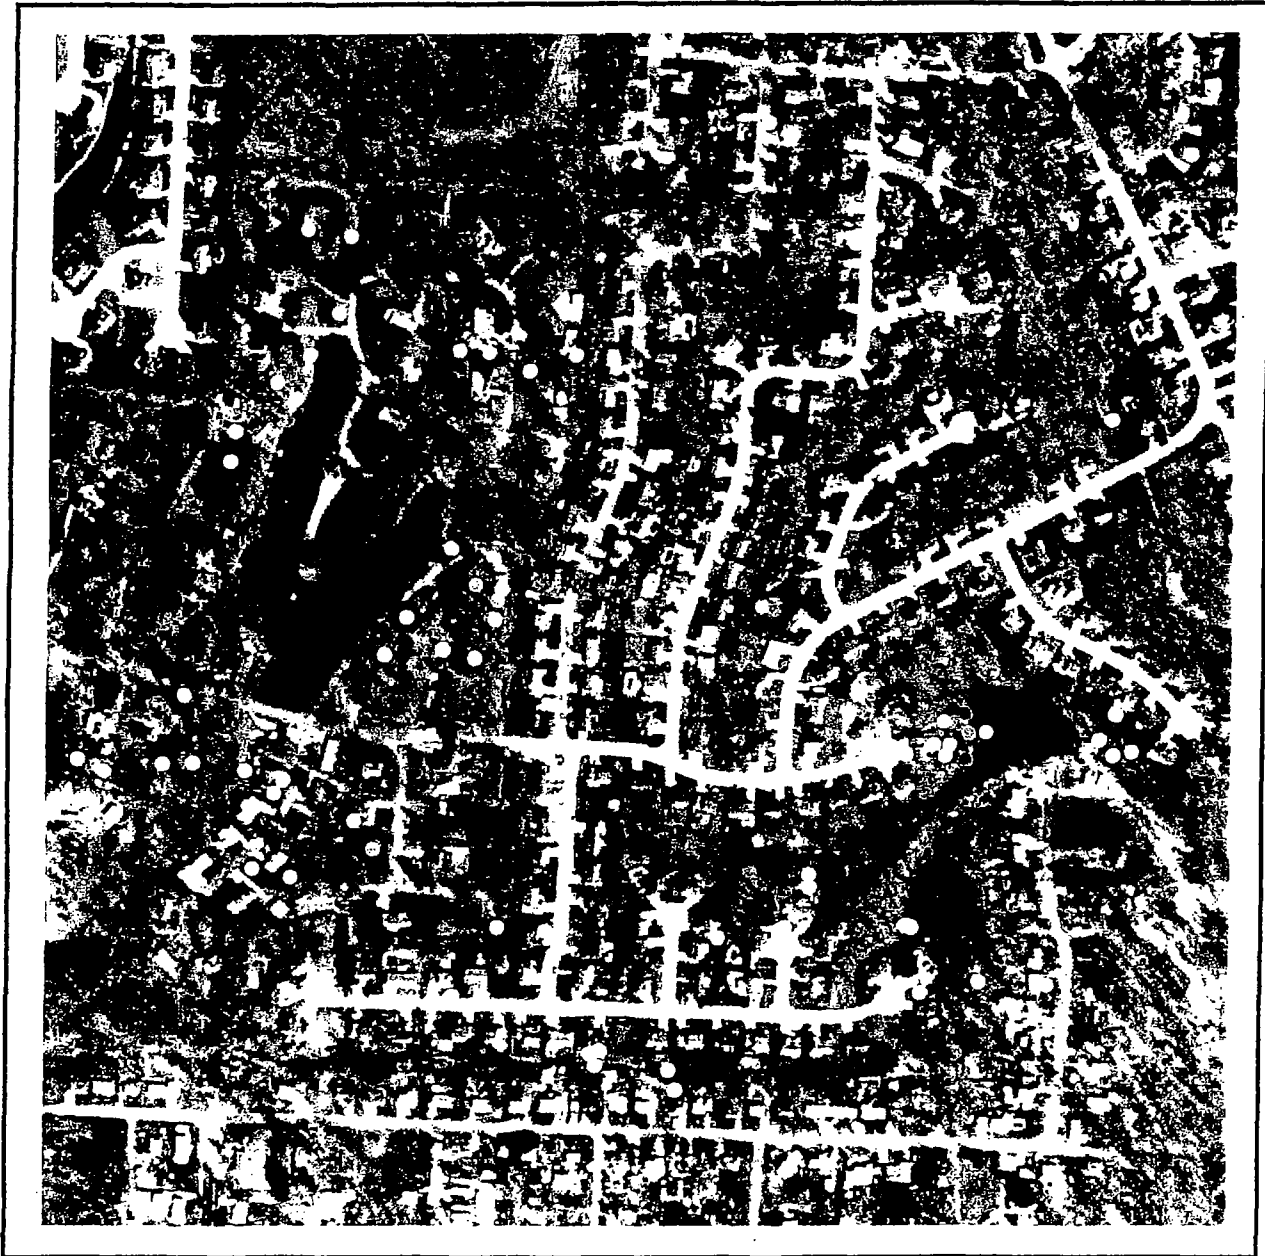
Figure 5  
Residential XRF Soil Sampling Locations  
Depth: Surface - 3 inches Below Ground Surface  
Concentrations in PPM

The XRF was used to obtain 198 readings from 51 different sampling locations on a total of 31 properties. Concentrations of lead ranged from below detection to over 90,000 ppm. Thirteen of the 31 properties tested had lead concentrations greater than 1000 ppm. Table 3 contains XRF results for lead and additional metals detected during the March 2002 investigation. Detected concentrations are compared to Illinois EPA's Residential Corrective Action Objectives as established within the Tiered Approach to Corrective Action Objectives (TACO). Figure 5 provides residential XRF locations and associated lead concentrations. Figure 6 combines 2002 XRF residential data from 0 – 3 inches below ground surface along with historical residential soil sampling data discussed in Section 1.3.

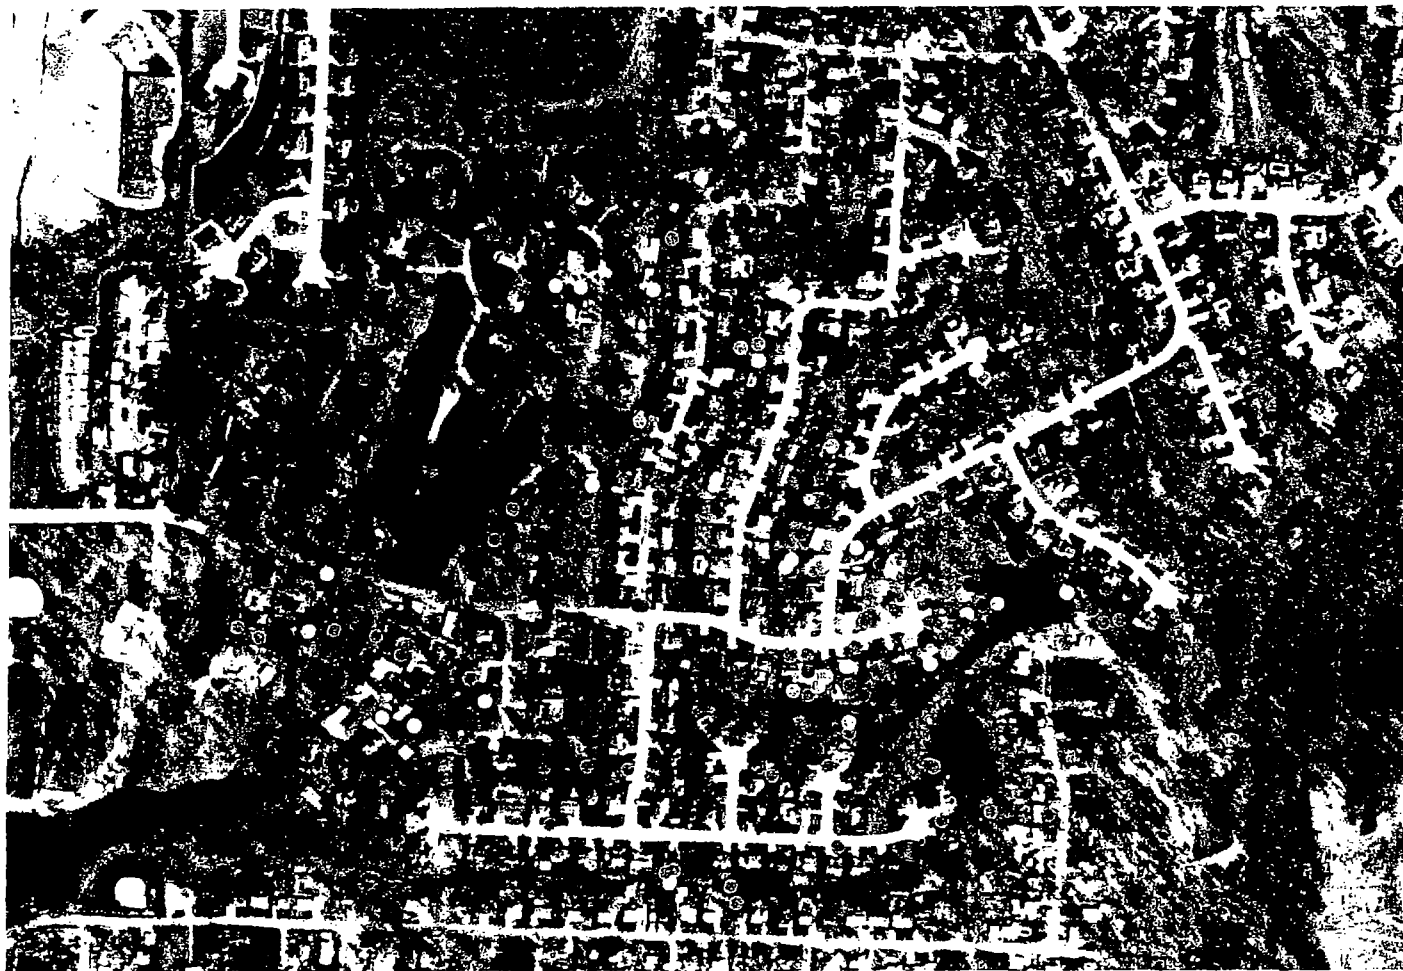
Figure 6

Historical Soil Sample Locations 1985 - 2001 and March 2002 X-ray Fluorescence Locations  
Depths: Surface - 3 inches below ground surface
