**Third Five-Year Review Report**  
**for**  
**Pine Bend Sanitary Landfill SW-45**  
**Inver Grove Heights, Minnesota**

February 2010

United States Environmental Protection Agency  
Region 5  
Chicago, Illinois

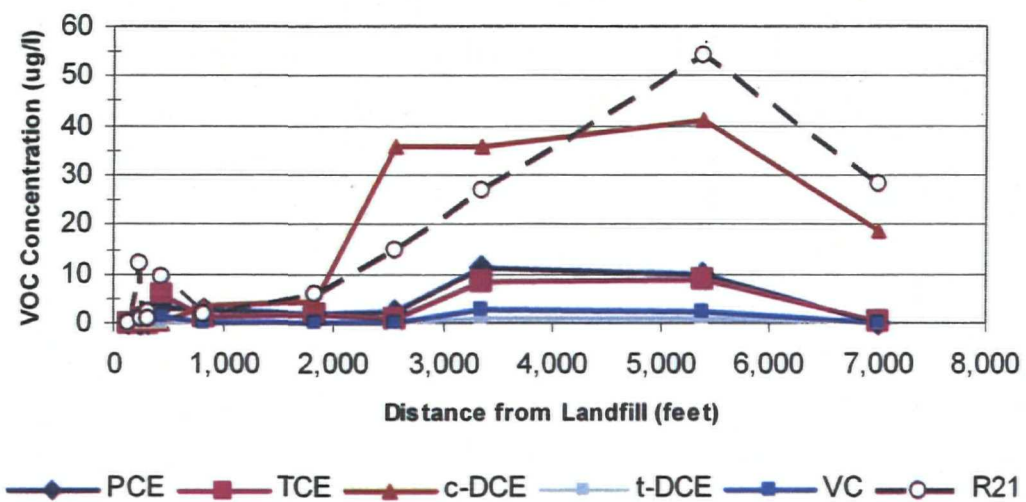
**Pine Bend Sanitary Landfill PCE and TCE Degradation Products**

**PCE and TCE Degradation Products and R21 Tracer in  
Shallow Wells and Pipeline Sping  
Distance Versus Concentration - Fall 2008**

Attachment 9 depicted the destruction of PCE and TCE down-gradient from the landfill and the appearance of biodegradation products cis-DCE and VC in the direction of groundwater transport as indicated by the VOC refrigerant dichlorofluoromethane (R21). In general, chloroethane (PCE, TCE, cis-DCE, and VC), and refrigerant concentrations continue to decrease along the flow path relative to previous years. Vertically in the aquifer, contaminant concentrations also appear to be decreasing.

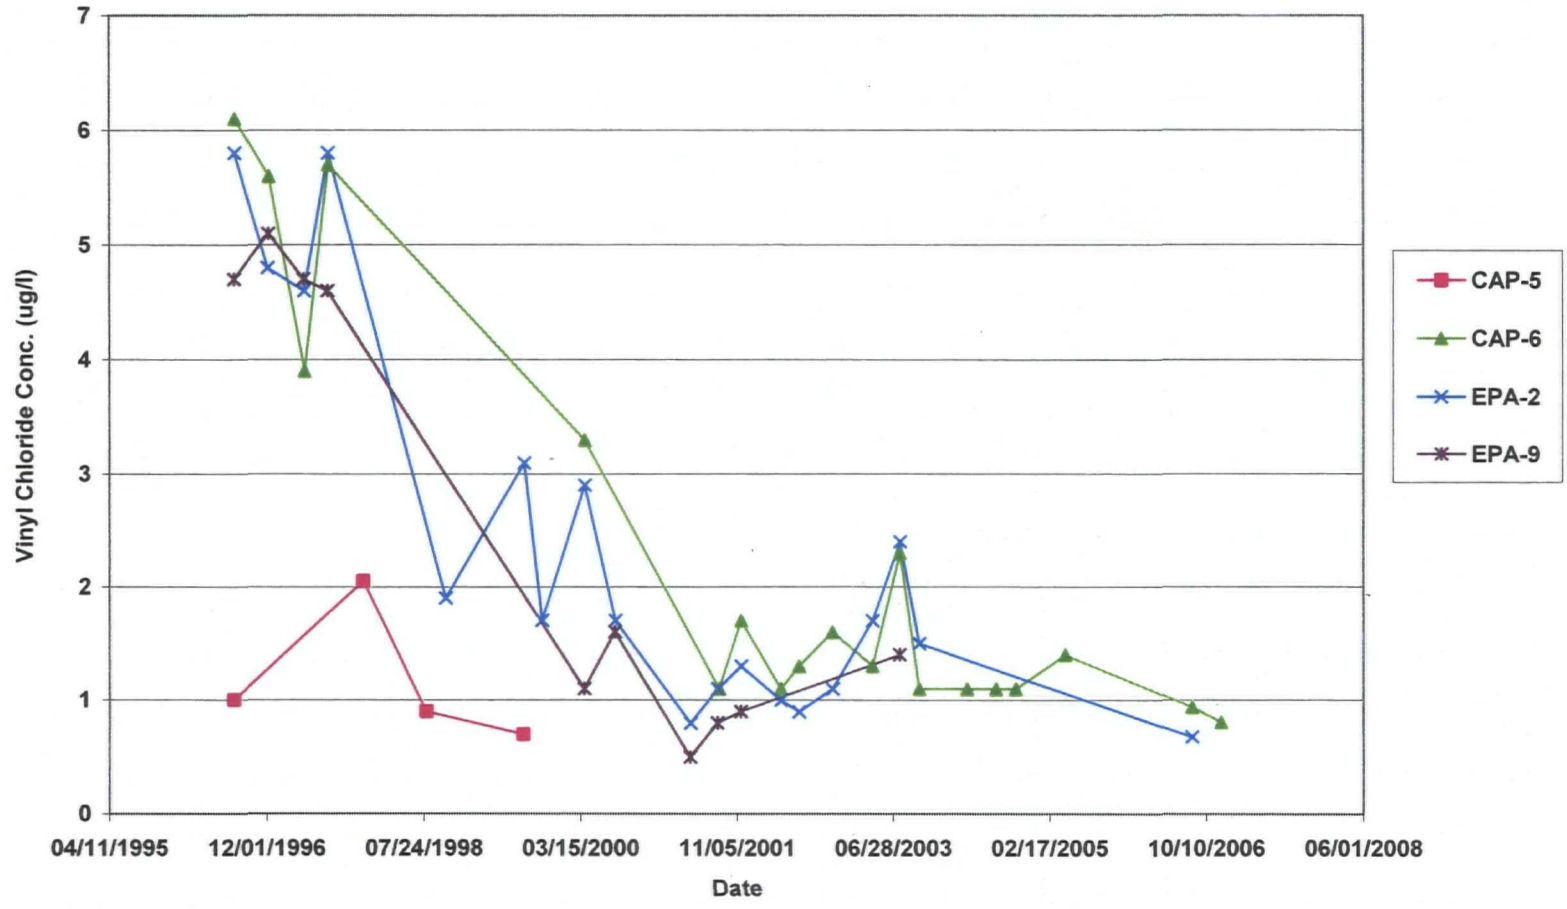
**Attachment 10**  
**Crosby American Properties Landfill Vinyl Chloride Trends**

Crosby American Properties Landfill  
 Vinyl Chloride Conc. Trends- ug/L

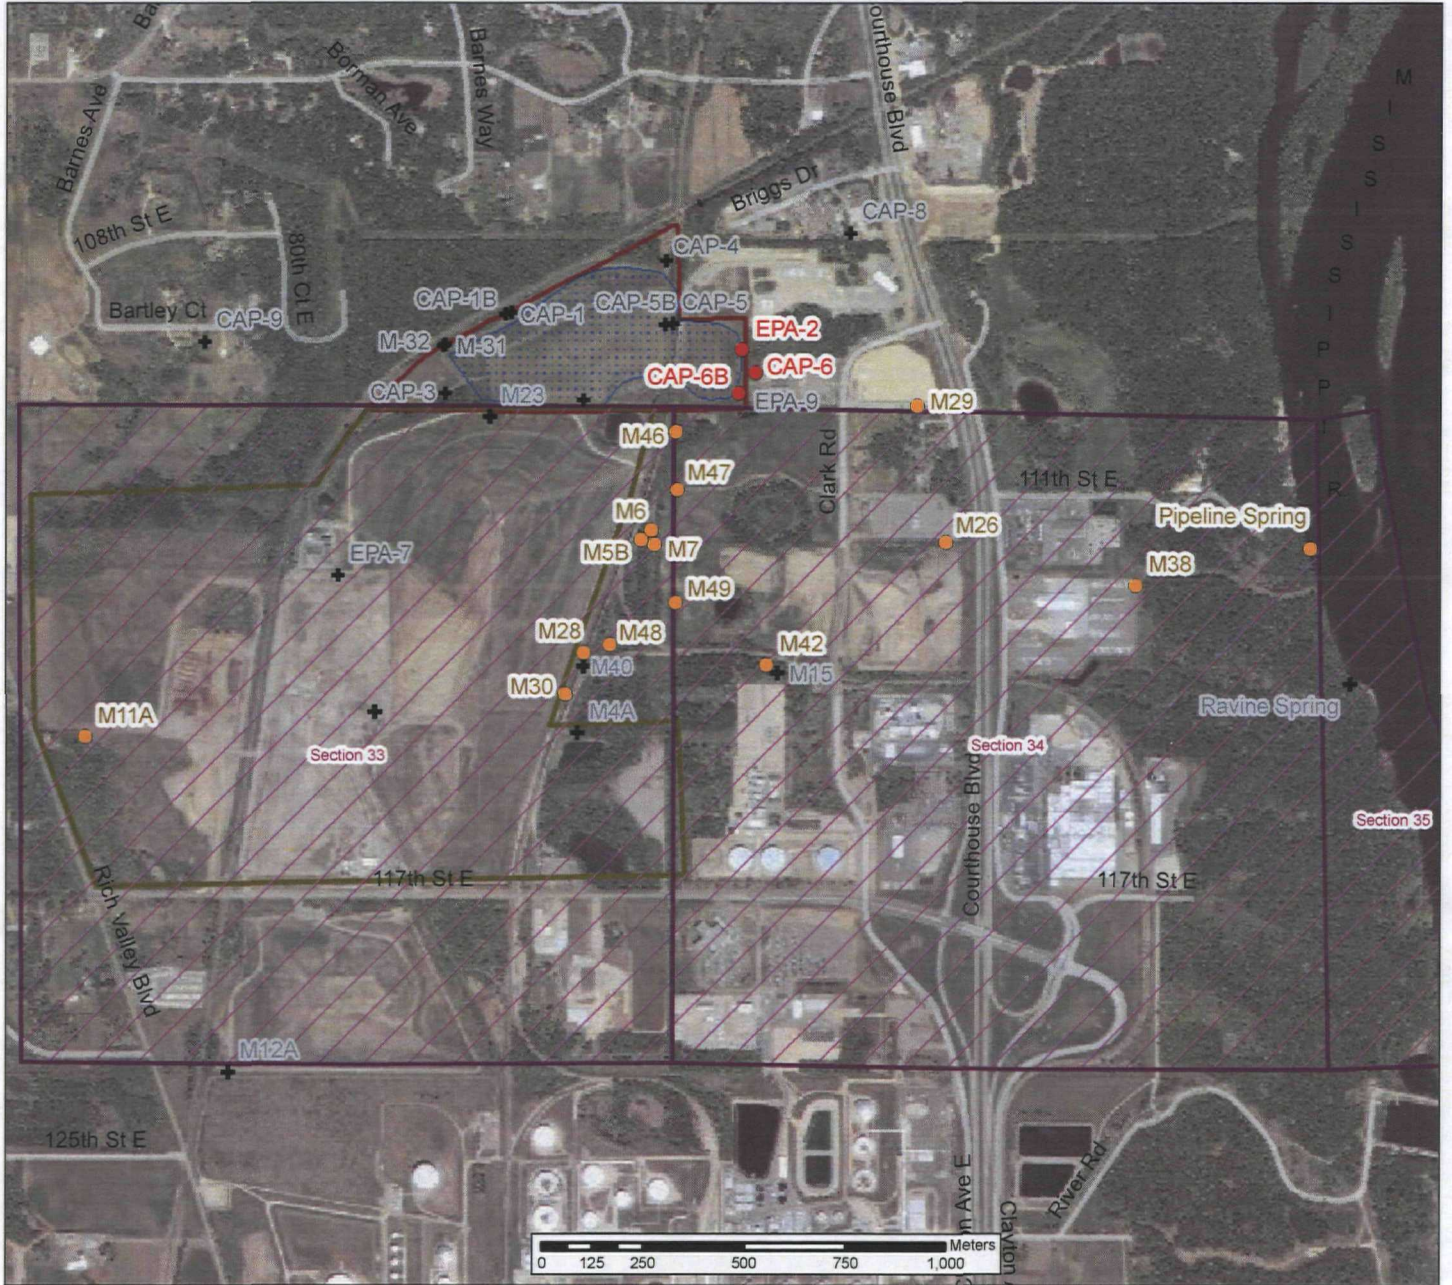
**Attachment 11**  
**Minnesota Special Well Construction Area Map**

Pine Bend Sanitary Landfill  
Dakota County, MN

without first obtaining a permit from the city. The PBSL and Crosby American Properties Landfill are covered under the Inver Grove Heights Code 715.0.5. EPA recommends that the Minnesota Department of Health extend the special well construction area to include the Crosby American Properties Landfill plume area as well but it is not critical as the concentrations of vinyl chloride are approaching non-detect in all wells. The Crosby American Properties Landfill plume is discussed further in Section VI.
