WETLAND DELINEATION

**NORTH SANITARY LANDFILL
DAYTON, MONTGOMERY COUNTY, OHIO**

**Prepared For:
Valleycrest Landfill Site Group**

**JUNE 2001
REF. NO. 16816 (2)**

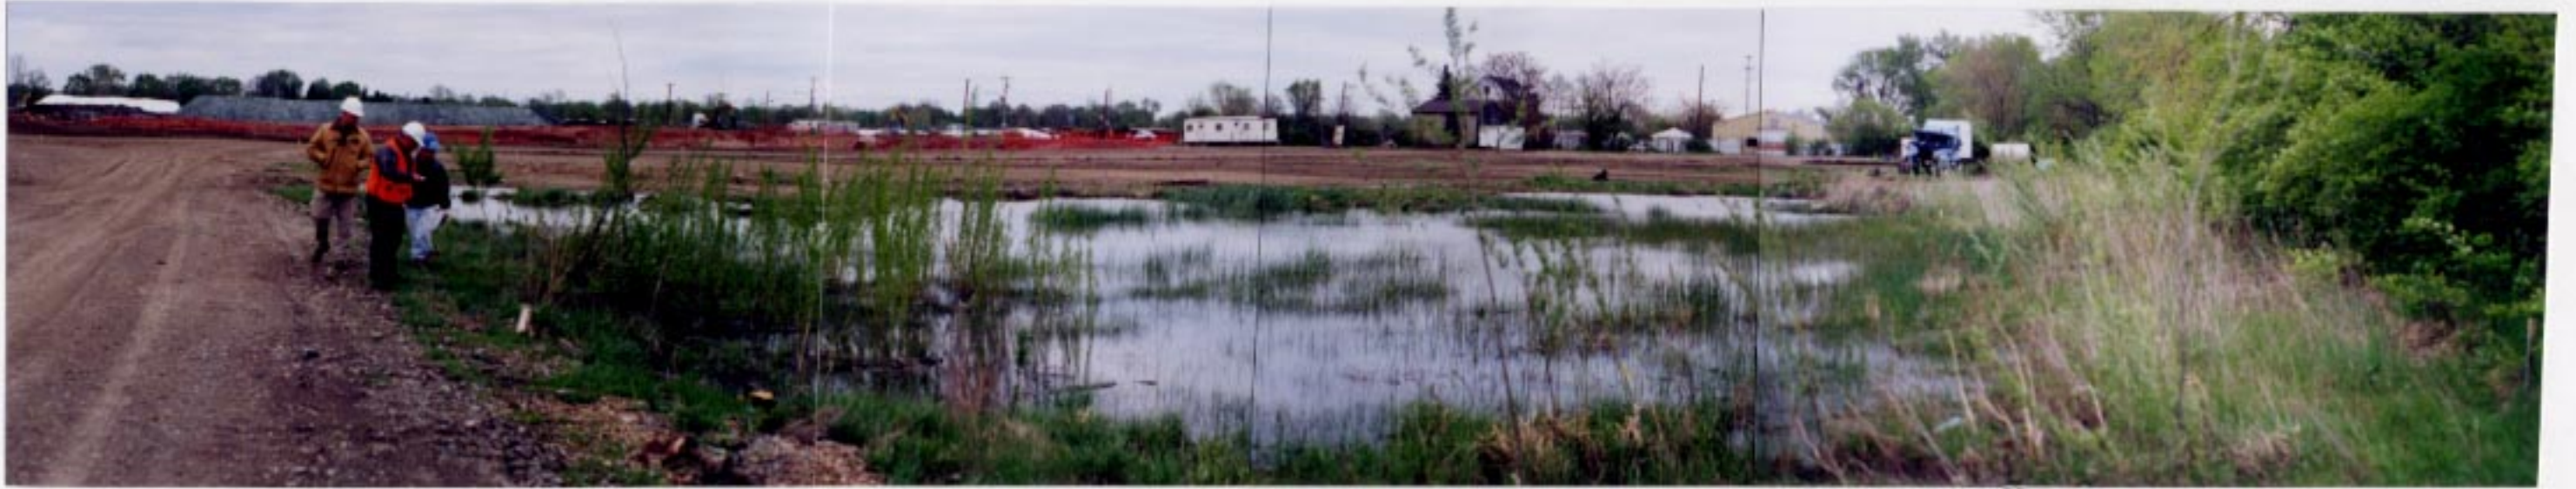
PHOTOGRAPH 1: Sample Location 1.

Hydrophytic Vegetation Present (Yes) (Circle) No Wetland Hydrology Present? (Yes) (Circle) No Hydric Soils Present? Yes (No) (Circle)	Is this Sampling Point Within a Wetland? (Yes) (Circle) No
Remarks: Soil observed is inundated and saturated, and appears to remain so for a significant portion of the growing season.

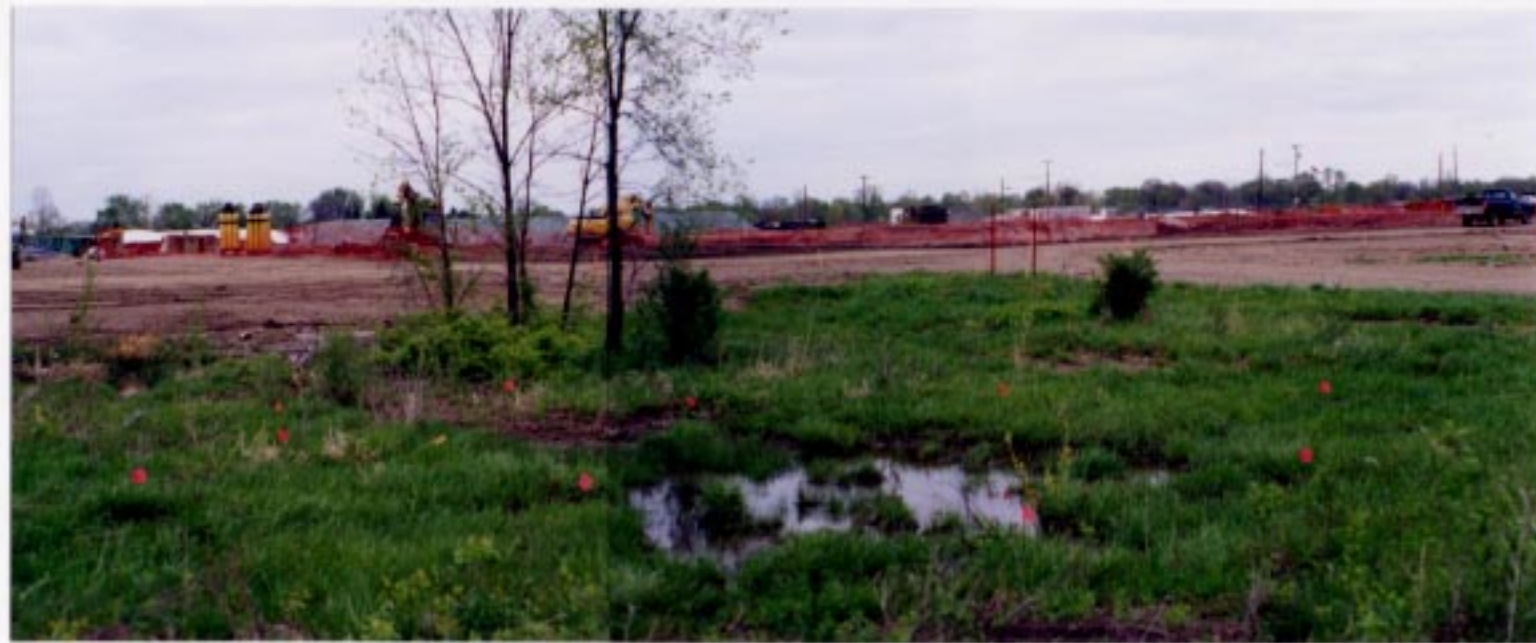
PHOTOGRAPH 2: Sample Location 2.

Hydrophytic Vegetation Present (Yes) (Circle) No Wetland Hydrology Present? (Yes) No Hydric Soils Present? Yes (No)	(Circle) Is this Sampling Point Within a Wetland? (Yes) No
Remarks: Soil observed is inundated and saturated, and appears to remain so for a significant portion of the growing season.

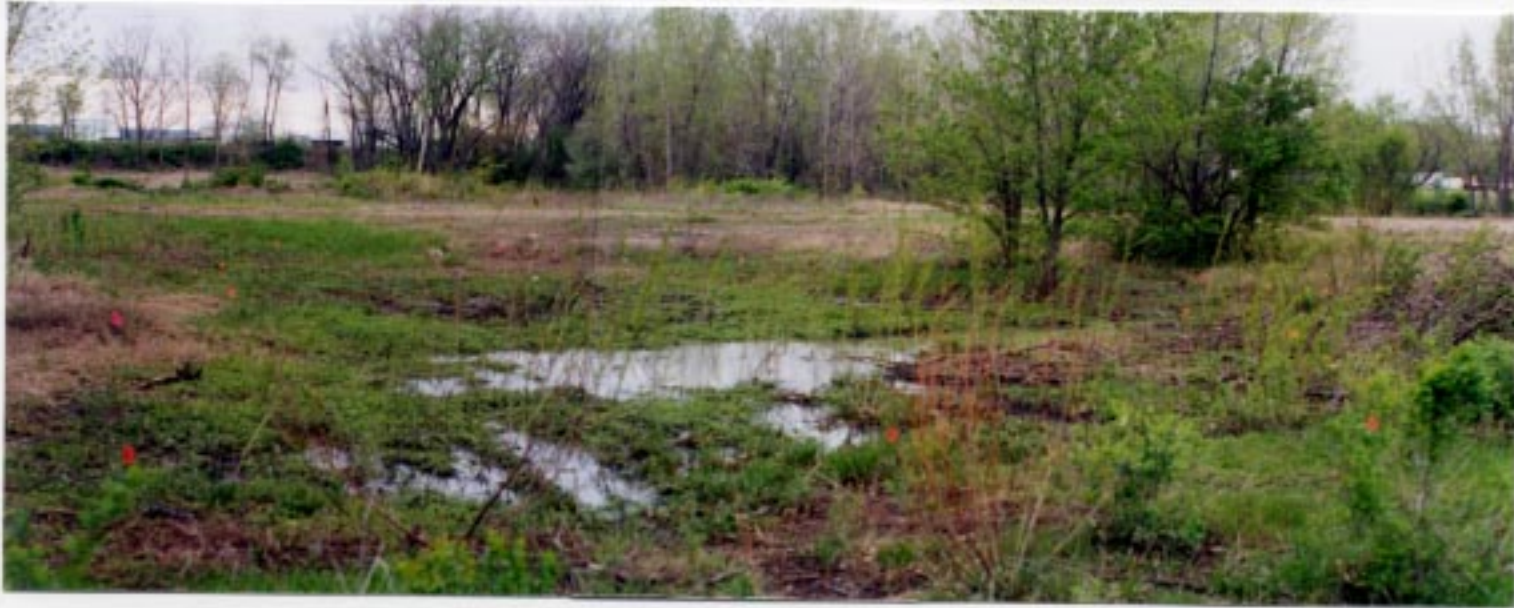
PHOTOGRAPH 3: Sample Location 3.

Hydrophytic Vegetation Present	(Yes)	(Circle)	No	
Wetland Hydrology Present?	(Yes)		No	
Hydric Soils Present?	Yes		(No)	Is this Sampling Point Within a Wetland? (Yes) No
Remarks: Soil observed is inundated and saturated, and appears to remain so for a significant portion of the growing season.
