**FIVE-YEAR REVIEW REPORT FOR  
PINE BEND SANITARY LANDFILL SUPERFUND SITE  
DAKOTA COUNTY, MINNESOTA**

**U.S. Environmental Protection Agency  
Region 5  
Chicago, Illinois**

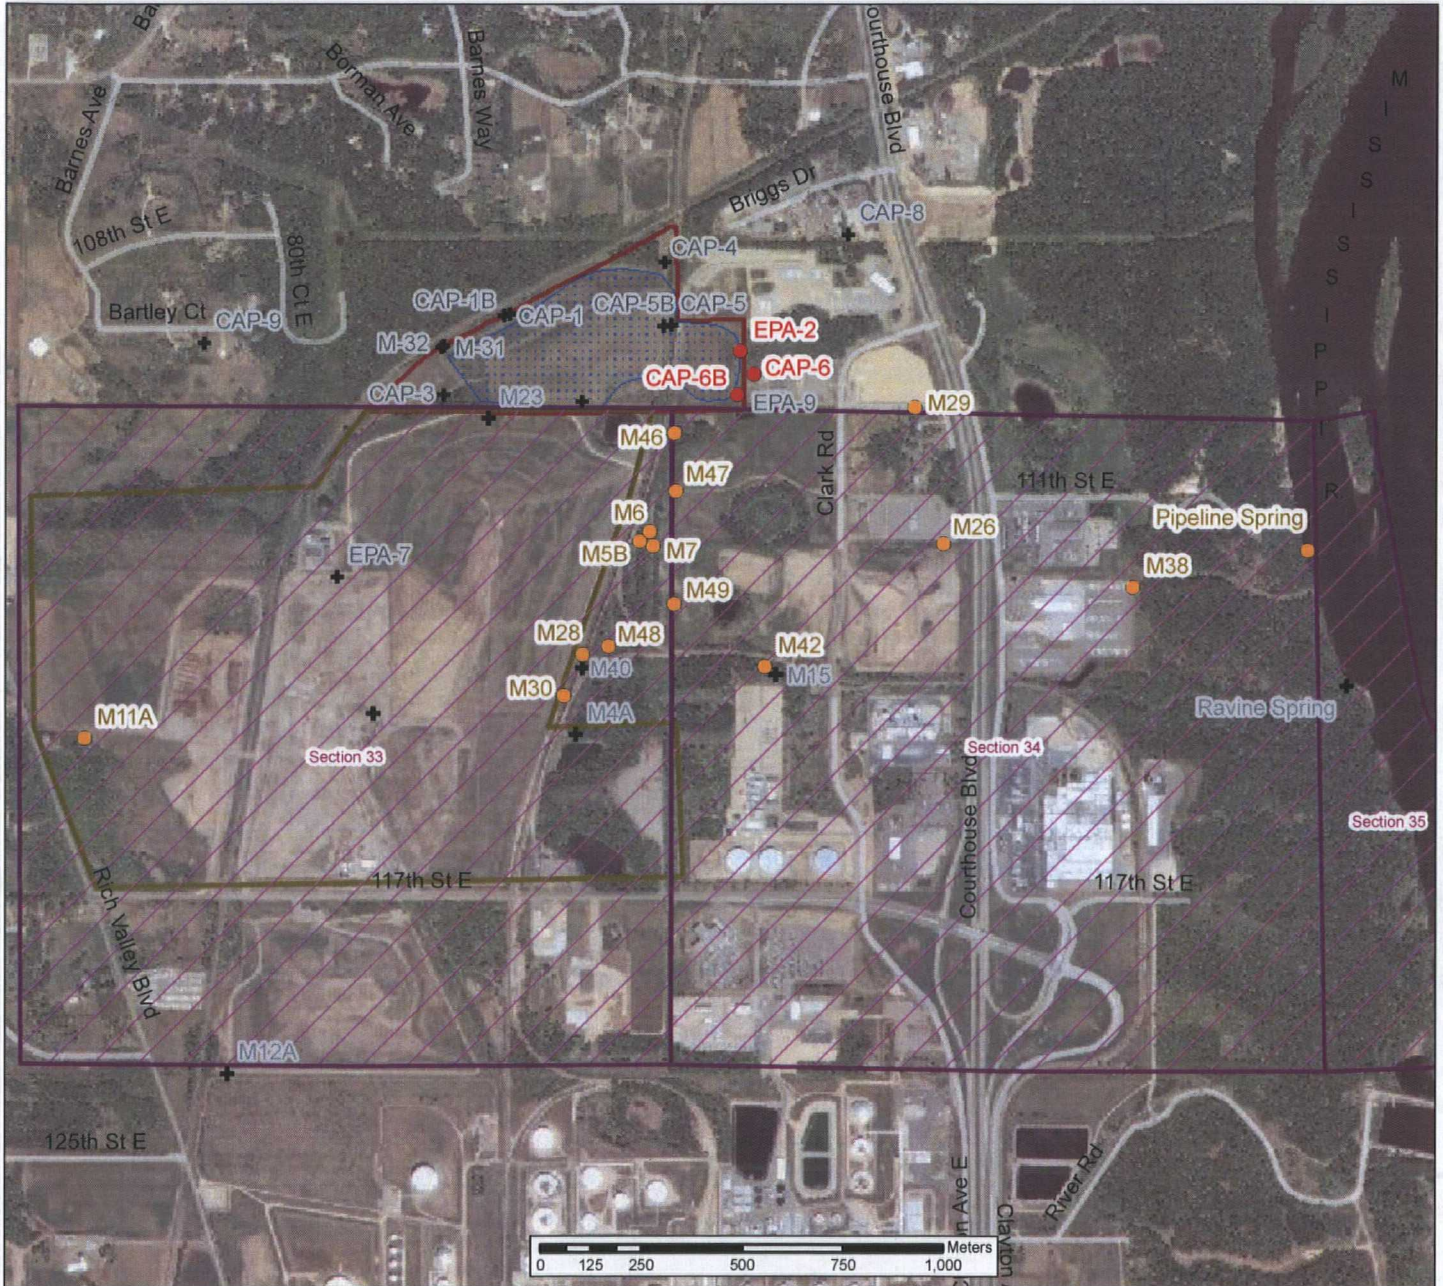
- Wells with Exceedances: Pine Bend Landfill\*\*
- Wells with Exceedances: Crosby American Landfill\*
- ⊕ Other Wells\* \*\*
- ▭ Pine Bend Landfill site boundary\*\*
- ▭ Crosby American Landfill site boundary\*
- ▭ Crosby American: Limit of Waste\*
- ▭ Sections with Institutional Controls^

Groundwater samples analyzed from the monitoring network included a total of five metals that exceeded groundwater ILs in July 2013. These metals consisted of arsenic (well M-5B), barium (well M-5B), boron (well, M-26, M-38, and M-46), manganese (wells M-5B, M-6, M-7, M-28, M-30, M-46, M-47, M-48, M-49 and Pipeline Spring), and nickel (M-46). Nitrate also exceeded the IL value at three wells (M-11A, M-15 and M-49) in 2013. Manganese is a naturally occurring element that is associated with iron-oxide coating on the aquifer sand grains. In the degradation of carbon-containing material and under anaerobic conditions, bacteria will reduce manganese oxides found on sand-grain coating and increase its solubility. Barium is also a natural occurring element that is known to substitute for magnesium and calcium cations in carbonate minerals. Nitrates are typically derived from fertilizers and are anticipated to be consumed by microbes in locations where dissolved organic carbon is present.
