HRS DOCUMENTATION RECORD

Name of Site: Old American Zinc Plant

Date Prepared: September 2015

EPA ID No. IL0000034355

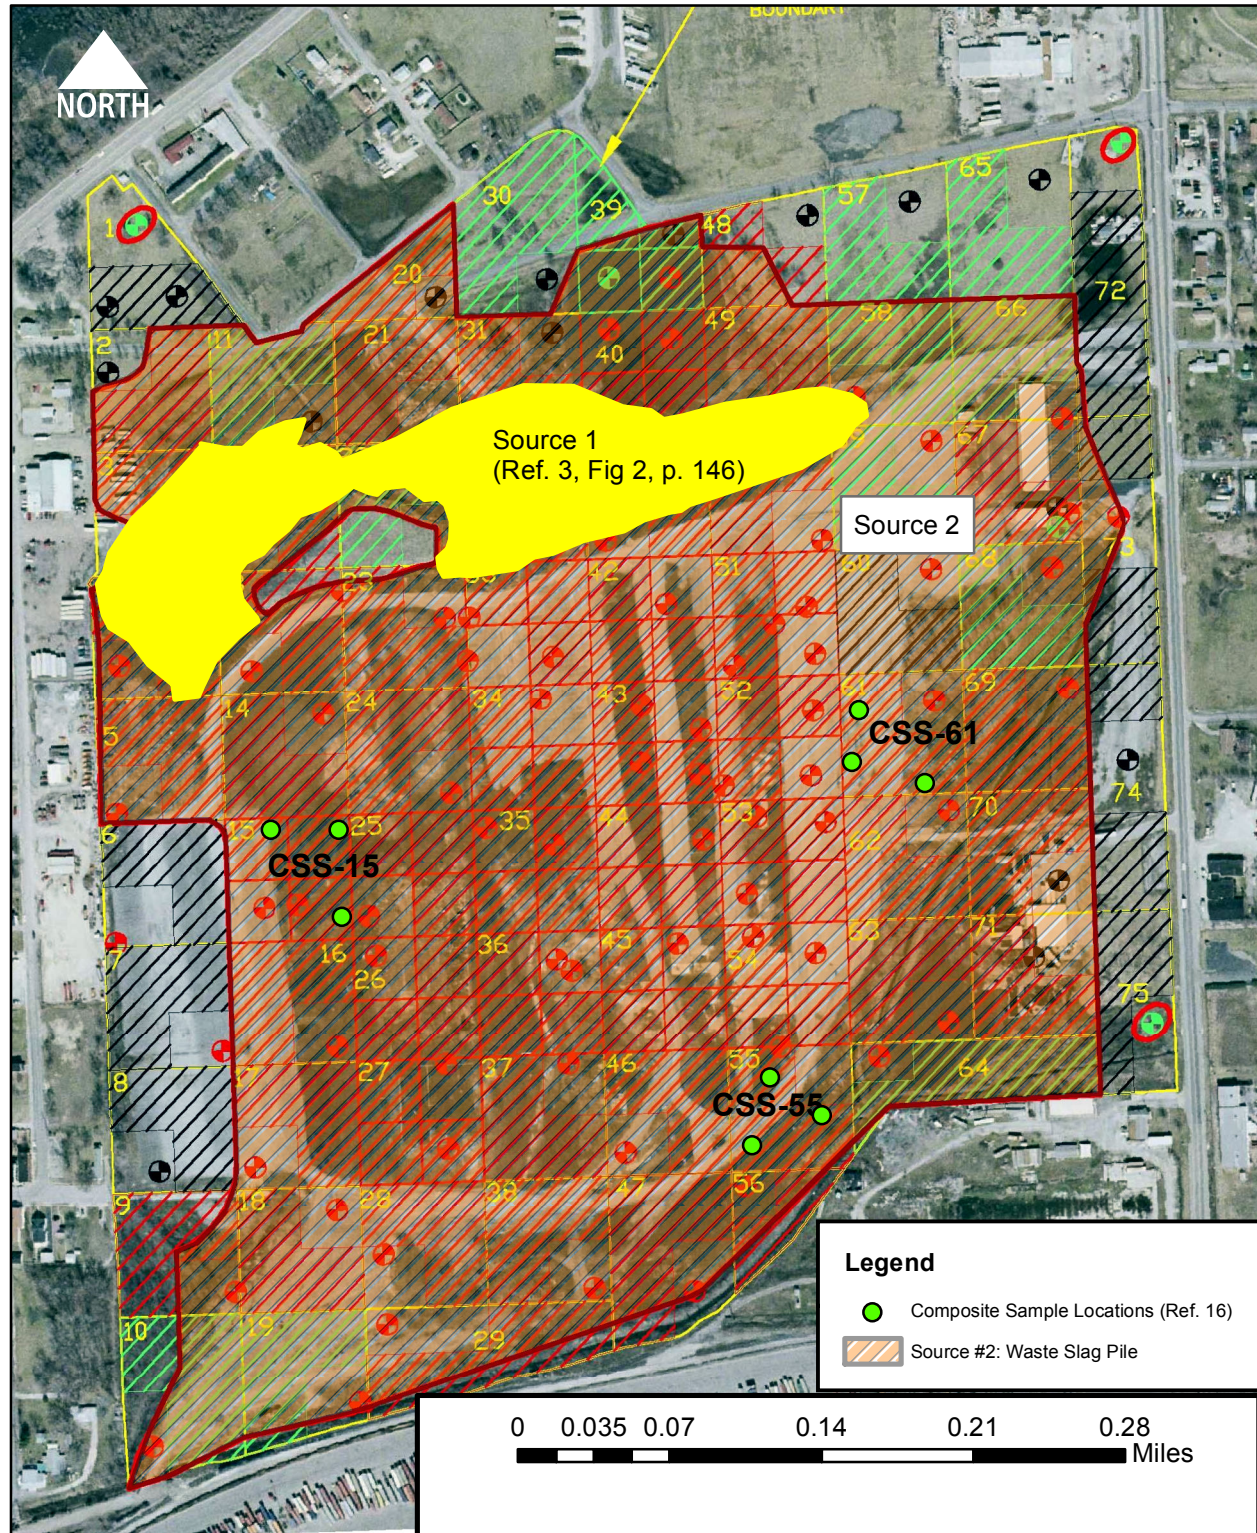
Figure 7
Area of Source #2
Old American Zinc Plant

Illinois State Geological Survey. Prairie Research Institute. University of Illinois at Urbana-Champaign. Illinois Geospatial Data Clearing House. Access 2005 DOQQ files for Illinois by County Universal Transverse Mercator (UTM) Zones 15 and 16, St. Clair, Monks Mound Quadrangle, SW section. <http://www.isgs.uiuc.edu/nsdihome/webdocs/doq05/county/stclair.html>. Accessed on June 15, 2015. Ref. 9 explains how area was calculated. Ref. 3, Fig. 19, p. 166 was used for sample locations. Basemap was provided by Surdex, Chesterfield, MO (2005 Ortho-Rectified Aerial Photograph). Composite Sample Locations (Ref. 16)

Sample ID	Lab Sample ID	Sample Type	Sampling Date	Hazardous Substance	Hazardous Substance Concentration (mg/kg)	Method Detection Limit*	Reference
CSS-15	246903-5	Slag (Ref. 3, Table 4-4, p. 208, Table B.1.a-1, p. 4510)	6/2/2006	Arsenic Cadmium Mercury Lead Zinc	480 260 3.7 23,000 110,000	0.34 0.054 0.13 23 130	Ref. 3, Appendix L p. 1583, 1588, 1639, 1640; Ref. 16, p. 4; Fig. 7 of this HRS documentation record
CSS-55	247049-9	Slag (Ref. 3, Table 4-4, p. 209, Table B.1.a-1, p. 4511)	6/8/2006	Arsenic Cadmium Mercury Lead Zinc	280 190 3.8 11,000 46,000	0.38 0.059 0.64 51 280	Ref. 3, Appendix L p. 1959, 1968, 2025, 2026; Ref. 16, p. 4; Fig. 7 of this HRS documentation record
CSS-61	247049-19	Slag (Ref. 3, Table 4-4, p. 210, Table B.1.a-1, p. 4511)	6/8/2006	Arsenic Cadmium Mercury Lead Zinc	350 310 43 11,000 59,000	0.39 0.062 0.68 53 290	Ref. 3, Appendix L p. 1959, 1978, 2025, 2026; Ref. 16, p. 4; Fig. 7 of this HRS documentation record
