**REMOVAL ASSESSMENT REPORT
ELECTRO PLATING SERVICES SITE - RS
MADISON HEIGHTS, OAKLAND COUNTY, MICHIGAN**

FINAL Report

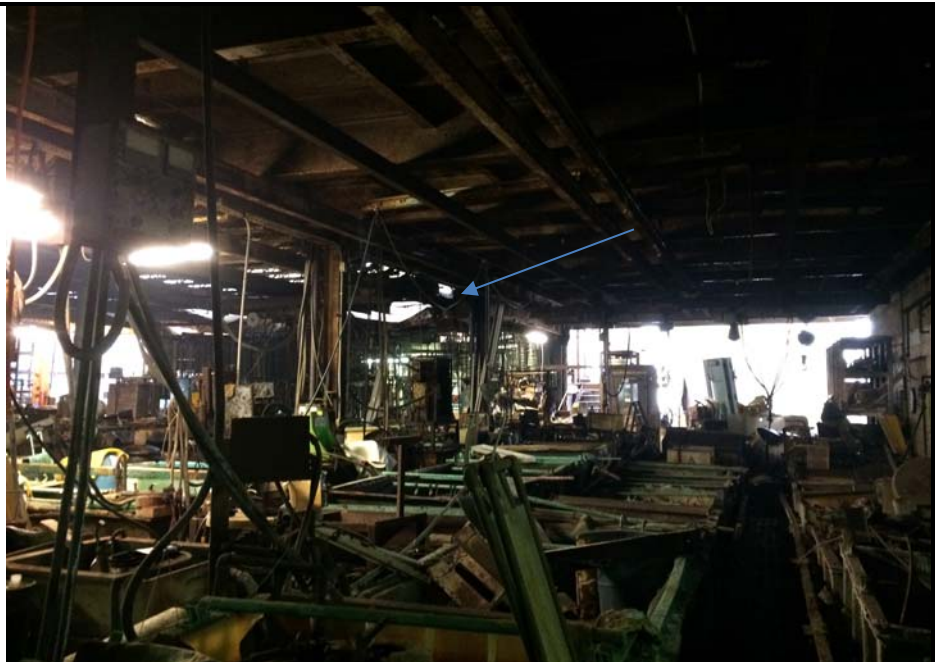
Official Photograph No.1: Second
level general layout of facility.
Ceiling caving is depicted in this
photograph

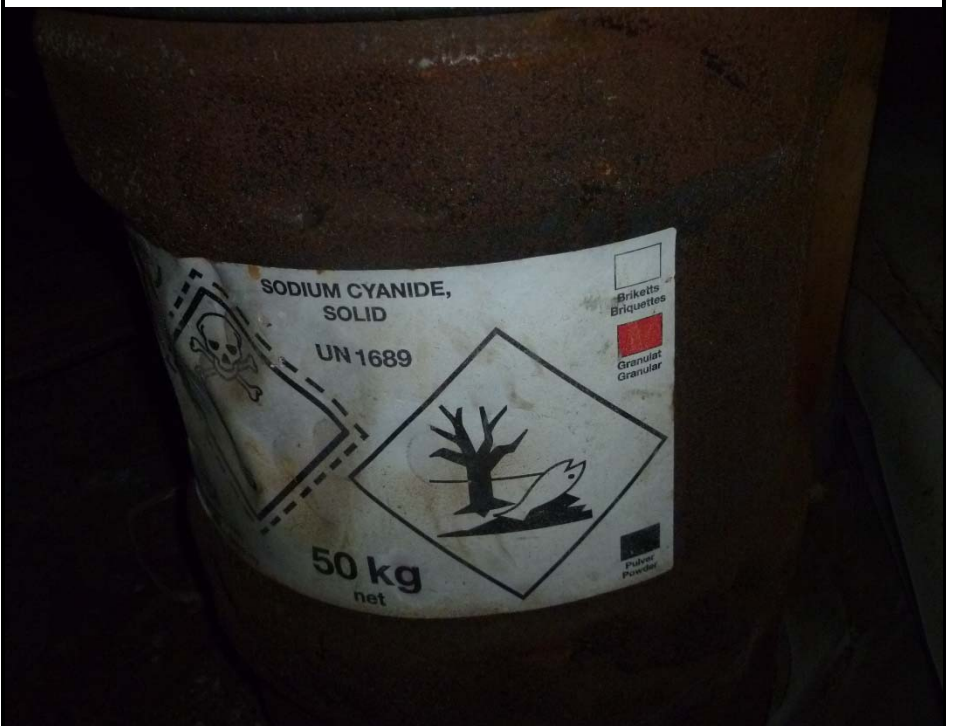
Official Photograph No.2: Rusty
metal drum with sodium cyanide
label.

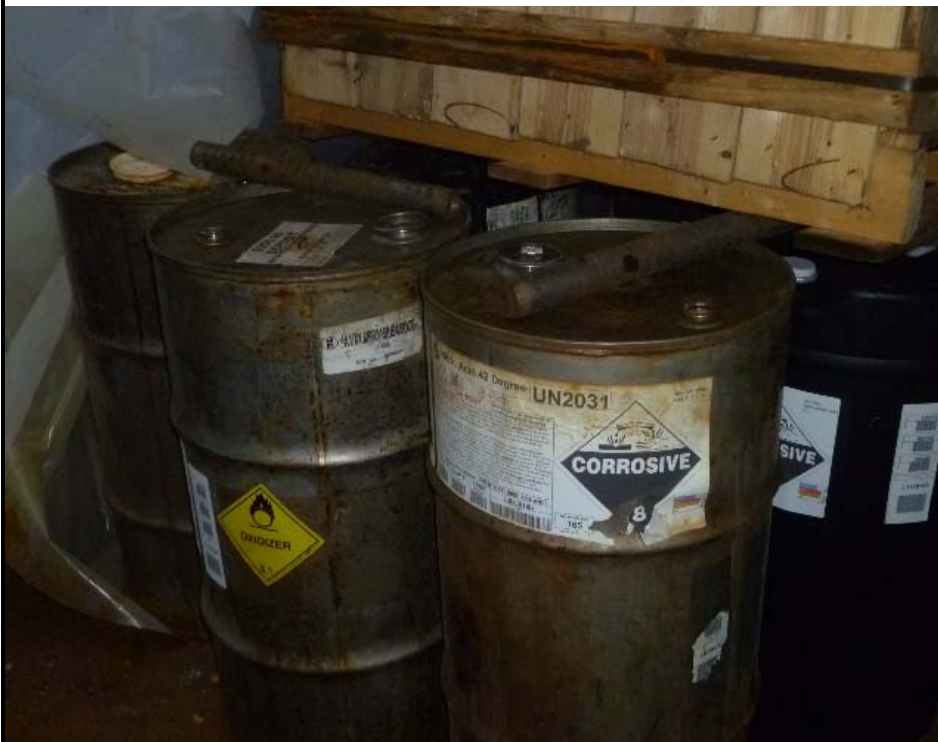
Official Photograph No.3: Oxidizer
 and Corrosive containers stored next
 to each other. Containers were not
 sampled due to safety concerns.

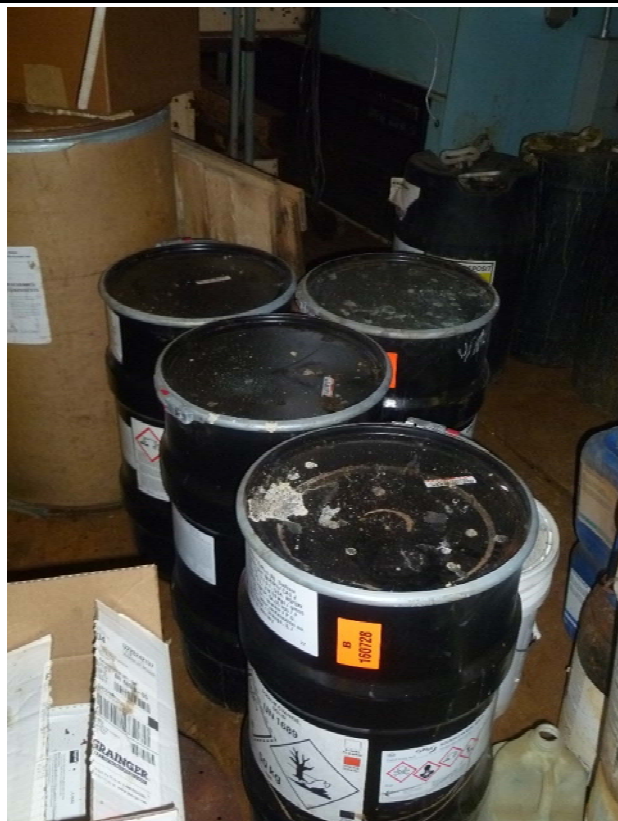
Official Photograph No.4: Suspected
 sodium cyanide containers.
 Containers were not sampled due to
 safety concerns.

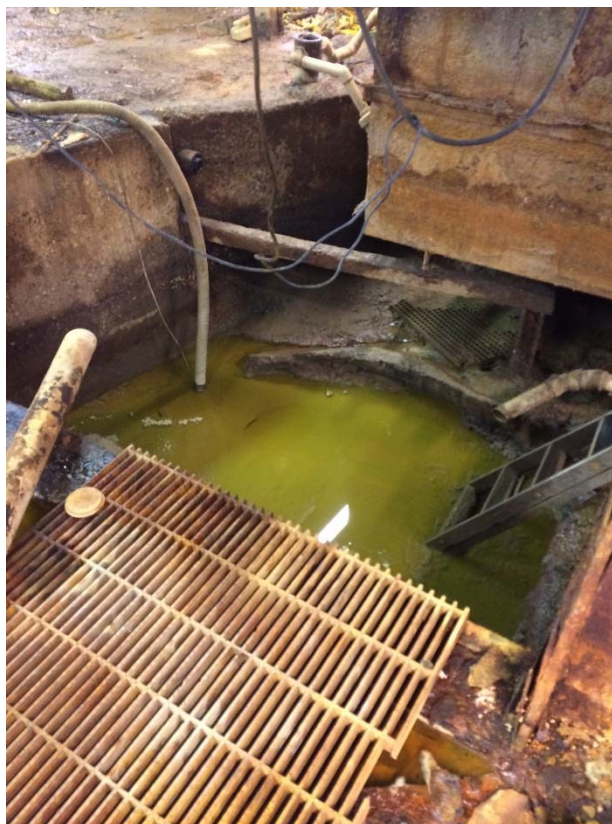
In the basement area, the floor was a combination of concrete and exposed soil. Near the center of the basement, the “pit” as described by MDEQ, was observed containing a pool of greenish hue sludge/liquid (Photographs 5, Appendix C). In one area, a berm allegedly made from hazardous sludge, held plating operations waste/sludge that was once at the bottom of the “pit.” Along the walls of the basement were numerous containers (opened and unopened) of liquids, sludges, and solid material. SRS documented one 55-gallon metal drum labeled “Trichloroethene.” Many of the containers assumed to hold waste from the

Official Photograph No.5: Pit in the
 middle of the basement with
 liquid/sludge

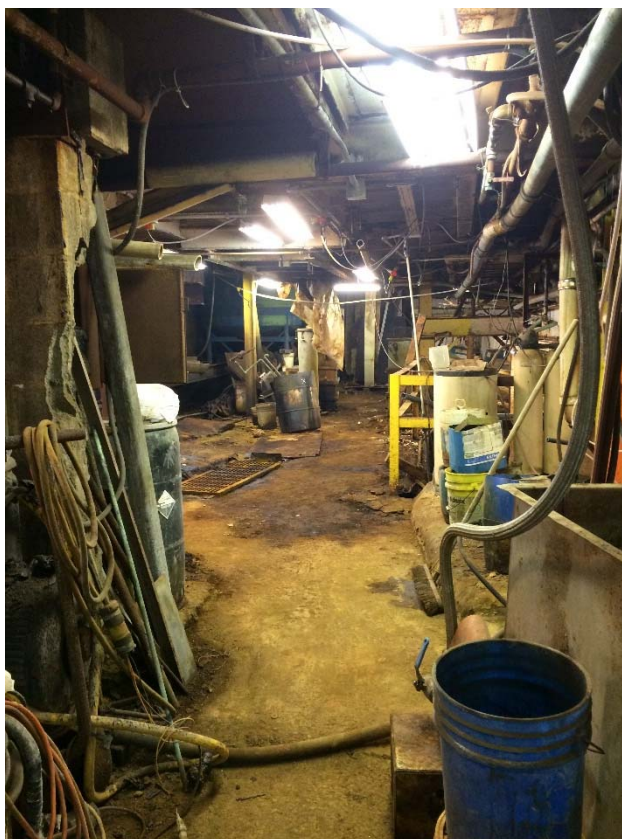
plating operations were in unmarked buckets, plastic jugs (1-5 gallon capacities) or 55-gallon plastic drums that were sawed in half (Photograph 6, Appendix C). There were visible areas where leaks from the floor above the basement had corroded the cement in the basement and parts of the ceiling of the basement were extremely corroded (Photograph 7 and 8, Appendix C). Staining of the floor and soil in the basement were visible.

Official Photograph No.6:
 Open containers of various types in the
 basement of the facility. Also in view is
 the stained and corroded floor

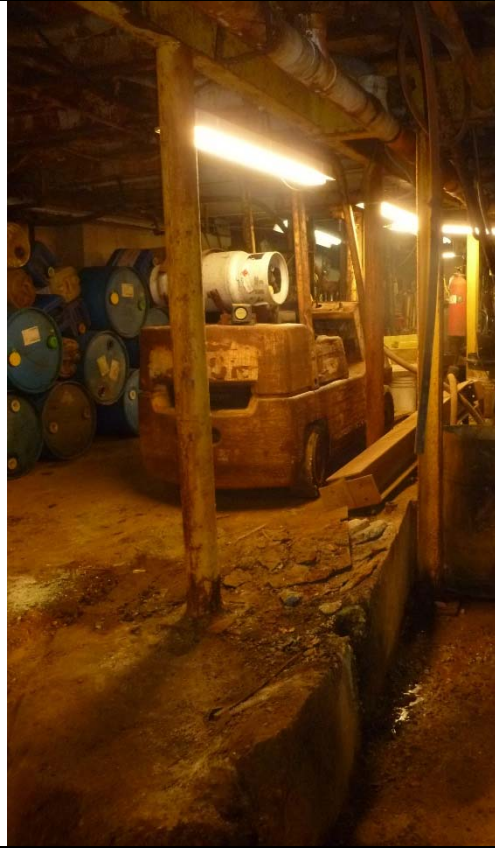
Official Photograph No.7: Corroded
basement floor from waste dripping
from the ceiling

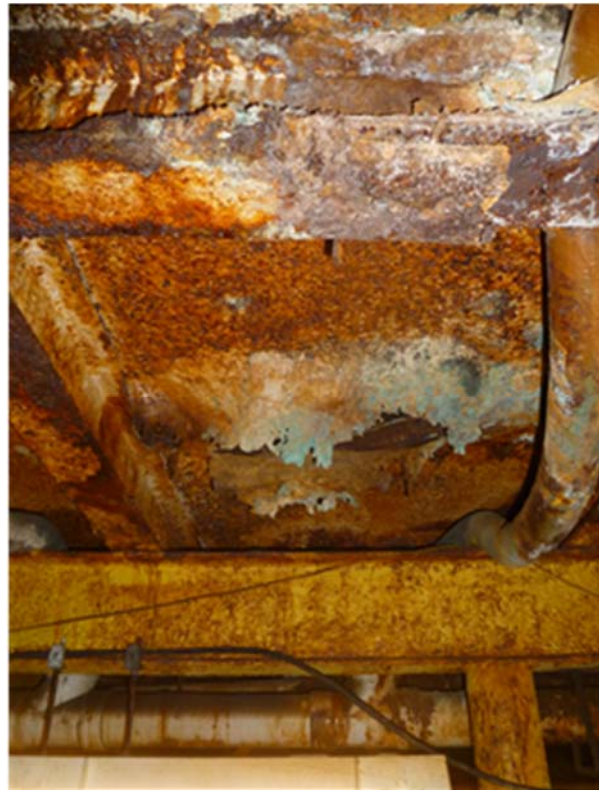
Official Photograph No.8: Corroded
ceiling of the basement

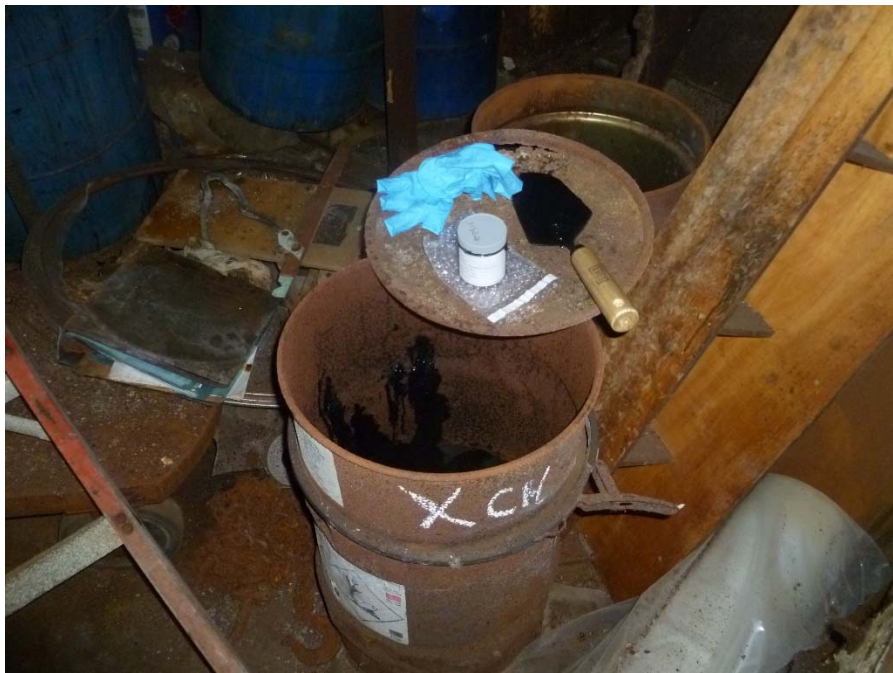
Sample ID: EPS-1

One sample (EPS-1) was analyzed for total and amenable cyanide collected from a rusted metal drum with a label, “Sodium Cyanide” affixed to the drum. The sample collected from the drum was a black sludge material (see Photograph 9, Appendix C). Total cyanide was detected at a concentration of 0.95 ppm of cyanide. The presence of cyanide in the sample as well as the four documented drums labeled as containing sodium cyanide at the Site potentially meets the Characteristic of Reactivity as outlined in 40 CFR 261.23(a)(5).

Rusted metal drum with sodium cyanide label.

Sample description: Black sludge material

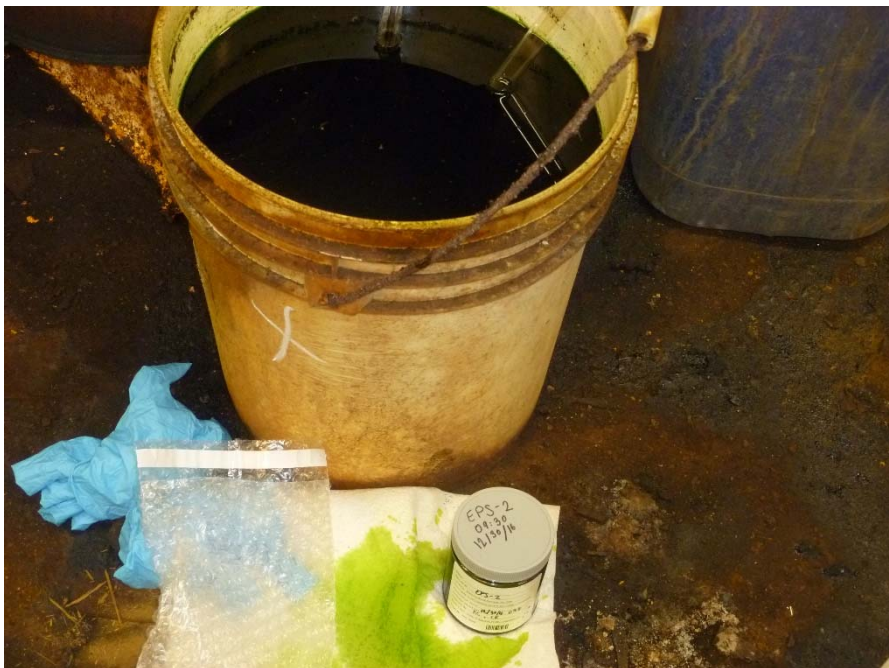
Sample ID: EPS-2

Sample description: Dark Green liquid

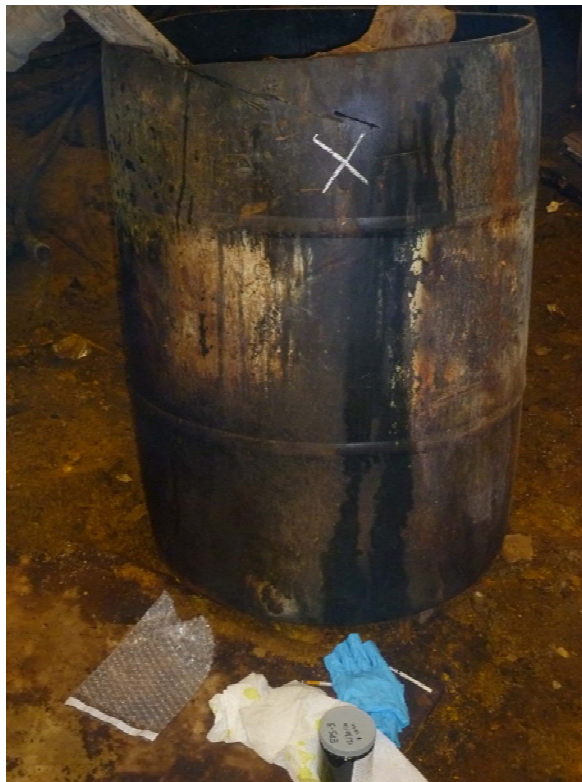
Official Photograph No.11:
 55-gallon plastic drum that appears to
 have been used to store waste located in
 basement of the facility.
 Sample ID: EPS-3
 Sample description: Black liquid

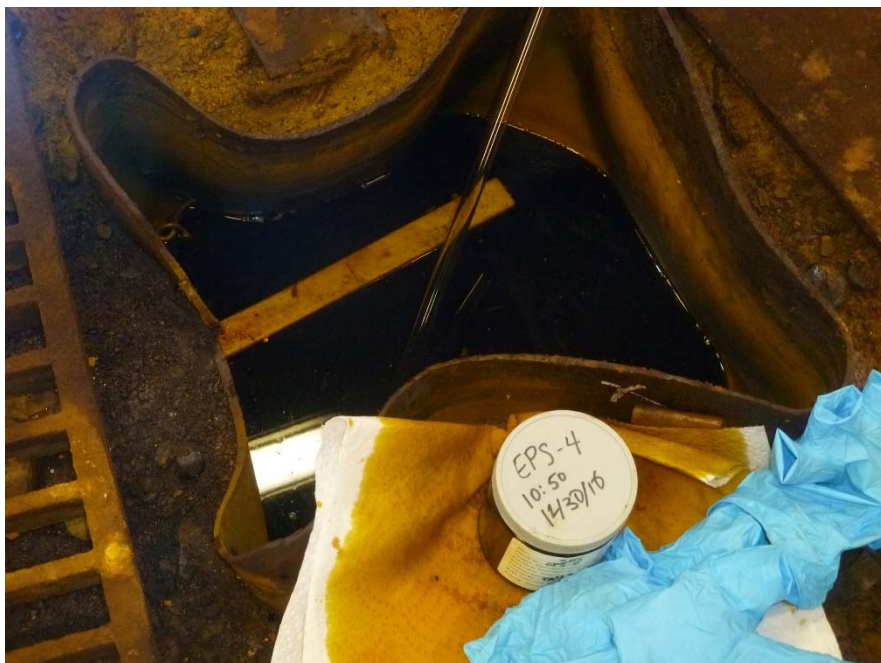
Official Photograph No.12: Makeshift
 container buried in the floor of the
 basement holding liquid waste.
 Sample ID: EPS-4
 Sample description: Brownish/orange
 liquid.

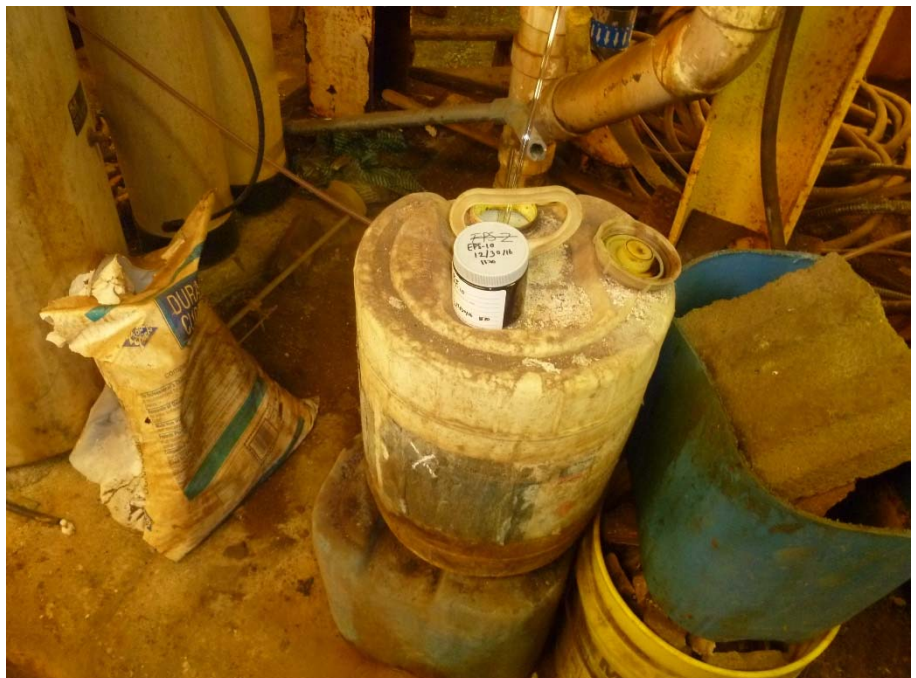
Sample ID: EPS-10

5-gallon plastic container located labeled "corrosive" in basement of facility

Sample description: Black liquid with greenish tint

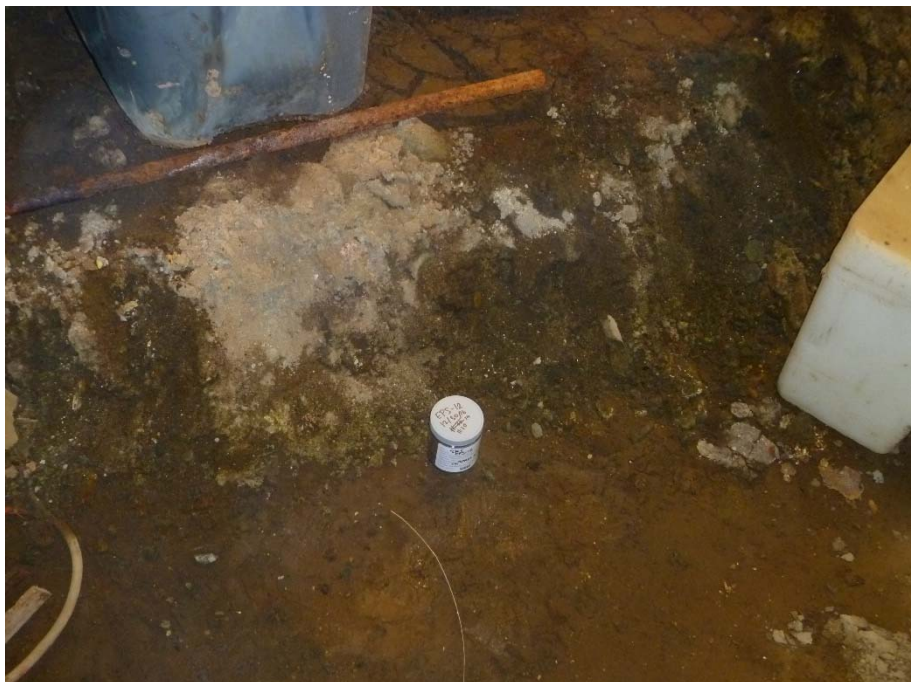
Sample ID: EPS-12

Berm reportedly made from hazardous waste surrounding an area used to dry sludge.

Sample description: Green/black/brown granular solid material

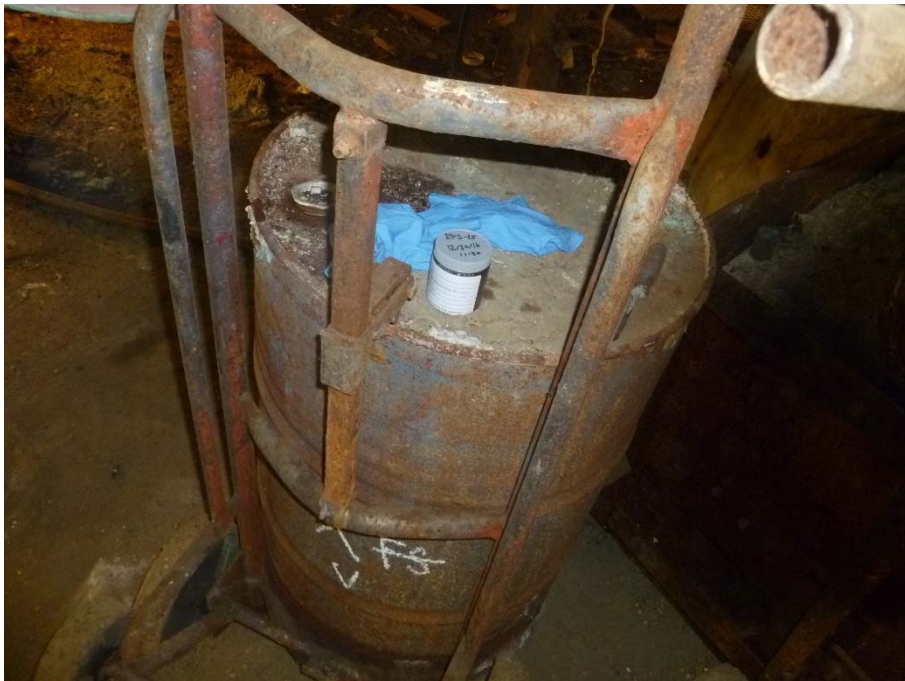
Sample ID: EPS-15

Rusted 55-gallon metal drum labeled
"Trichloroethene".

Sample description: Transparent liquid
