**FOURTH FIVE-YEAR REVIEW REPORT FOR  
PENTA WOOD PRODUCTS SUPERFUND SITE  
BURNETT COUNTY, WISCONSIN**

**U.S. Environmental Protection Agency  
Region 5  
Chicago, Illinois**

6/17/2020

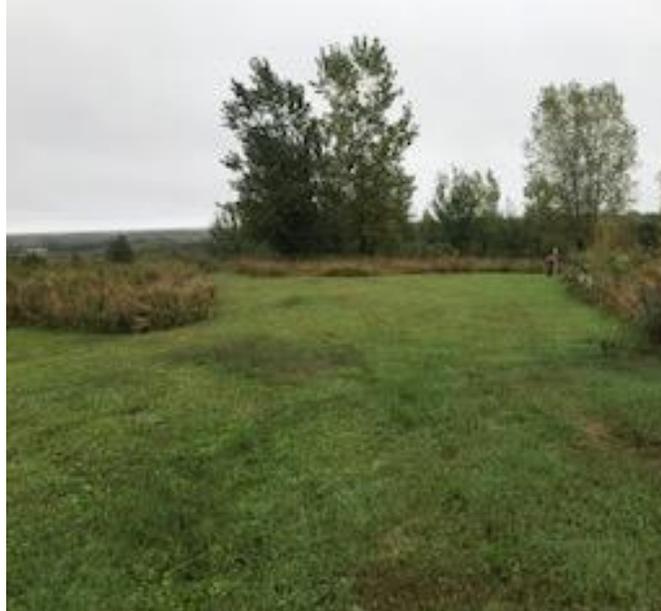
The physical components of the remedy, including the fencing, CAMU, monitoring wells, and the LNAPL/groundwater collection system appeared to be in good condition. There were no signs of cracking or deterioration of the CAMU cover and the fencing was well maintained.

Photo 1: Picture of CAMU Cover, September 30, 2019	Photo 2: Picture of Monitoring Well, September 30, 2019

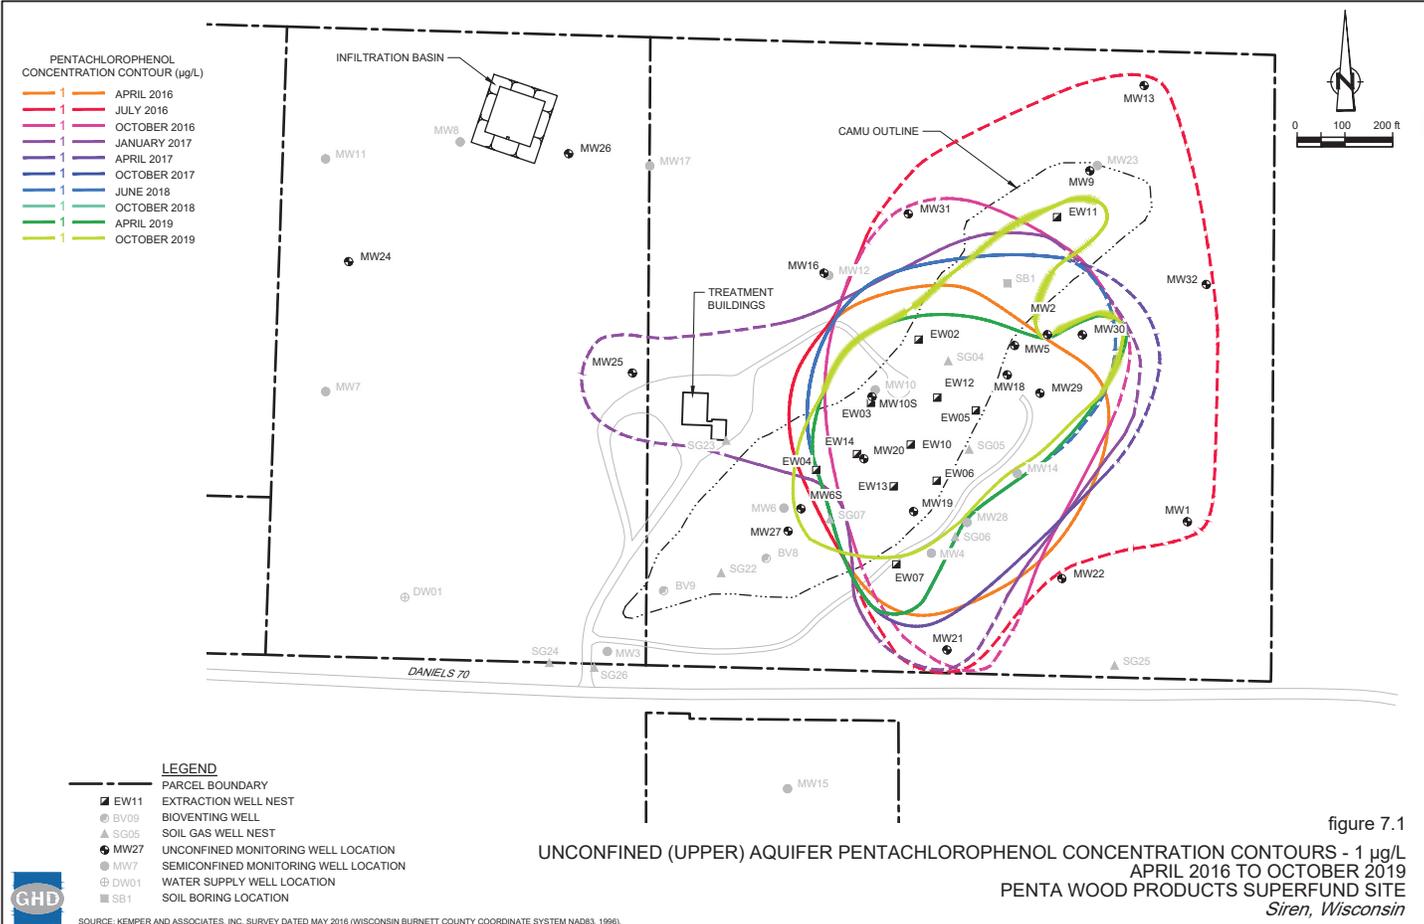
figure 7.1

PCP concentration contours shown in Appendix B, Figures 7.1 – 7.4, indicate that the plume did not migrate during the remediation system shutdown period and indicate overall plume stability. Once an LNAPL body stabilizes, it will typically remain so even if significant in-well LNAPL thicknesses are observed within the areal extent of LNAPL impacts. LNAPL limits shown on Figure 7.5 indicate that the LNAPL did not migrate during the remediation system shutdown period and indicate overall stability of the LNAPL body.

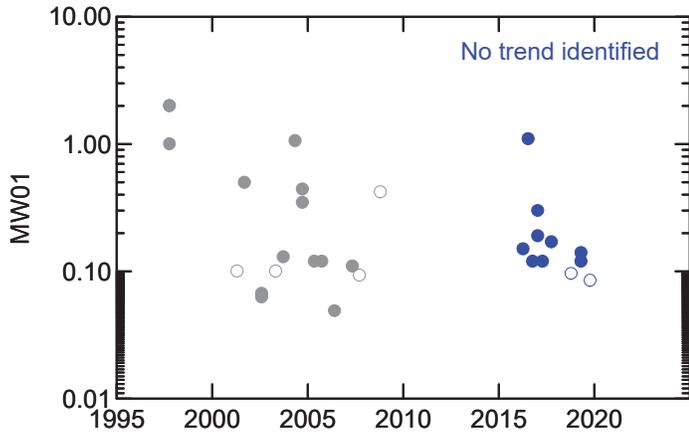
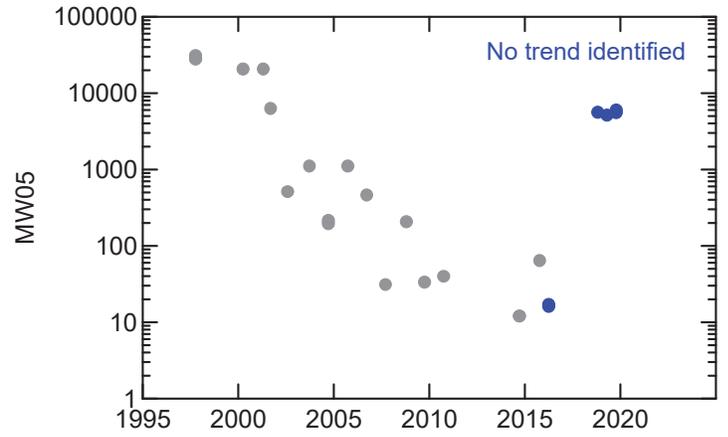
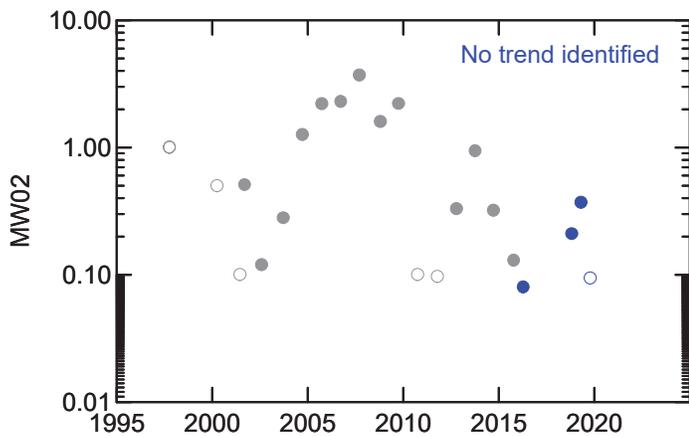
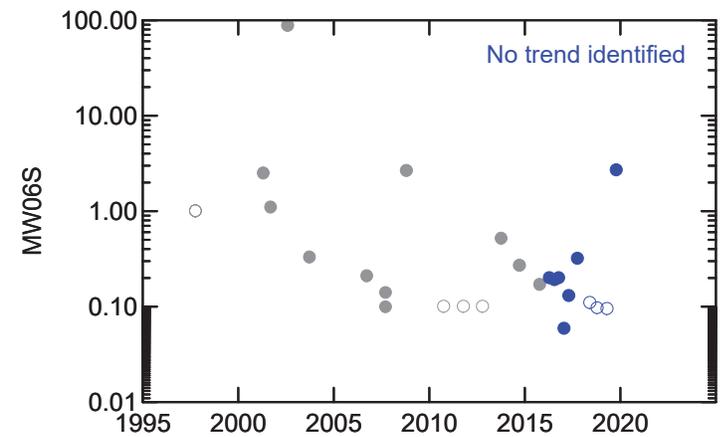
The trend test results are somewhat mixed in terms of changes in groundwater PCP concentrations following remediation system shutdown in November 2015. In the unconfined (upper) aquifer, wells in the aerobic zone (PCP concentrations below 1 µg/L) appear to have consistent decreasing concentration patterns, which is reflected in the overall area group tests results. In the mixed (1 to 1,000 µg/L) and anaerobic (>1000 µg/L) zones, some wells have exhibited increasing trends in PCP concentrations (EW13S, MW30), although concentrations may be stabilizing recently into morsteady-state conditions. See Appendix H, Groundwater Concentration Trend Plots.

UNCONFINED (UPPER) AQUIFER  
 PENTACHLOROPHENOL (µg/L) vs. TIME  
 PENTA WOOD PRODUCTS SUPERFUND SITE  
 Siren, Wisconsin

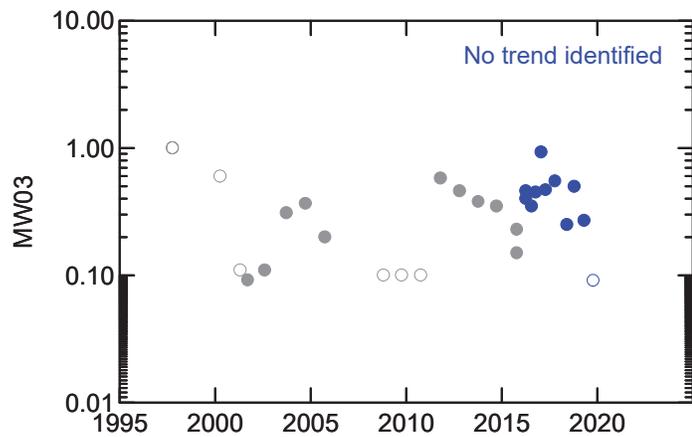
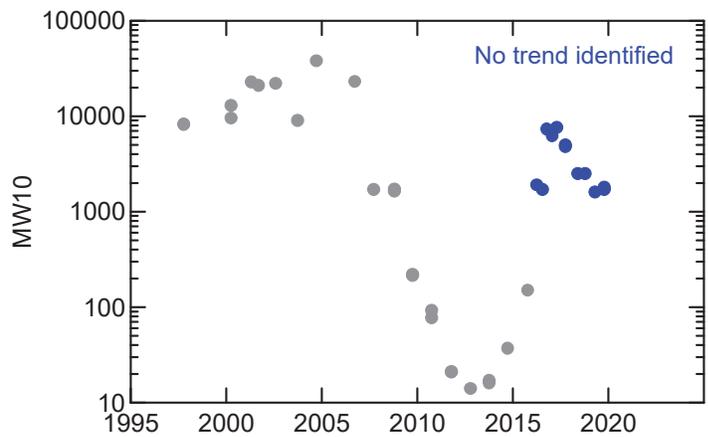
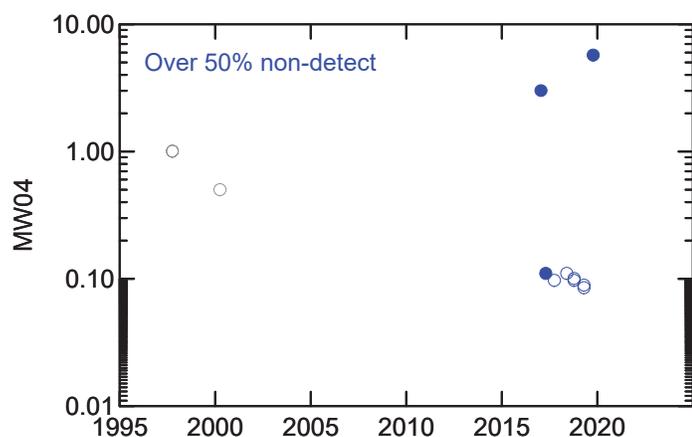
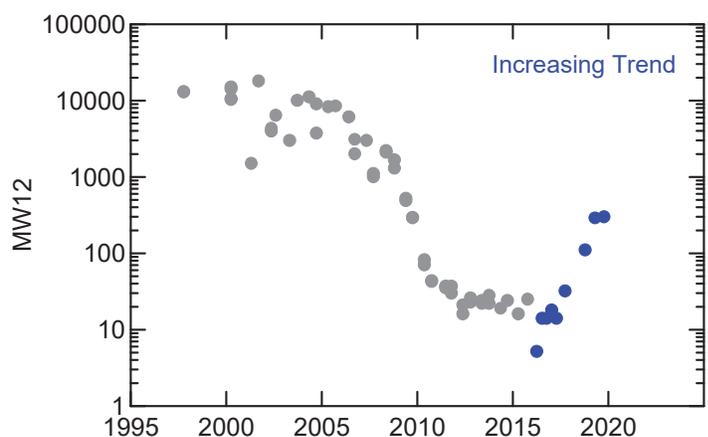
SEMICONFINED (LOWER) AQUIFER  
 PENTACHLOROPHENOL (µg/L) vs. TIME  
 PENTA WOOD PRODUCTS SUPERFUND SITE  
*Siren, Wisconsin*

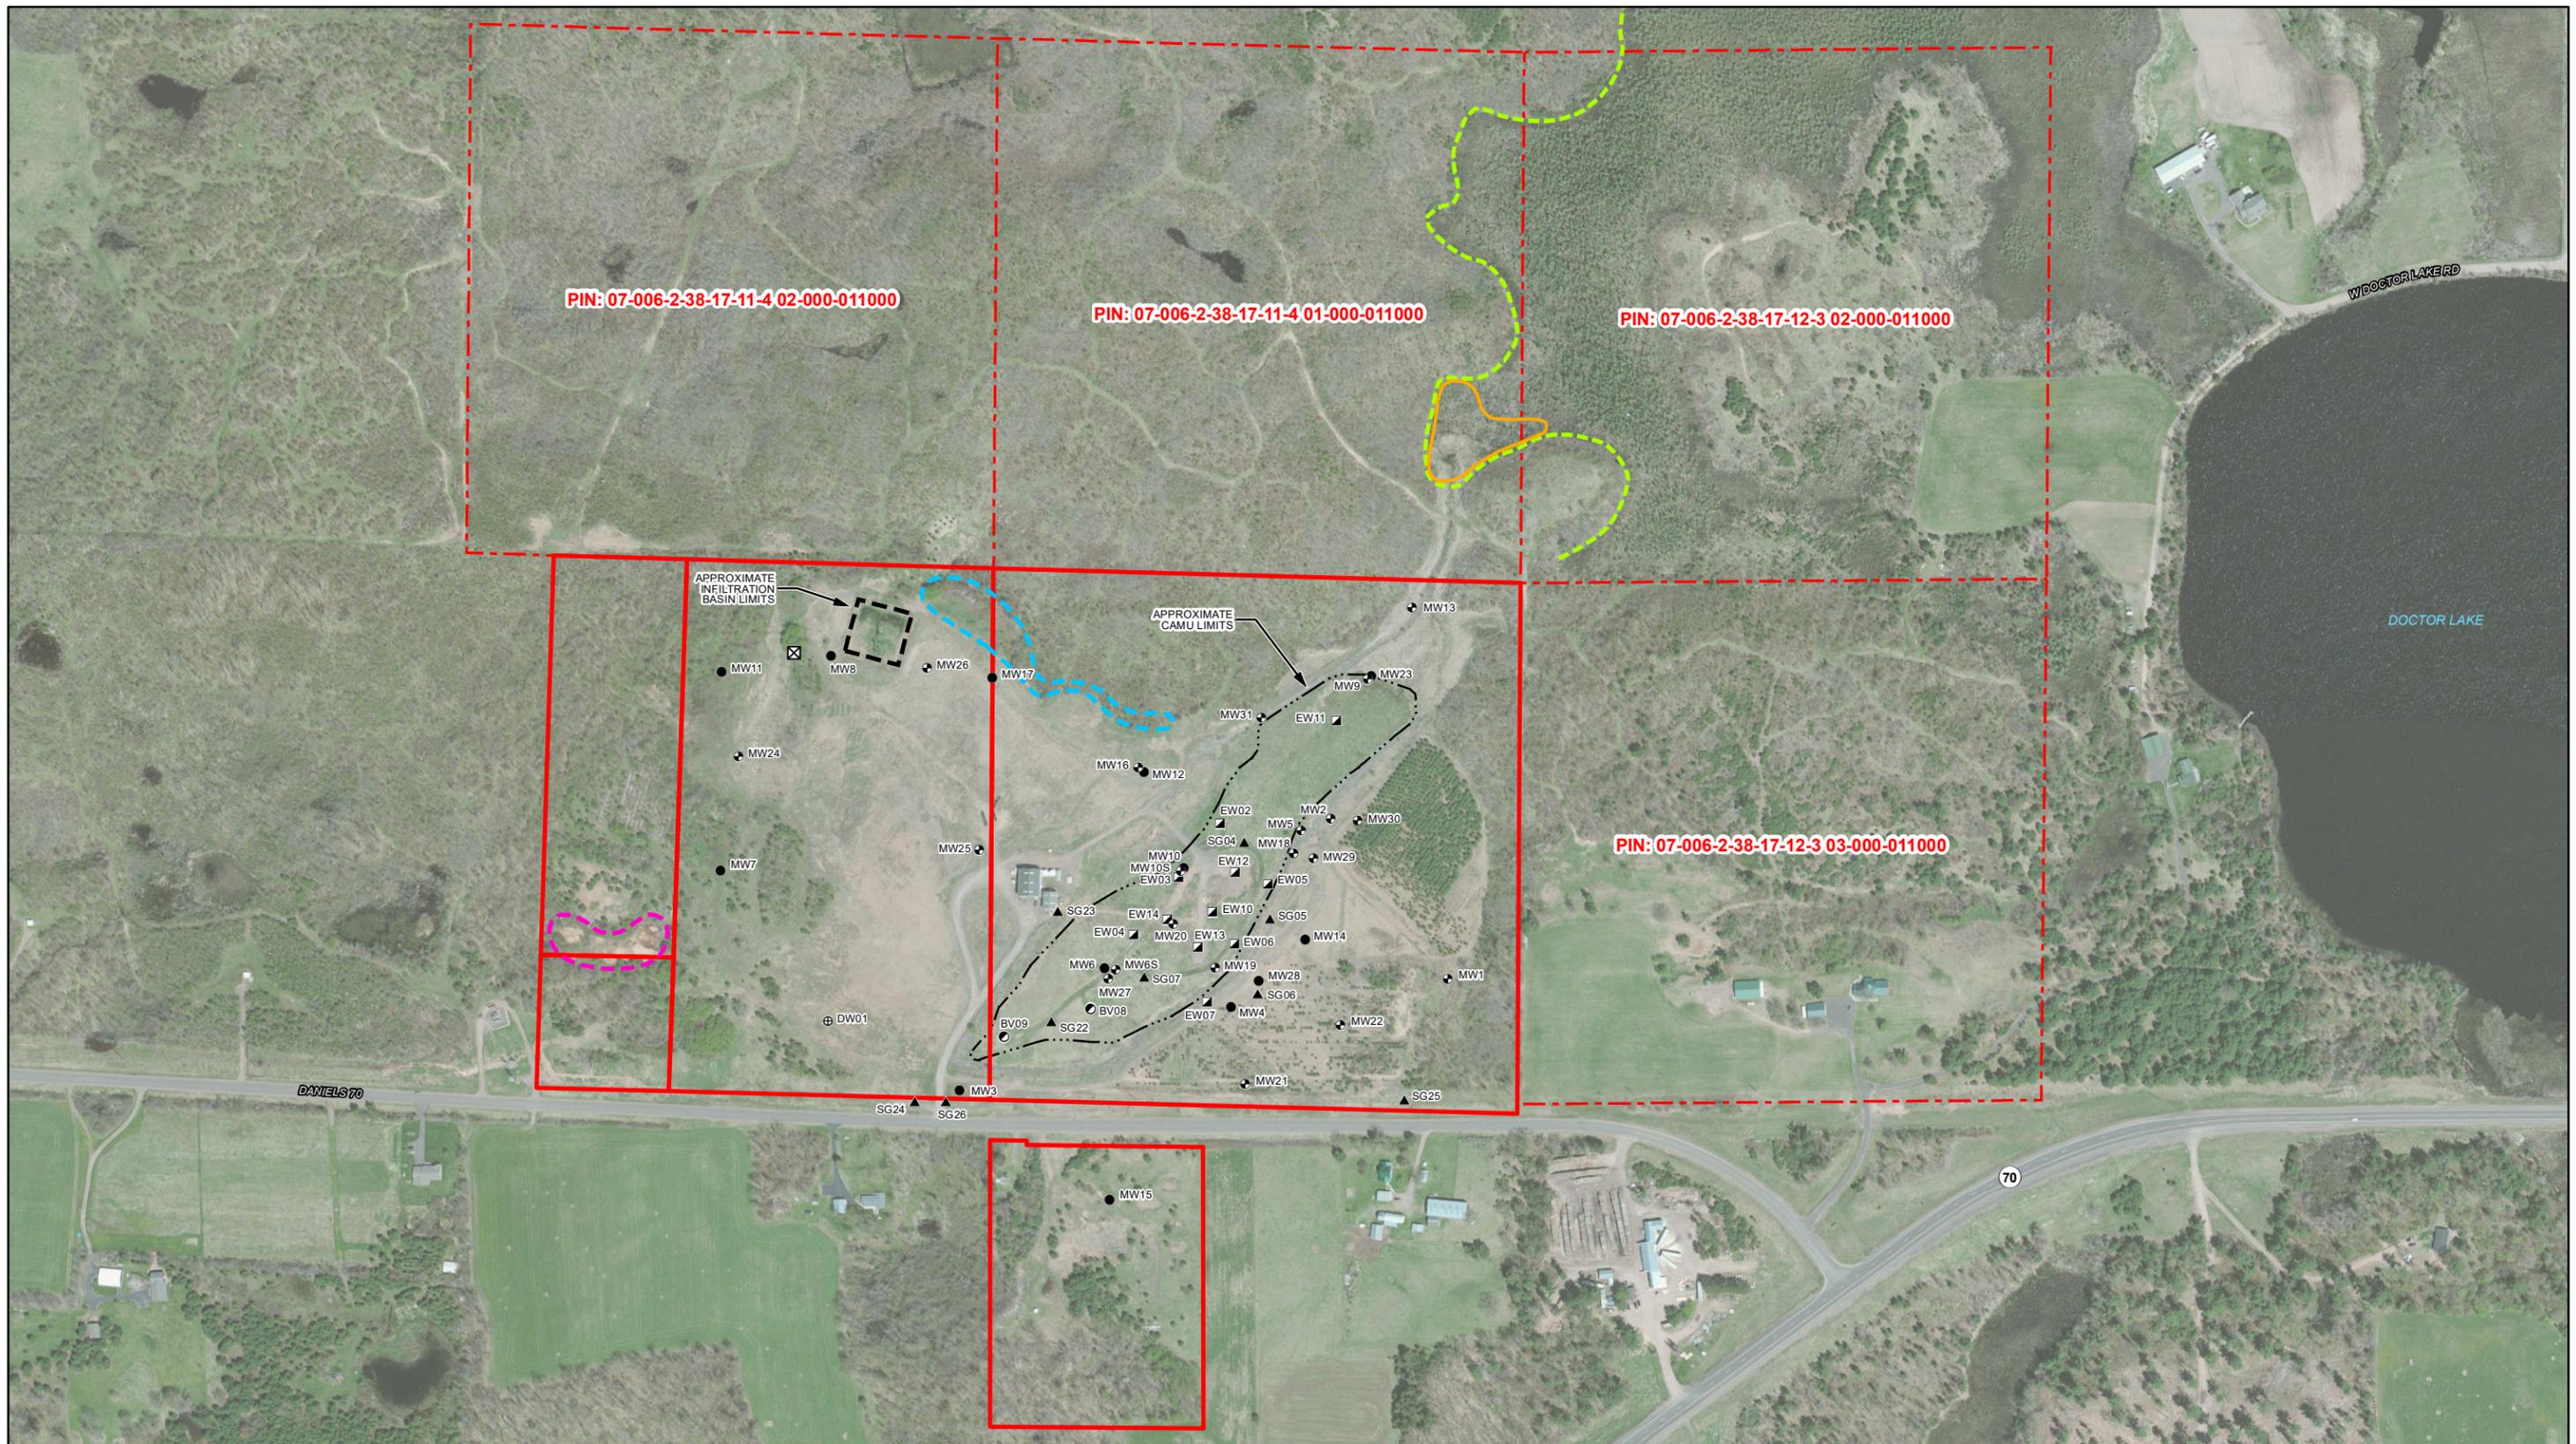
**APPENDIX I – WETLAND EXCAVATION AND SURFACE DEBRIS AREAS**

Issues and Recommendations Identified in the Five-Year Review:				
OU(s): OU1 (Sitewide)	<b>Issue Category: Changed Site Conditions</b>			
	<b>Issue:</b> PCP concentrations in the wetland northeast of the Site property exceed applicable criteria.			
	<b>Recommendation:</b> Remove contaminated soil/sediment located in a wetland adjacent to the Site and place the material within an expanded portion of the CAMU.			
<b>Affect Current Protectiveness</b>	<b>Affect Future Protectiveness</b>	<b>Party Responsible</b>	<b>Oversight Party</b>	<b>Milestone Date</b>
No	Yes	EPA/State	EPA	6/30/2022
OU(s): OU1 (Sitewide)	<b>Issue Category: Changed Site Conditions</b>			
	<b>Issue:</b> Surface debris located along the west and north Site property boundaries contains contaminants at concentrations exceeding the direct contact and groundwater protection residual contaminant level (RCLs) for arsenic, PCP, and other semi-volatile organic compound (SVOCs).

<b>Recommendation:</b> Cover contaminated surface debris along the west and north Site property boundaries with clean borrow soil.			
<b>Affect Current Protectiveness</b>	<b>Affect Future Protectiveness</b>	<b>Party Responsible</b>	<b>Oversight Party</b>	<b>Milestone Date</b>
No	Yes	EPA/State	EPA	6/30/2022
