**FIRST FIVE-YEAR REVIEW REPORT FOR  
WPSC STEVENS POINT SUPERFUND SITE  
PORTAGE COUNTY, WISCONSIN**

**U.S. Environmental Protection Agency  
Region 5  
CHICAGO, ILLINOIS**

This is the first FYR for the WPSO Stevens Point Superfund Alternative Site (Site). The triggering action for this statutory review is the on-site construction start date of the remedial action. The FYR has been prepared due to the fact that hazardous substances, pollutants, or contaminants remain at the site above levels that allow for unlimited use and unrestricted exposure (UU/UE). The Site consists of one Site-Wide Operable Unit (OU) which will be addressed in this FYR.

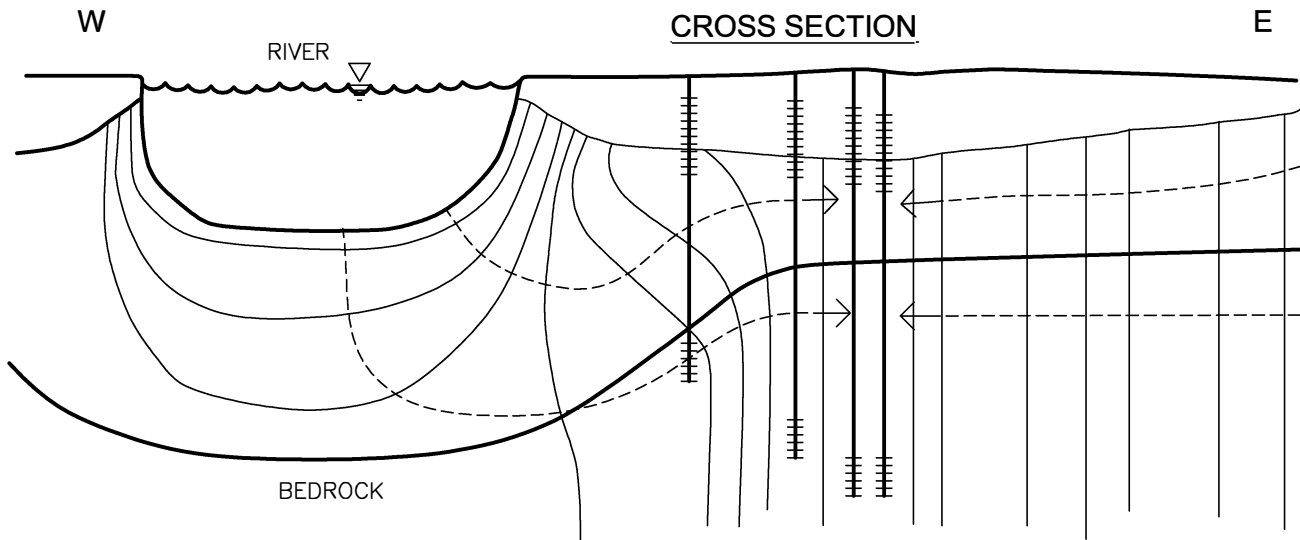
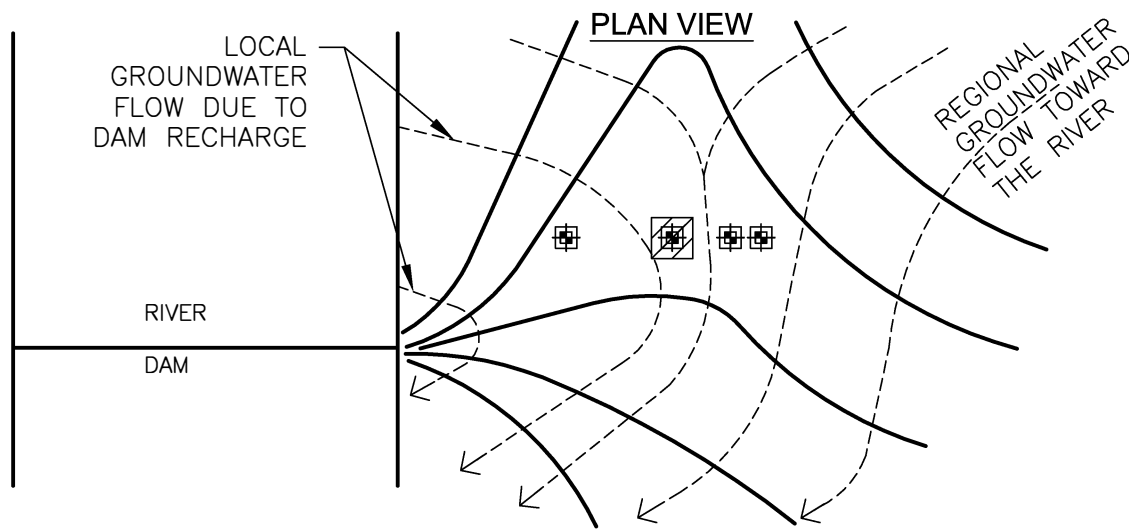
FIGURE NO.  
2

## CONCEPTUAL FLOW MODEL

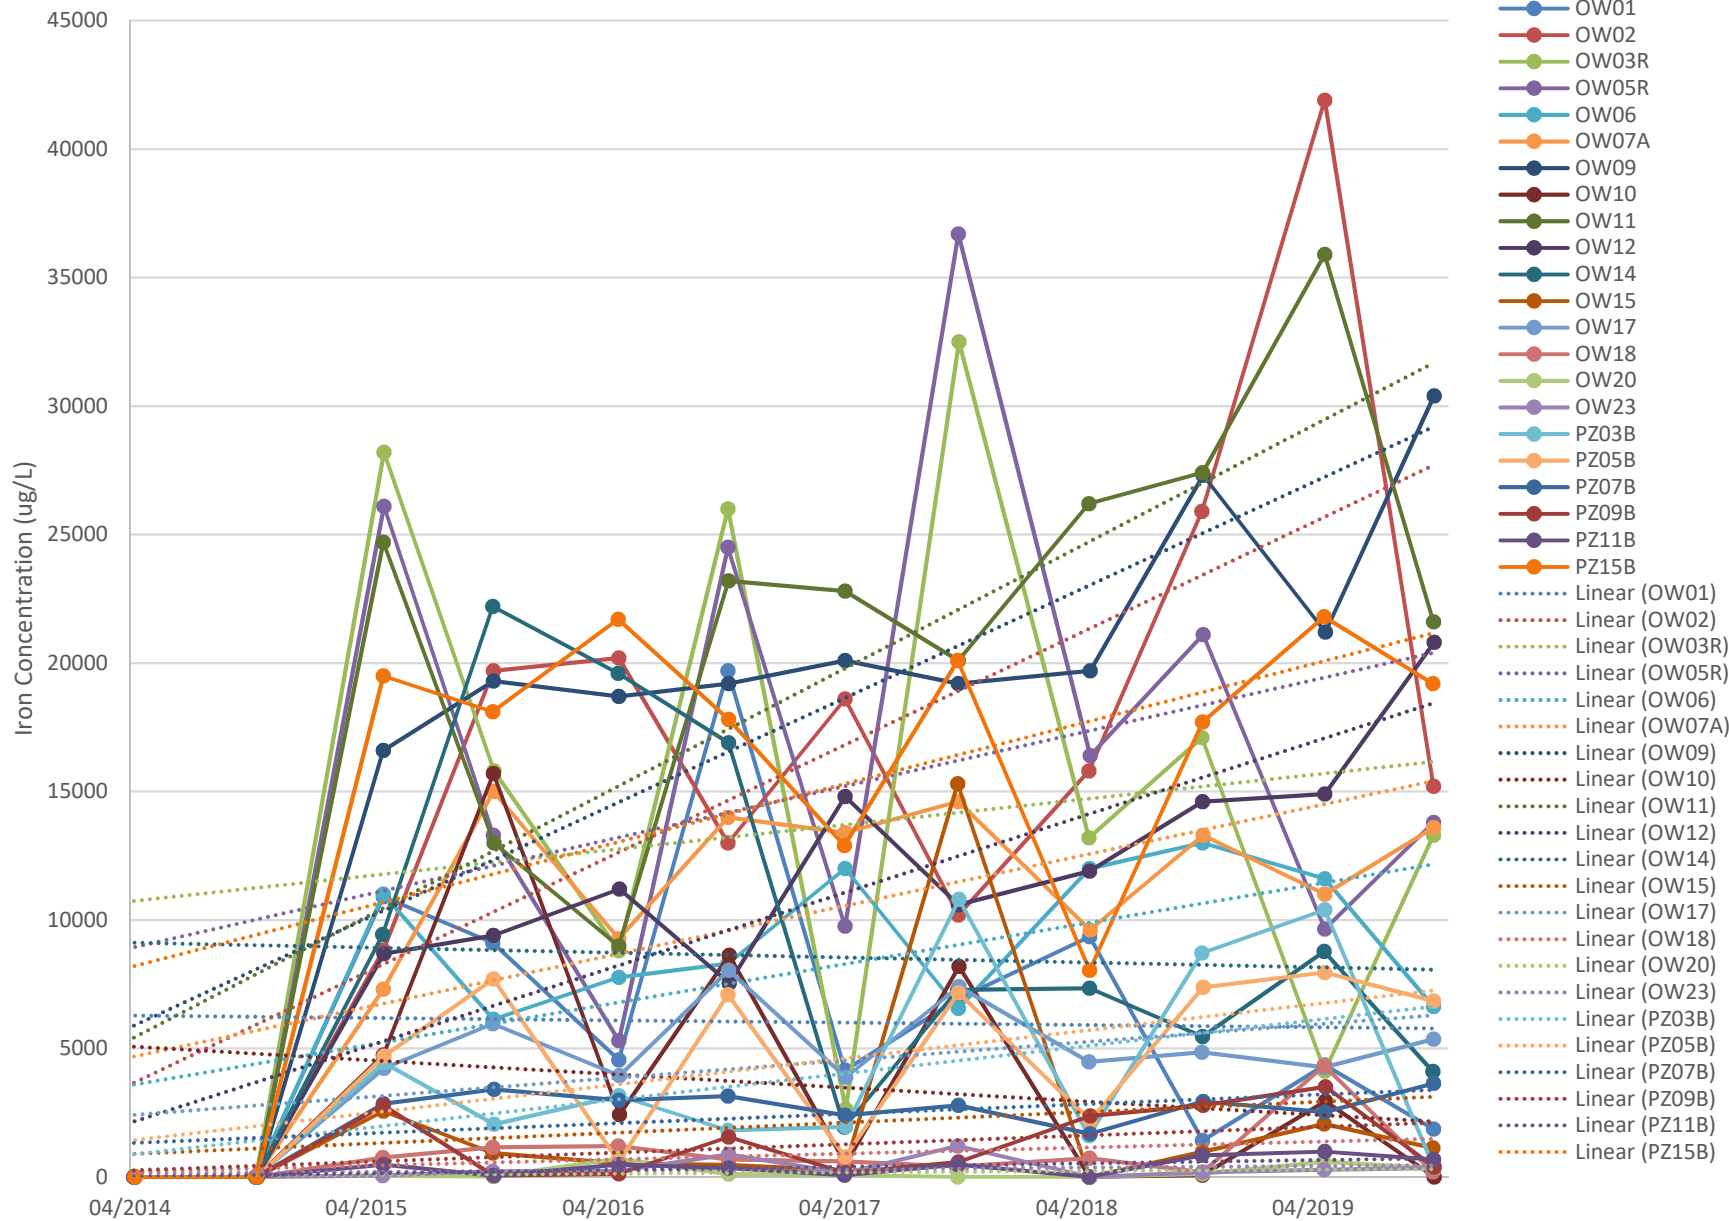
Figure 22 - Iron Concentrations and Trends in Select Wells 2014-2019

Average iron concentrations in plume wells are higher than in outside plume wells which is a positive indication that microbial activity and biodegradation is occurring. However, the average iron concentrations exceed the CL at both inside plume wells and outside plume wells. The average iron concentrations at wells outside the plume and the IC areas (Table 4 in Attachment 1) are:

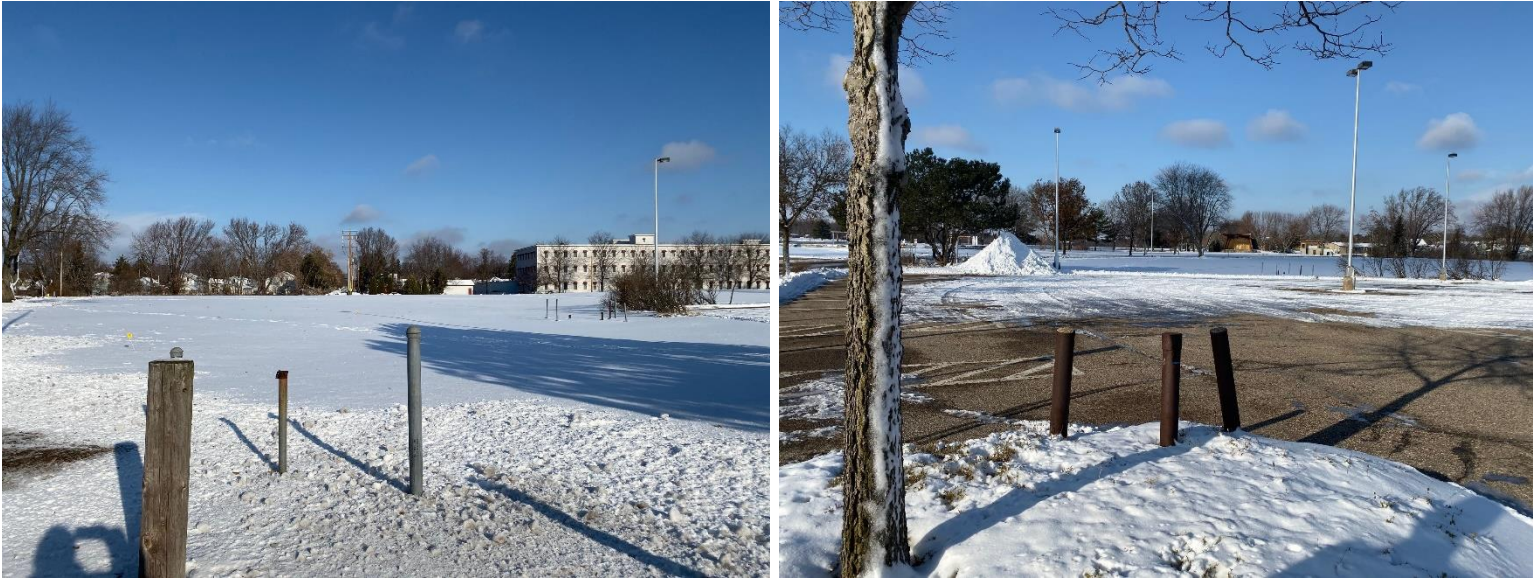
12/2/2019: Monitor wells OW02 (from south) & OW08 (from northeast). Wells are protected from snow removal.

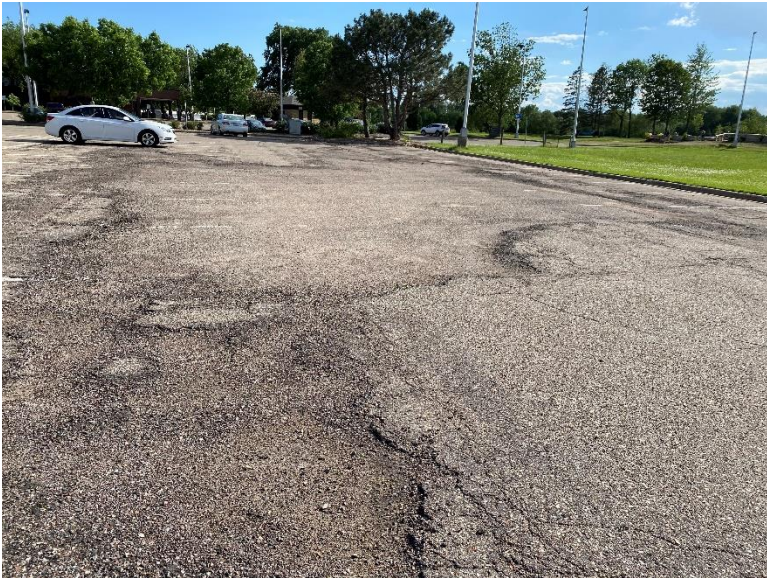
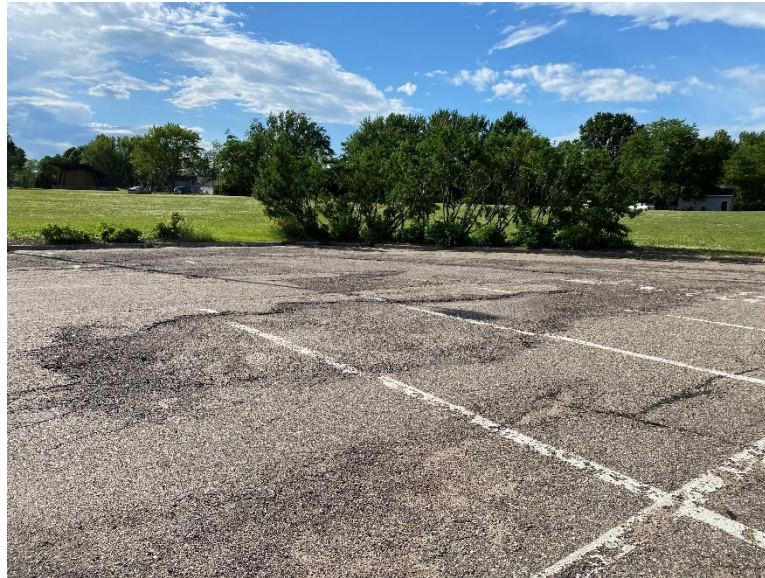
6/11/2020: View of City-owned parking lot from the north end of the westernmost row, to the south and northwest. Some asphalt erosion and cracking present.

Portions of the cap in the western portion of the parking lot were degraded, with asphalt cracking, large potholes, and loose gravel observed. Because no ponding or issues with drainage were observed and it continues to provide a barrier to direct contact with the top four feet of soil, repair of the cap in this area is expected to coincide with City redevelopment plans.

- *At the time of Site inspection, the asphalt cap in the western parking lot appeared to be degraded. Continued monitoring to confirm protectiveness is still effective should be performed until such time as a repair can be made during City redevelopment construction.*

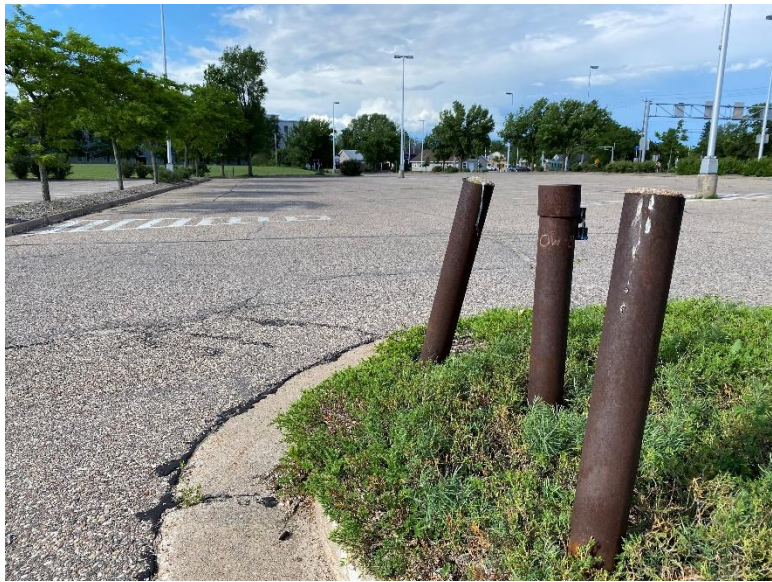
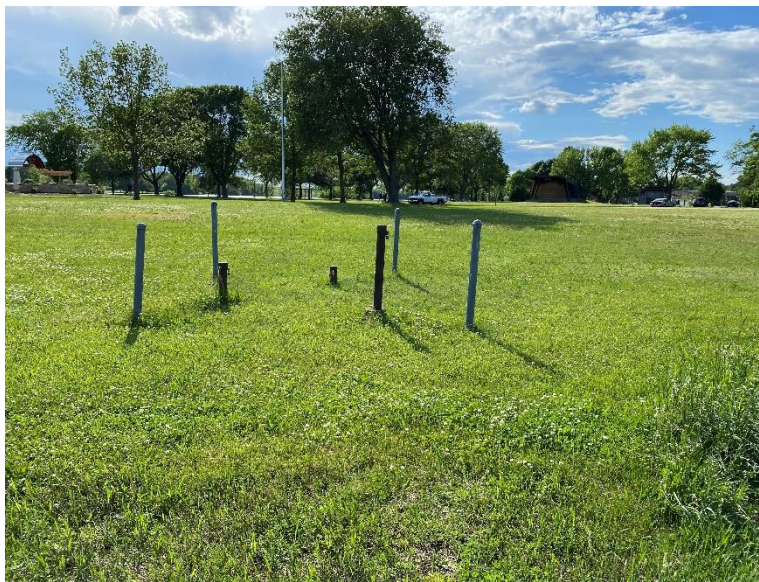
6/11/2020: View of OW08 (from south) and OW07A & PZ07B (from east). Monitor wells and bollards are in good condition and secure.

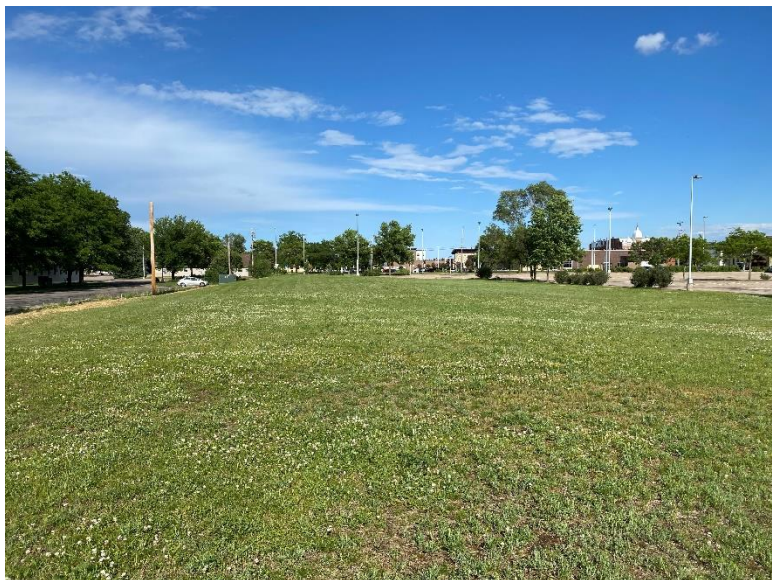
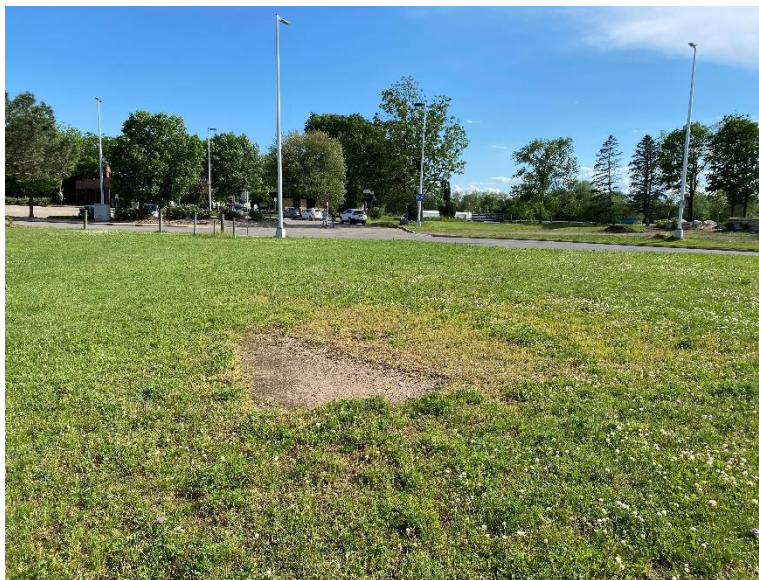
6/11/2020: Grassy cap, view to east and to south. Grass is in good condition over most of the cap, some patchy areas. No cracking, sinking or mounding observed.

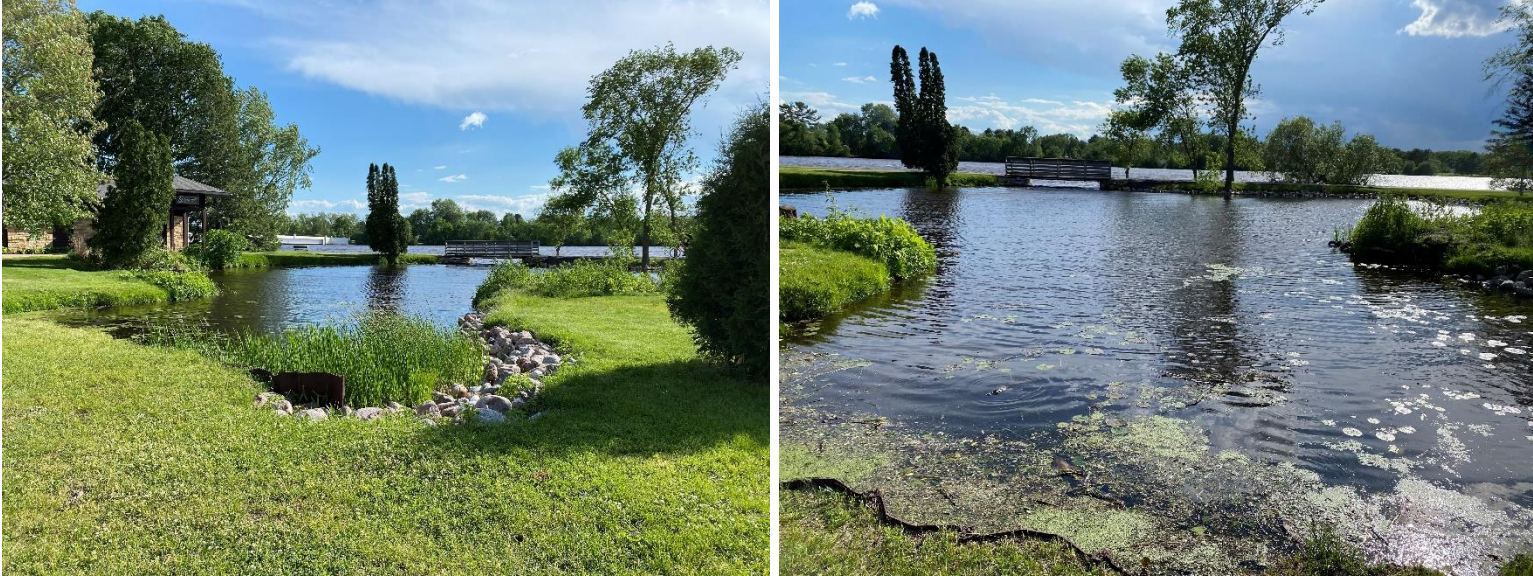
6/11/2020: View of pond from east. Water elevation is controlled by River. Sand cap and rock armor cover appear to be in good condition. No erosion of sides of pond observed. Grasses, algae, ducks and fish observed.
