**SIXTH FIVE-YEAR REVIEW REPORT FOR  
REILLY TAR & CHEMICAL CORP. (ST. LOUIS PARK PLANT)  
SUPERFUND SITE  
HENNEPIN COUNTY, MINNESOTA**

**U.S. Environmental Protection Agency  
Region 5  
Chicago, Illinois**

6/14/2021

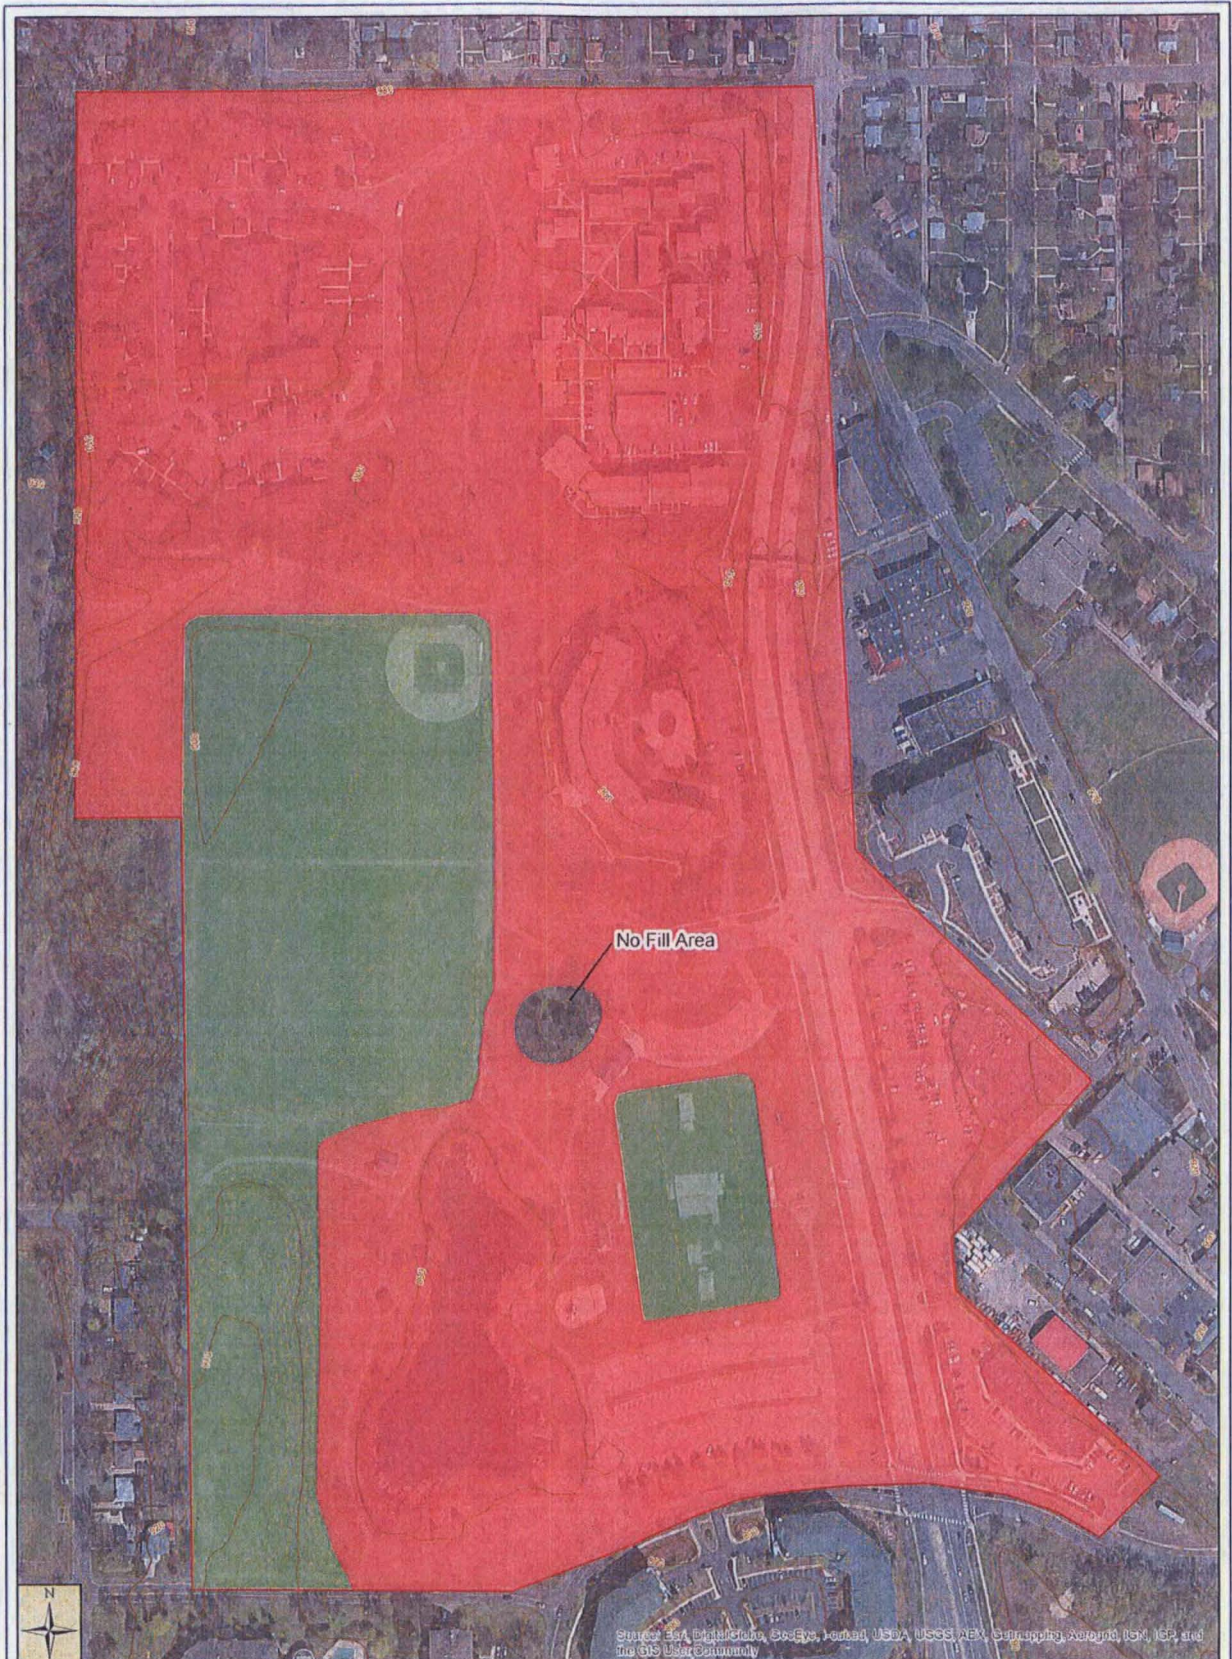
**Figure 3**

Ground Elevation Contours based on LIDAR dataset available from Minnesota Geospatial Information Office

- Explanation**
- Approximate Reilly Site Boundary
  - Estimated Soil Cover Thickness**
  - 0.5 to 3 feet
  - Over 3 feet
  - Ground Elevation Contours**
  - 10 foot contours
  - 2 foot contours

- The City reports that soil cover on the Site, the result of the capping and filling of exposed hazardous waste in the vicinity of the bog area, is not less than six inches and is more typically one to two feet thick, with the exception of a tree-covered mound near the center of the Site, where a stone curb is visible today. Figure 3 in Appendix B illustrates the current depths of clean soil cover at the Site. Also, in October 2020, the City submitted a draft Site Soil Cover Report (City of St. Louis Park, 2020), which documented the condition of the Site cover, as required by the Amended CD/RAP.

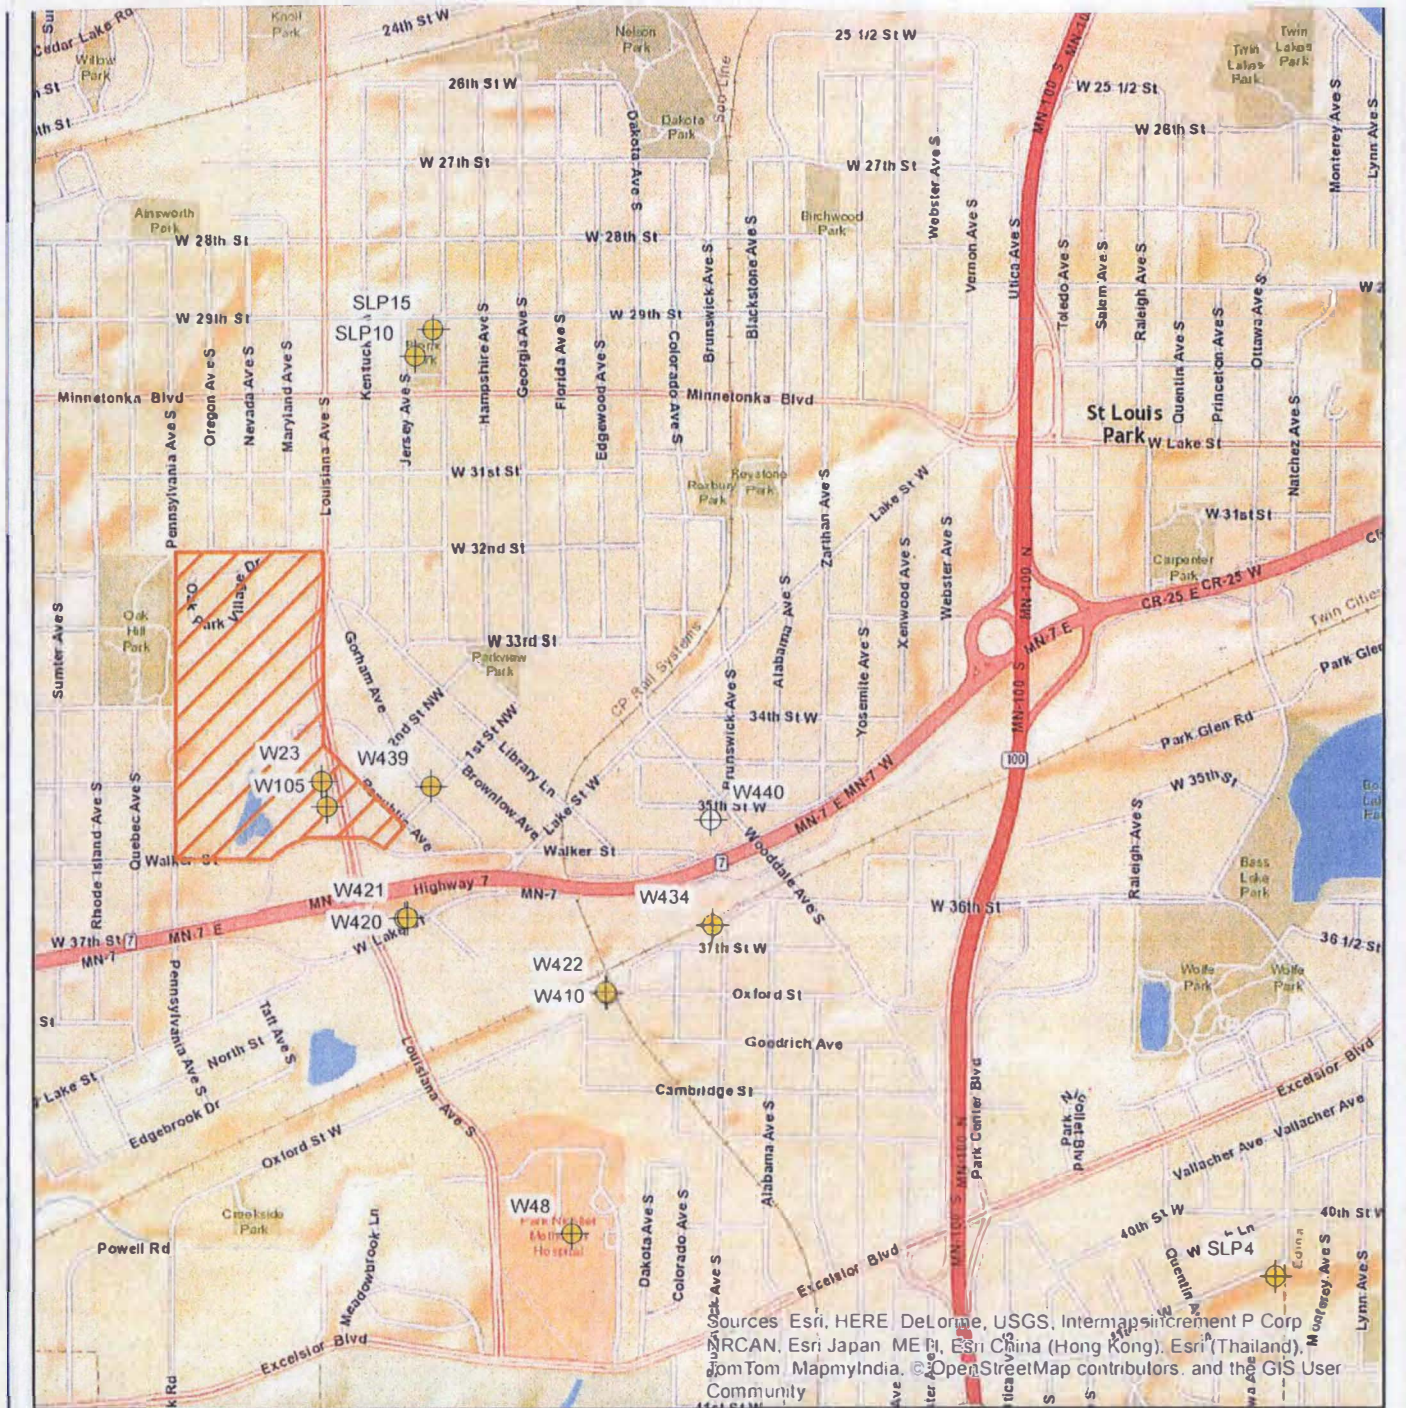
**Figure 7. Location of Reilly Site Pumping and Previously-Pumping Wells**

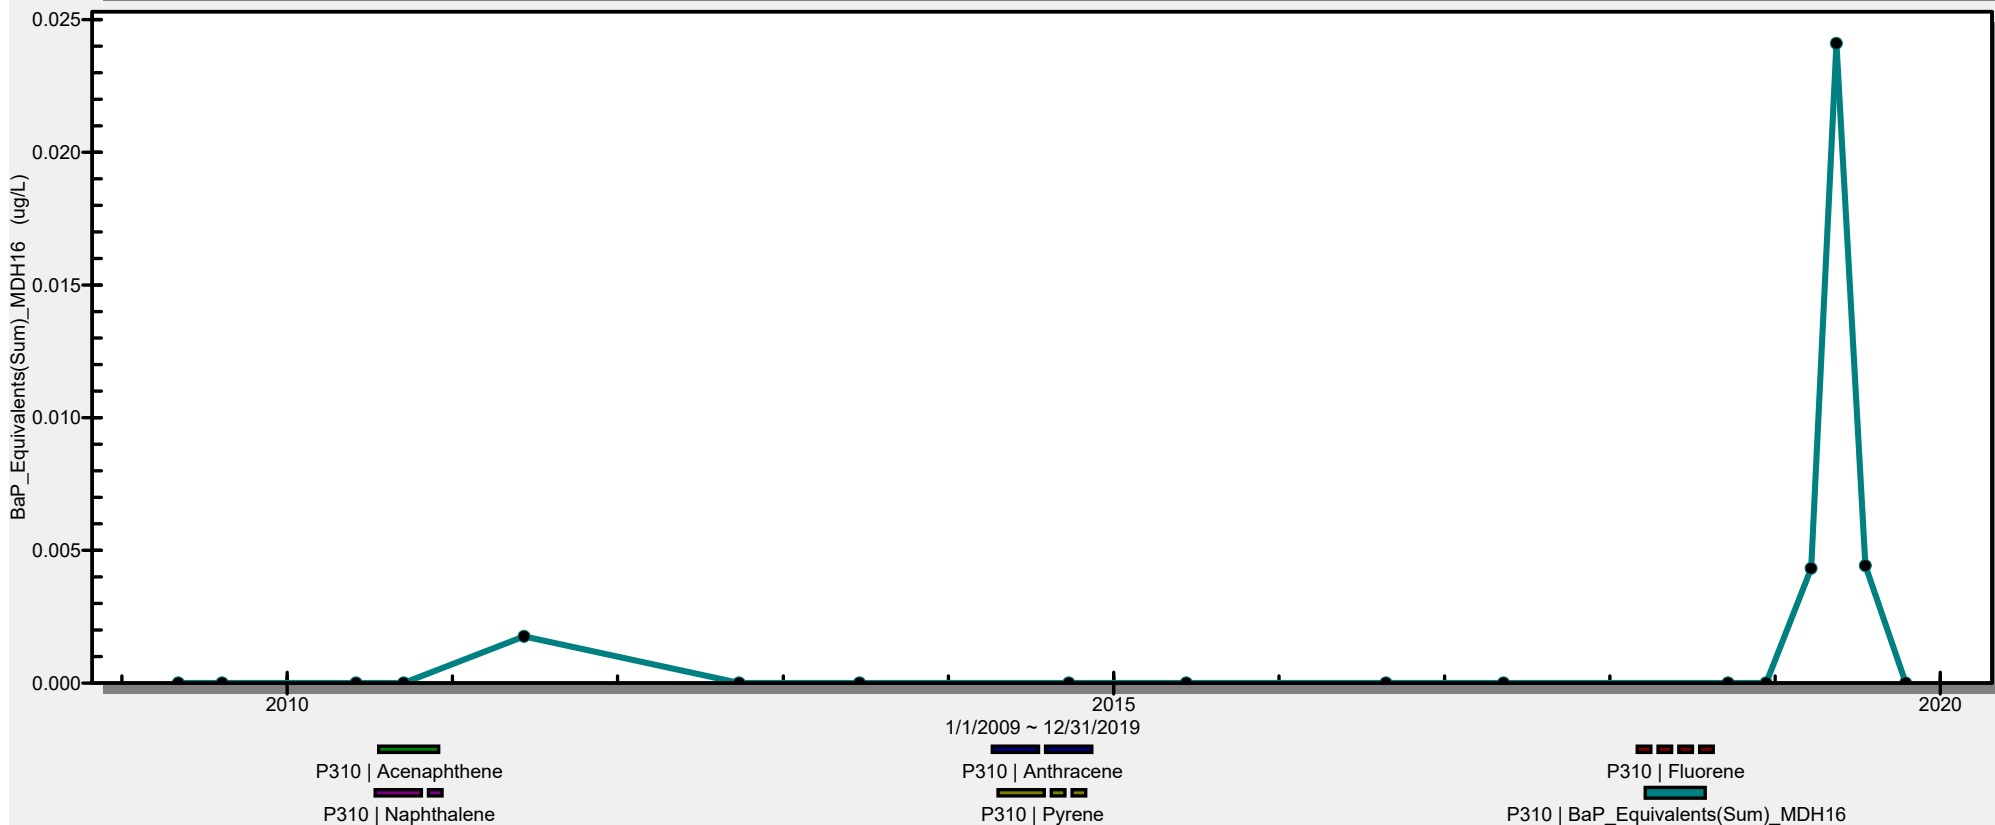
# P310

PAH With MDH Values, 2009-2019

- P310 | Acenaphthene (Green line)
- P310 | Naphthalene (Purple dashed line)
- P310 | Anthracene (Blue dashed line)
- P310 | Pyrene (Yellow dashed line)
- P310 | Fluorene (Red dashed line)
- P310 | BaP\_Equivalents(Sum)\_MDH16 (Teal line)

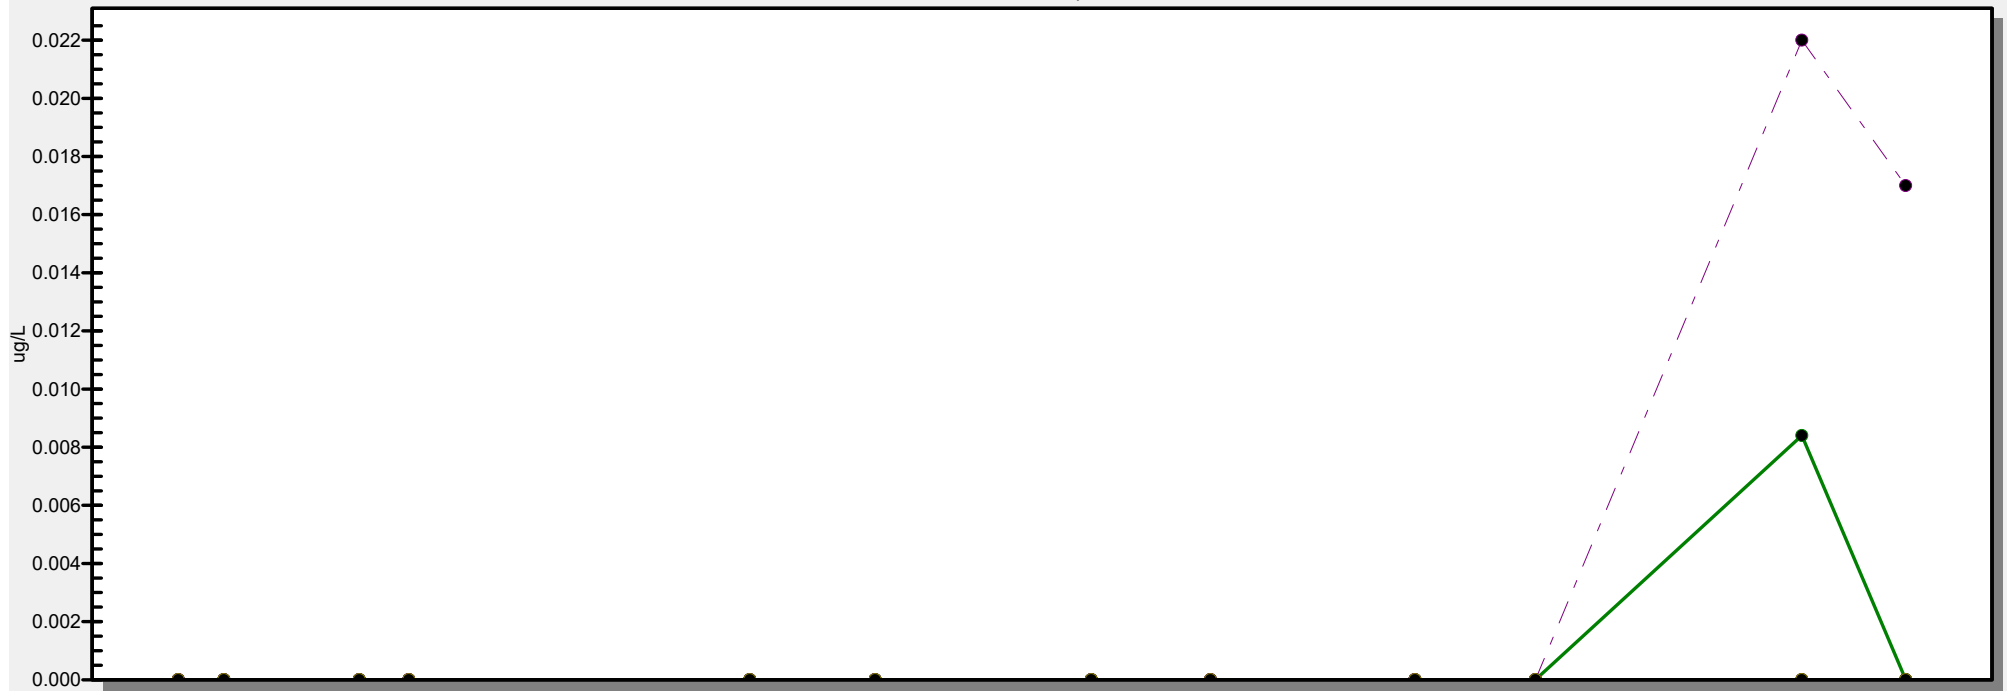
PAH With MDH Values, 2009-2019

W128 | Acenaphthene  
W128 | Naphthalene

1/1/2009 ~ 12/31/2019  
W128 | Anthracene  
W128 | Pyrene

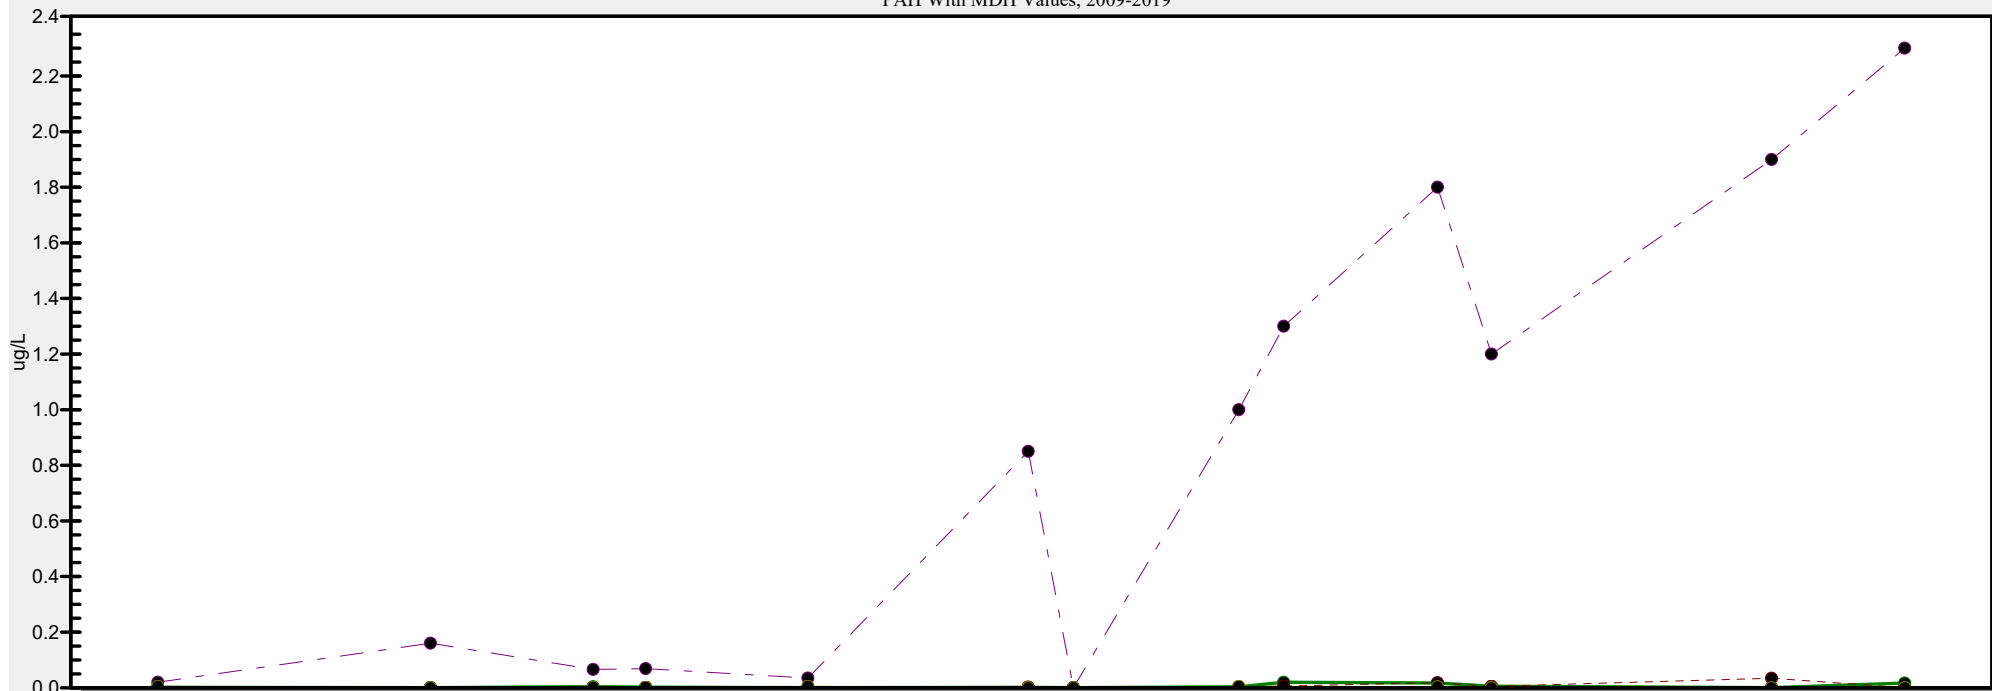
PAH With MDH Values, 2009-2019

- W129 | Acenaphthene
- W129 | Anthracene
- W129 | Fluorene
- W129 | Naphthalene
- W129 | Pyrene
- W129 | BaP\_Equivalents(Sum)\_MDH16

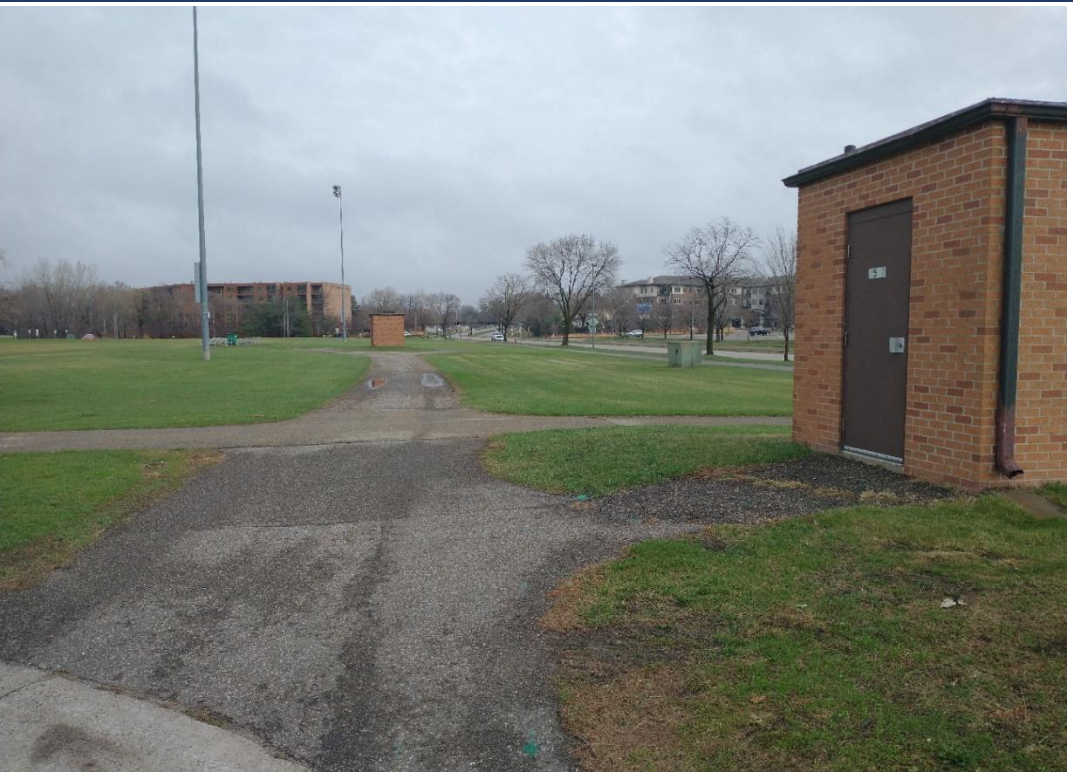
<b>Photo No.</b> <b>1</b>	<b>Date:</b> 4/7/21

<b>Direction Facing:</b> North		
<b>Description:</b> Exterior  View of the Reilly Site and well houses for W23 and W105.		
<b>Photo No.</b> <b>2</b>	<b>Date:</b> 4/7/21

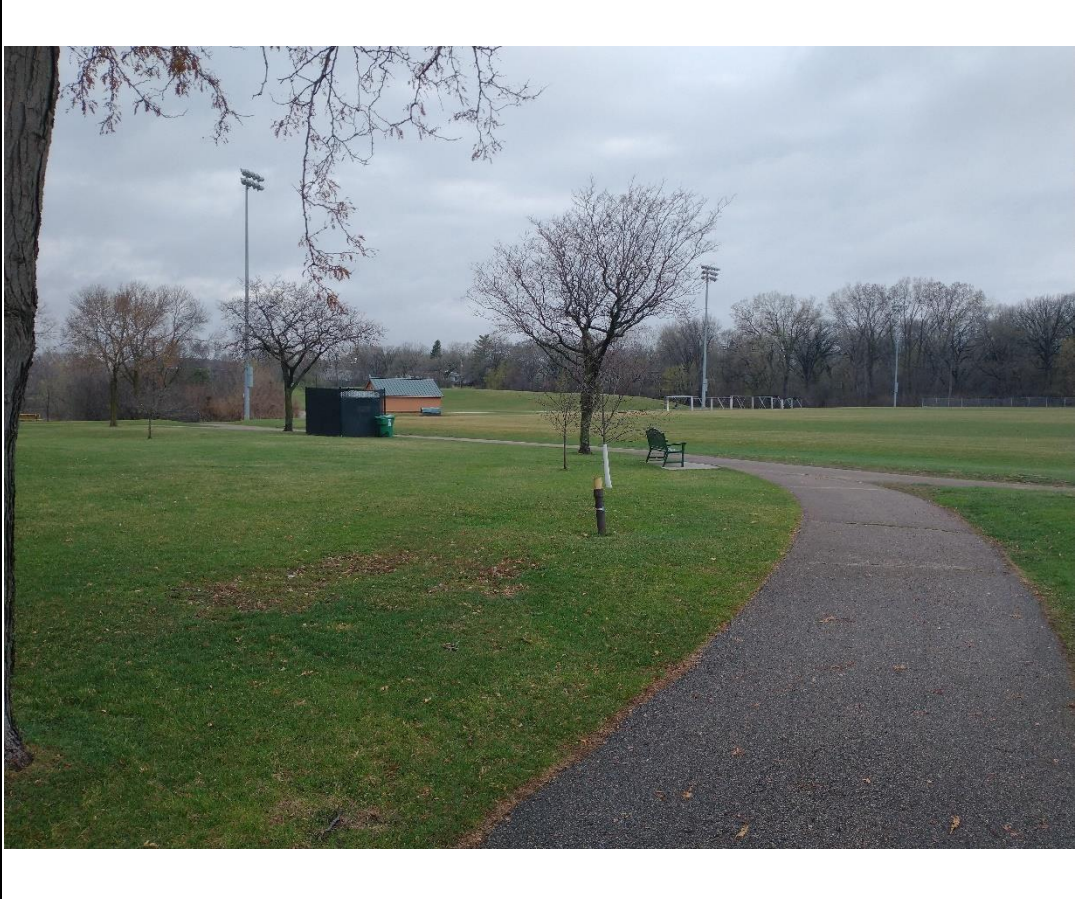
<b>Photo No.</b> <b>6</b>	<b>Date:</b> 4/7/21
<b>Direction Facing:</b> West	
<b>Description:</b> Exterior	
View of the western portion of the Reilly Site with well W22.

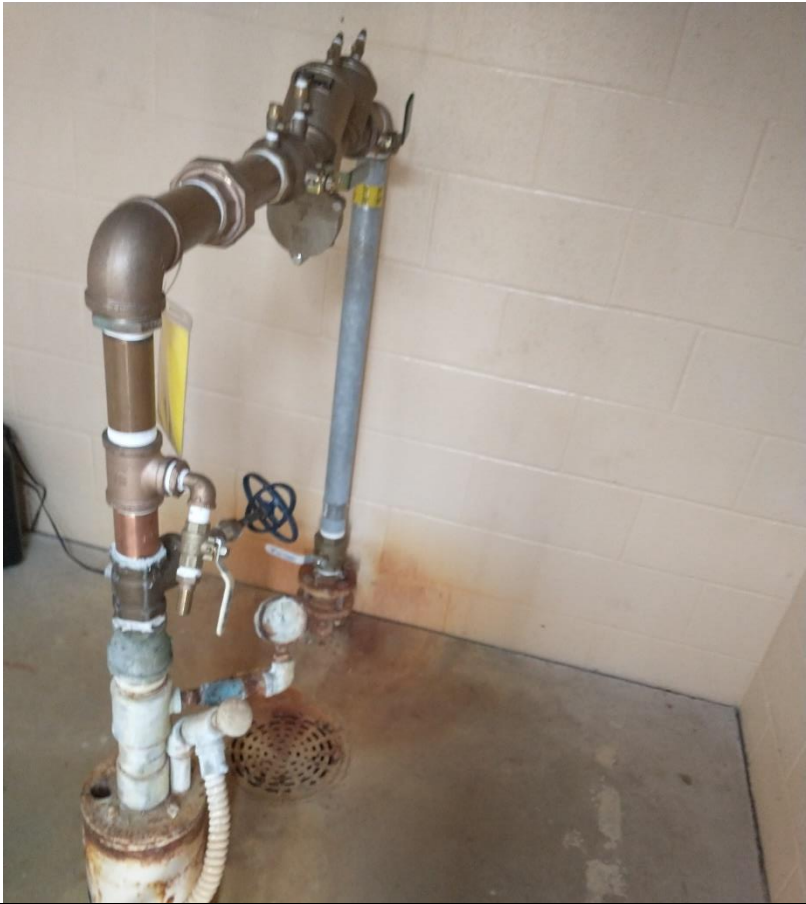
<b>Photo No.</b> <b>9</b>	<b>Date:</b> 4/7/21

A photograph showing the interior of a well enclosure for well W105. The well is inactive. It features a vertical pipe assembly with a brown elbow at the top, a blue handwheel valve, and a pressure gauge. The pipe is mounted on a concrete base. The background is a light-colored cinder block wall.
<b>Direction Facing:</b> East		
<b>Description:</b> Interior  View of the inactive pumping well W105.

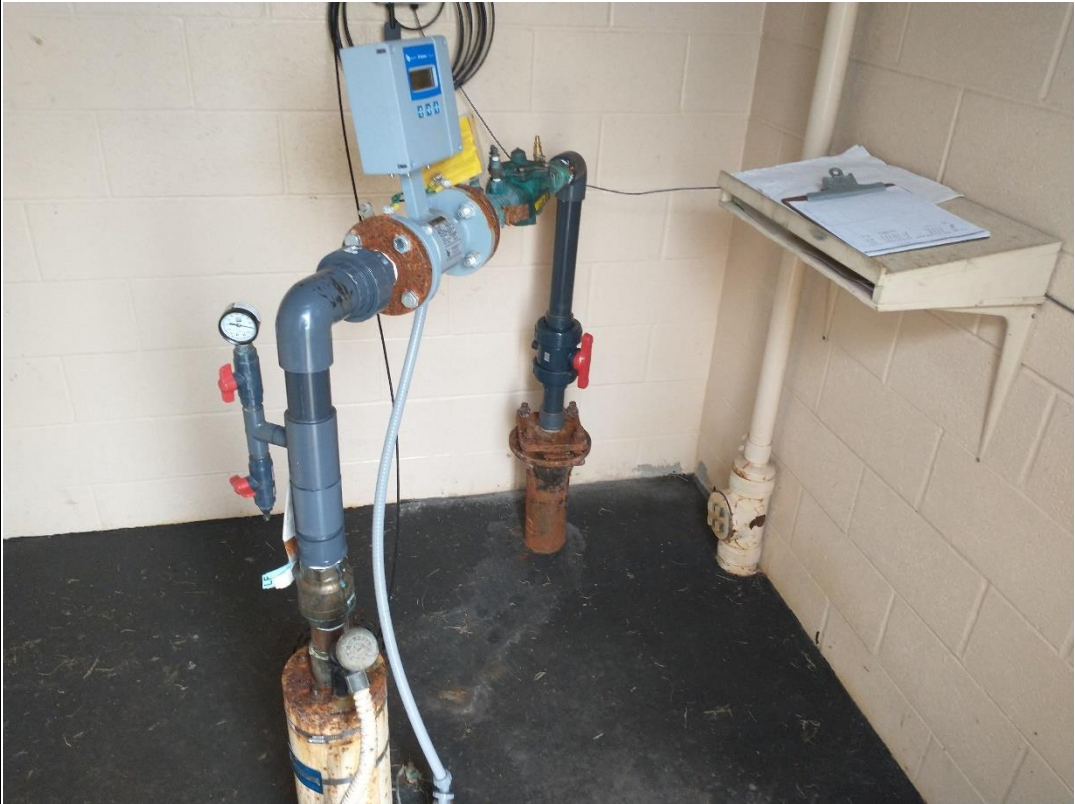
<b>Photo No.</b> <b>10</b>	<b>Date:</b> 4/7/21

A photograph showing the interior of a well enclosure for well W23. The well is active. It features a vertical pipe assembly with a blue elbow, a pressure gauge, and a blue electrical control box mounted on the wall. The pipe is mounted on a concrete base. The background is a light-colored cinder block wall. A clipboard with papers is visible on a shelf to the right.
<b>Direction Facing:</b> East		
<b>Description:</b> Interior  View of the active pumping well W23.

- Pumping well W23 was pulled and the pump was replaced in 2019.

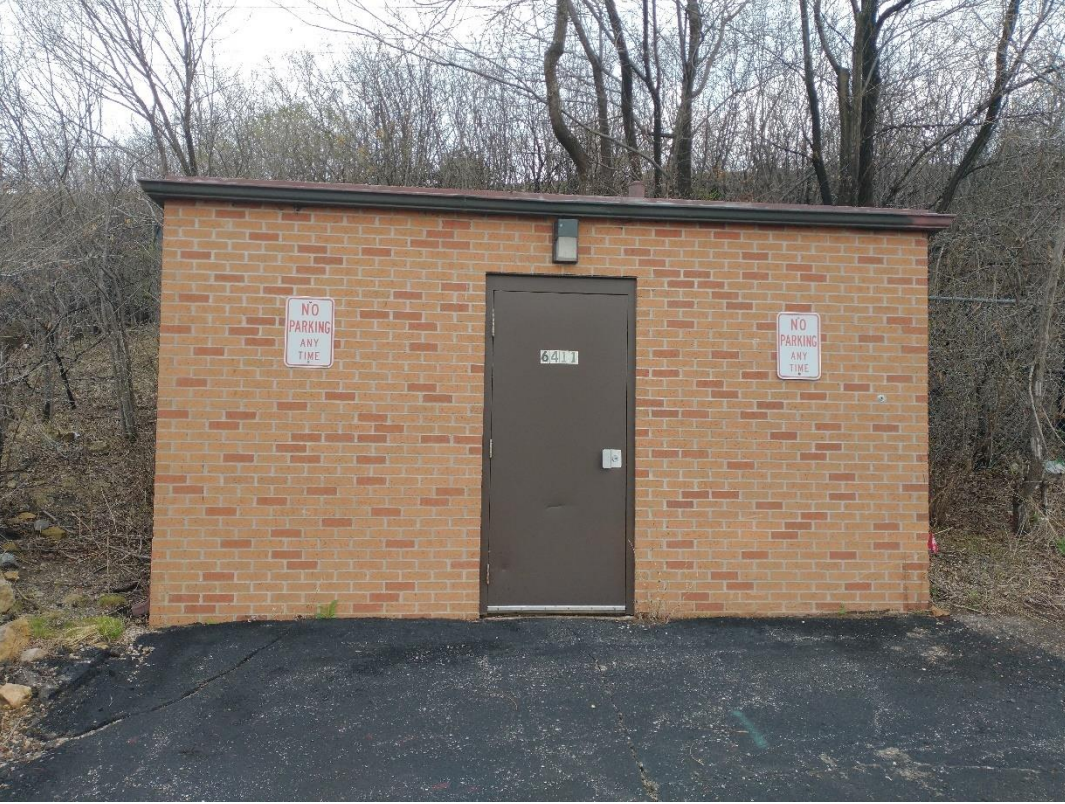
<b>Photo No.</b> <b>11</b>	<b>Date:</b> 4/7/21

<b>Direction Facing:</b> East		
<b>Description:</b> Exterior  View of the well house for wells W410 and W422.		
<b>Photo No.</b> <b>12</b>	<b>Date:</b> 4/7/21	 
<b>Direction Facing:</b> Southeast		
<b>Description:</b> Interior  View of the inactive pumping well W410 with transducer cable (blue wire).

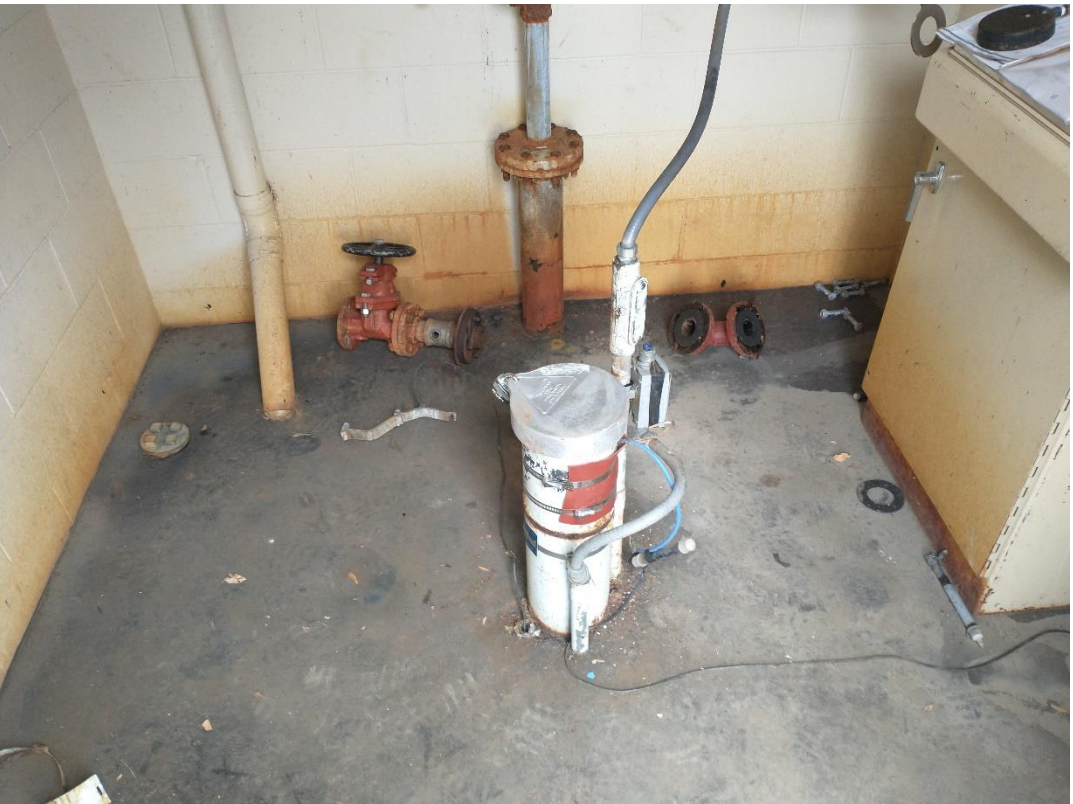
<b>Photo No.</b> <b>16</b>	<b>Date:</b> 4/7/21

<b>Direction Facing:</b> West		
<b>Description:</b> Interior  View of the inactive pumping well W439. Note that the pump as been removed.

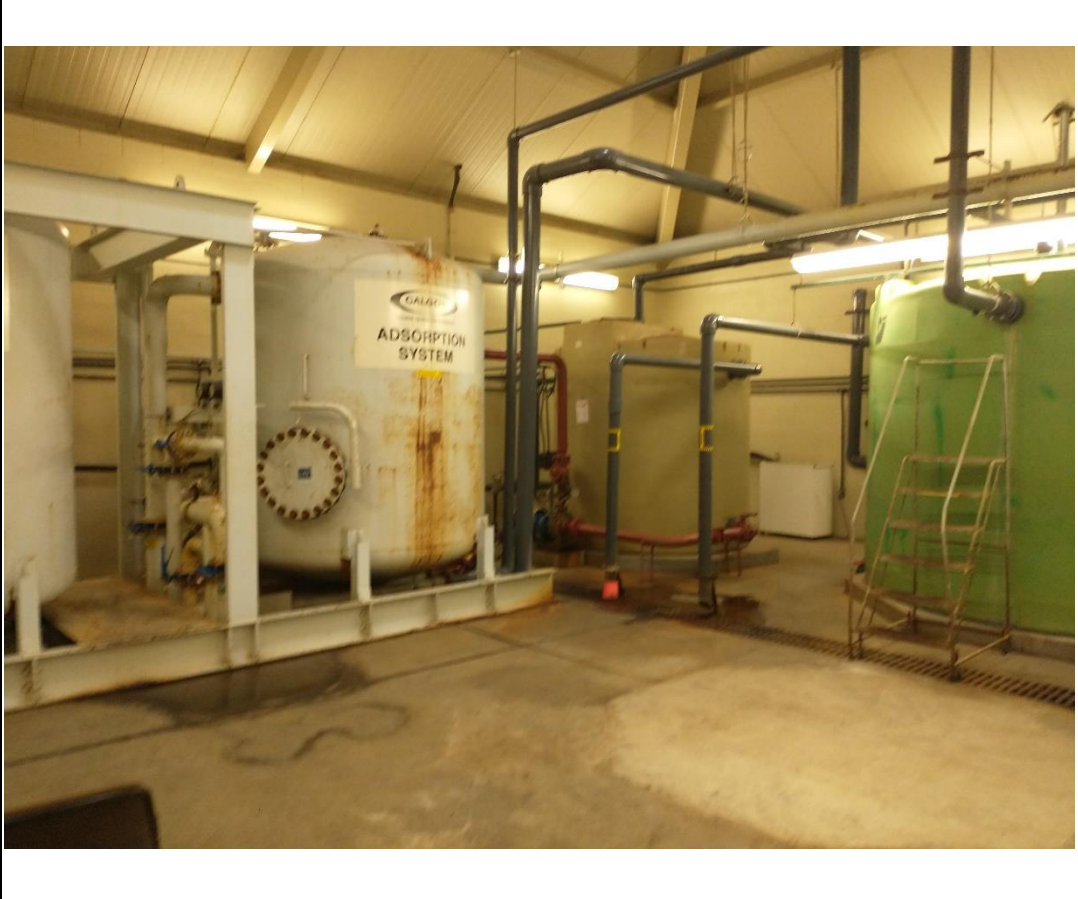
View of the Granular Activated Carbon (GAC) tanks inside the Groundwater Treatment Facility.

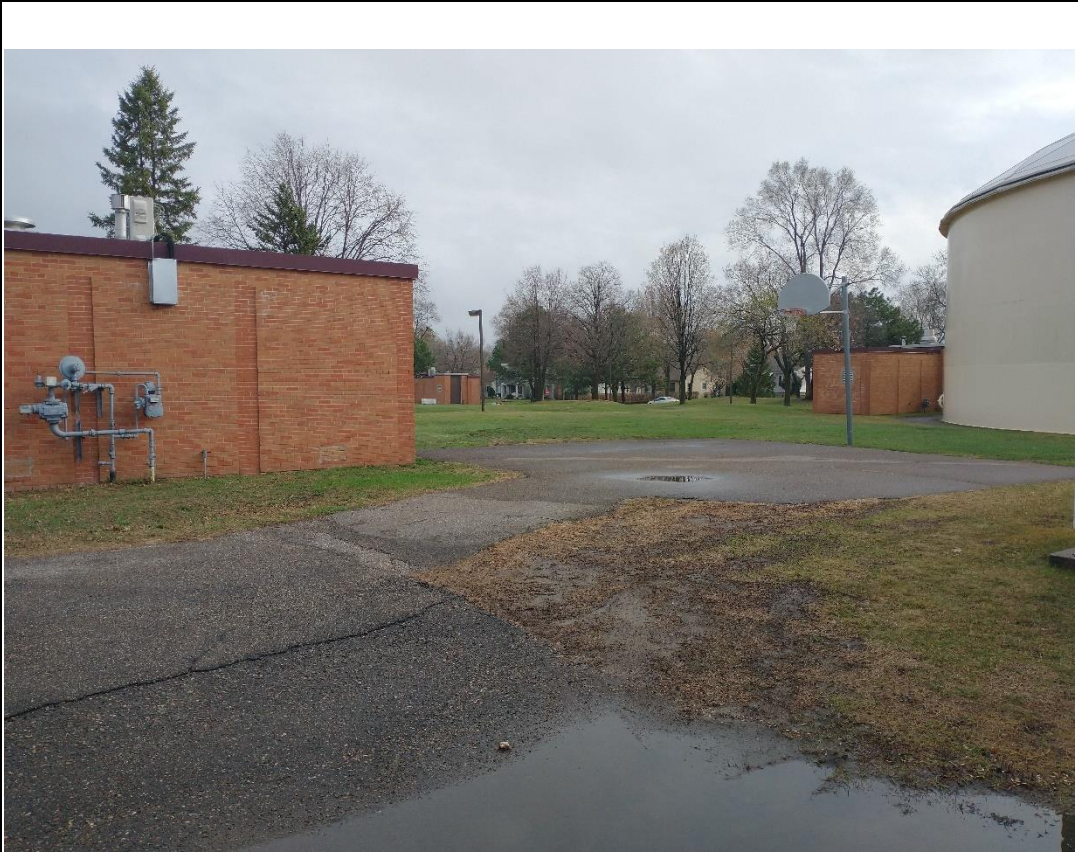
<b>Photo No.</b> <b>19</b>	<b>Date:</b> 4/7/21
<b>Direction Facing:</b> Northeast	
<b>Description:</b> Exterior	
View of the well houses for SLP10, SLP11, and SLP15; also a municipal reservoir.

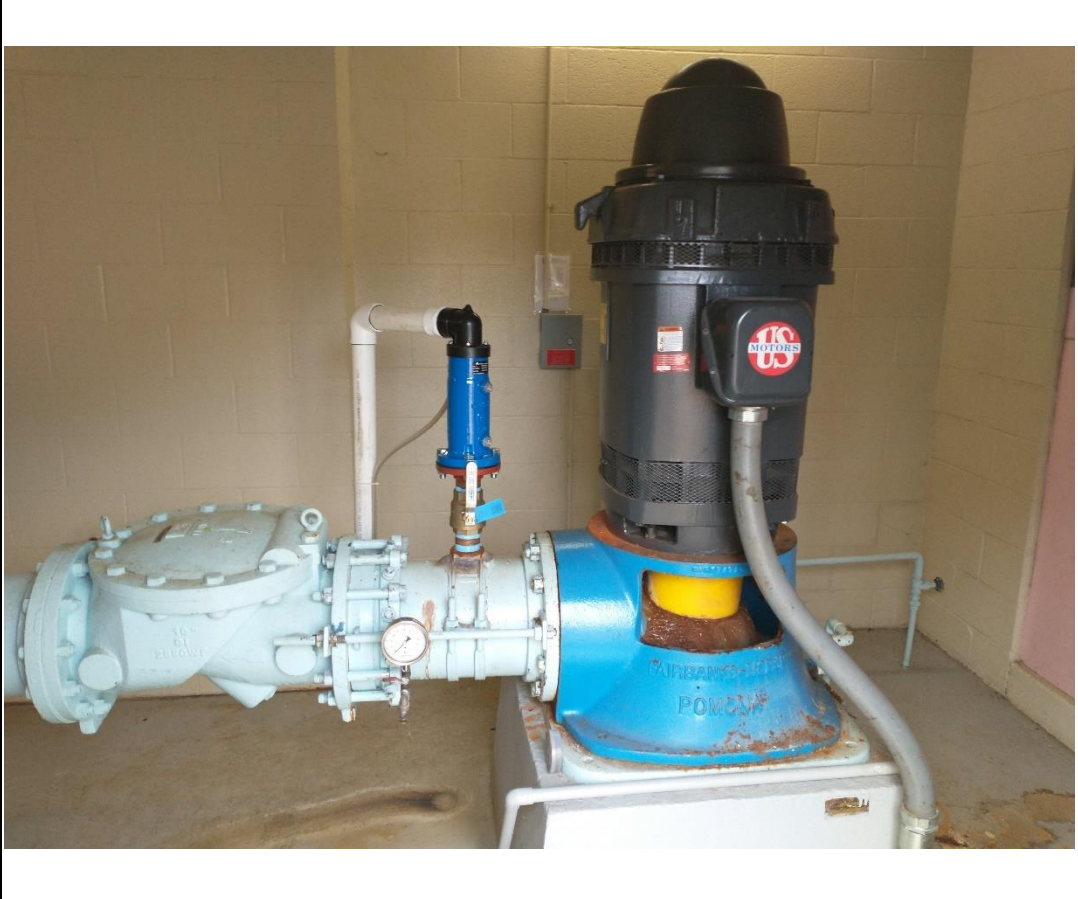
<b>Photo No.</b> <b>20</b>	<b>Date:</b> 4/7/21
<b>Direction Facing:</b> South	
<b>Description:</b> Interior	
View of the municipal well SLP10.

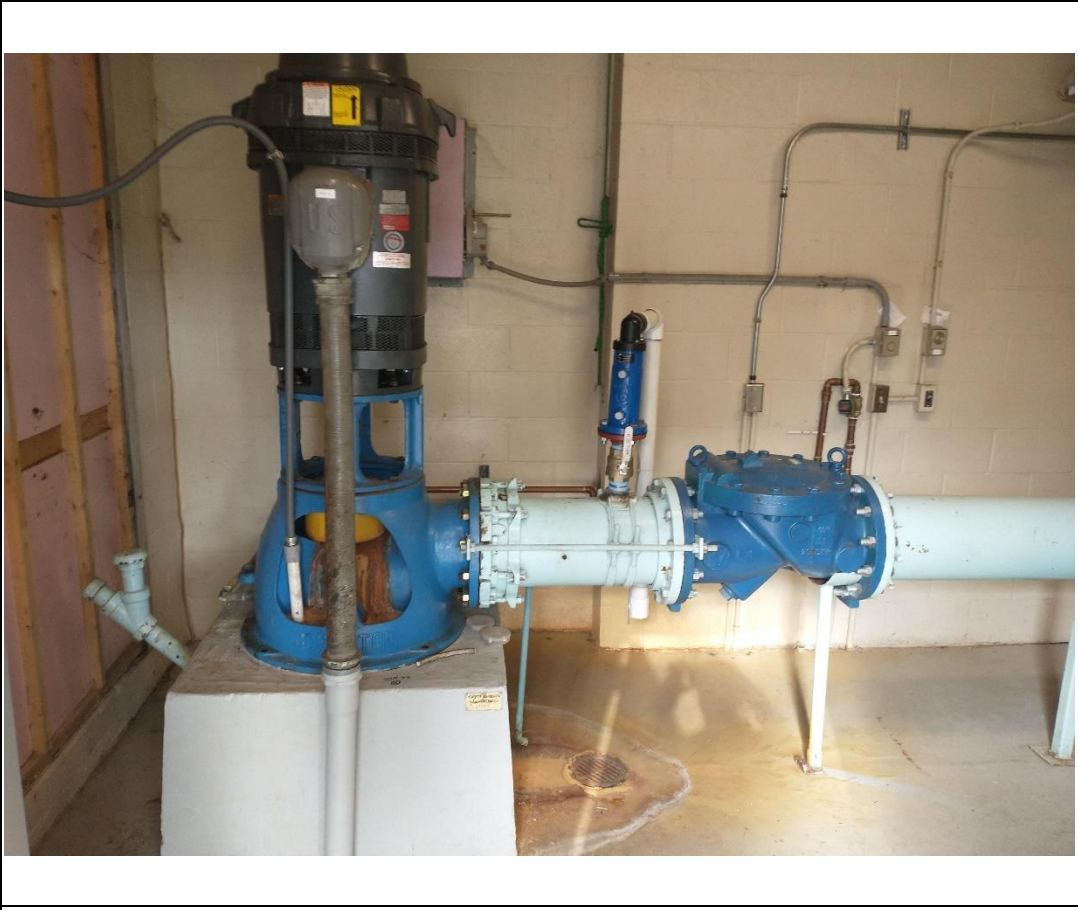
<b>Photo No.</b> <b>21</b>	<b>Date:</b> 4/7/21
<b>Direction Facing:</b> West	
<b>Description:</b> Interior	
View of the municipal well SLP15.

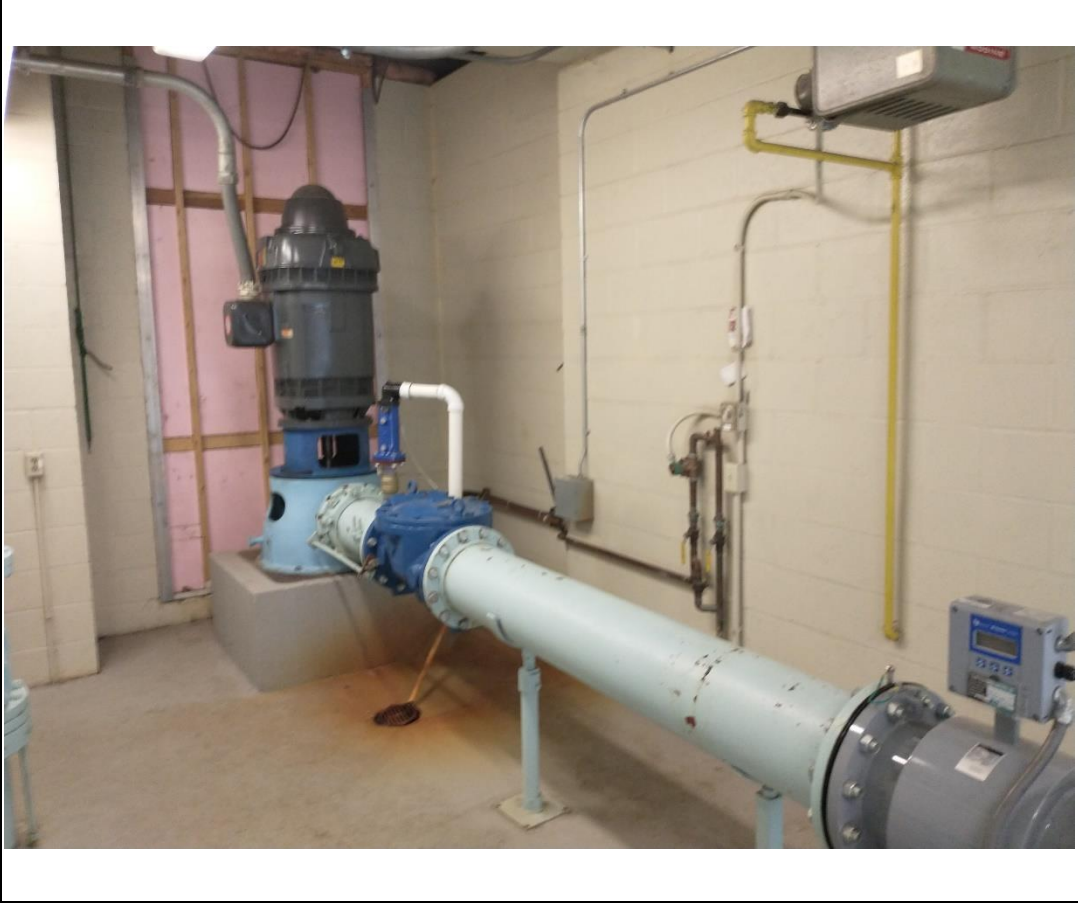
<b>Photo No.</b> <b>22</b>	<b>Date:</b> 4/7/21
<b>Direction Facing:</b> Southeast	
<b>Description:</b> Interior	
View of the municipal well SLP11.

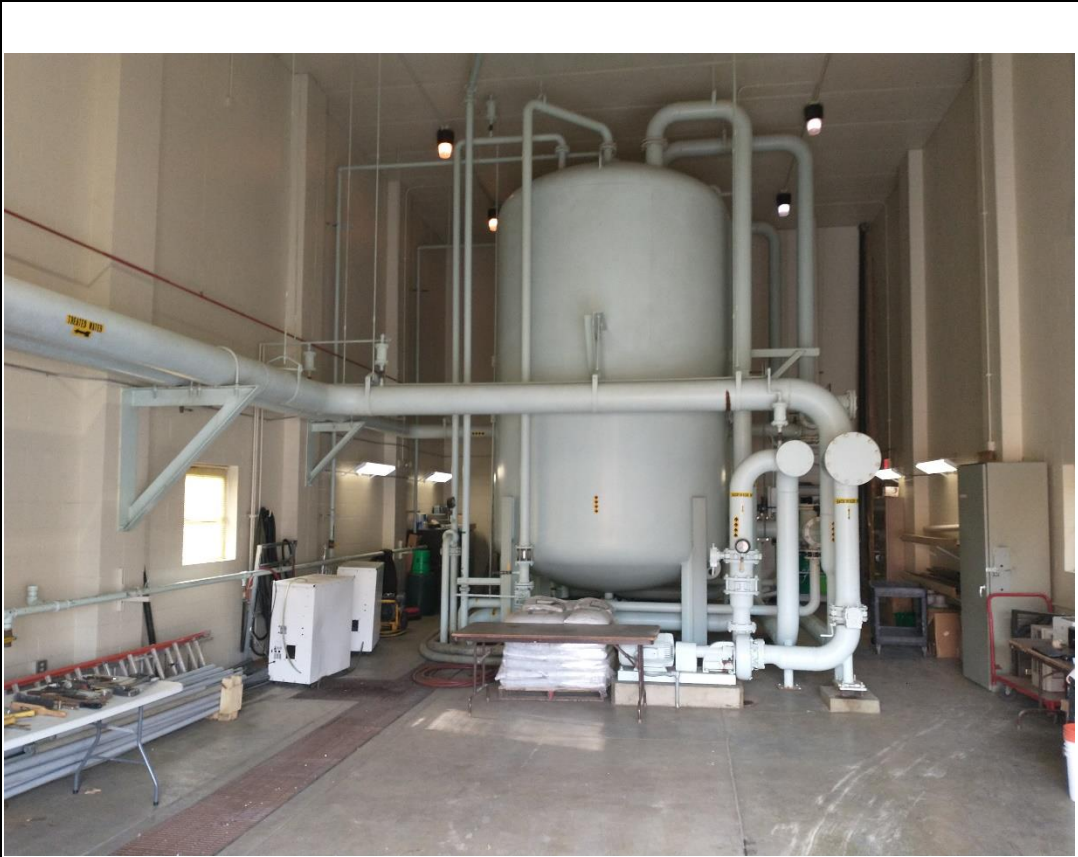
<b>Photo No.</b> <b>23</b>	<b>Date:</b> 4/7/21
<b>Direction Facing:</b> South	
<b>Description:</b> Interior  View of the GAC tanks located at Water Treatment Plant 1, servicing wells SLP10 and SLP15.

- O&M of the GAC treatment plant for drinking water wells SLP 10/15, located at the City’s Treatment Plant 1, including quarterly monitoring of treated water and annual monitoring of feed water. Also, the City generally replaces the GAC every other year. The GAC was replaced in September 2017 and September 2019.

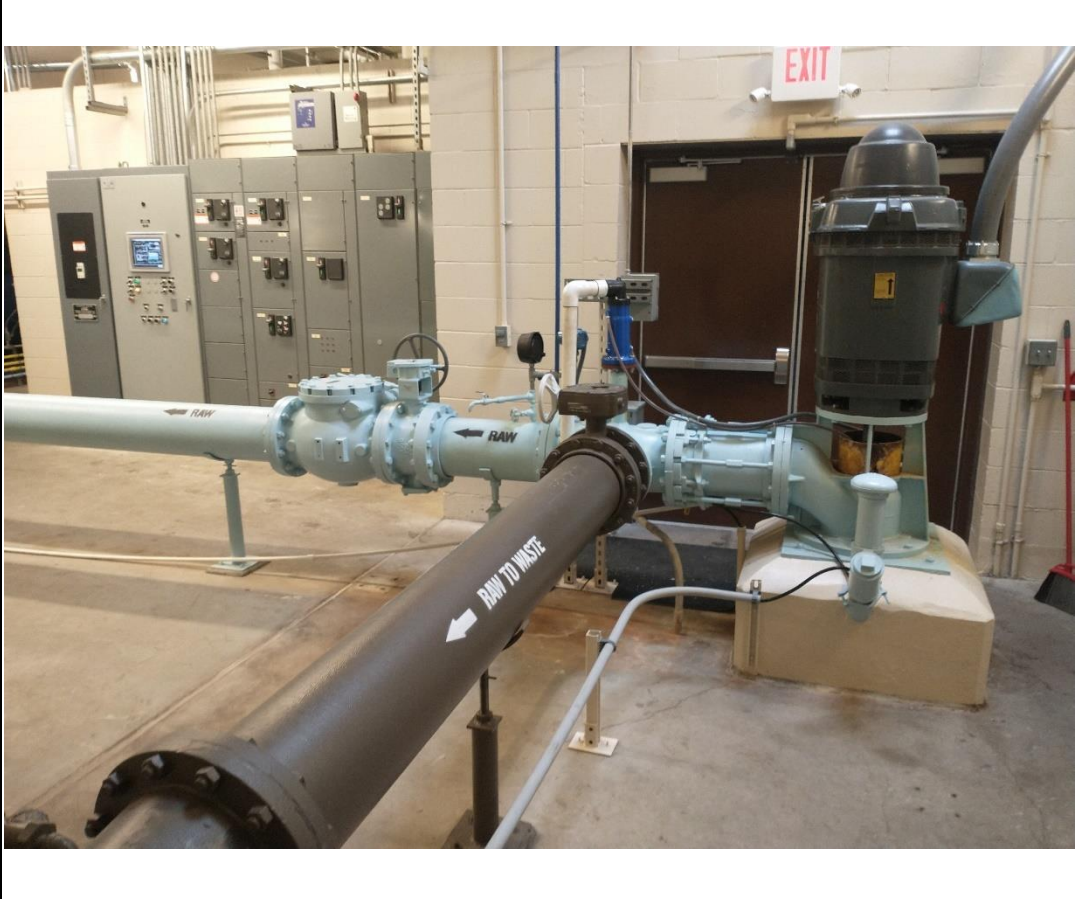
<b>Photo No.</b> <b>24</b>	<b>Date:</b> 4/7/21
<b>Direction Facing:</b> North	
<b>Description:</b> Interior  View of the municipal well SLP4

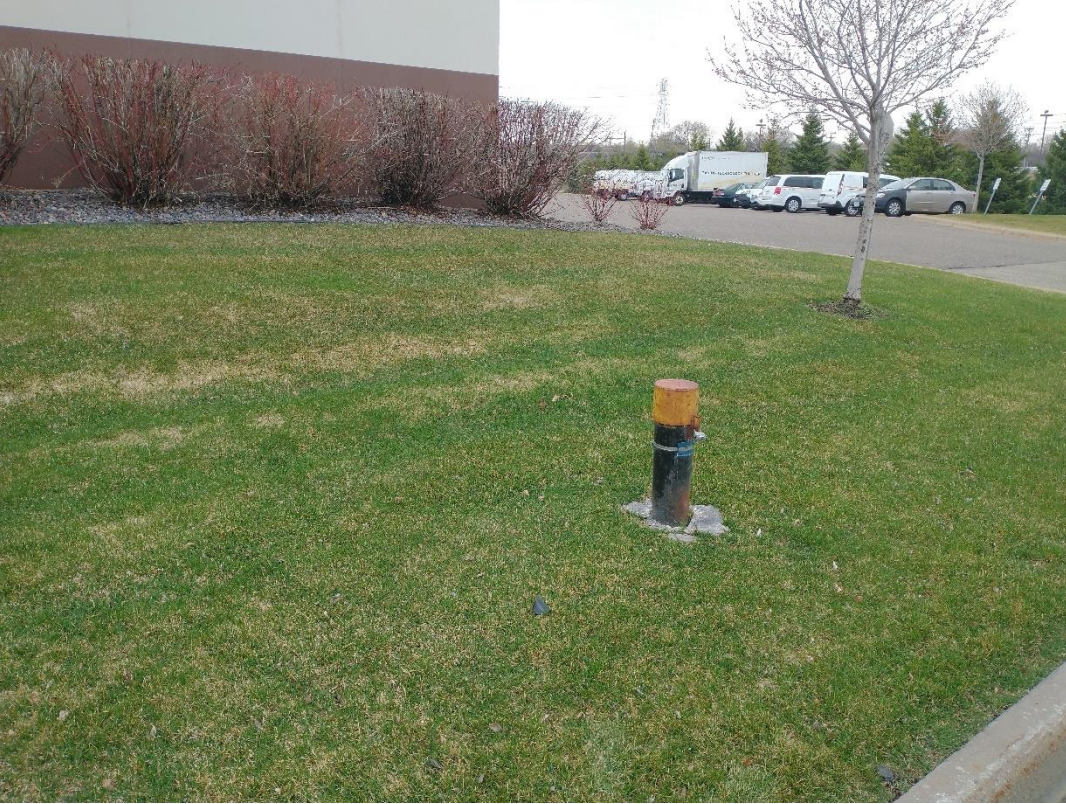
<b>Photo No.</b> <b>27</b>	<b>Date:</b> 4/7/21

<p data-bbox="180 289 402 359"><b>Direction Facing:</b> Southeast</p> <p data-bbox="212 426 370 495"><b>Description:</b> Exterior</p> <p data-bbox="168 590 415 705">View of the new Drift Aquifer well W442 located on Monitor Street.</p>
<b>Photo No.</b> <b>28</b>	<b>Date:</b> 4/7/21
