**SIXTH FIVE-YEAR REVIEW REPORT FOR  
REILLY TAR & CHEMICAL CORP. (ST. LOUIS PARK PLANT)  
SUPERFUND SITE  
HENNEPIN COUNTY, MINNESOTA**

**U.S. Environmental Protection Agency  
Region 5  
Chicago, Illinois**

6/14/2021

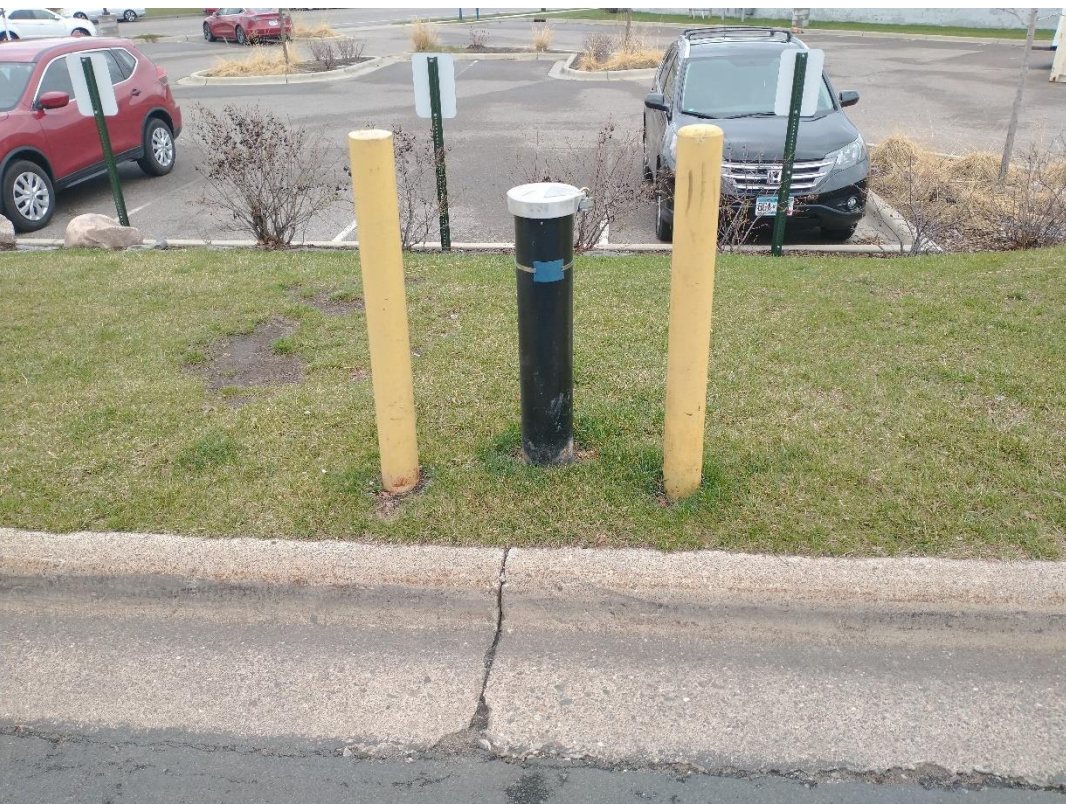
<p data-bbox="180 1188 402 1257"><b>Direction Facing:</b> West</p> <p data-bbox="212 1325 370 1394"><b>Description:</b> Exterior</p> <p data-bbox="168 1488 415 1604">View of the new Drift Aquifer well W444 located on Gorham Avenue.</p>

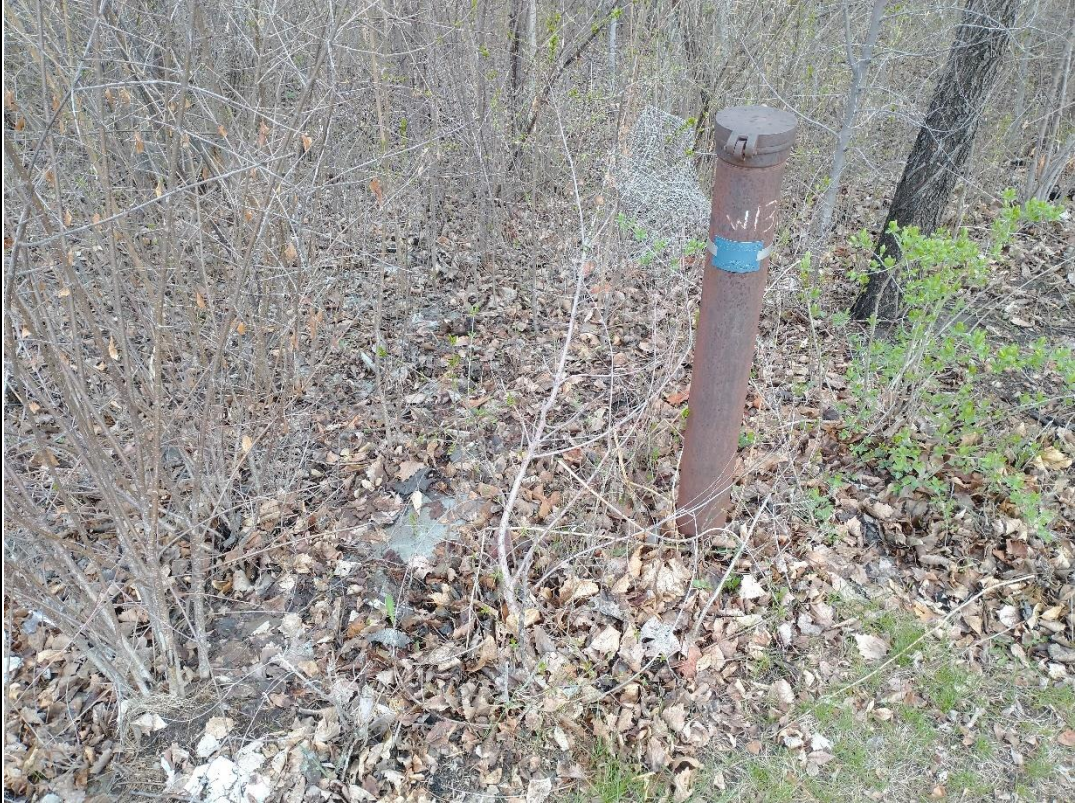
<b>Photo No.</b> <b>29</b>	<b>Date:</b> 4/7/21
<b>Direction Facing:</b> Northeast	
<b>Description:</b> Exterior	
View of well W136 and the abandoned well W131.
