**Re: Tittabawassee River Floodplain 2015 Annual Report
Settlement Agreement No. V-W-15-C-018
The Tittabawassee River Eight-Year Floodplain
Dow Submittal Number: 2016.007**

TITTABAWASSEE RIVER FLOODPLAIN 2015 ANNUAL REPORT

TITTABAWASSEE RIVER FLOODPLAIN 2015 SEGMENT 2 FLOODPLAIN COMPLETION REPORT

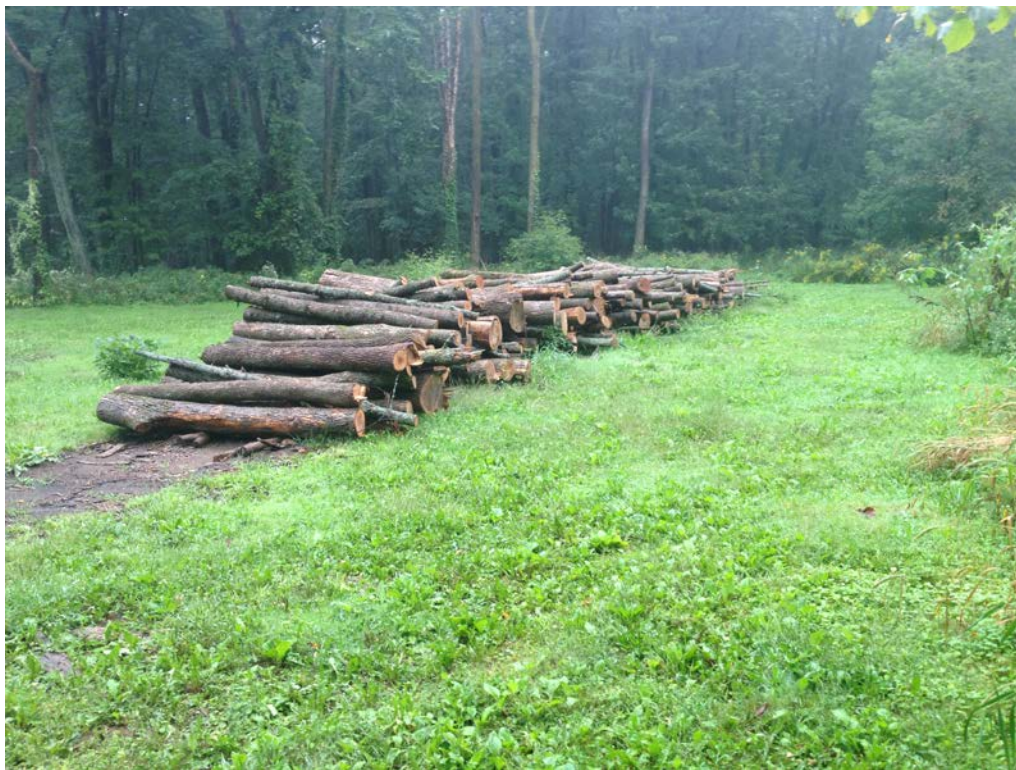
Preconstruction
conditions of remedial
area

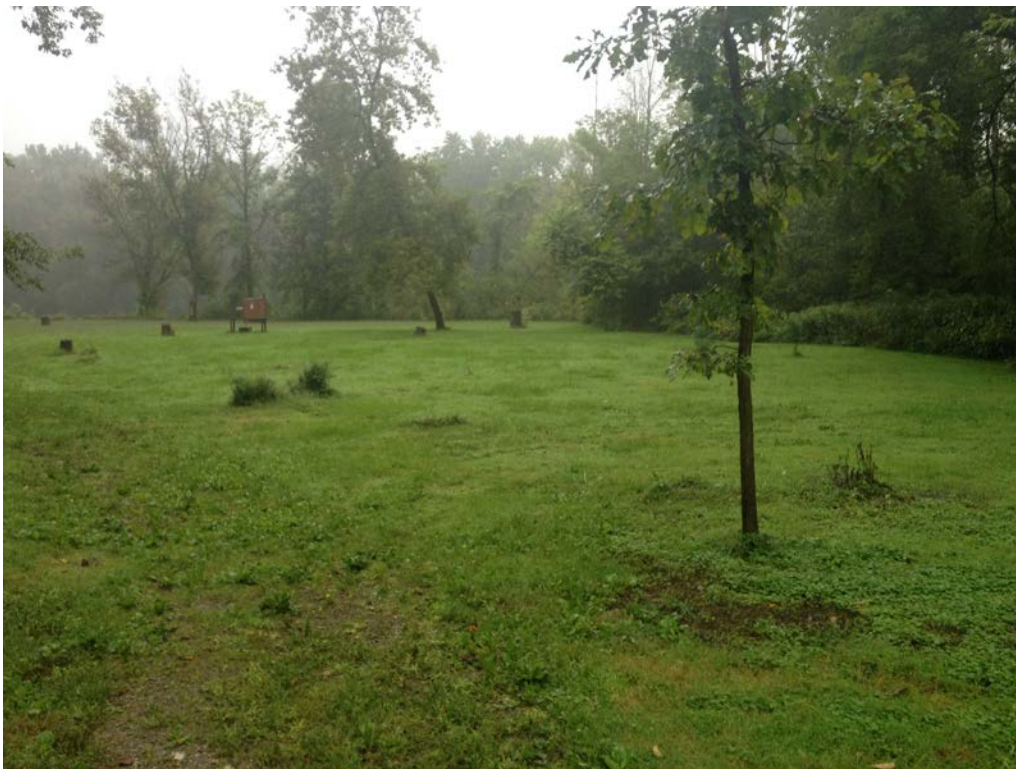
Temporary material staging area being constructed adjacent to River Road

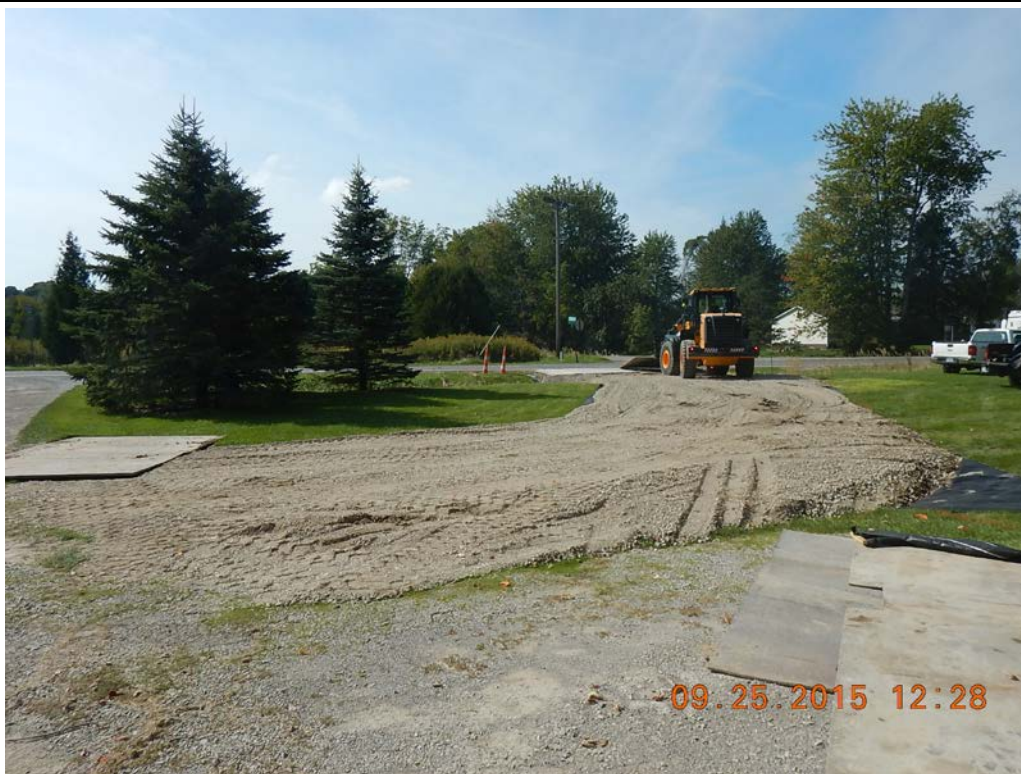
Photo No.
4

Crew removing soil from remedial area

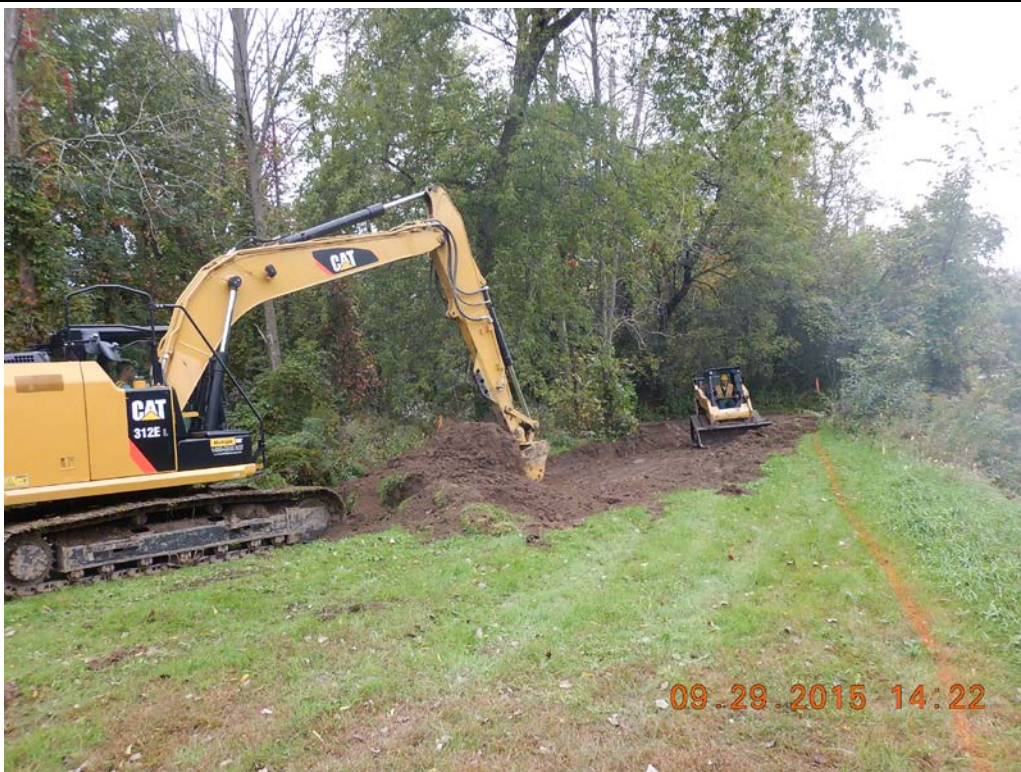
Crew loading and transporting soil

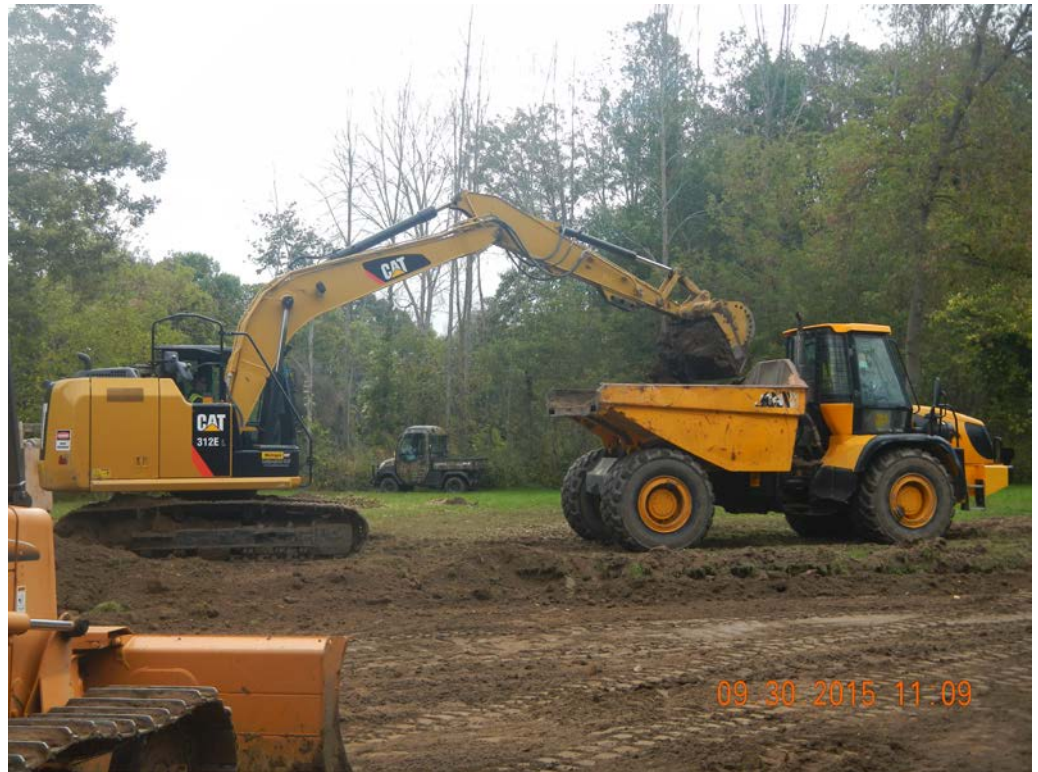
Photo No.
6

Soil removed from floodplain being offloaded at material staging area

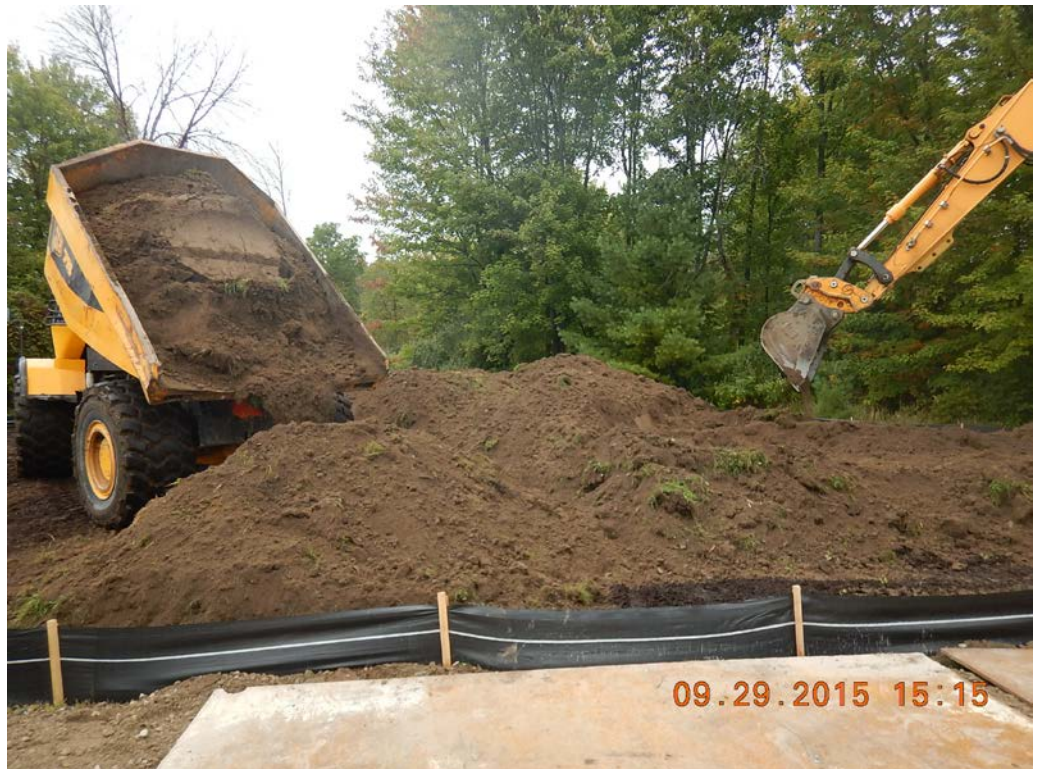
Soil being placed into
truck for disposal

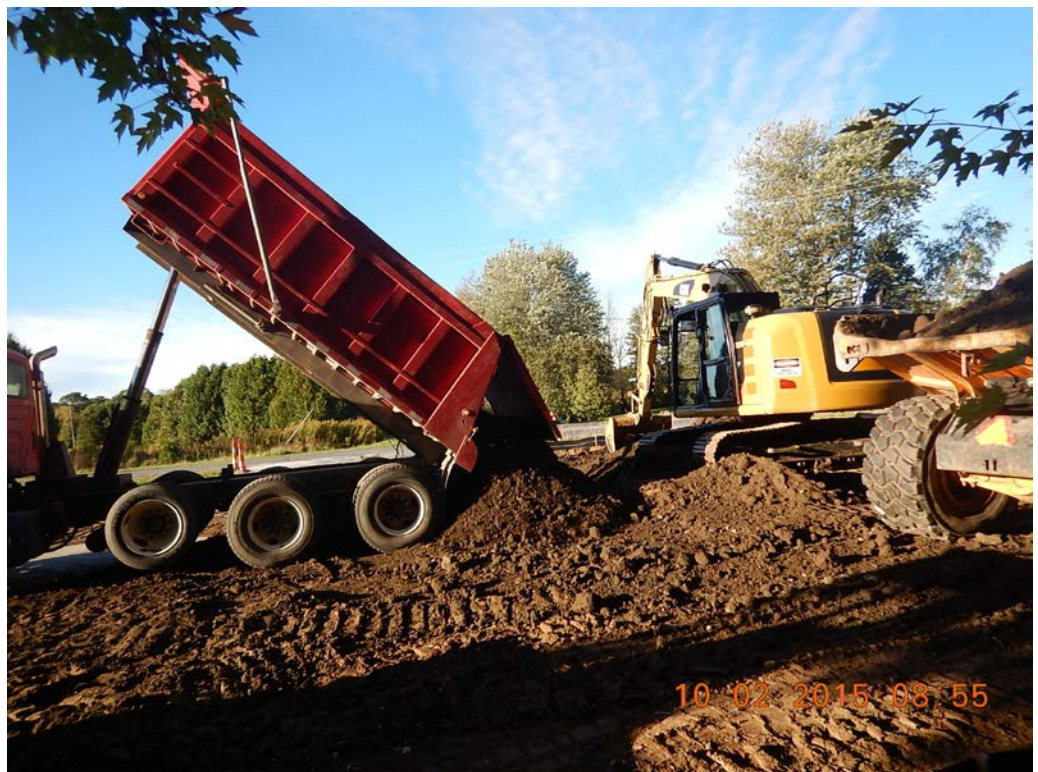
Topsoil being offloaded
within remedial area

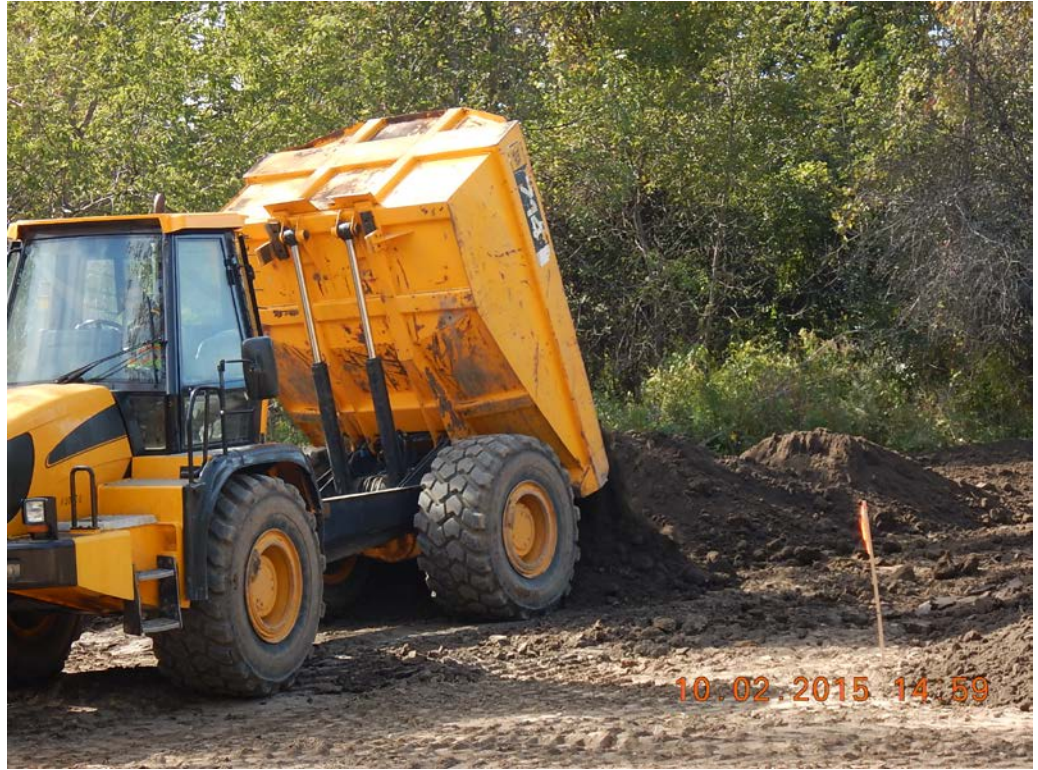
Photo No.
10

Crew applying hydro-
seed slurry

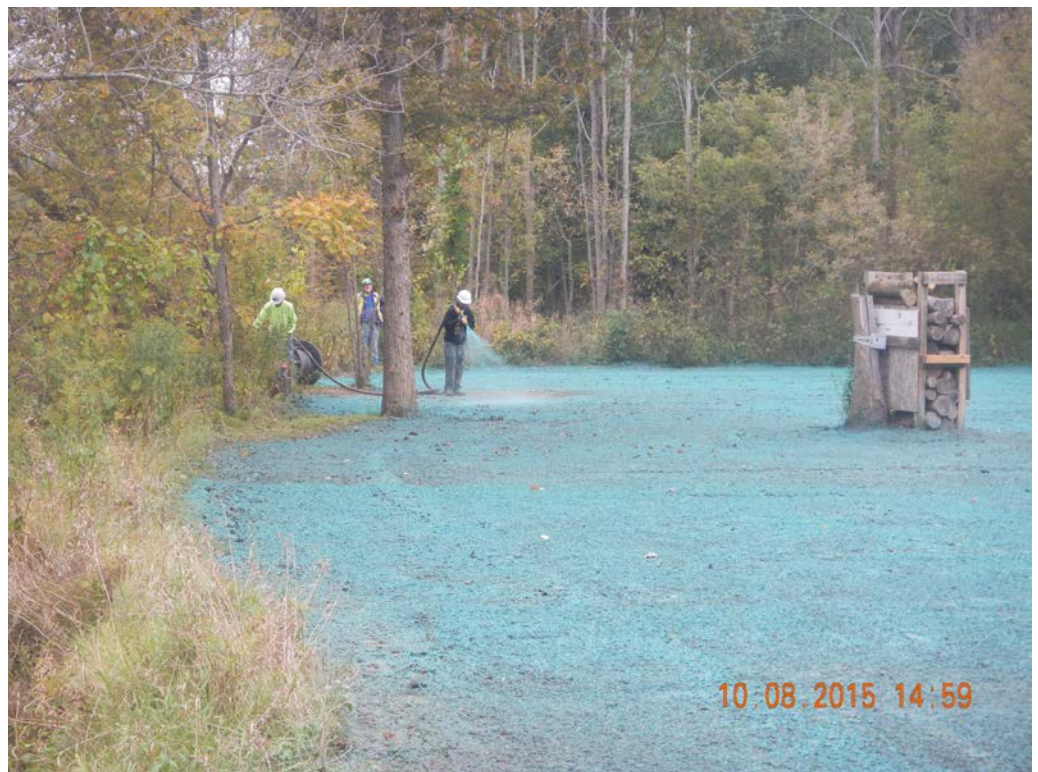
Material staging area
restored prior to seeding

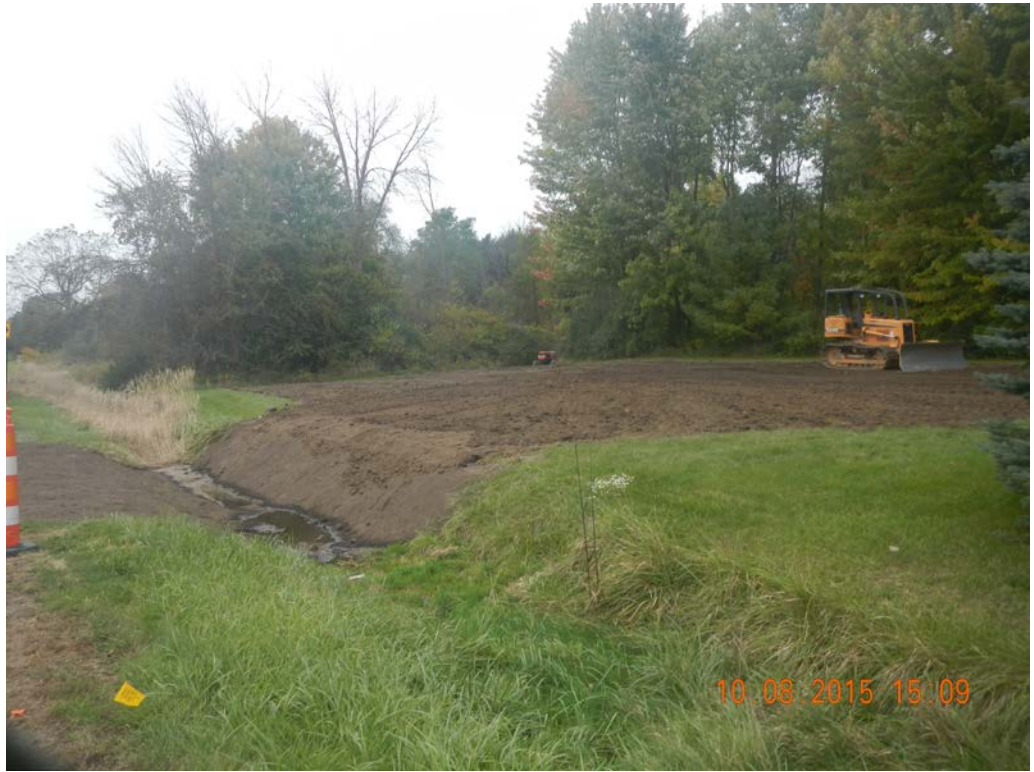
Photo No.
12

Post construction
monitoring

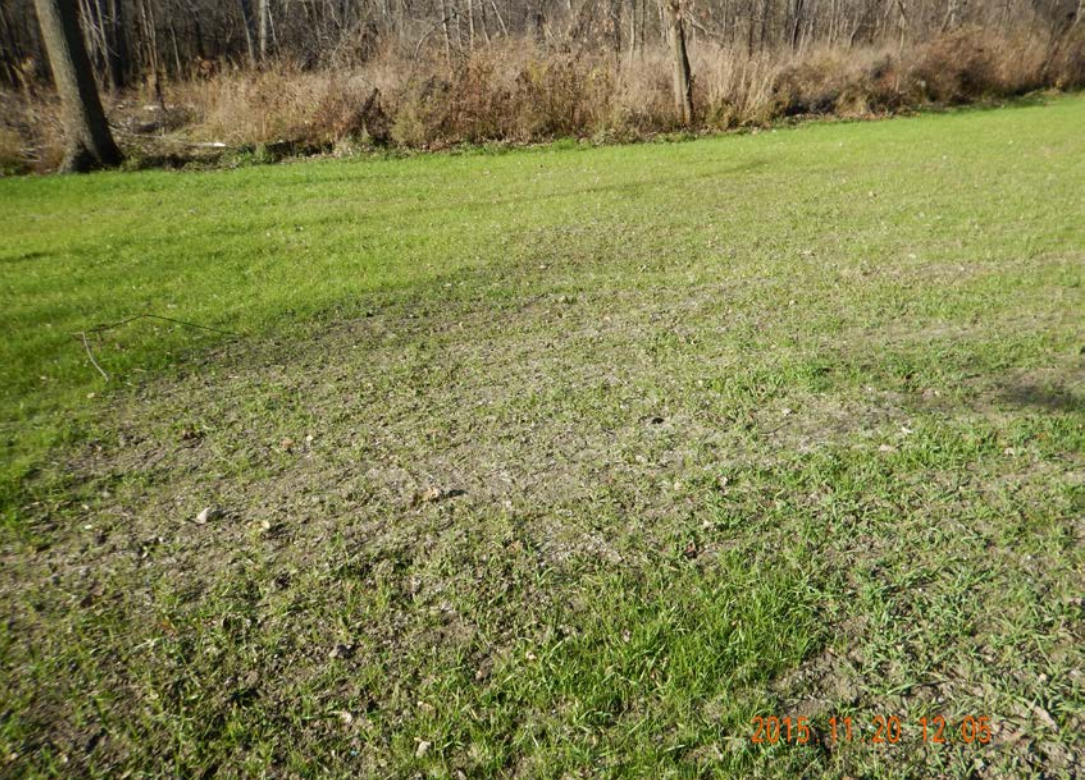
Direction Photo Taken: North			
Description: Sparse area of newly seeded lawn

Make additional observations in the Spring and additional seeding may be required due to sparse growth observed during the fall monitoring event.

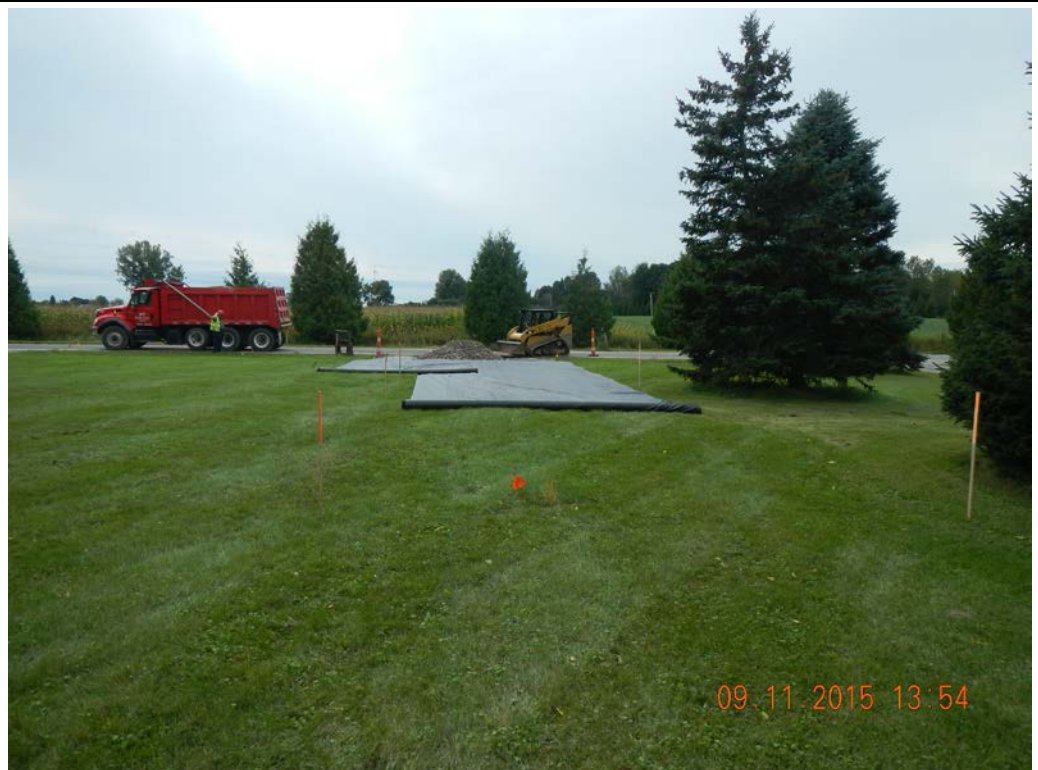
Site access improvements being performed along existing ramp.

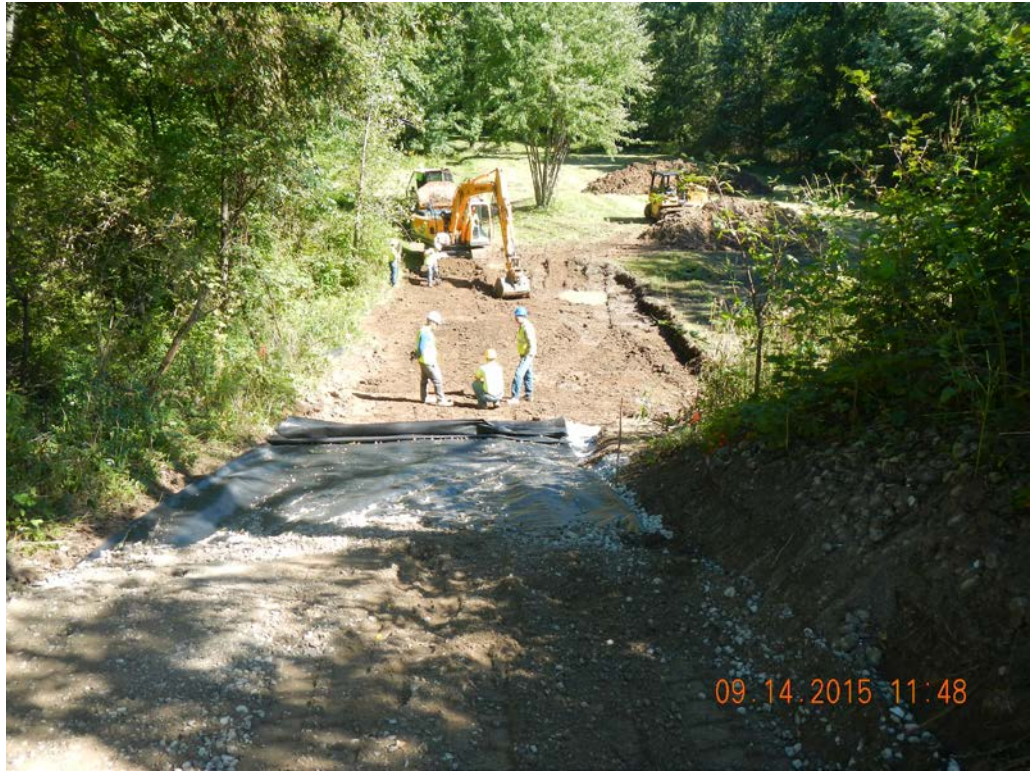
Photo No.
4

QA/QC activities being performed near SW portion of remedial area.

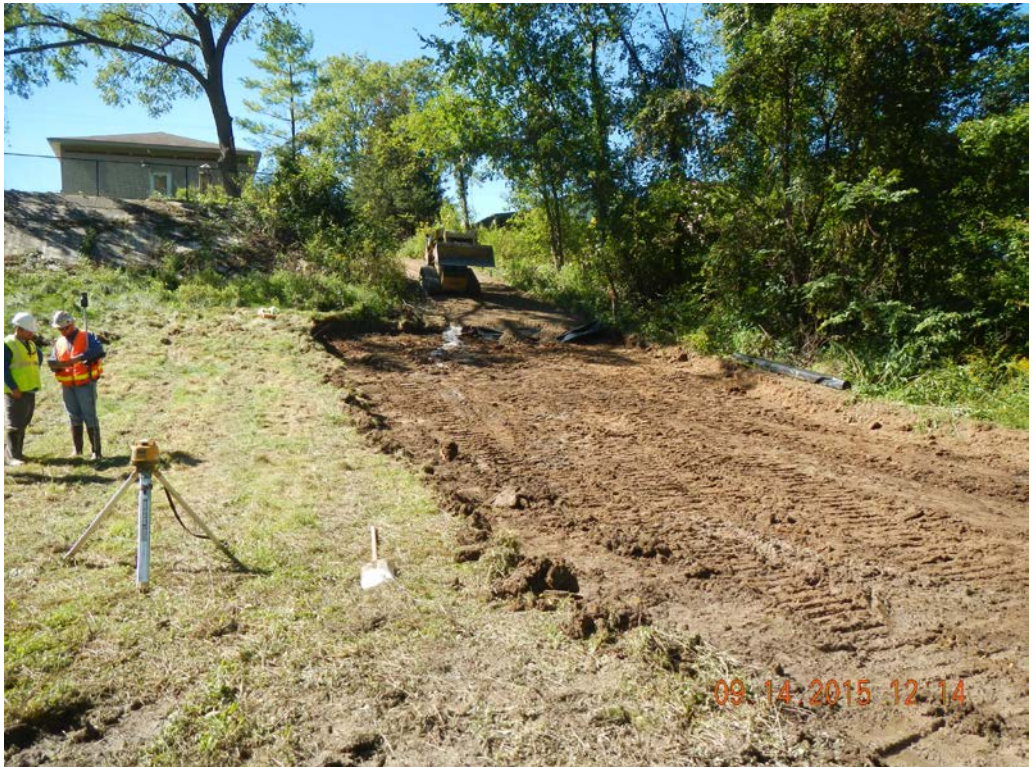
Soil removal and transport activities being performed

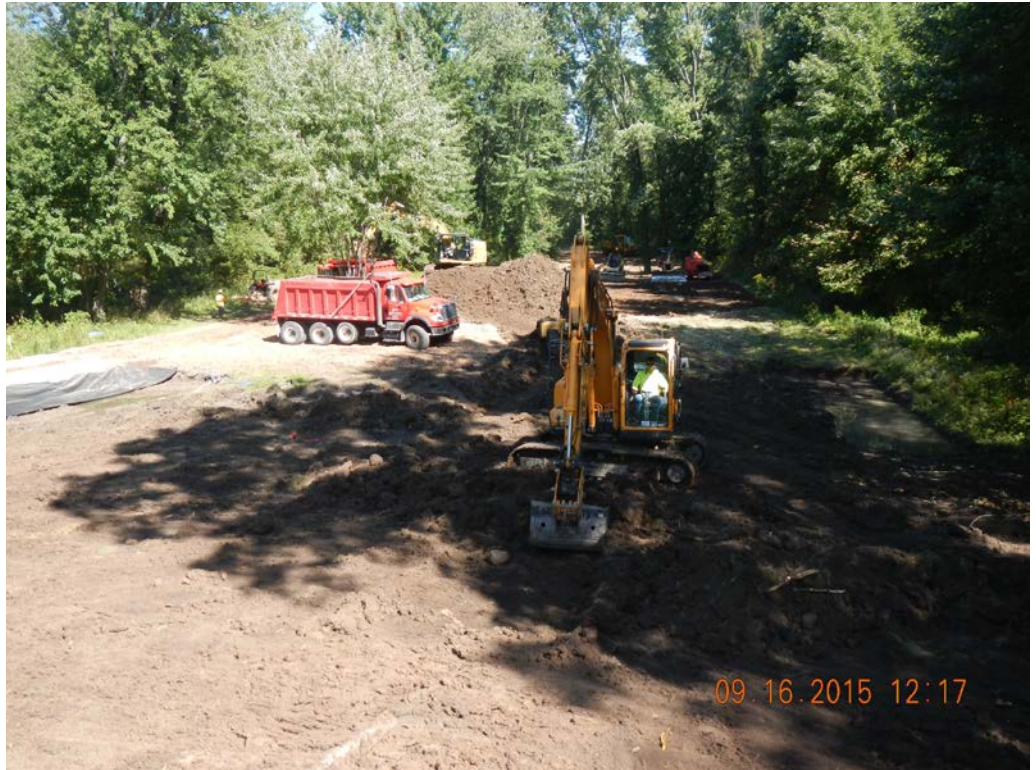
Photo No.
6

Crew placing & grading topsoil

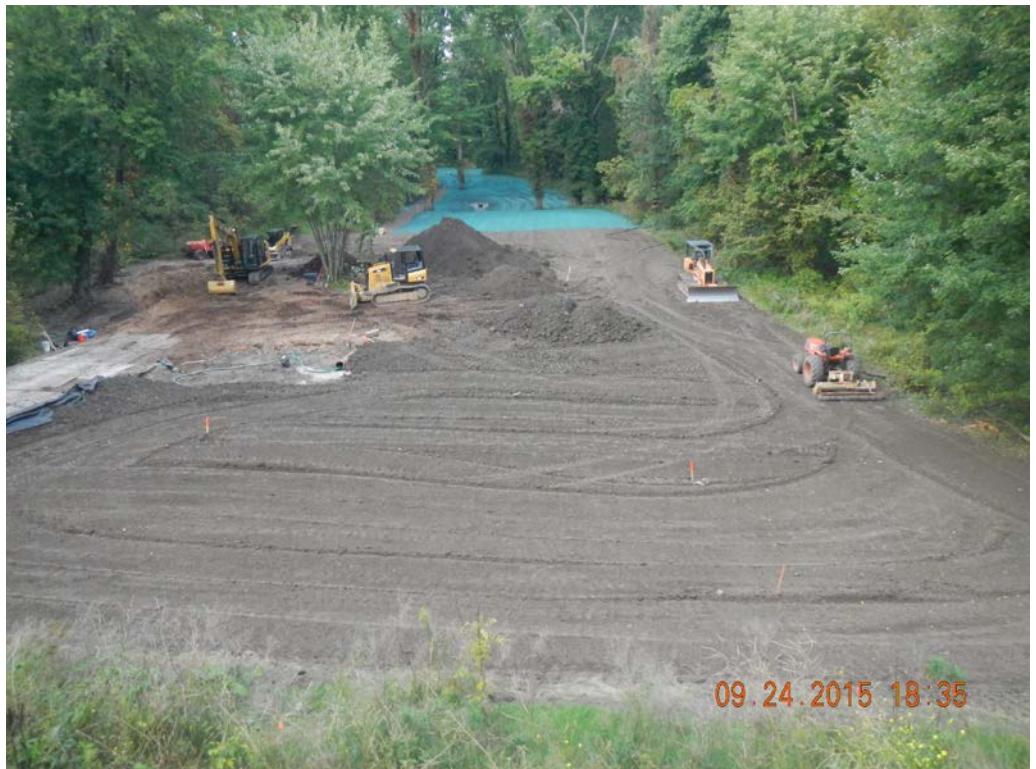
Remedial activities
complete

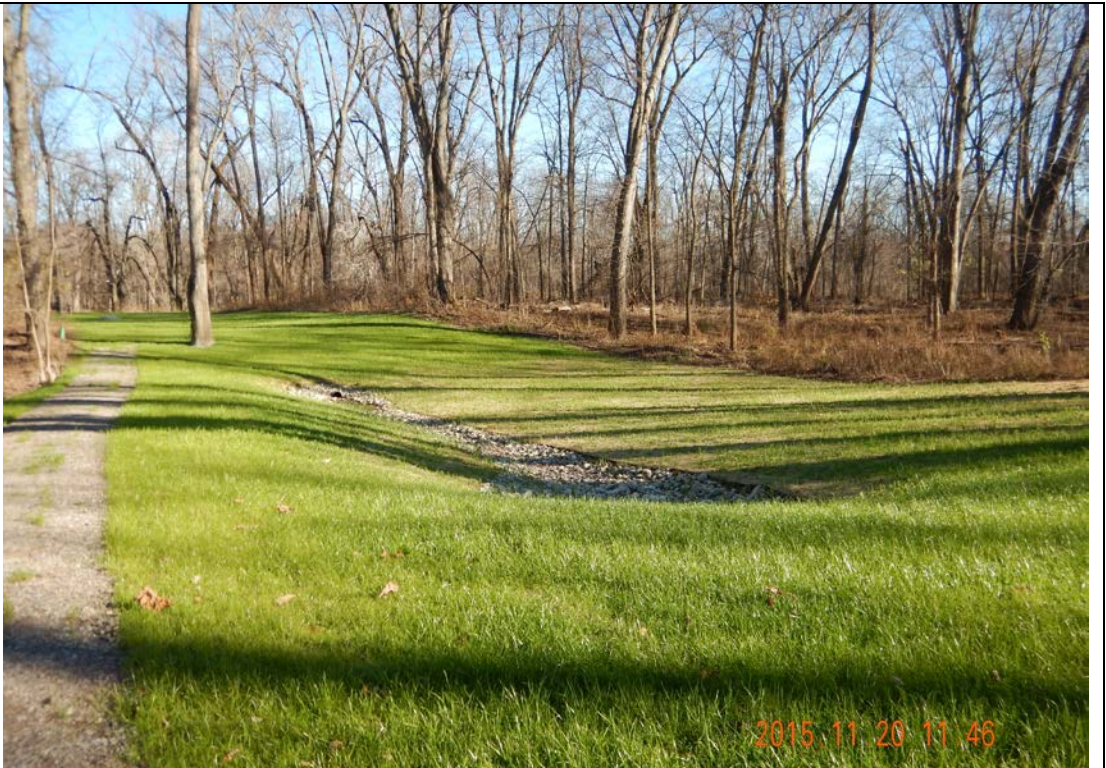
<p>2015.11.20.11.46</p>
Direction Photo Taken: South/East		
Description: Area B wetland swale area plus newly seeded maintained area in floodplain

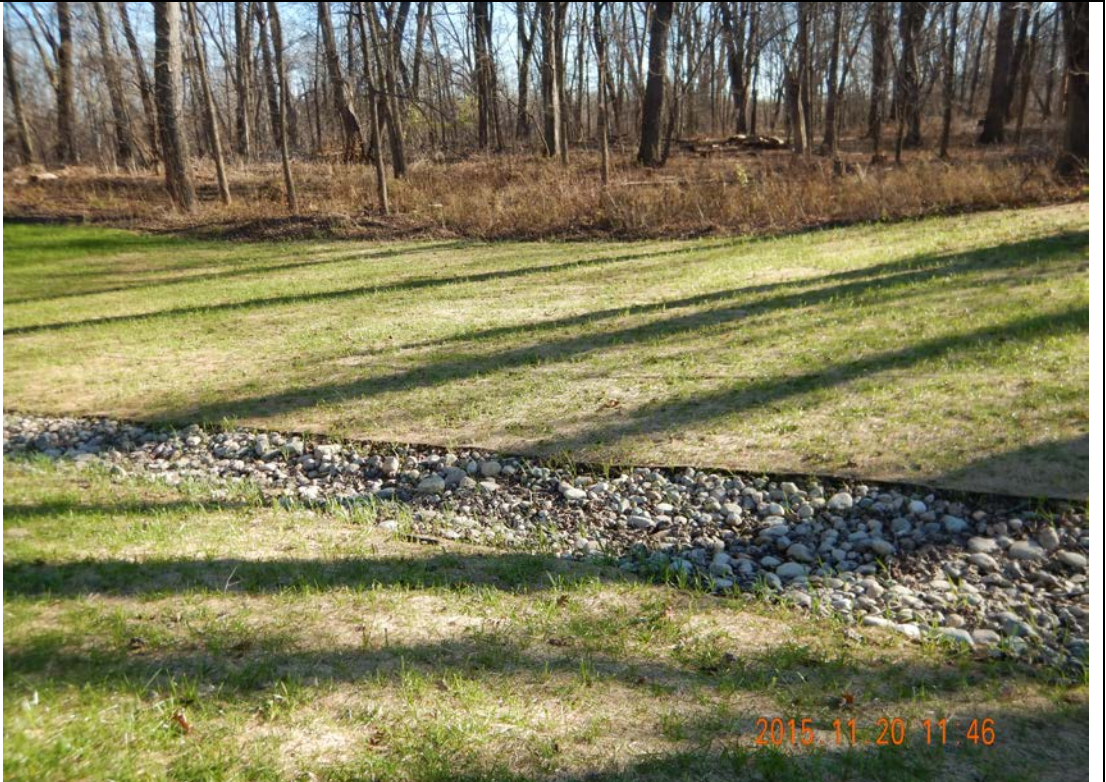
Direction Photo Taken: South			
Description: Area B swale in maintained area in the floodplain

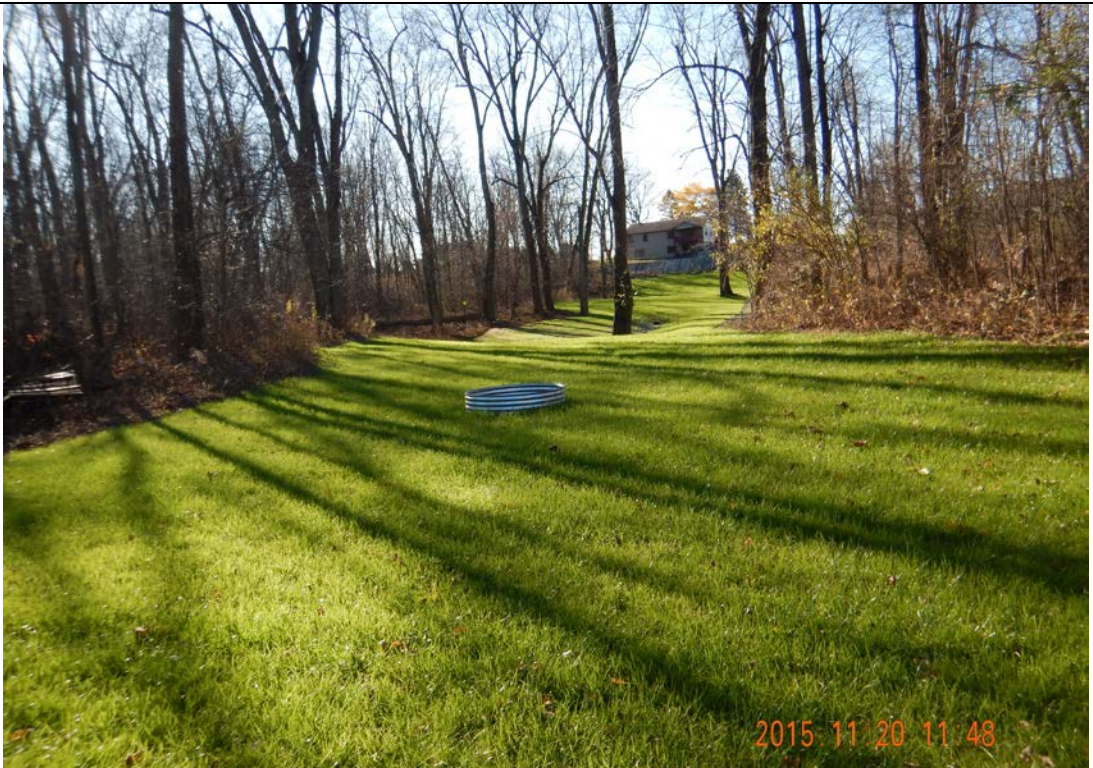
Direction Photo Taken: West		
Description: New fire pit and newly seeded lawn in floodplain
