**FINAL SECOND SUPPLEMENTAL
CORRECTIVE MEASURE IMPLEMENTATION WORK PLAN**

**Amphenol Corporation
Former Bendix Facility
Administrative Order on Consent, Docket #RCRA05-2024-0006
EPA ID # IND 044 587 848
980 Hurricane Road
Franklin, Indiana 46131**

Date: May 3, 2024

**IWM Consulting Group, LLC
7428 Rockville Road
Indianapolis, IN 46214
Phone No. (317) 347-1111
Fax No. (317) 347-9326**

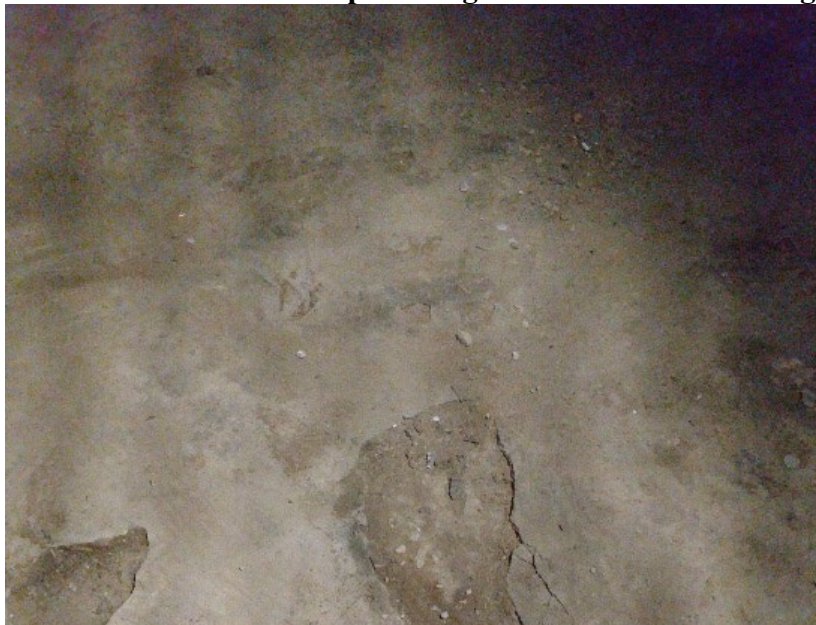
Photo #1: Basement floor before install/repairs.

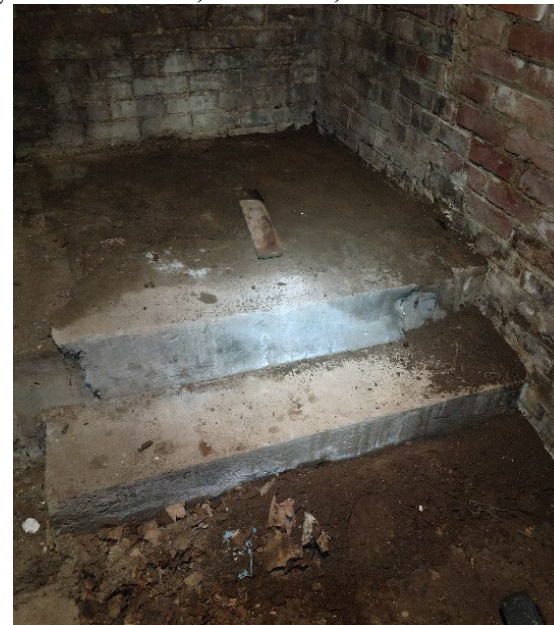
Photo #2: Bottom of staircase landing before install.

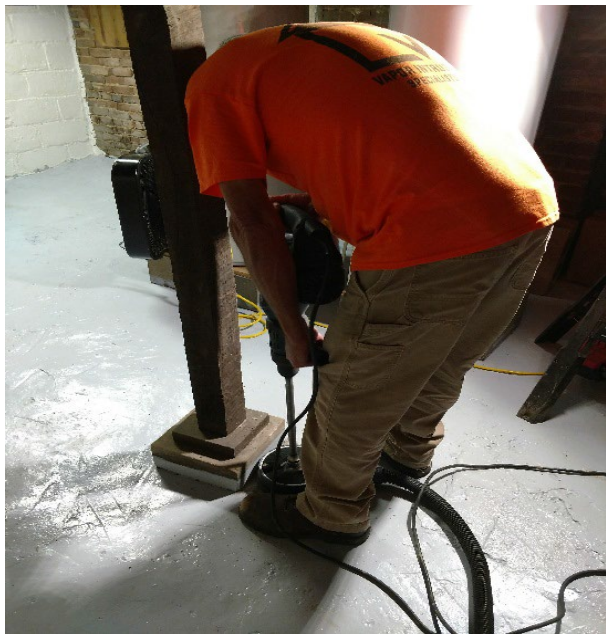
Photo #19: After sealing the basement, VIS conducted PFE testing to determine system design.

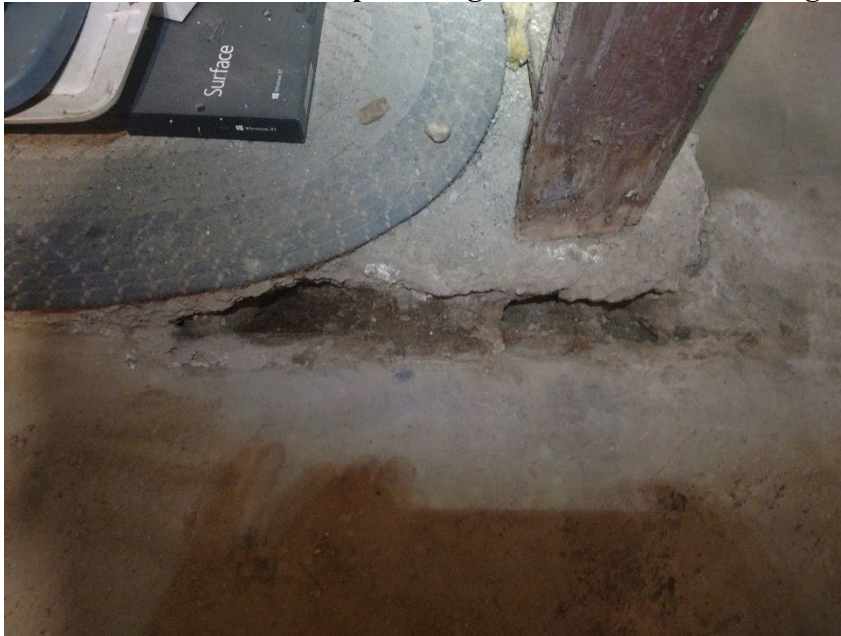
Photo #5: Additional holes in foundation slab.

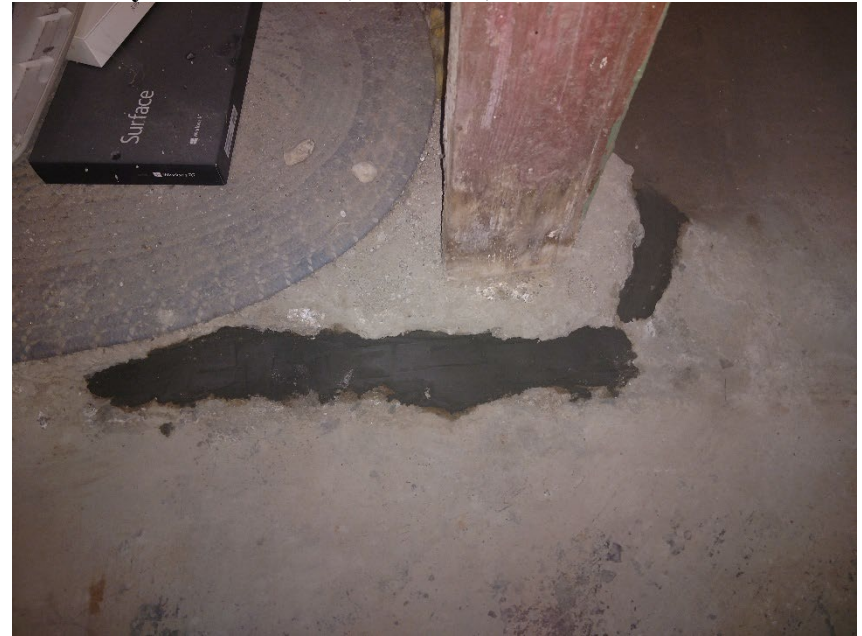
Photo #6: Foundation slab holes filled with hydraulic cement.

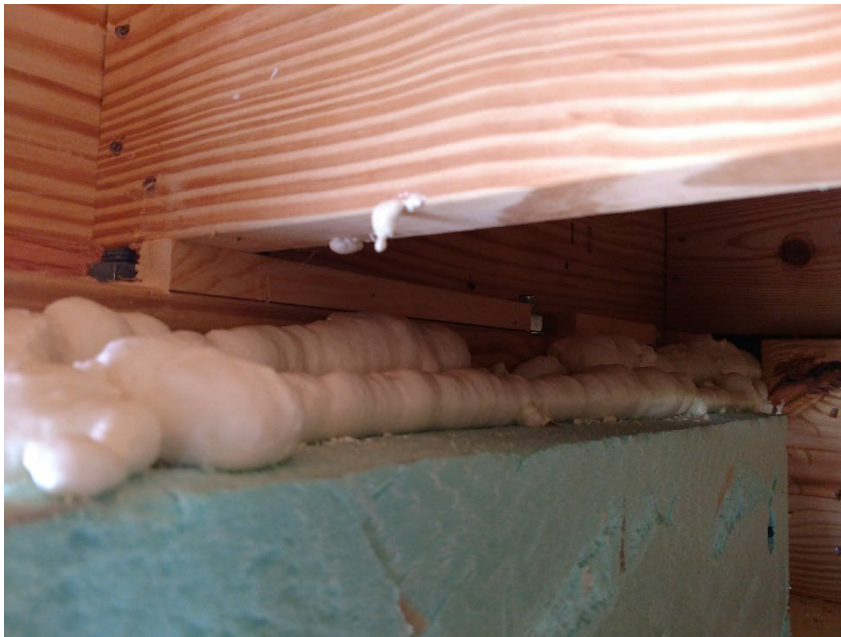
Photo #15: Open foundation wall block tops were sealed with spray foam.

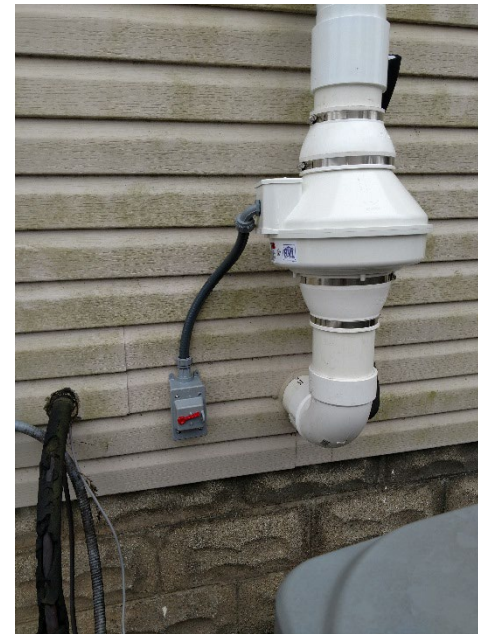
Photo #16: Mounted Fantech® Rn4 mitigation fan with a service switch in a weather tight enclosure.

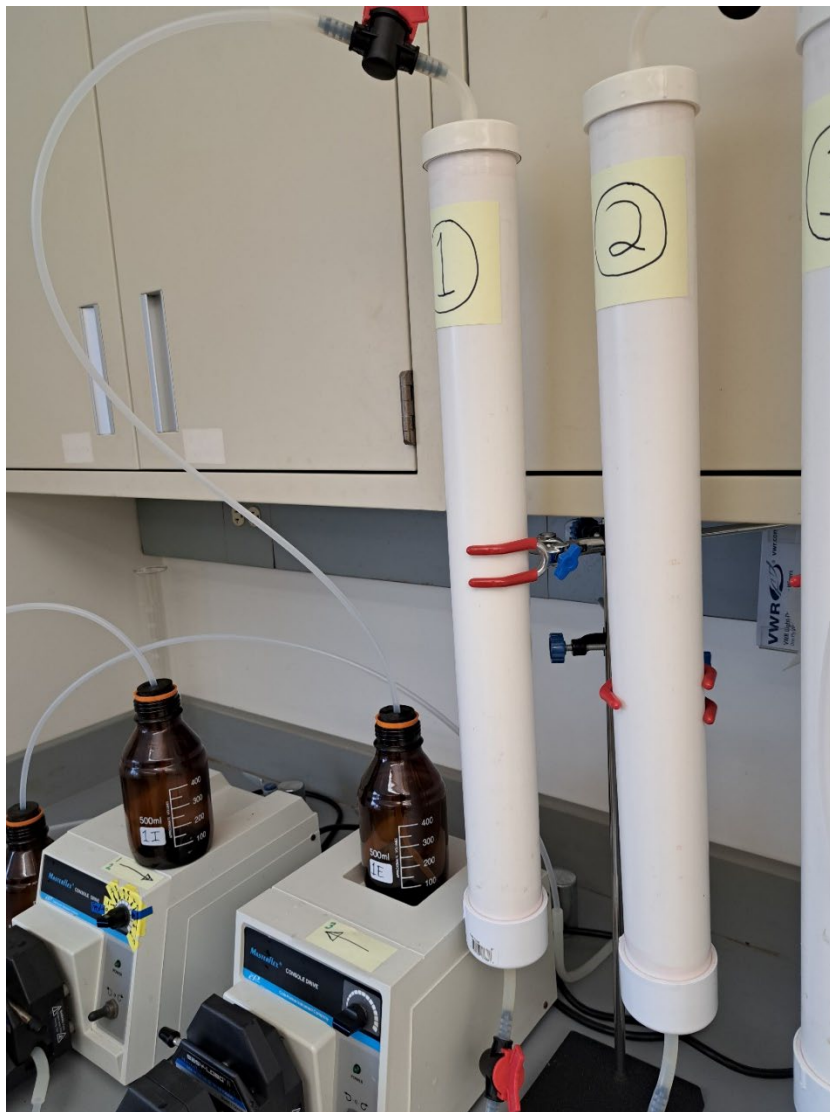
Every day, 500 mL of groundwater were placed in 500-mL amber reagent bottles that were stoppered (to minimize CVOC stripping). These 500-mL bottles served as the influent water reservoirs for Column 1, 2, and 5. The tubing in the influent bottles reached all the way to the bottom, and volume was greater than the 432 mL/day, to ensure no air entered the tubing as the bottles emptied. The same 500-mL amber reagent bottles were also used to collect the effluent from Reactor 1, Reactor 4, and Reactor 6, which were stoppered to minimize stripping. The influent water to the Column 1, 2, and 5 was analyzed daily for CVOCs, as was the effluent from Column 1, 4, and 6.

Figure 10. A picture showing the columns, influent and effluent bottles, and the pumps used to force water upward through the columns.

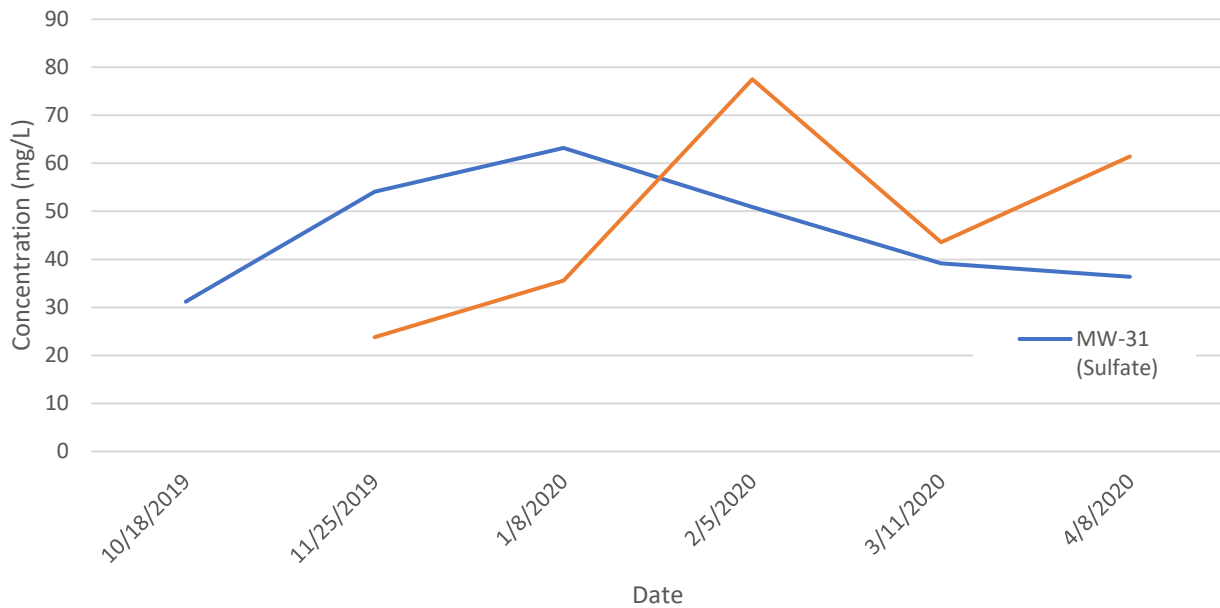
Sulfate Trends in MW-31 and MW-38

The sustained reduction of nitrate and increase in dissolved manganese with only temporary reductions in sulfate and the temporary increase in iron indicates that groundwater reducing conditions in the area are manganese reducing, which is ideal for maintaining lower dissolved methane concentrations. However, nitrate and manganese concentrations were not detected in monitoring wells MW-31 and MW-38.
