**THIRD FIVE-YEAR REVIEW REPORT FOR
NORTH RAILROAD AVENUE PLUME SUPERFUND SITE
ESPAÑOLA, RIO ARRIBA COUNTY, NEW MEXICO**

AUGUST 2020

**U.S. Environmental Protection Agency
Region 6
Dallas, Texas**

**THIRD FIVE-YEAR REVIEW REPORT
NORTH RAILROAD AVENUE PLUME SUPERFUND SITE
EPA ID#: NMD986670156
ESPAÑOLA, RIO ARRIBA COUNTY, NEW MEXICO**

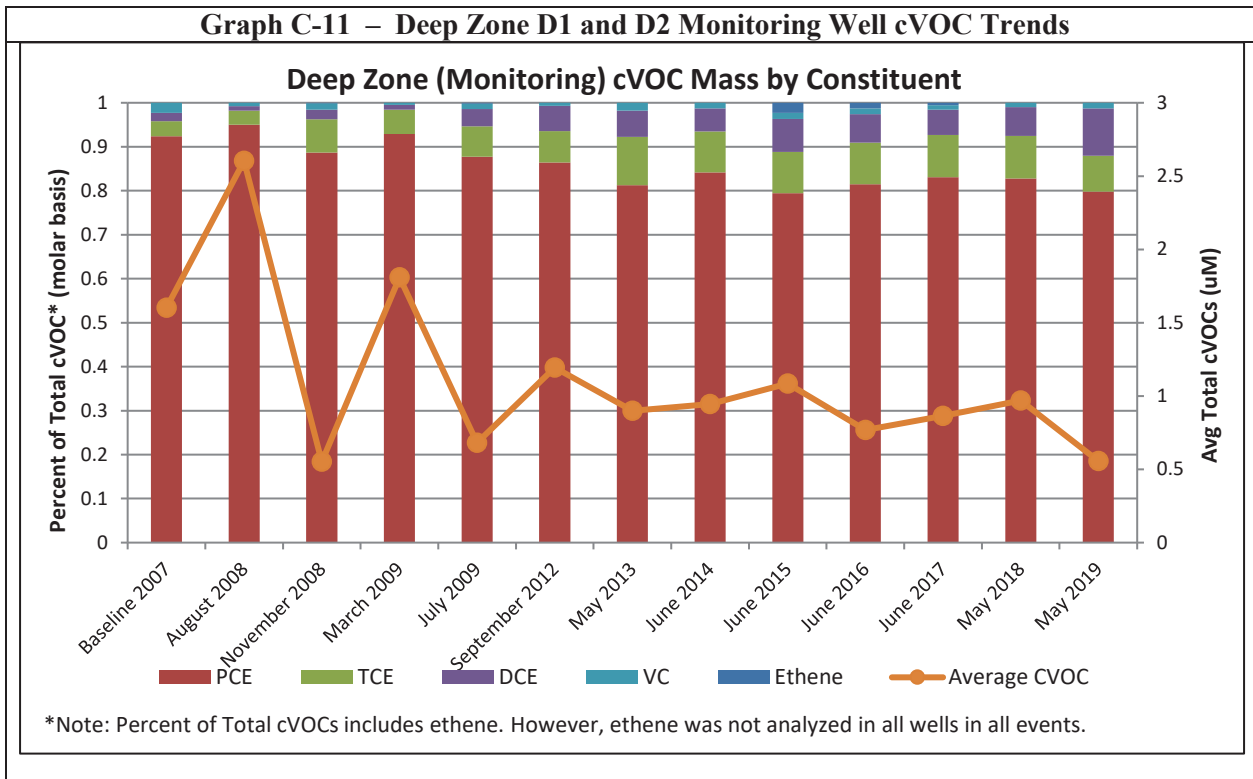
Graph C-11 – Deep Zone D1 and D2 Monitoring Well cVOC Trends

All cVOCs except VC are below the Site cleanup levels in the injection wells as of the most recent sampling in 2017. Vinyl chloride concentrations ranged from 1.6 µg/L to 12 µg/L. However, the cVOC mass remains relatively unchanged in the Deep Zone monitoring wells which are located within approximately 40 feet of the injection wells. Tetrachloroethene in the monitoring wells represents approximately 80% of the contaminant mass (Graph C-11).

The May-September 2019 PCE concentrations in samples collected from the D1 Zone monitoring wells ranged from 1.5 µg/L in the sample from R-12(D1) to 310 µg/L in M-09. The highest PCE concentrations within the D1 Zone were in samples from wells M-09 (310 µg/L), R-29A(D1) (208 µg/L) and M-15 (172 µg/L), located southeast, east and south of the plaza, respectively. Tetrachloroethene concentrations in samples from DM-1(D1) and DM-2(D1), located in the Plaza de España, were 132 µg/L and 22 µg/L, respectively. Trichloroethene concentrations in samples collected from the D1 Zone monitoring wells are less than 17 µg/L. Compared to the June 2014 analytical results, PCE concentrations remained consistent in all the wells except monitoring well M-09, where PCE has fluctuated from a maximum of 540 µg/L in June 2014 to a minimum of 220 µg/L in June 2016. The September 2019 PCE concentration in M-09 was 310 µg/L. At M-09, the increasing levels of PCE daughter products, TCE, cDCE, tDCE and VC, following the most recent substrate injection in 2012 at R-09(D1), suggests degradation effects at this downgradient monitoring well through 2015 (Graph C-12 and Graph C-13). However, PCE degradation product concentrations have decreased or remained stable since 2015.

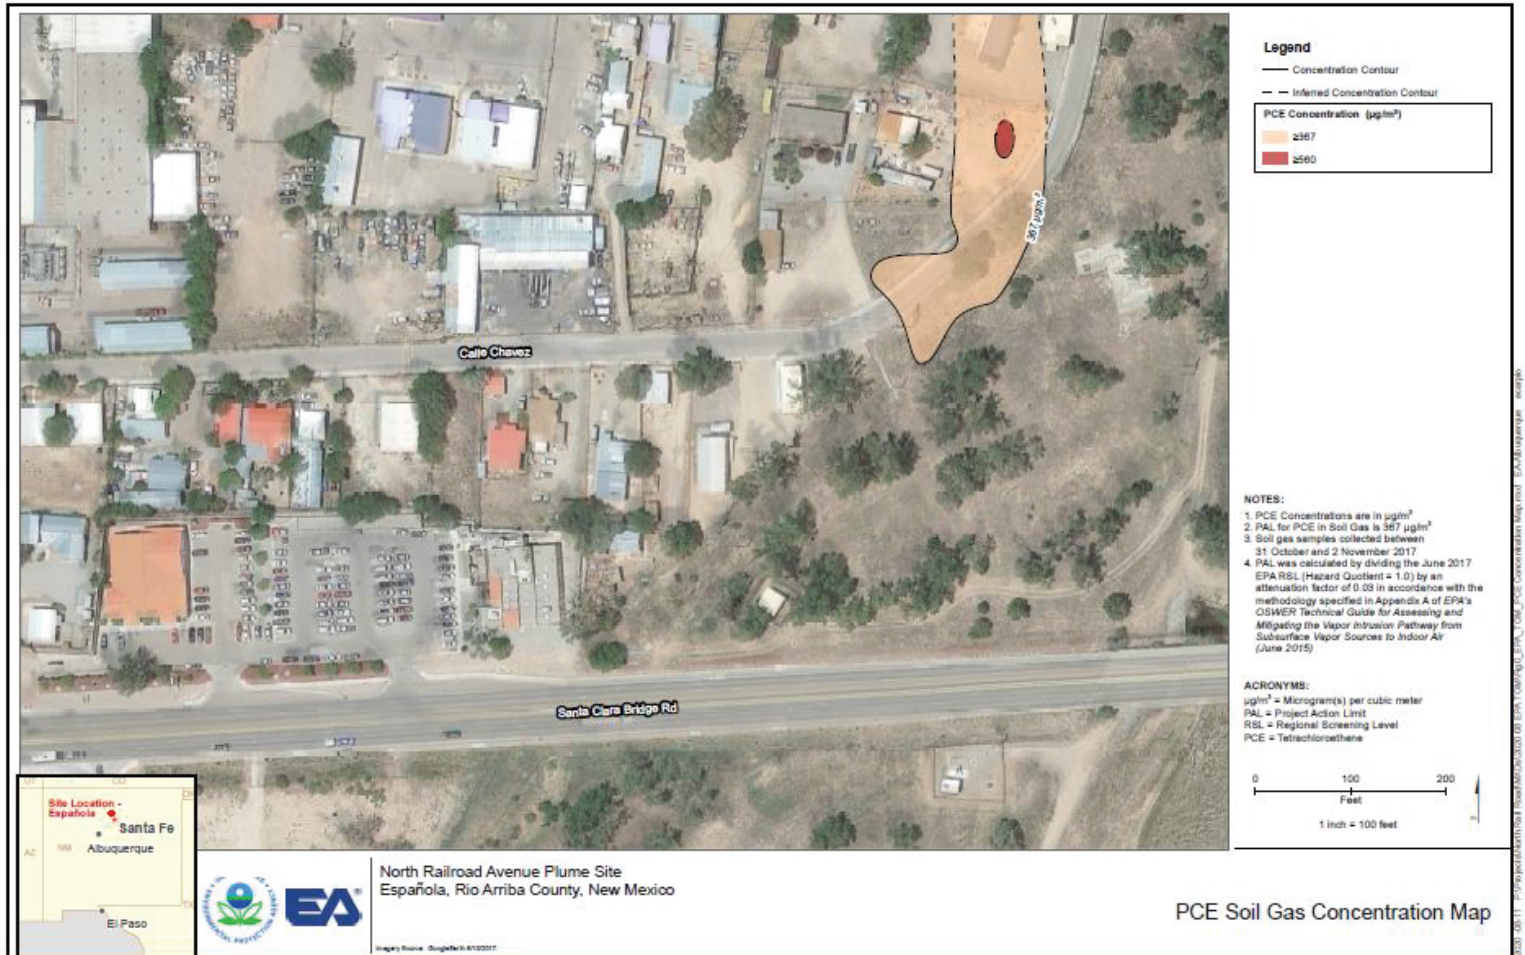
**FIGURE D-1
PCE SOIL GAS CONCENTRATION MAP**

Soil gas sampling locations not depicted.

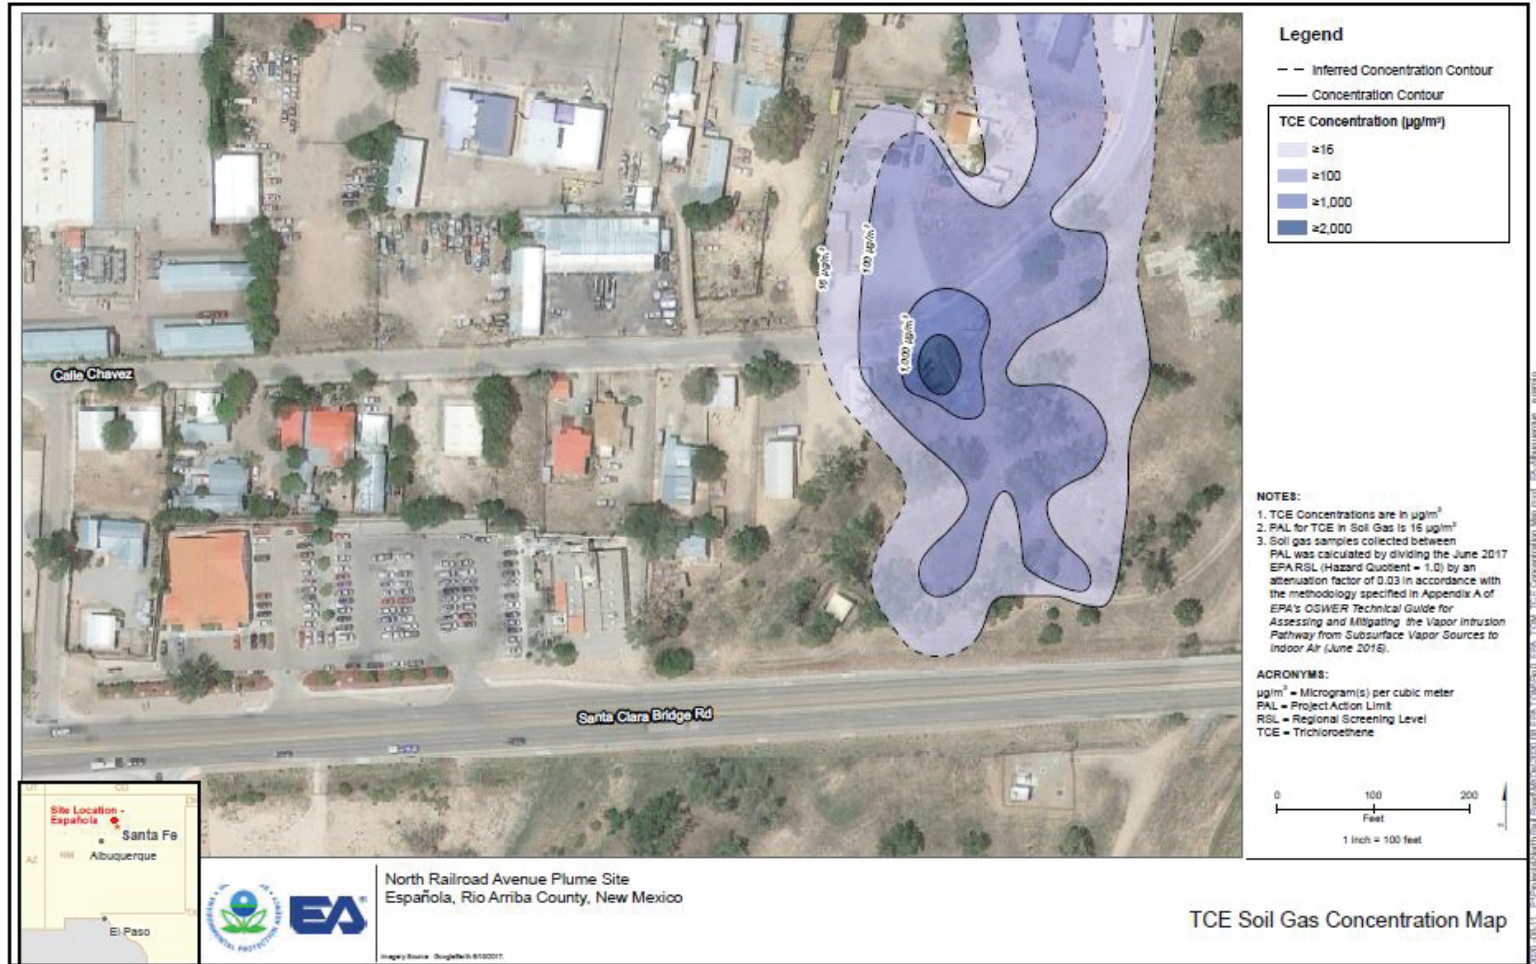
**FIGURE D-2
TRICHLOROETHENE (TCE) SOIL GAS CONCENTRATION MAP**

Soil gas sampling locations not depicted.

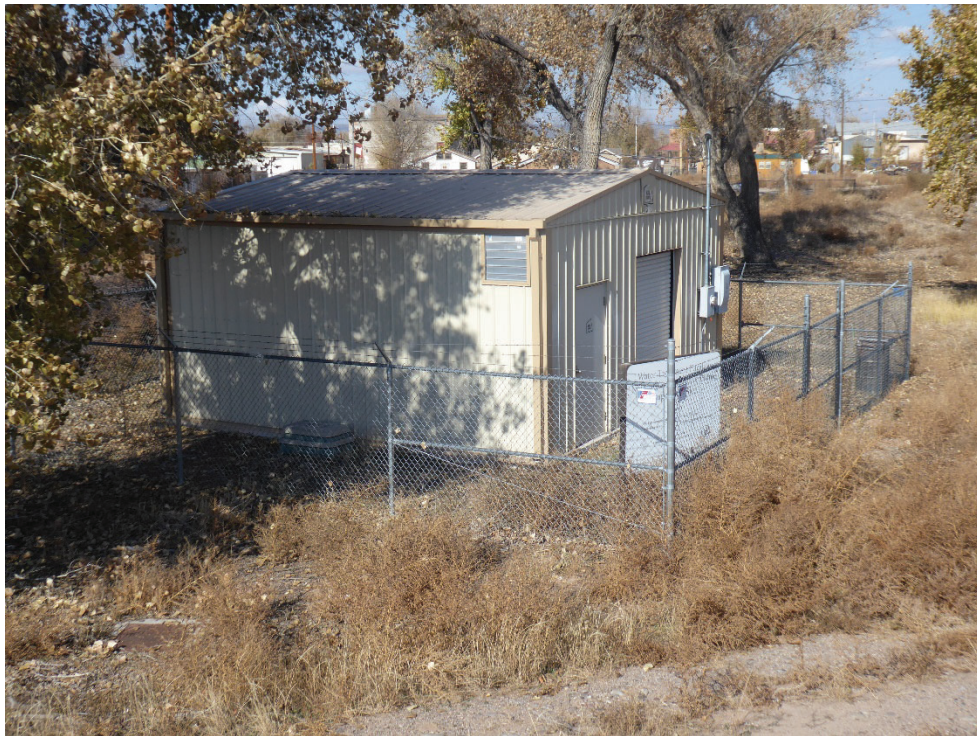
Photo 1: Biocurtain Building. Photo looking north.

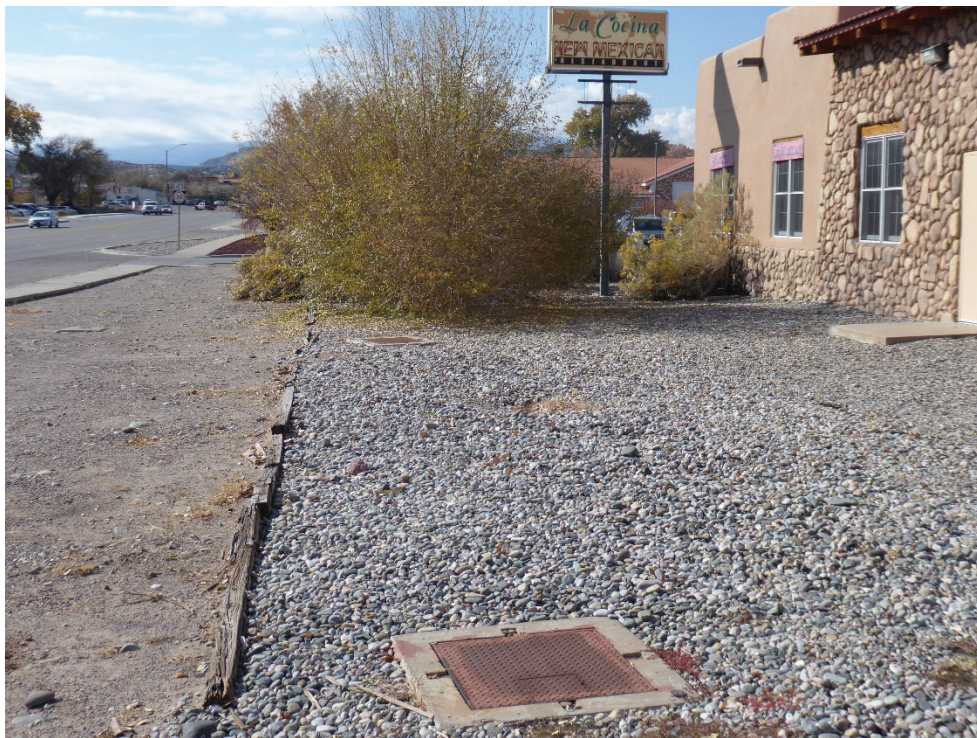
Photo 2: Biocurtain remediation well located southeast of La Cocina restaurant. Photo looking west.

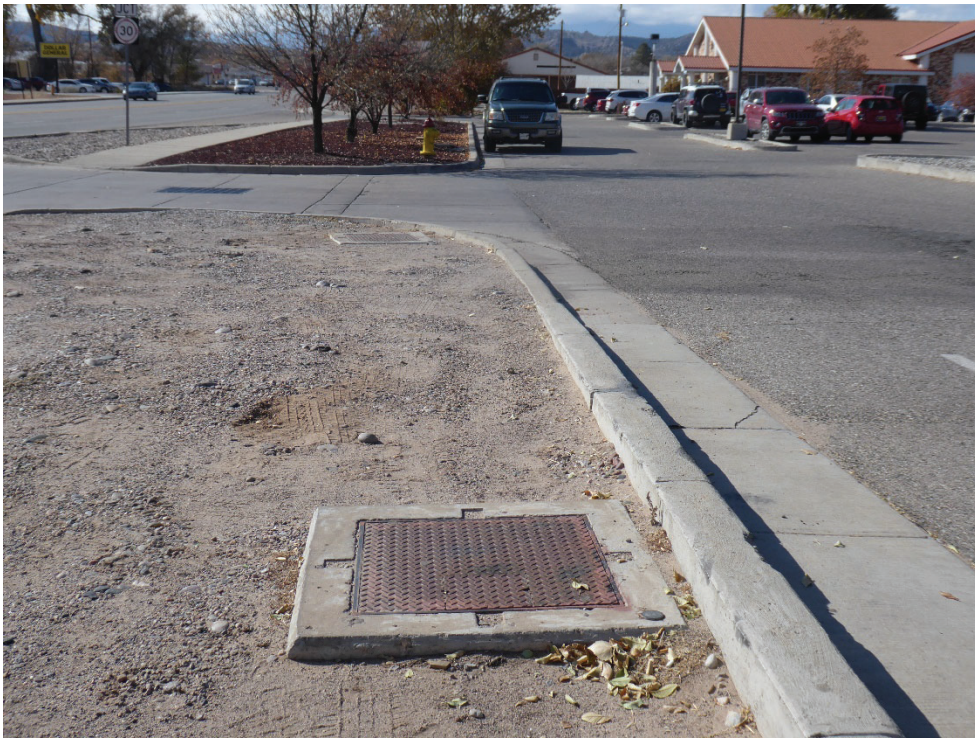
Photo 3: Biocurtain remediation well located south of La Cocina restaurant. Photo looking west.

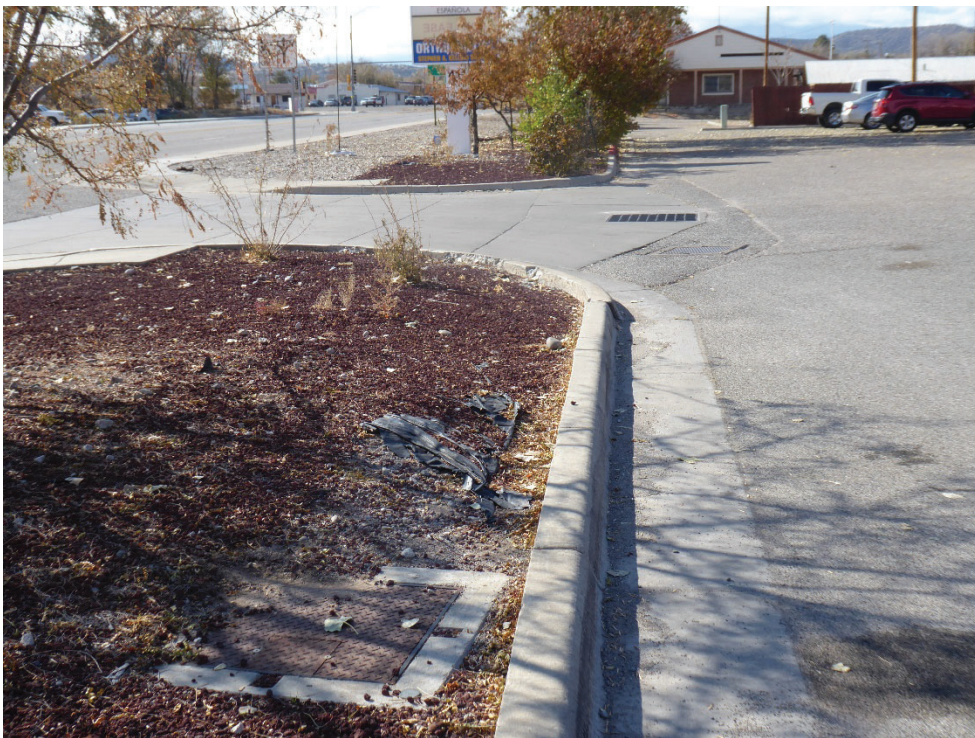
Photo 4: Biocurtain remediation well located southwest of La Cocina restaurant. Photo looking west.

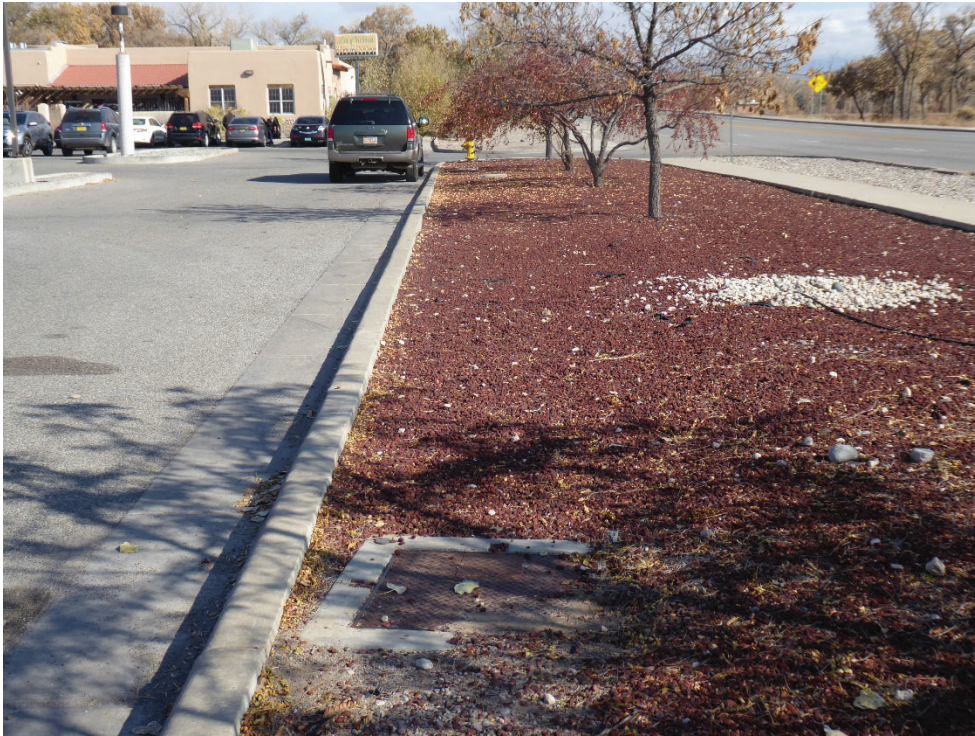
Photo 5: Biocurtain remediation well located east of La Cocina restaurant. Photo looking east.

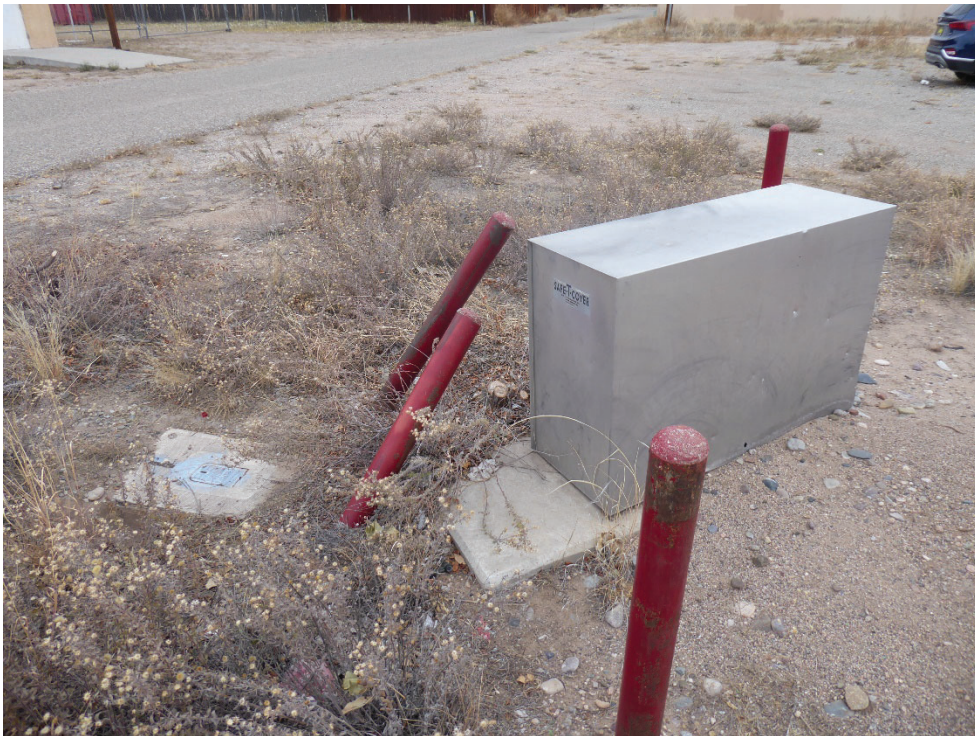
Photo 6: Hot Box over the backflow preventer installed on the water line that formerly serviced the Source Area/Hot Spot (SA/HS) building. Photo looking northeast. Note that bollards protected the box from damage.

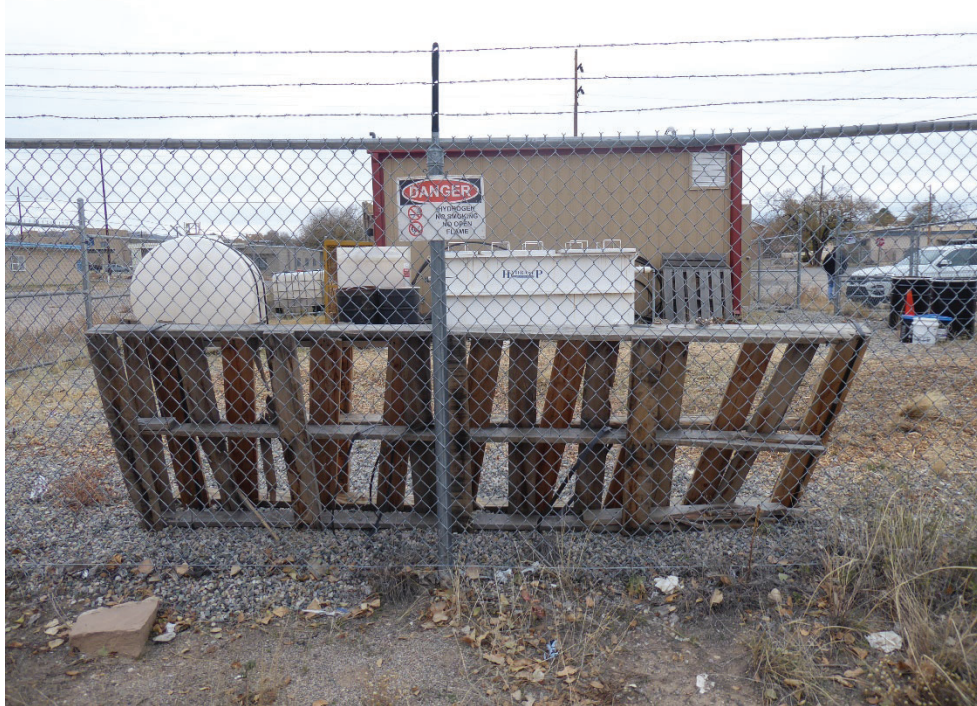
Photo7: Section of Fence on east side of the SA/HS enclosure that was cut by vandals and temporarily repaired with bailing wire. Photo looking west, DNAPL separator and building in background.

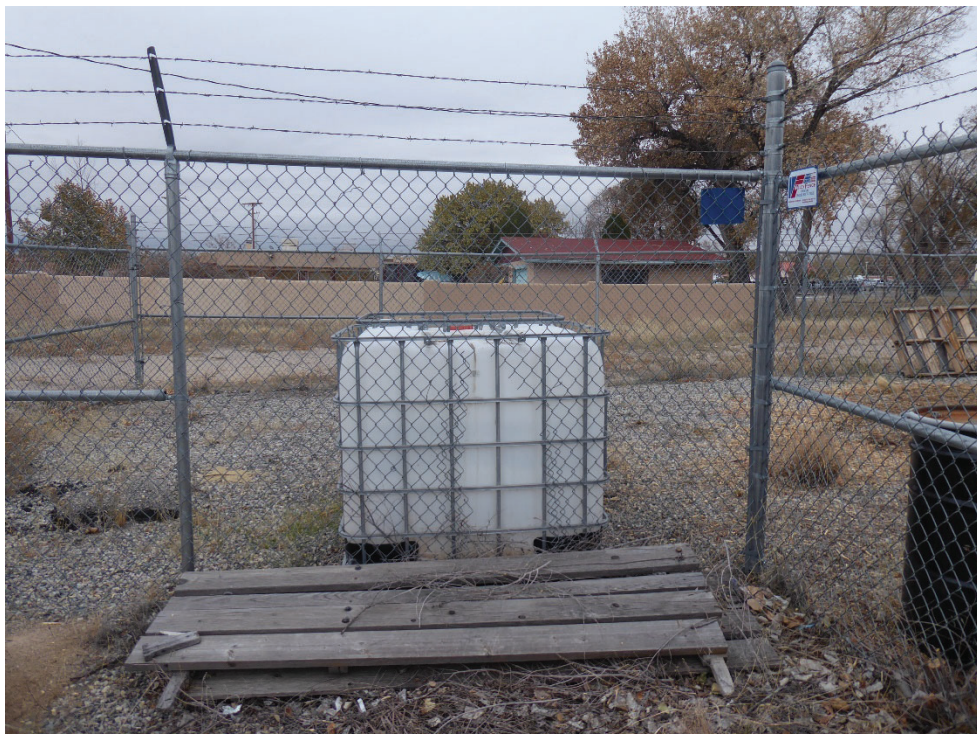
Photo 8: Existing (unrepaired) hole cut in the SA/HS Fence in the northeast end of the enclosure. Photo looking east.

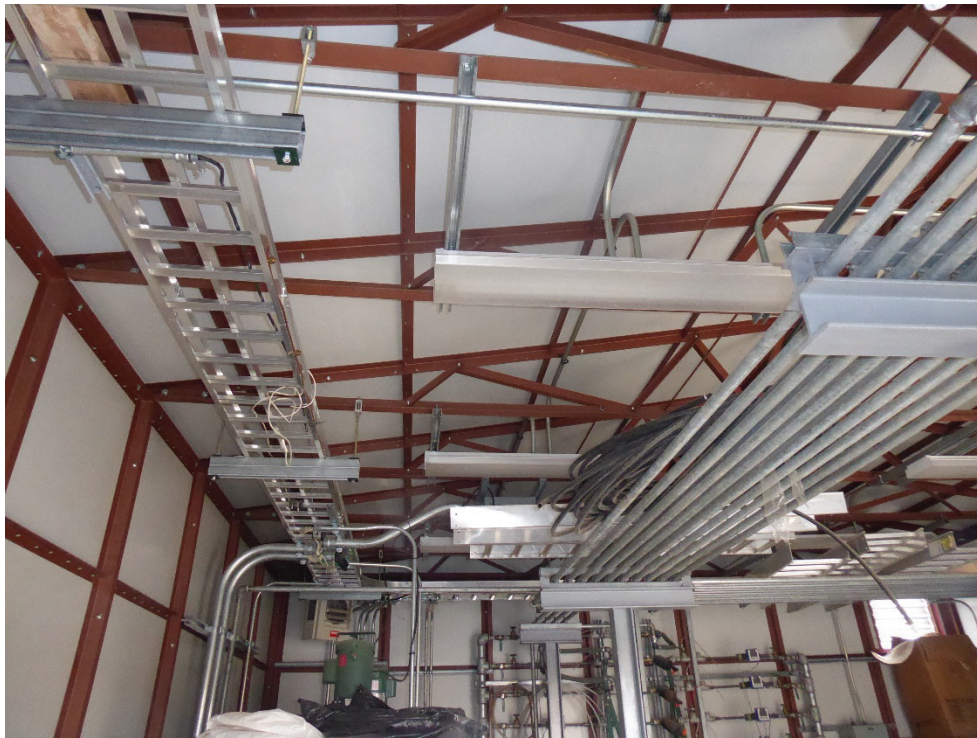
Photo 9: Interior of the SA/HS building, showing overhead conveyance pipe and conduit (looking south).

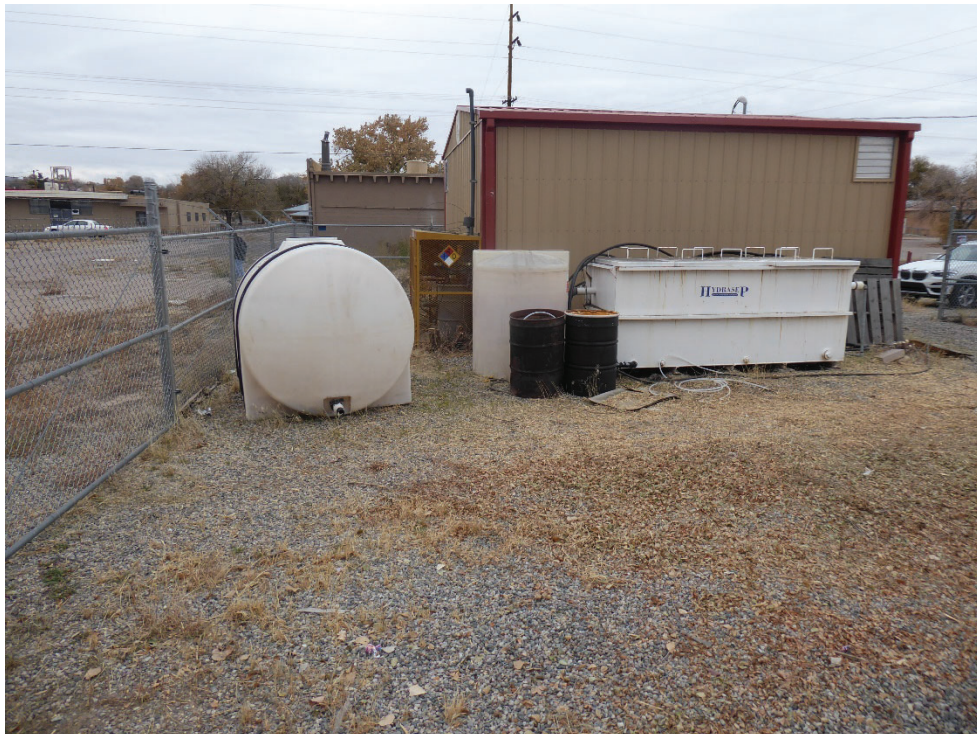
Photo 10: Tanks, DNAPL separator, and building inside of the SA/HS enclosure. Photo looking west.

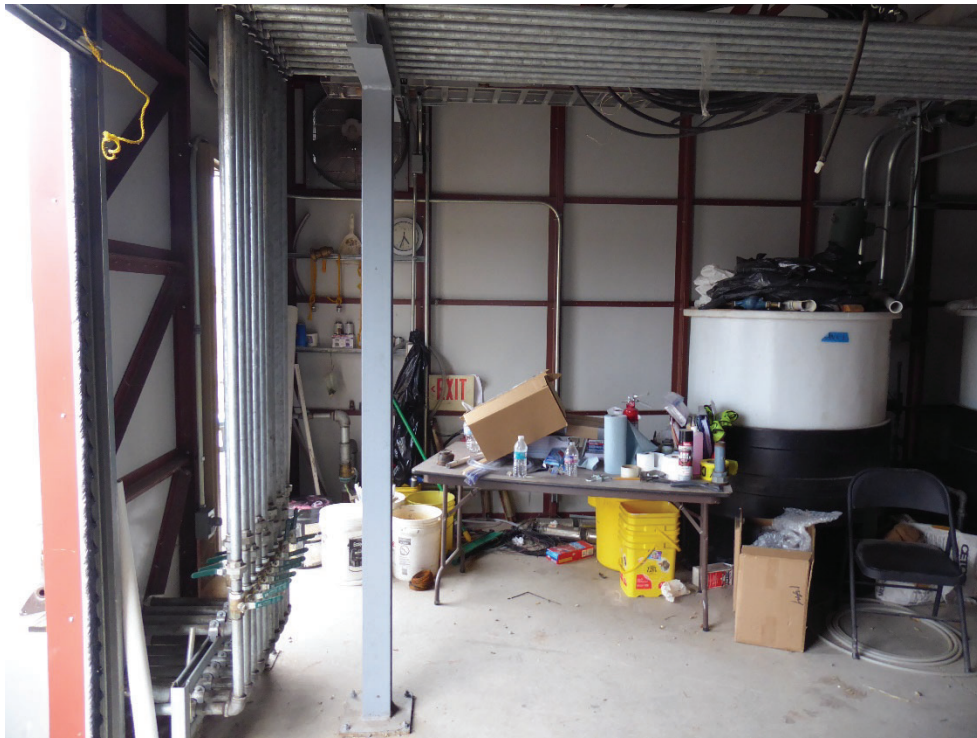
Photo 11: Interior of SA/HS building looking east from roll-up door entrance.

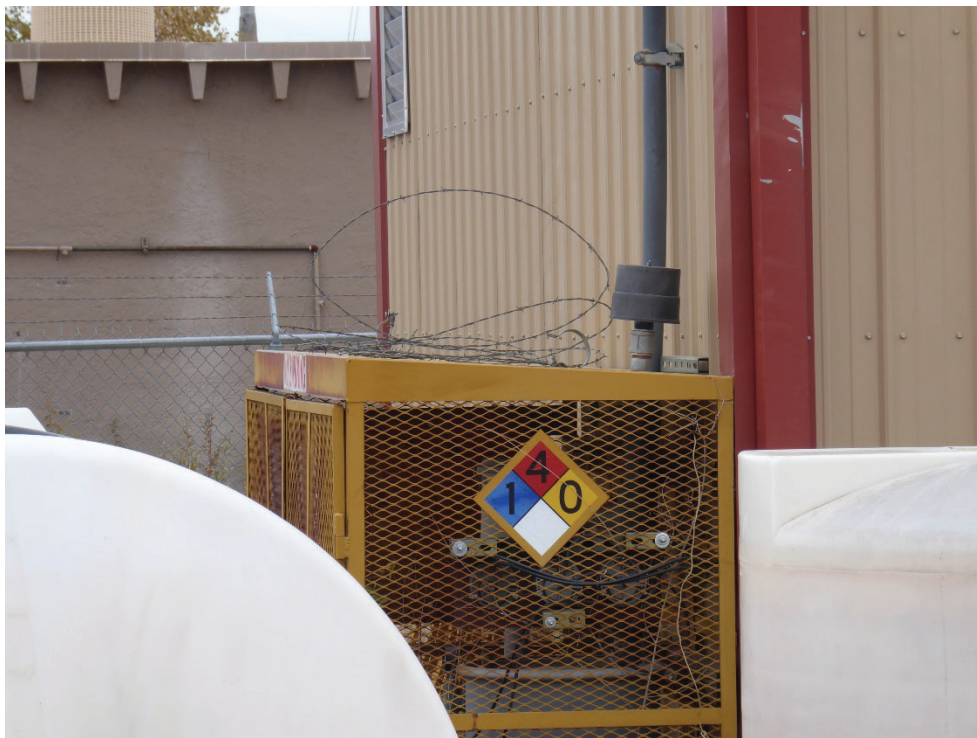
Photo 12: Placarded SVE/hydrogen storage enclosure on south side of SA/HS building. Photo looking west.

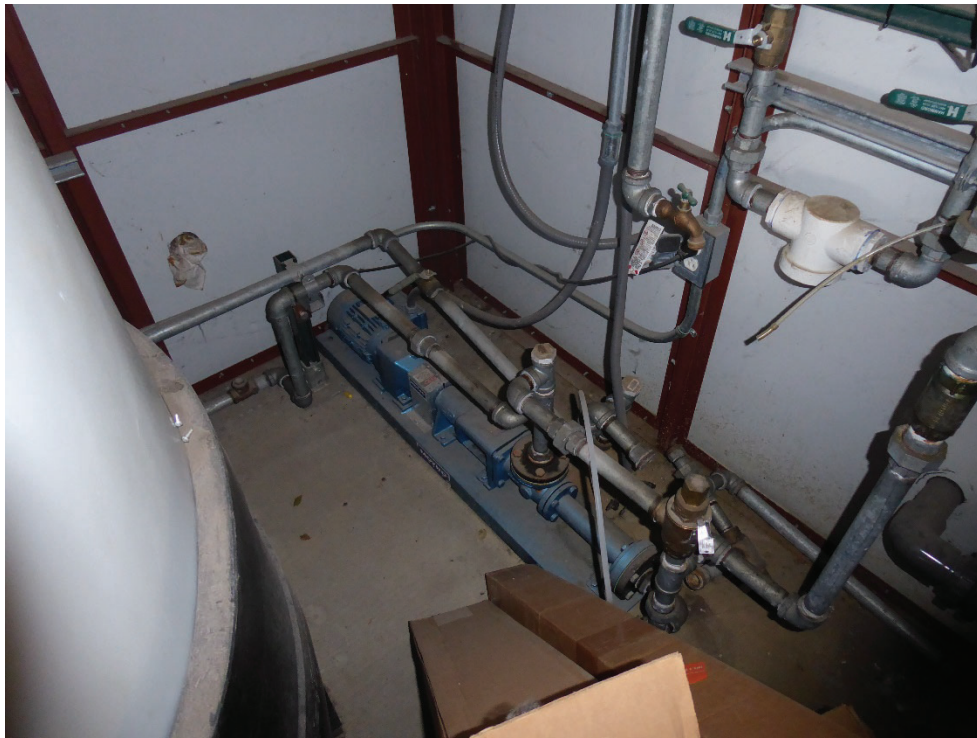
Photo 13: Existing unused injection pump in the SA/HS building. Photo looking southeast.

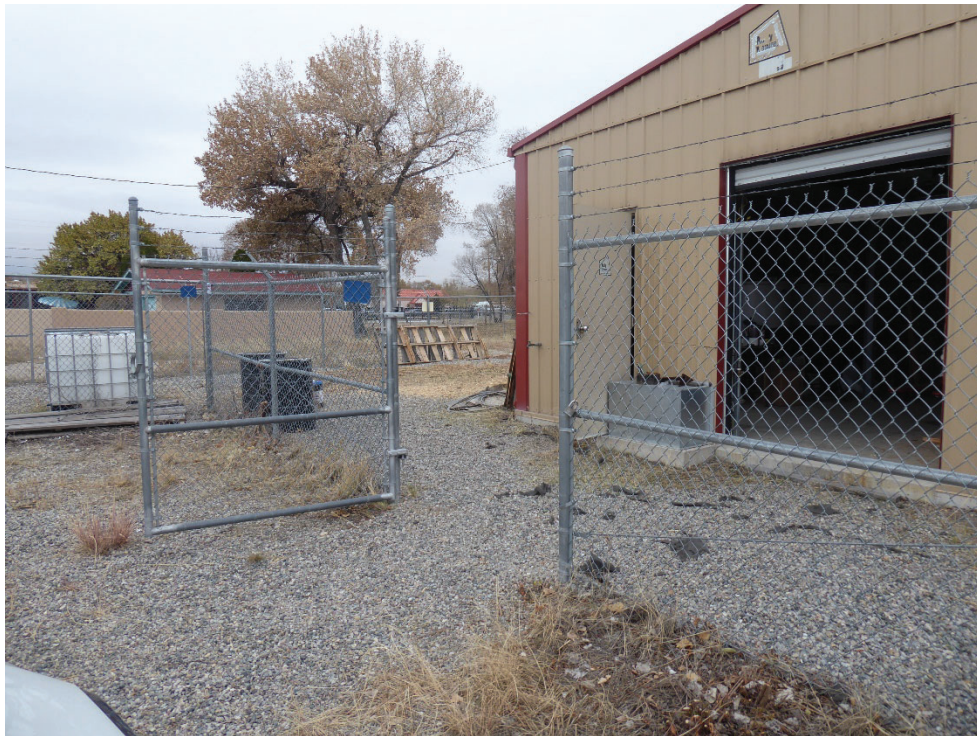
Photo 14: Normally locked access gate and SA/HS building. Photo looking east-southeast. Note location of hole in the fence (at white tote) that is shown in Photo 8.

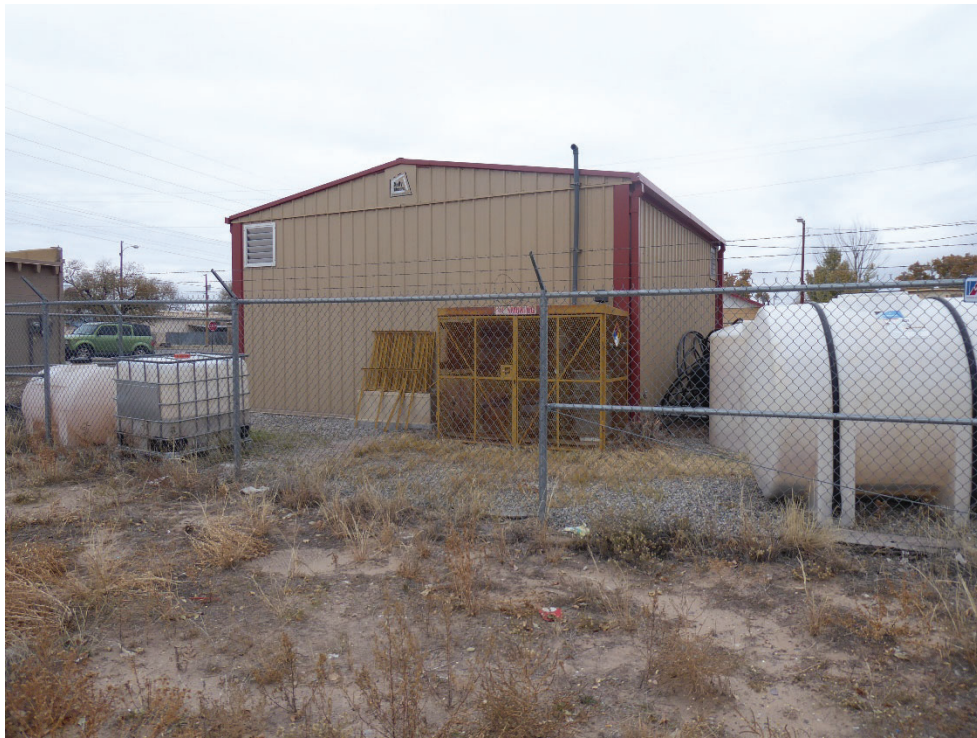
Photo 15: South side of the SA/HS building and enclosure. Photo looking northwest.

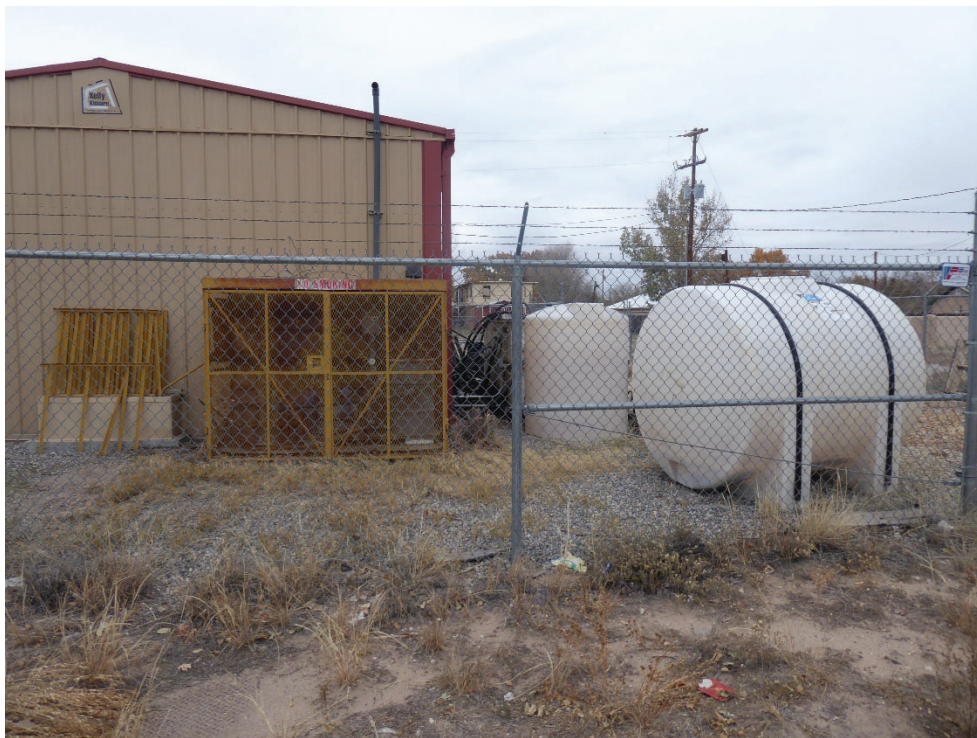
Photo 16: Tanks and SVE enclosure on the south side of the SA/HS Building. Photo looking north-northeast.

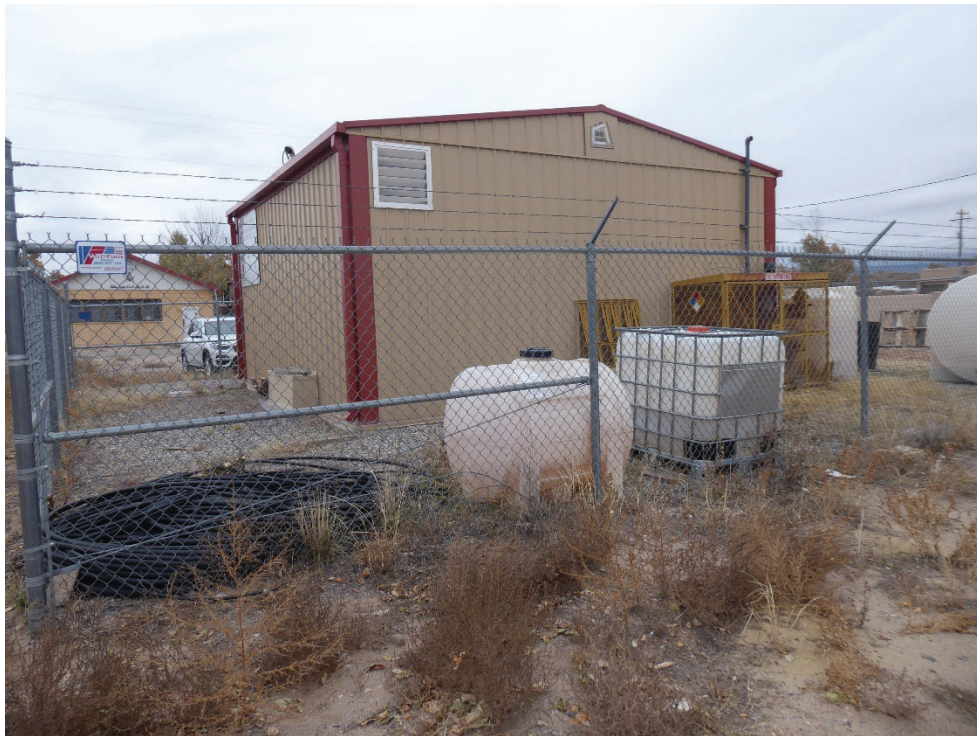
Photo 17: Southwest corner of the SA/HS Building, looking northeast.

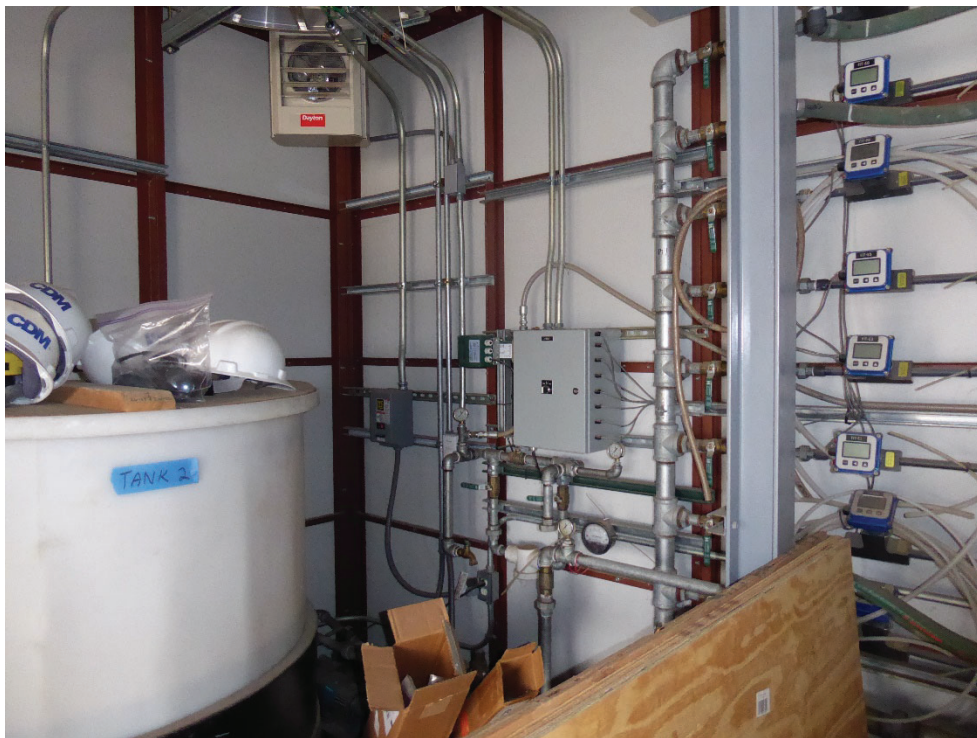
Photo 18: Interior (SE corner) of the SA HS building. The hydrogen injection system is shown in the center of the photograph. Photo looking southeast.

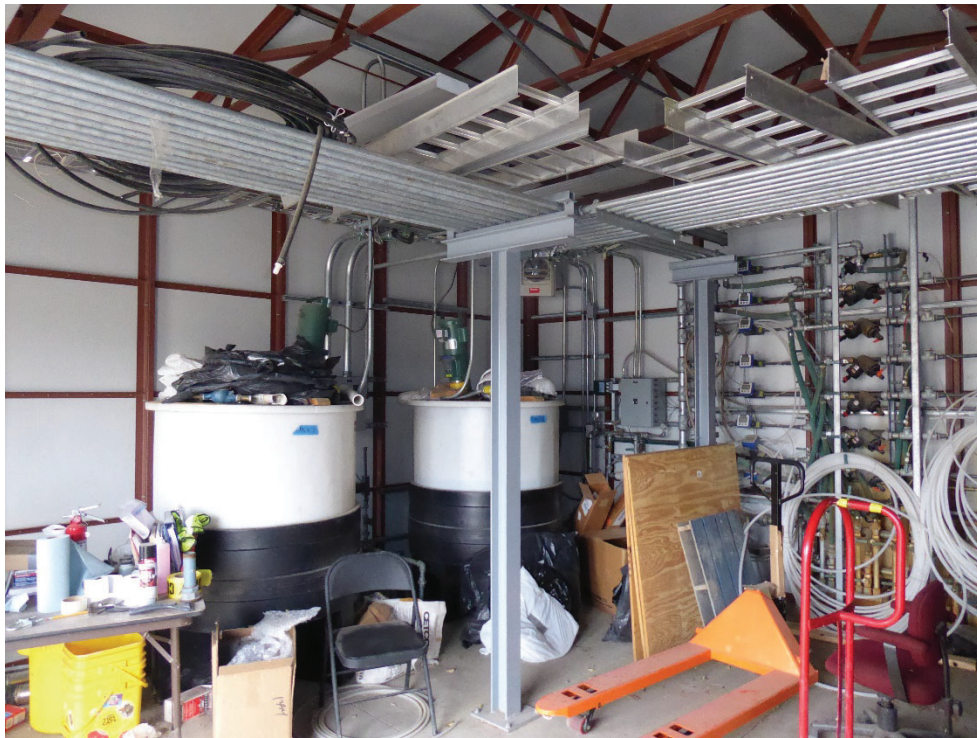
Photo 19: Southeast corner of SA/HS building. Note mixing tanks and mixers. Photo looking southeast.

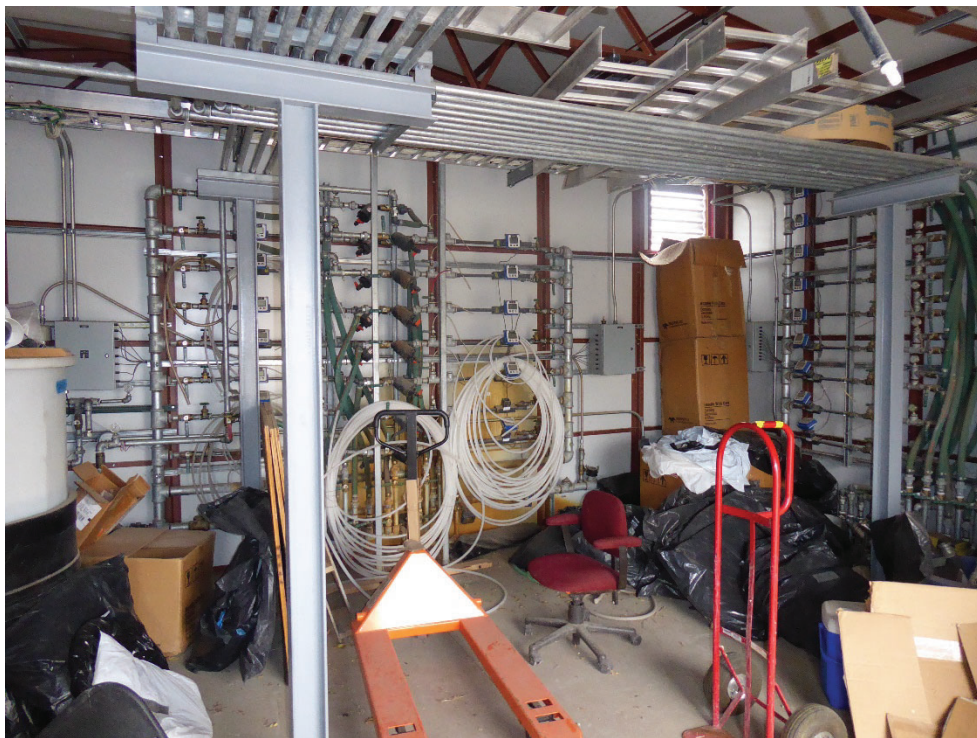
Photo 20: SA/HS building interior. Note injection and extraction manifolds mounted on the walls. The boxes in the corner contain auto samplers from the unexecuted SEAR. Photo looking south-southwest.

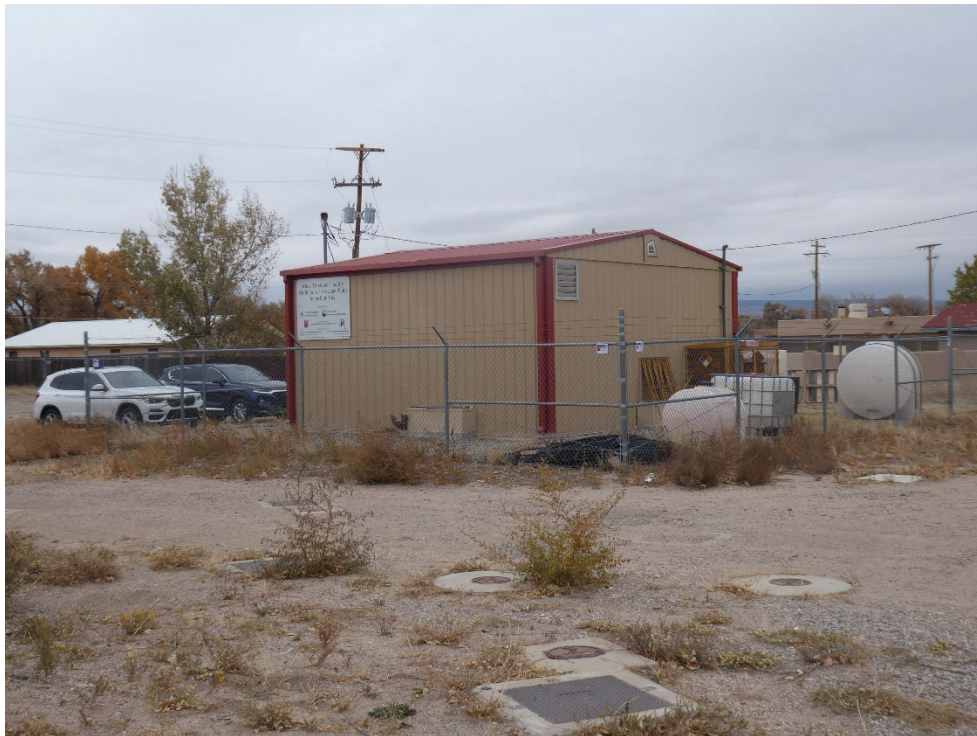
Photo 21: SA/HS building and enclosure with Source Area remediation and monitoring well vaults in the foreground. Photo looking northeast.

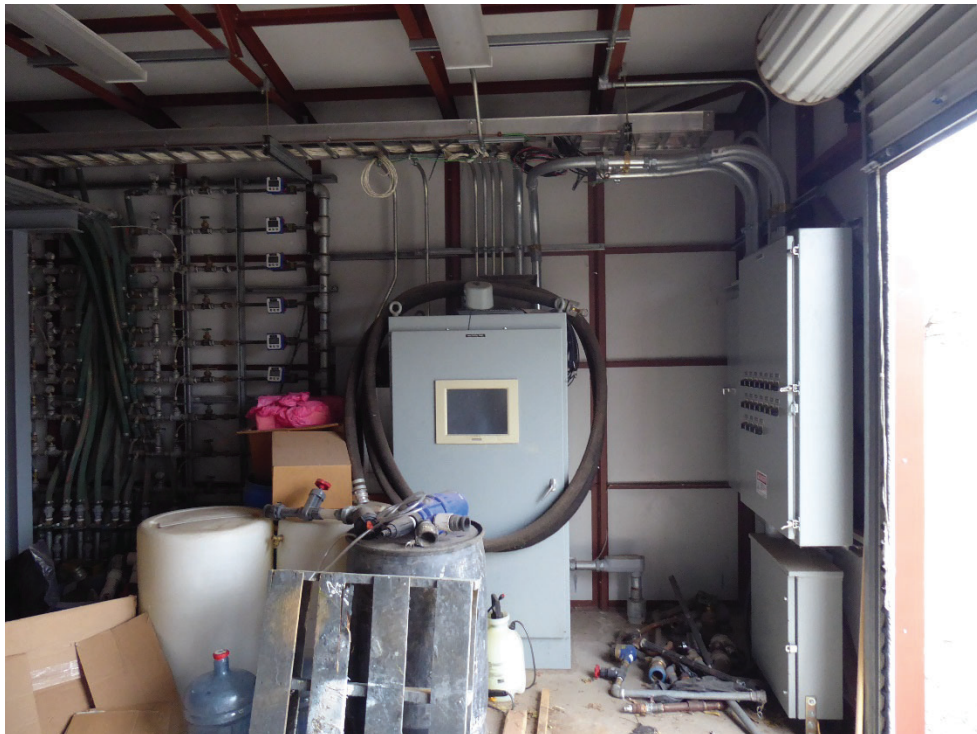
Photo 22: From left, manifold, SCADA cabinet with HMI panel, and breaker boxes/pump control cabinets in the SA/HS building. Photo looking west.
