**Andy Yung, P.E., CFM
Dodson | A Walter P.
Moore Company**

**Duane Barrett, P.E.,
CFM HDR
Engineering, Inc.**

RAIN BY THE CUBIT

The Great Southeast Texas Flood of 1994

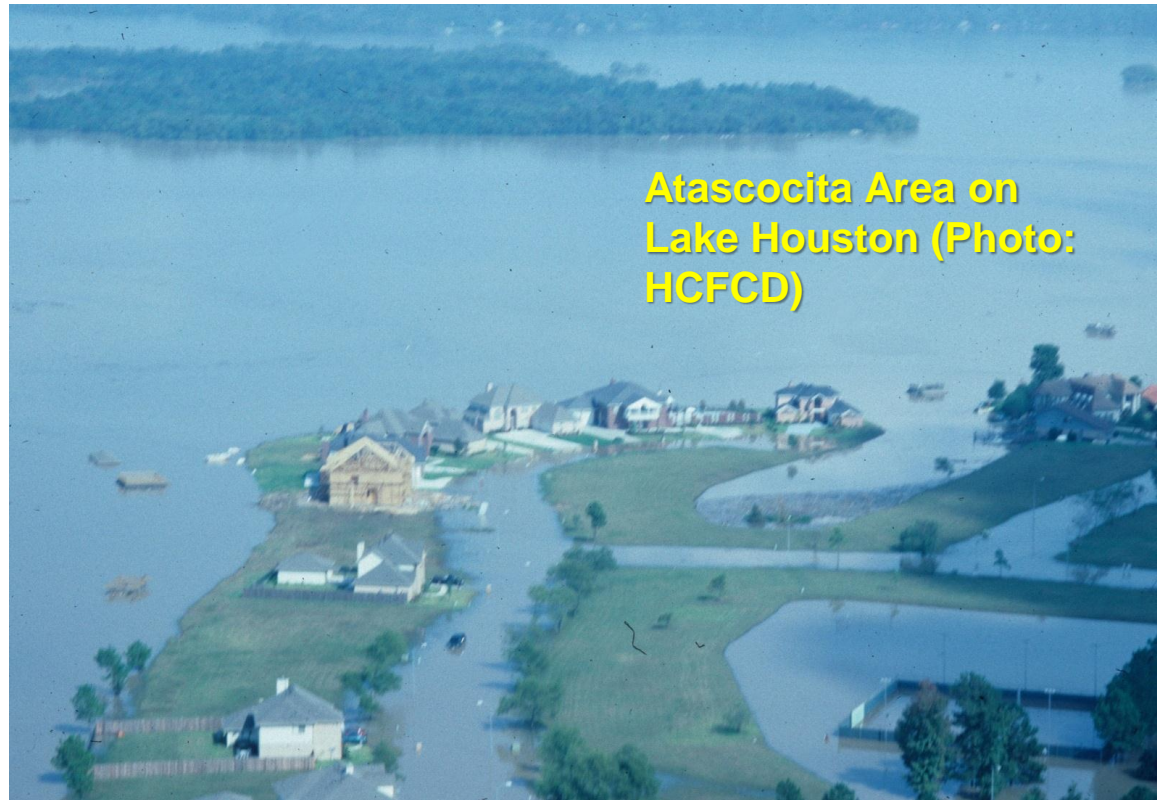
In response to the heavy rainfall over their respective watersheds, water levels in Lakes Conroe, Houston, and Livingston rose rapidly, and spillways went into operation.

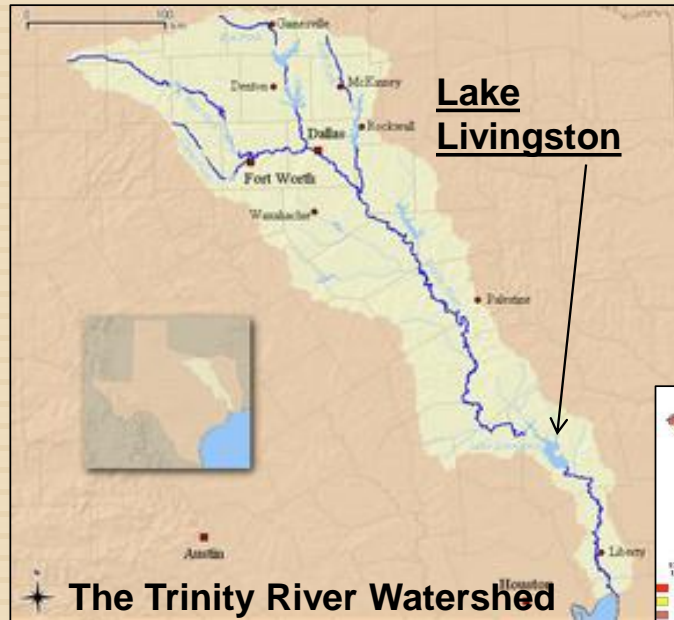
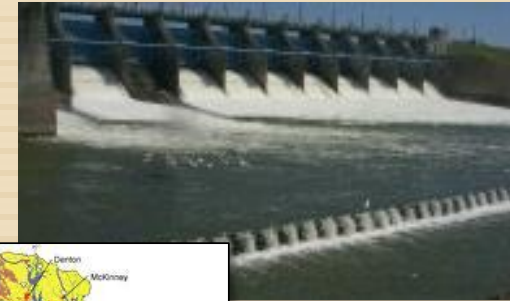
Watershed Area = 16,600 square miles at Lake Livingston

The Lake Livingston discharge reached a maximum of 110,600 cfs . The maximum lake level was 134.38 ft, 3.38 feet above the normal pool elevation of 131.00 ft. All this despite that the storm affected only the lower portion of the watershed! (Images: USGS, TRA)

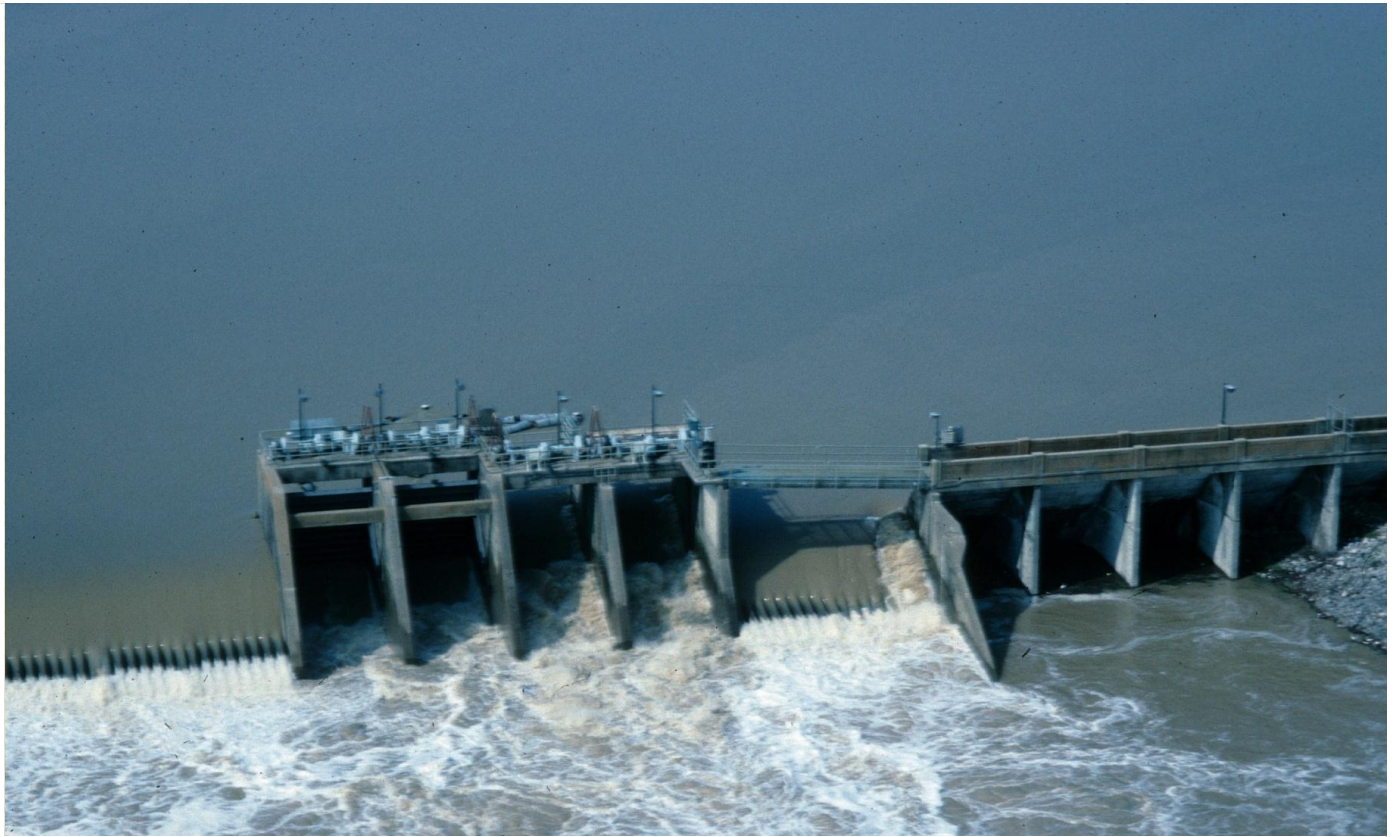
Lake Houston Gated Section of Spillway (Photo: HCFCD)

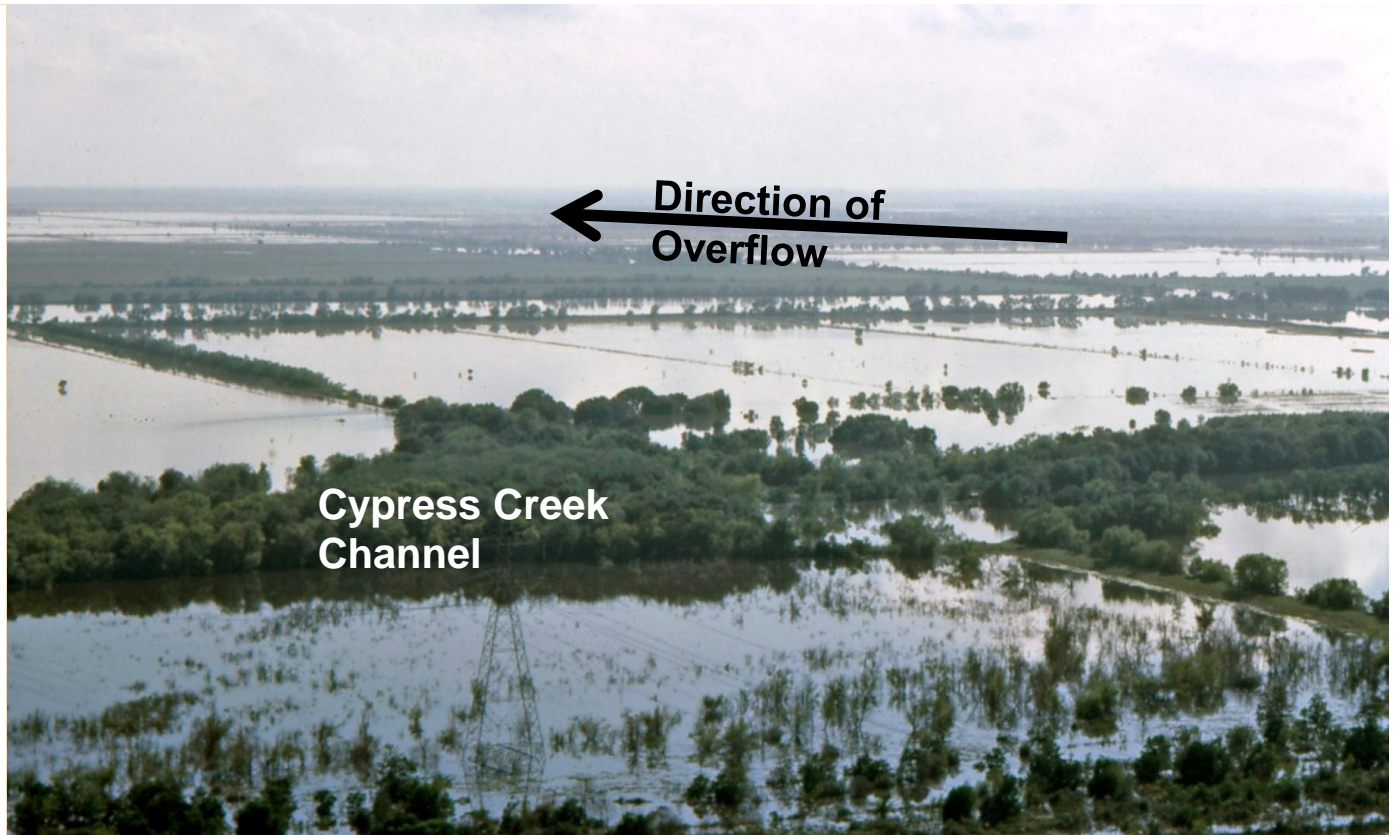
Cypress Creek Overflows

Cypress Creek overflowed its banks, sending thousands of acre-feet of storm water cross-country to the Addicks and Barker Reservoir watersheds and inundating thousands of acres of land. (Photo: HCFCD)

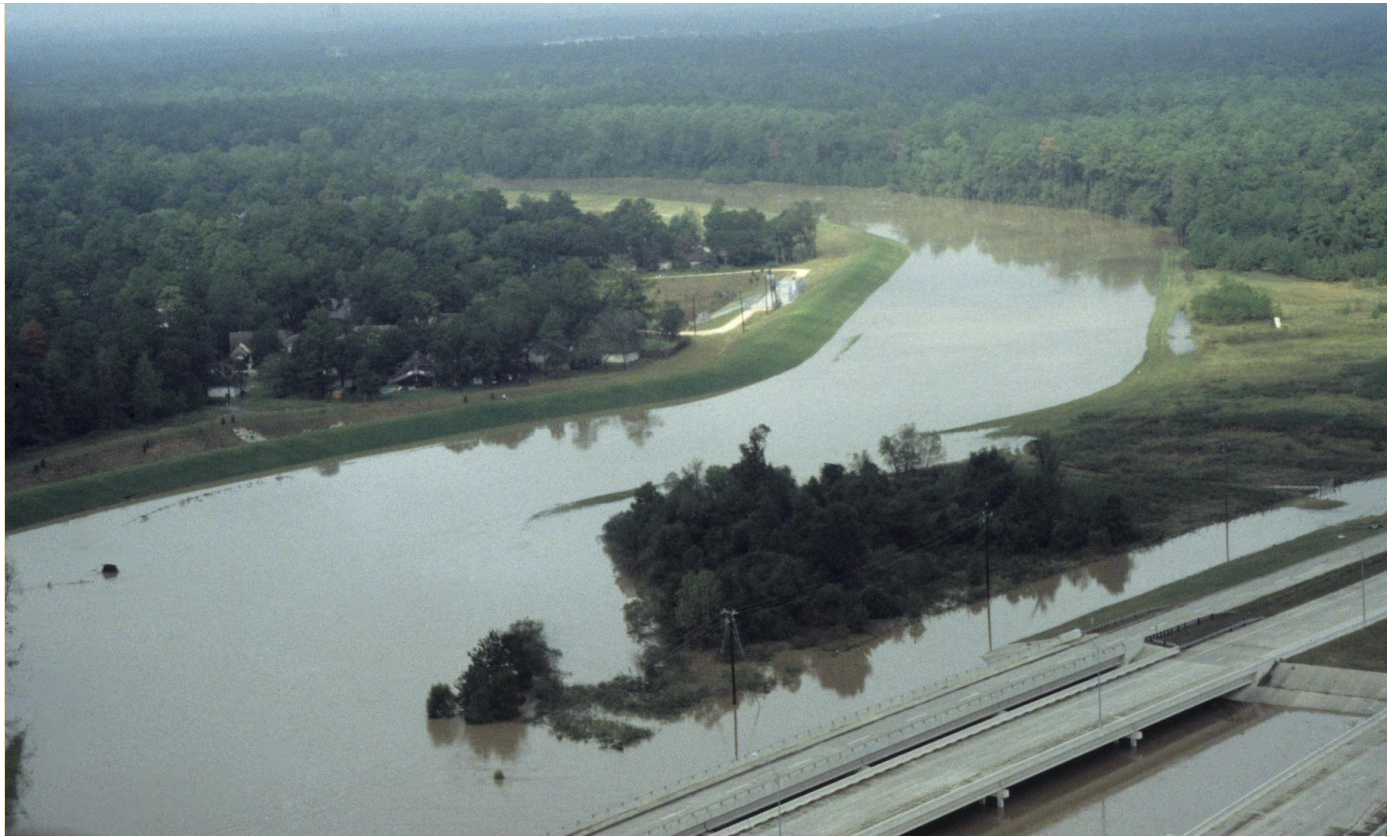
**Inverness Forest Levee on Cypress Creek at the Hardy Toll Road
(Photo: HCFCF)**

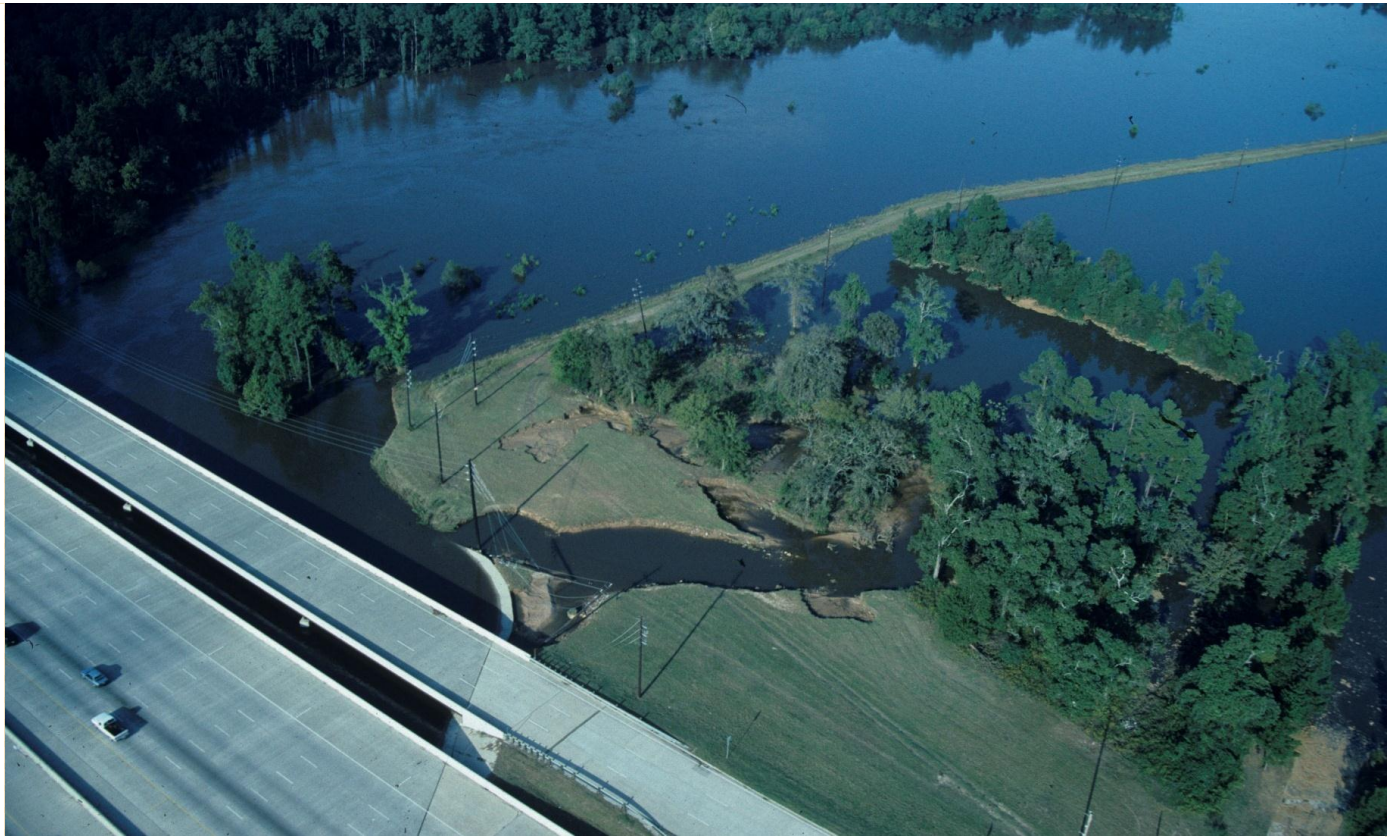
Northgate Crossing Levee

Maximum flood levels along Spring Creek exceeded FEMA 1% annual chance values by 4.0 to 4.5 feet. The Northgate Crossing levee was overtopped on October 18, 1994. This is one of only two levee systems in Harris County. (Photo: HCFCD)

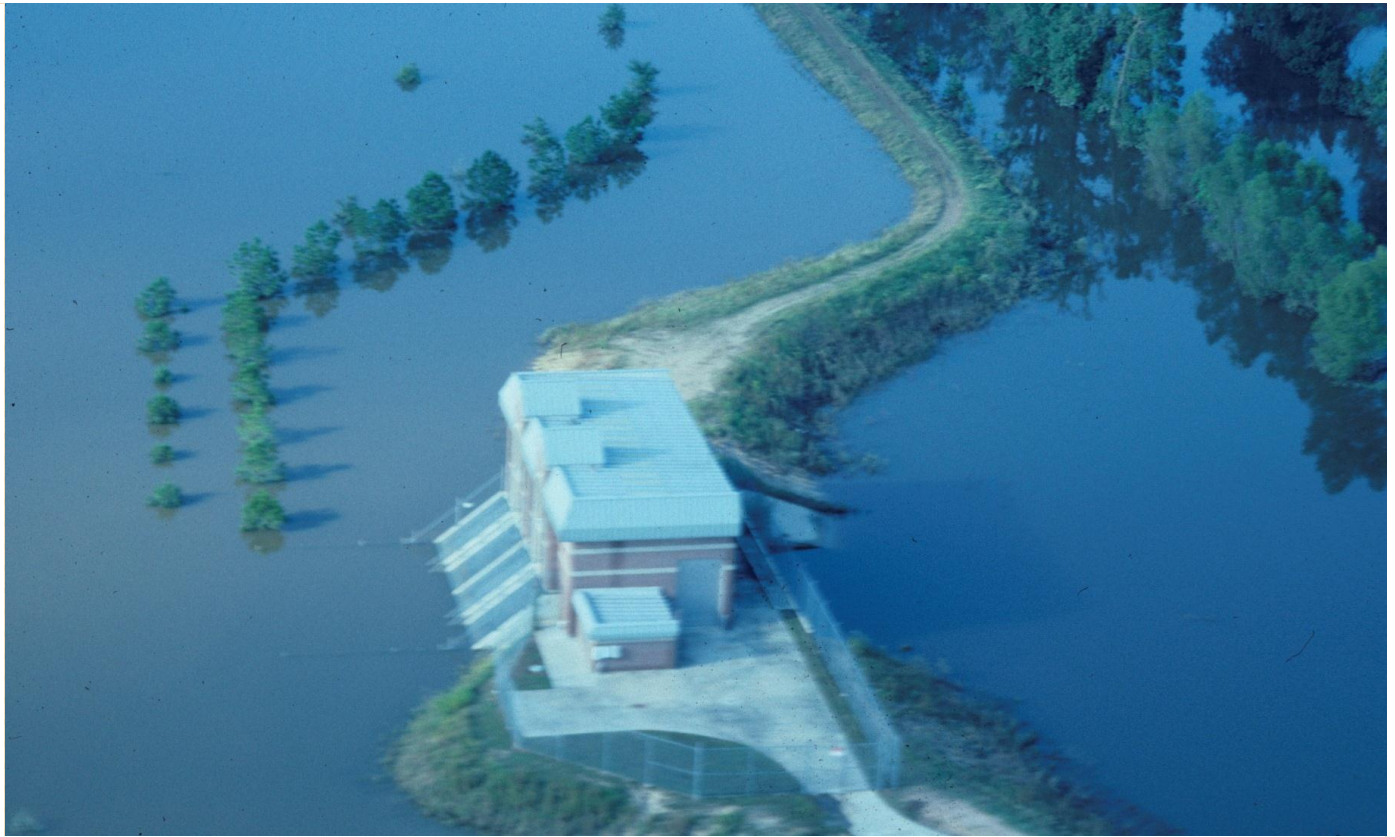
Northgate Crossing Levee and Pump House (Photo: HCFCD)

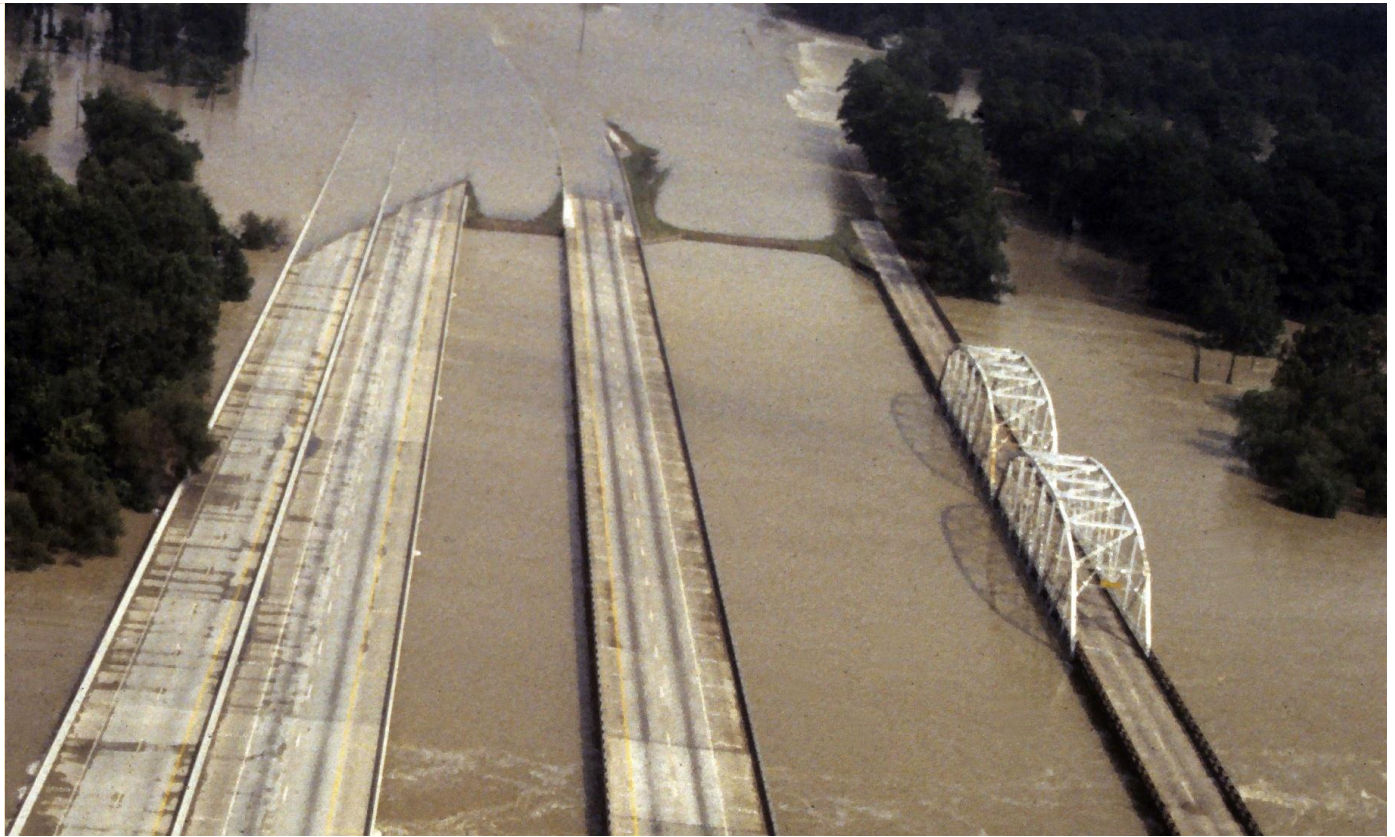
West Fork of the San Jacinto River

West Fork San Jacinto River at U.S. 59 (Photo: HCFCD)

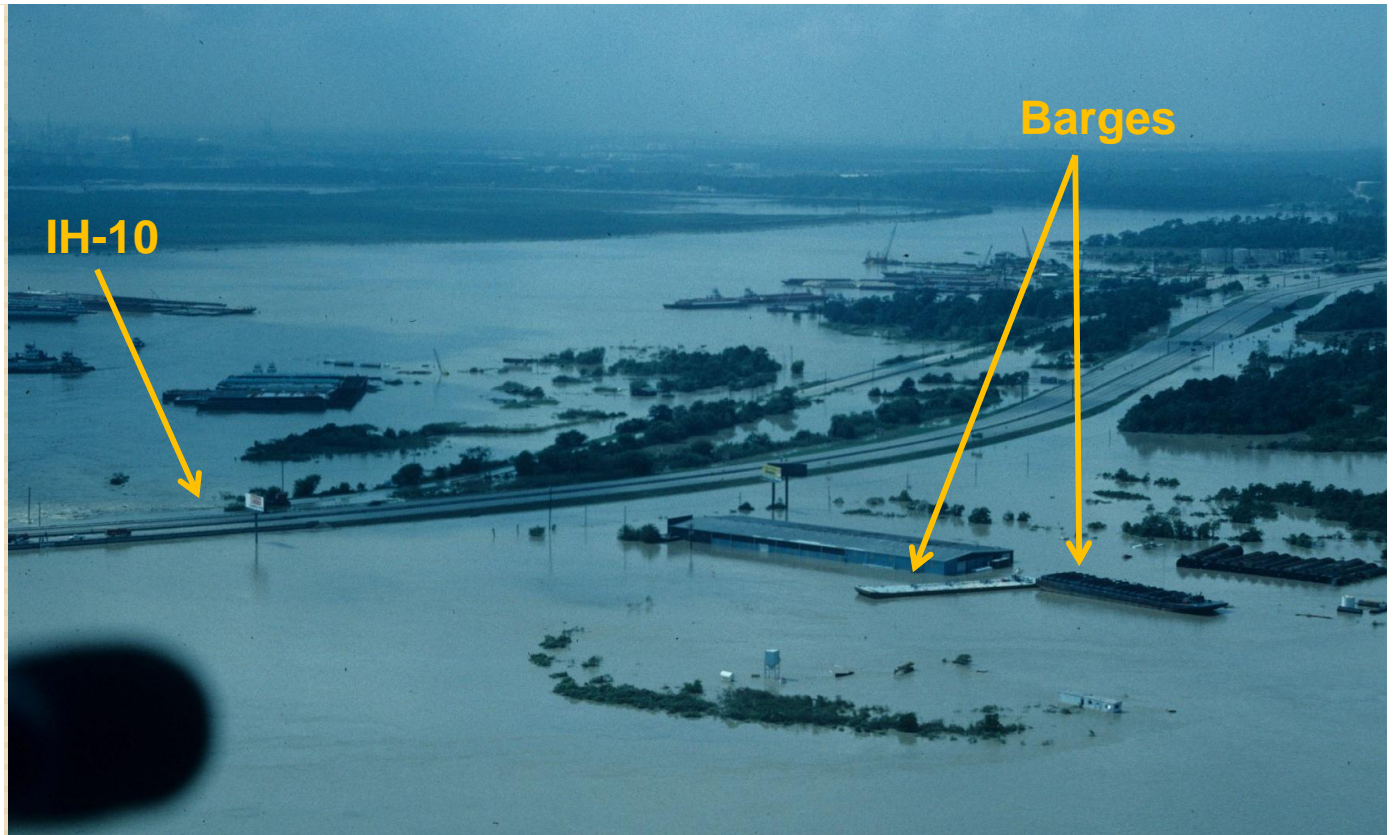
Lower San Jacinto River

San Jacinto River at I-10 (Photo: HCFCD)

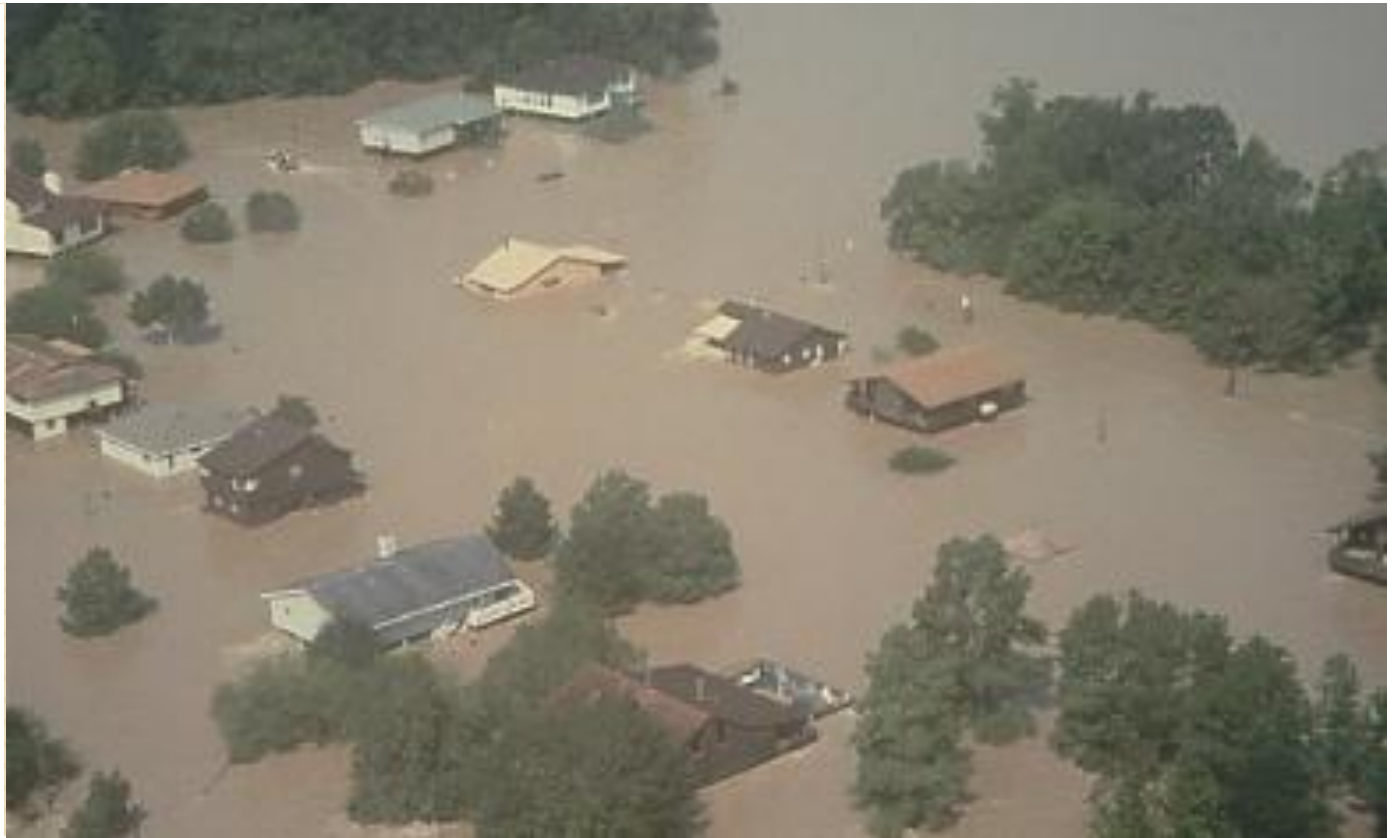
The 1994 flood produced peak flows on the San Jacinto and Lavaca Rivers that exceeded historical maxima from much larger watersheds .

Location	Drainage Area (sq mi)	Peak Discharge (cfs)	Peak Discharge (cfs/sq mi)
San Jacinto River D/S Lake Houston	2,880	360,000	125
Lavaca River at Edna, TX	817	150,000	184
Spring Creek at Riley-Fuzzel Rd.	420	78,800	188
Trinity River at Liberty, TX	17,500	135,000	7.7
Brazos River at Richmond, TX	45,100	300,000	6.7

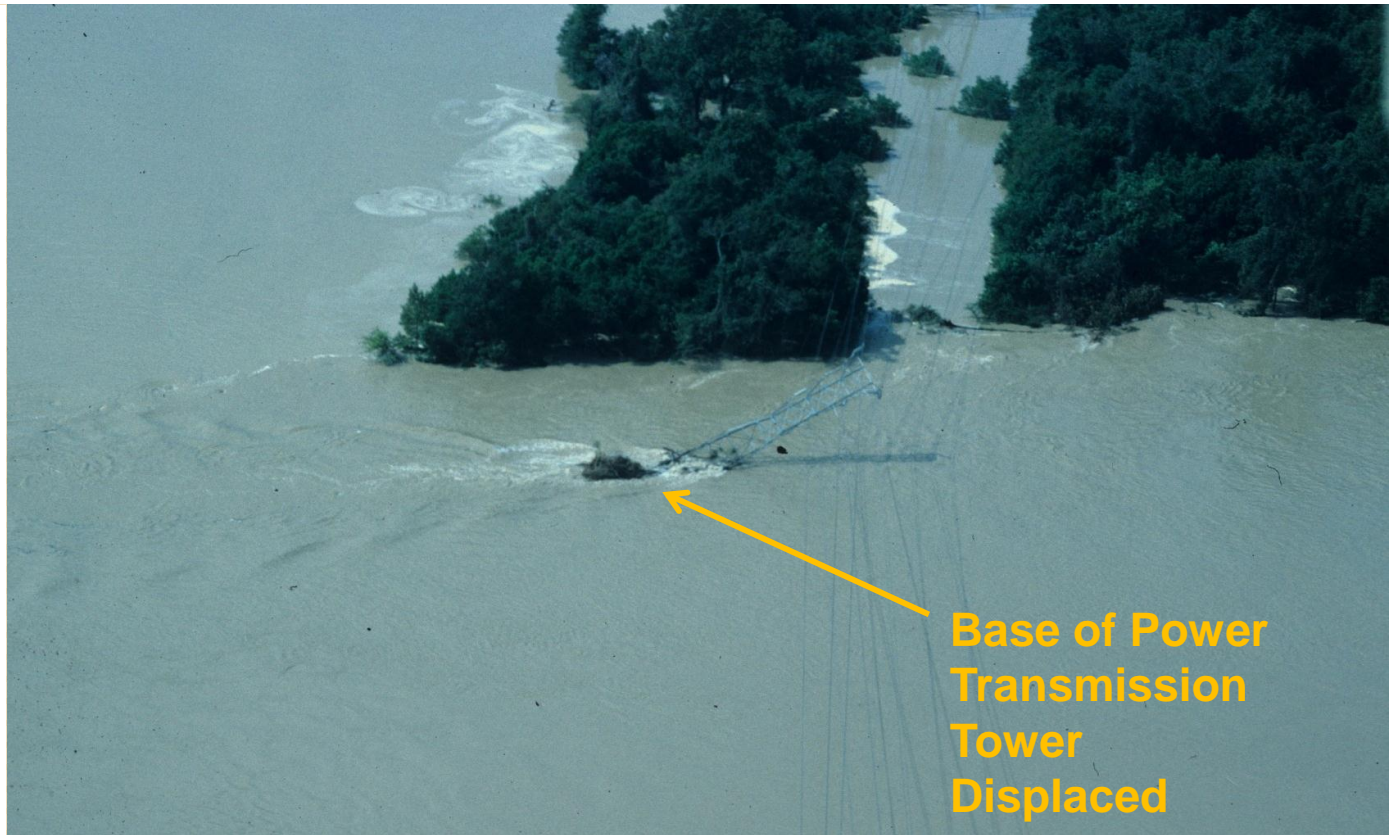
Power Line Near the Upper End of Lake Houston on the West Fork of the San Jacinto River (Photo: HCFCD)

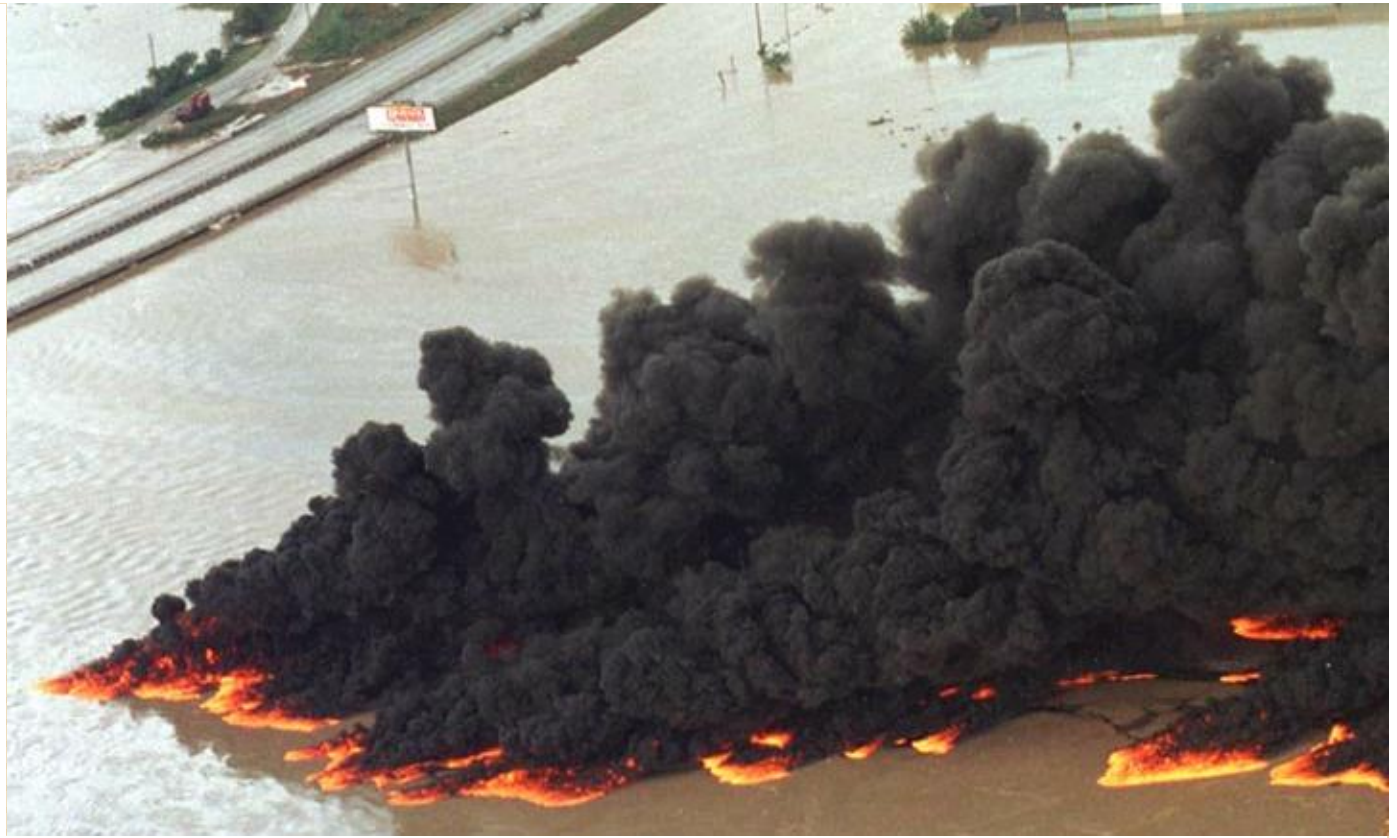
The San Jacinto River Fire (October 20th)

Breakage of pipelines across the river led to a fire that sent plumes of black smoke hundreds of feet into the air. (Photo: *Houston Chronicle*)

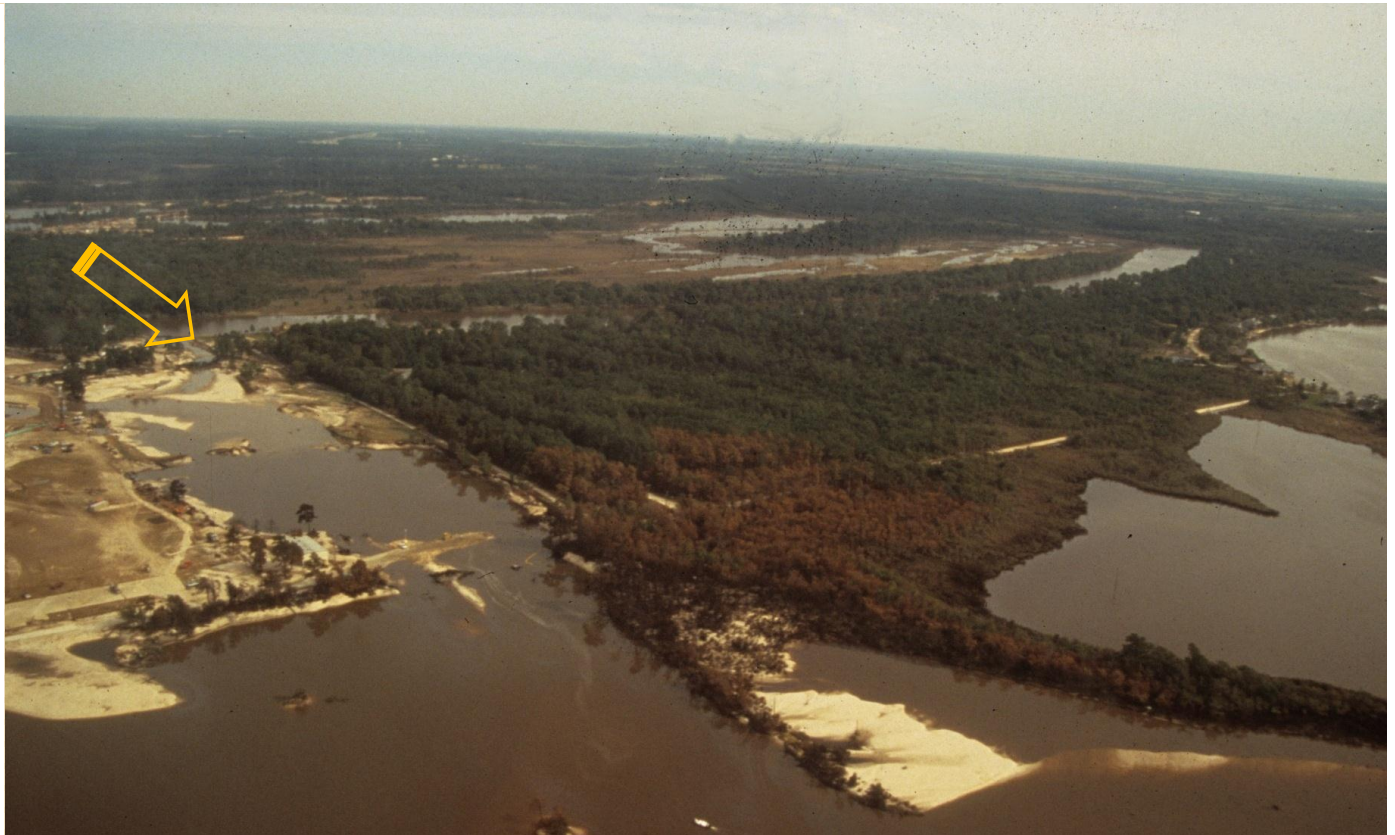
San Jacinto River Shortcut across Banana Bend/Rio Villa Meander. This is near the location of exposed pipelines; note burned trees. (Photo: HCFCD)
