**FOURTH FIVE-YEAR REVIEW REPORT**  
**29<sup>TH</sup> and MEAD GROUNDWATER CONTAMINATION SITE**  
**WICHITA, KANSAS**

**Prepared by**  
**U.S. Environmental Protection Agency**  
**Region 7**  
**Lenexa, Kansas**

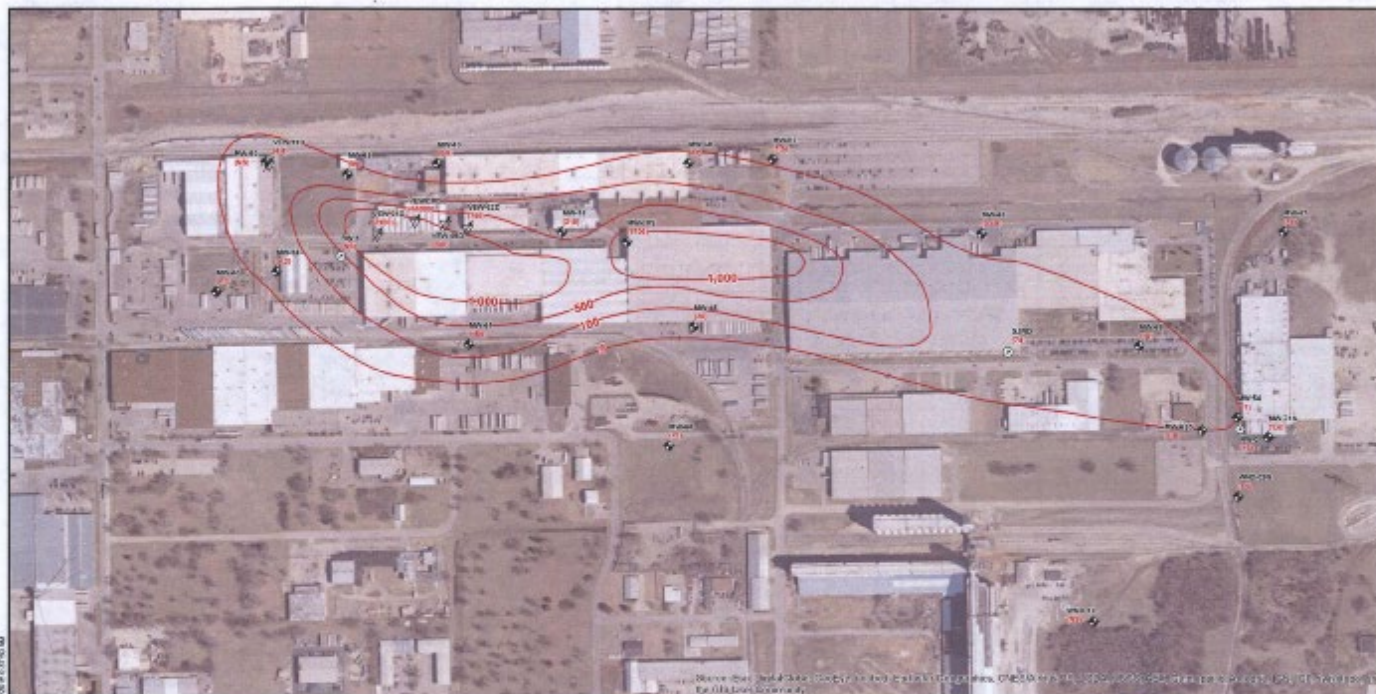
FIGURE:  
4

- ◆ Shallow Monitoring Well
  - ⊗ Vapor Extraction Well
  - ⊙ Recovery Well
  - ~ TCE Concentration Contour (ug/L)
  - █ TCE Concentration (ug/L)
  - NS - Not Sampled
- Maximum Contaminant Level for TCE = 5 ug/L

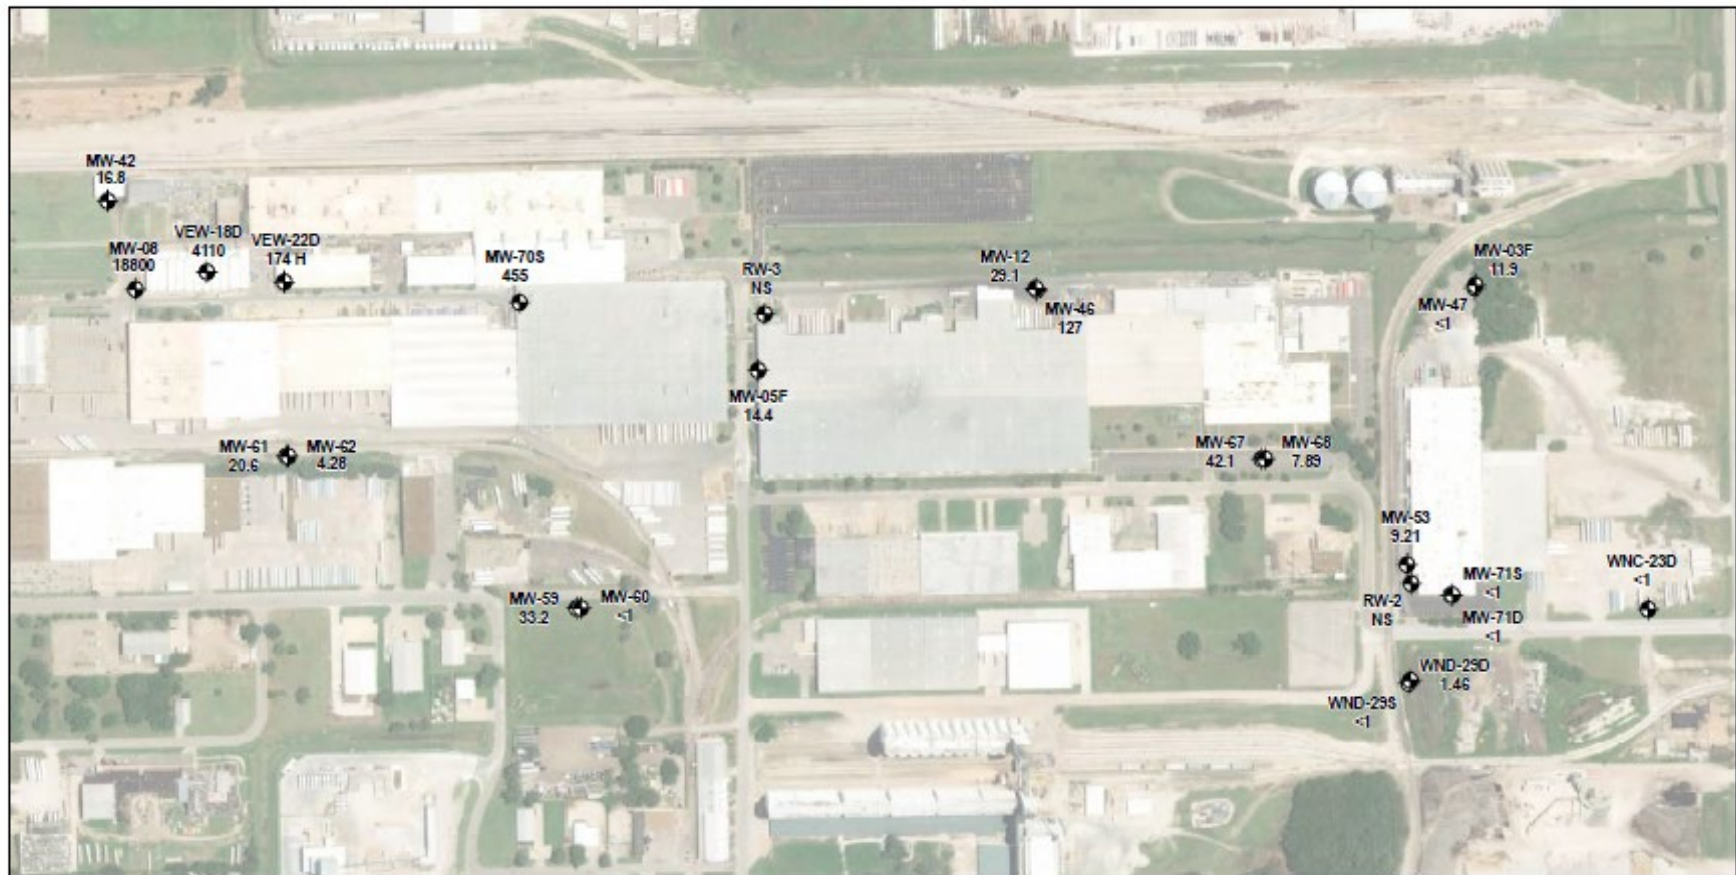
FIGURE  
5

⊕ Monitoring Well Location

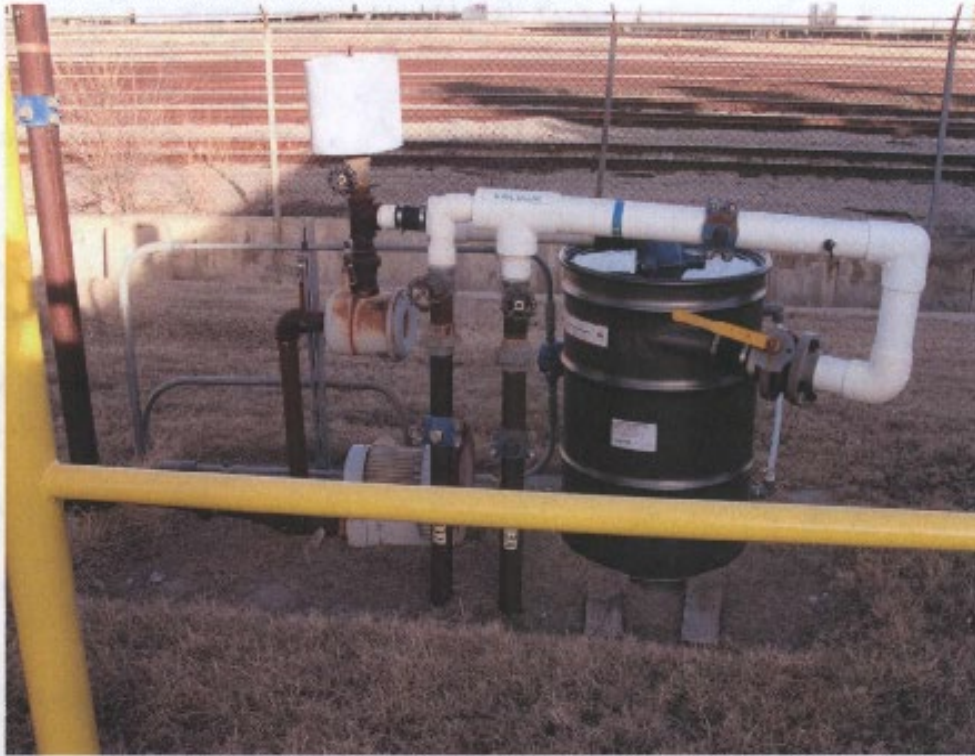
**Photo 6.** South Field Soil Vapor Extraction System (SVES)

**Description:** South Field (SF) soil vapor extraction (SVE) system, located in the east central portion of Site. Components of the system visible in the photograph include: 3 horsepower motor; SF west vapor extraction well riser pipe (center of photo, left pipe rising vertically from the ground); SF east vapor extraction well riser pipe (center of photo, right pipe rising vertically from the ground); water vapor knock-out tank (black barrel); emissions riser pipe (vertical brown pipe at far left of photo).

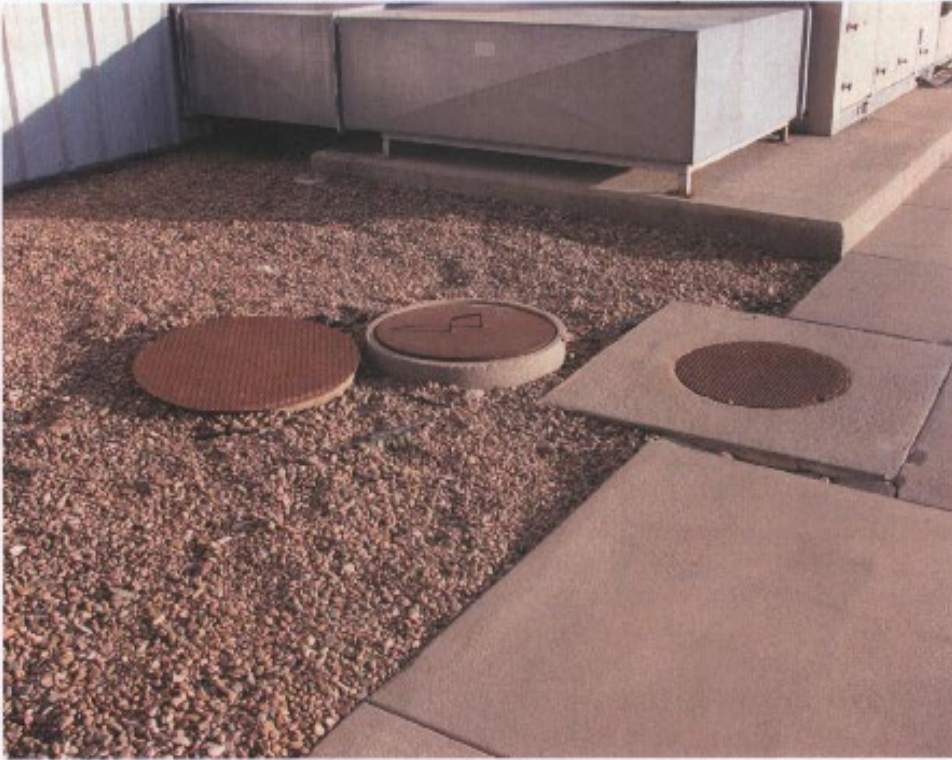
**Photo 14.** South Industrial Well

**Description:** South Industrial Well and associated dry wells for valving and pipe access.

| SVE and Air Stripper O&M | | |
|---|---|---|
| December-15 | Groundwater Recovery Wells | South Industrial well decommissioned due to screen failure |

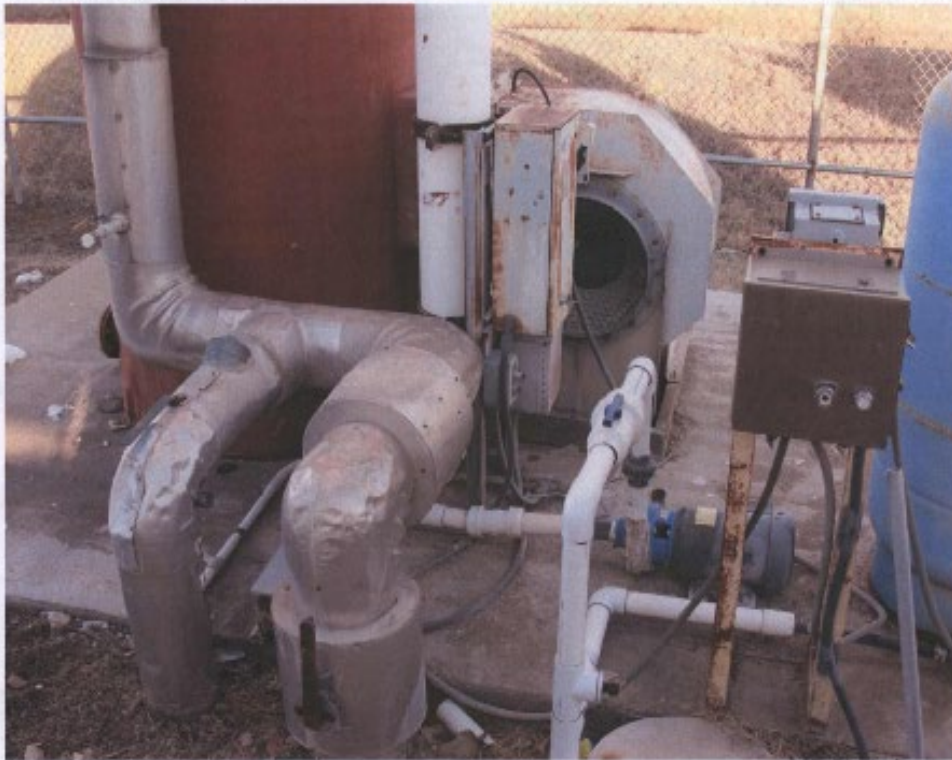
**Photo 16.** Air Stripper "AS-2"

**Description:** Air Stripper "AS-2". Visible components: insulated and aluminum clad pipes are the discharge pipes for RW-2 and the South Industrial Well; air blower located adjacent to the stripper column; electrical switch boxes; influent sampling port (located just above the 90° elbow where the influent pipe becomes vertical); and, water pre-treatment tank (blue tank, located at right edge of photo).

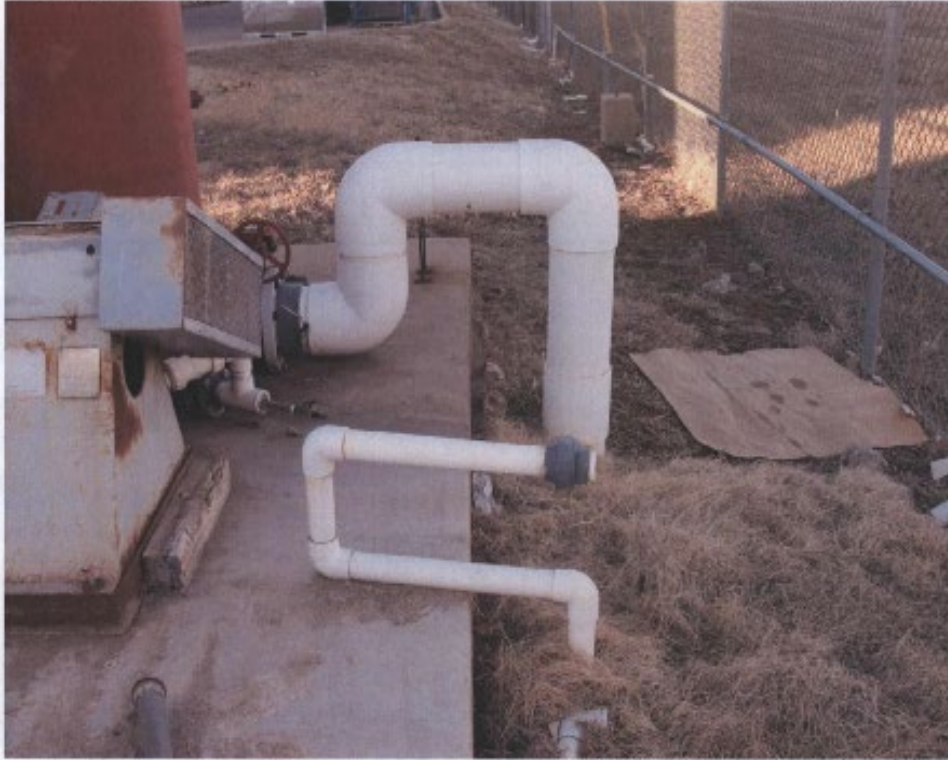
**Photo 17.** Air Stripper "AS-2"

**Description:** Air Stripper "AS-2". View is of the discharge side; large white "goosenecked" shaped pipe is the AS-2 effluent discharge pipe. Effluent sampling port is located just before the pipe makes its first 90° bend where it first becomes perpendicular to the ground (after running parallel to the ground a short distance from the stripper column).
