**THIRD FIVE-YEAR REVIEW REPORT FOR  
EUREKA MILLS SUPERFUND SITE  
EUREKA, JUAB COUNTY, UTAH**

Utah Department of Environmental Quality  
Division of Environmental Response and Remediation

U.S. Environmental Protection Agency  
Region 8  
Denver, Colorado

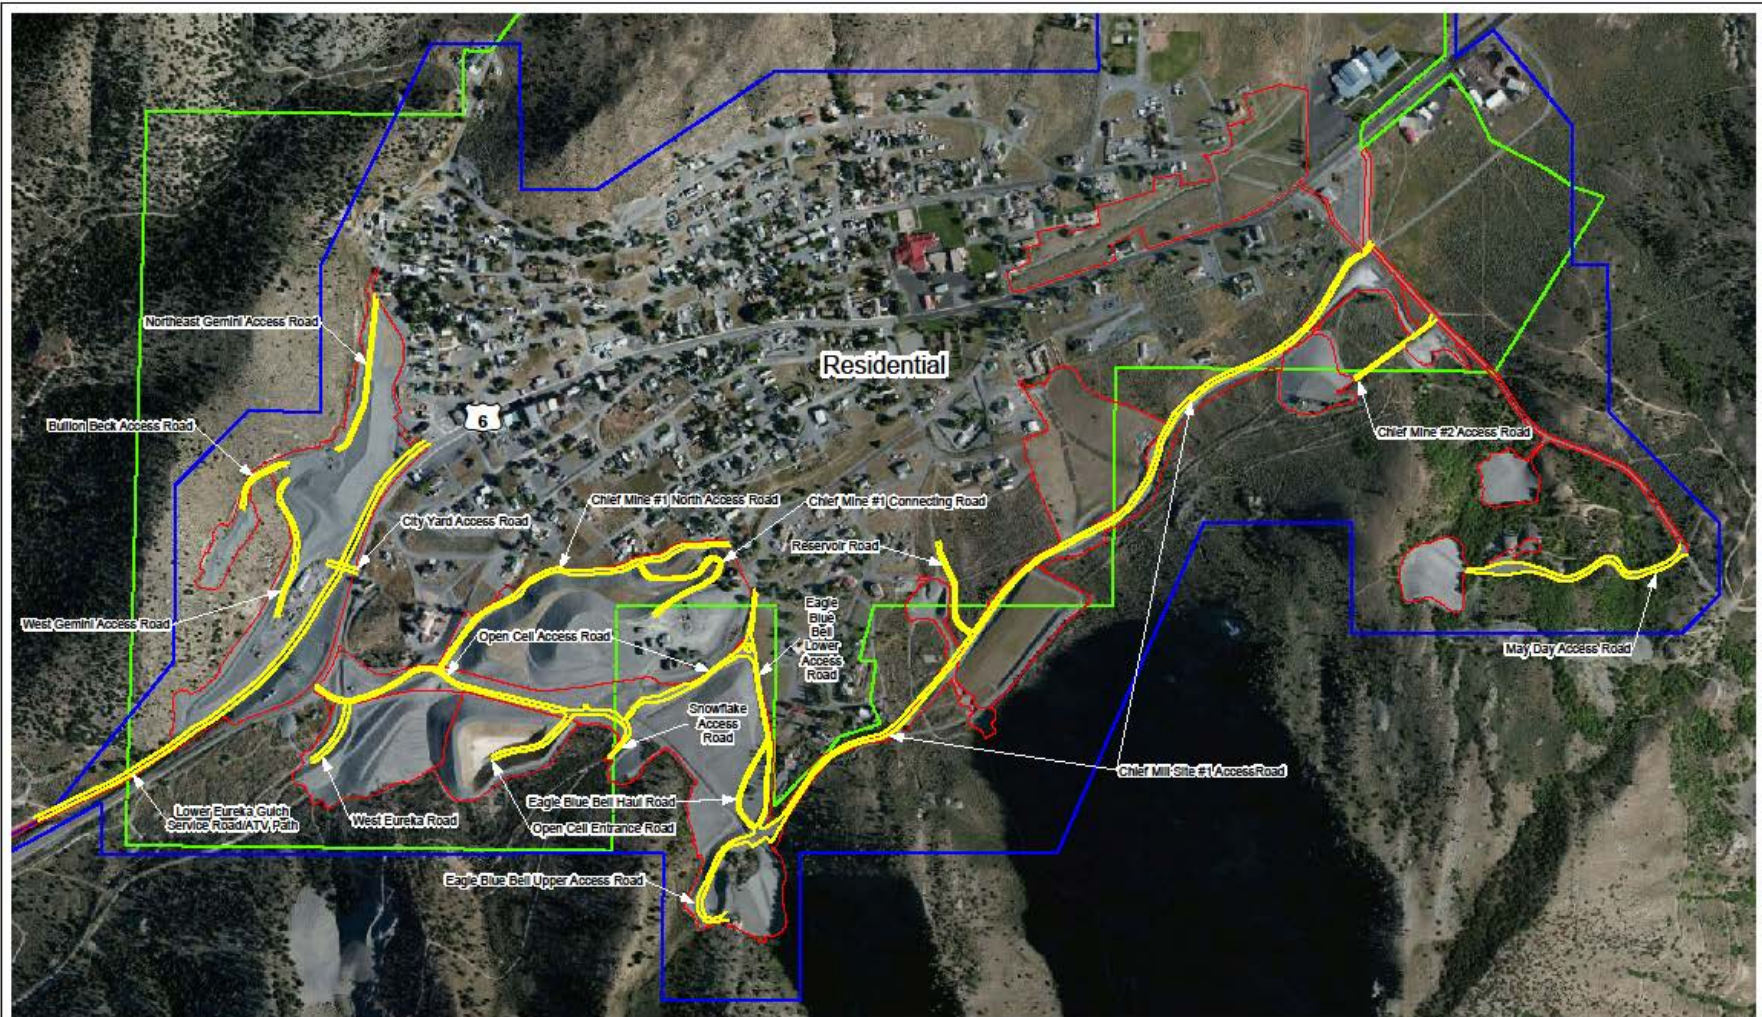
**Response Action Structures -  
Access Road Features Subject to O&M**  
5-Year Review Report  
Eureka Mills Superfund Site  
Eureka, UT

The O/M Plan outlines the responsibilities of the State that includes performing O/M on RAS, haul/access roads and sedimentation ponds (Figures 3, 4 and 5). The State conducts annual inspections and necessary maintenance/repairs of the mine waste cap systems/access roads like grading and slope repair, and erosion control.

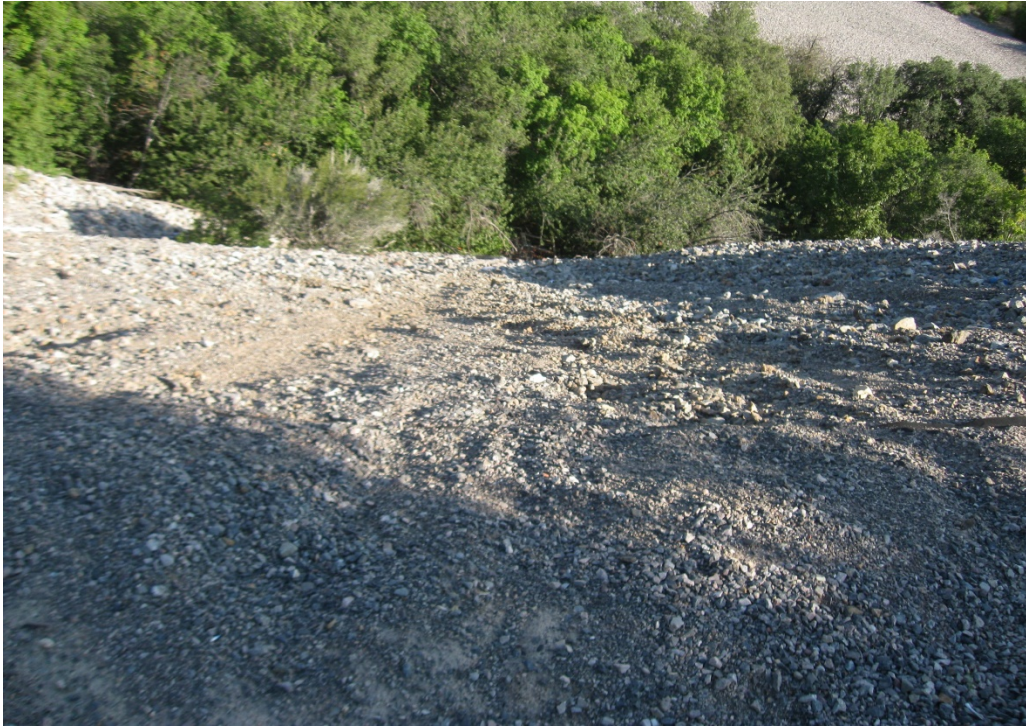
- **Upper Godiva Mine Waste Pile** – Two major erosion rills have occurred at the edge of the northeastern top of the mine waste pile where it intersects with the slope the upper part of the slope (57 ft. length x 3 ft. width x .83 ft. depth and 26 ft. length x 2 ft. width x .83 ft. depth). Also, marker barrier was exposed in some areas. Some minor ATV tracks were noticed on top of the coarse surface of the waste pile. The erosion rills on the cap and intersecting slope will need to be repaired (graded, contoured, and replaced with roadbase).

Roadbase eroded of lower slope of Upper Godiva

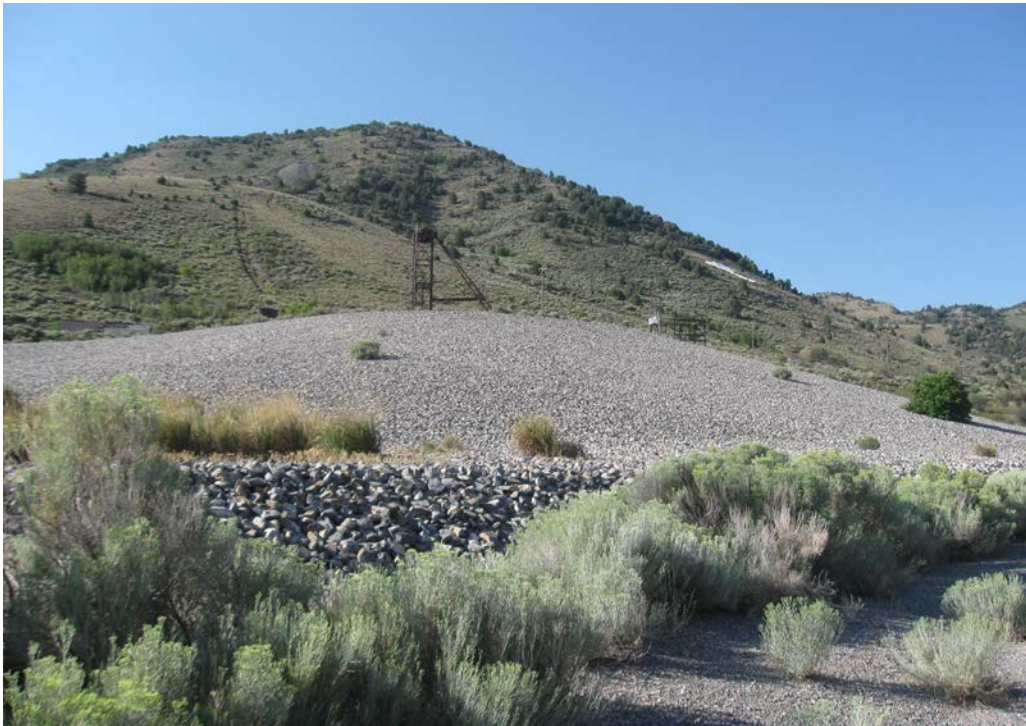
- **Chief Mine No. 2 Mine Waste Pile and Access Road** – Numerous weeds and small bushes were observed on the slopes and cap surface of the mine waste pile. Minor erosion rills were observed on the cap surface due to ATV traffic. No maintenance or repair is required at this time. Major erosion rill (170 ft. length x 1.5 ft. wide x 1 ft. depth) and exposed marker barrier were observed on the Chief Mine No. 2 Access Road and will need to be repaired (graded, contoured, and replaced with roadbase).

Slope of Chief Mine No. 2 looking south

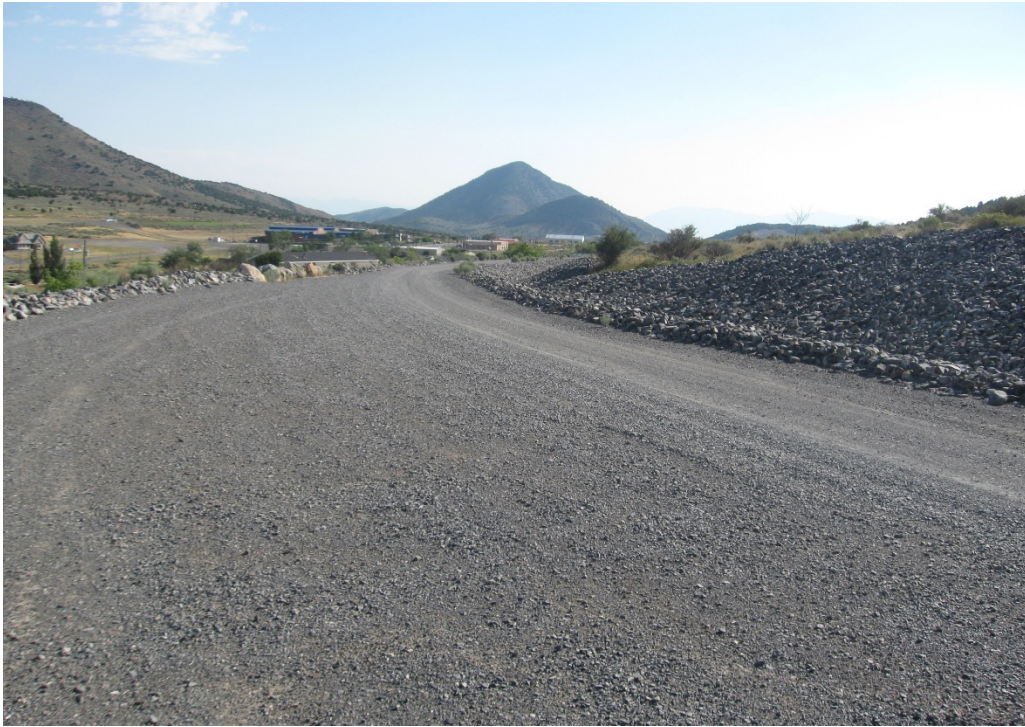
- **Chief Mill Site No. 1** – The armor rock and vegetative caps are intact and show no displacement. No repair or maintenance is required.
- **Chief Mill Site No. 1 Access Road/Drainage Channel** – The access road and drainage channel has some minor weeds. No maintenance or repairs are required.

Looking east on Chief Mill Site No.1 access road

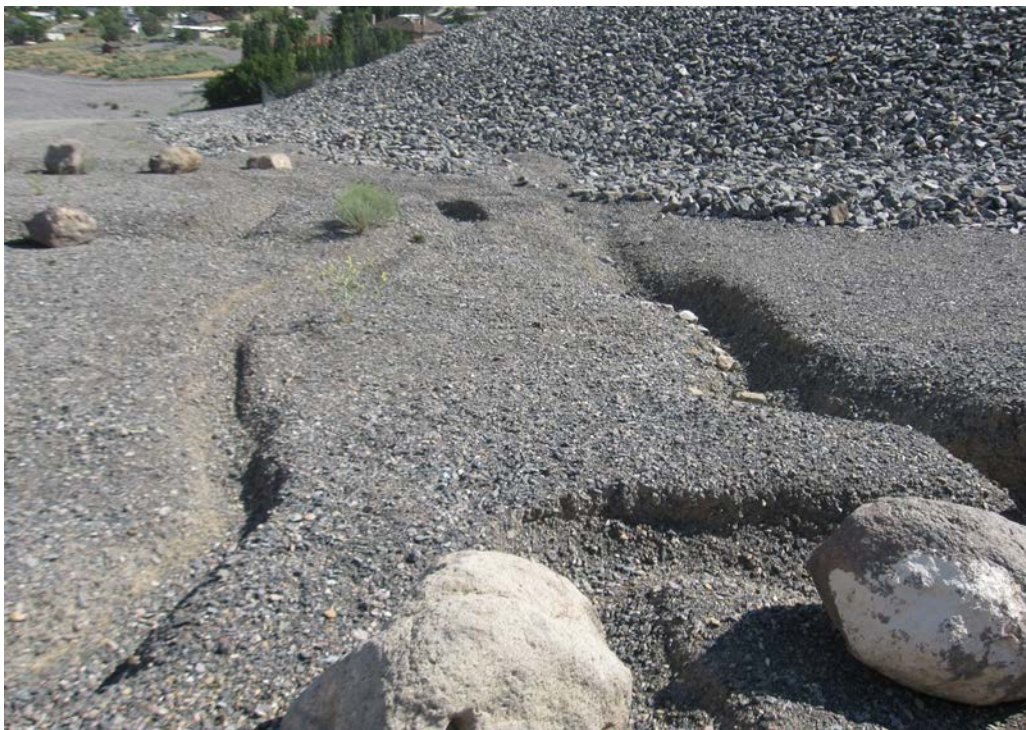
- **Eagle Blue Bell Mine Waste Pile** – Some sparse weeds were observed on the cap surface and armored rock slopes. A breakthrough has occurred at water bars located on the west side resulting in two major erosion rills (45 ft. length x 2 ft. width x 1 ft. depth and 62 ft. length x 2 ft. width x 1 ft. depth) and repair of the erosion rills should be completed (graded, contoured, and replaced with roadbase). Inspection of the top of the Eagle Blue Bell Haul Road located just south of the waste pile showed two erosion rills (each 10 ft. length x 2 ft. width x 1 ft. depth) and should be repaired (graded, contoured and replaced with roadbase). There was a major erosion rill and exposed marker barrier located on the main haul road (250 ft. length x 3 ft. width x .25 ft. depth). Also, the Upper Access Road had a major erosion rill (88 ft. length x 2 ft. width x 1 ft. depth). The Upper Access Road and main haul road are not used for public or private access so it may be prudent to repair the roads with armor rock instead of roadbase material which will provide a more permanent repair of the roads (armor rock should prevent erosion rills occurring in the future).

Erosion rills on west side of Eagle Blue Bell Water Bars

- Erosion rills/exposed marker barriers (caused by weather) were observed at several access roads and RASs. The DERR is working with the Division of State Purchasing on developing a scope of work to procure a contractor to conduct the maintenance repairs by the summer of 2018.
- A sinkhole associated with mining activities was observed on the eastern surface of the Chief Mine No. 1 Waste Pile. The Division of Oil, Gas and Mining (DOG M) and the property owner (Enirgi Group) are planning to backfill/cap the sinkhole by the summer of 2018.

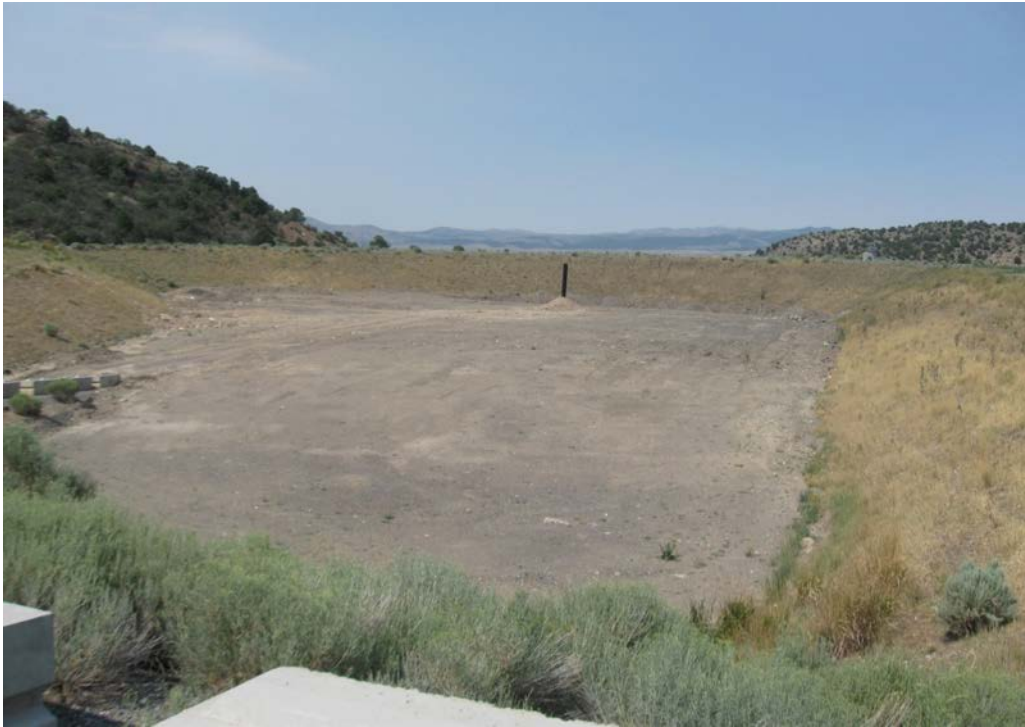
- **Open Cell** – Inspection of the rock cap slopes, vegetative cover and interior slopes of the Open Cell are in good condition. The floor of the Open Cell was being continually graded and compacted during the ongoing excavated soil deposition related to the Water/Sewer line Project and daily use of the repository (grading and compaction has been completed). The drainage pipe located on the western end of the repository has been elevated approximately five feet due to the increase in volume of soil and the corresponding increase in the elevation of the floor of the repository. The floor of the repository has been graded and compacted.

Looking west of Open Cell
