**Technical Memorandum
for Oversight of the Phase 1A-B Remedial Investigation
in PRI Areas 1 and 3 through 7 and Background**

**US Magnesium NPL Site
EPA Site ID. NO. UTN000802704
Tooele County, Utah**

8 January 2016

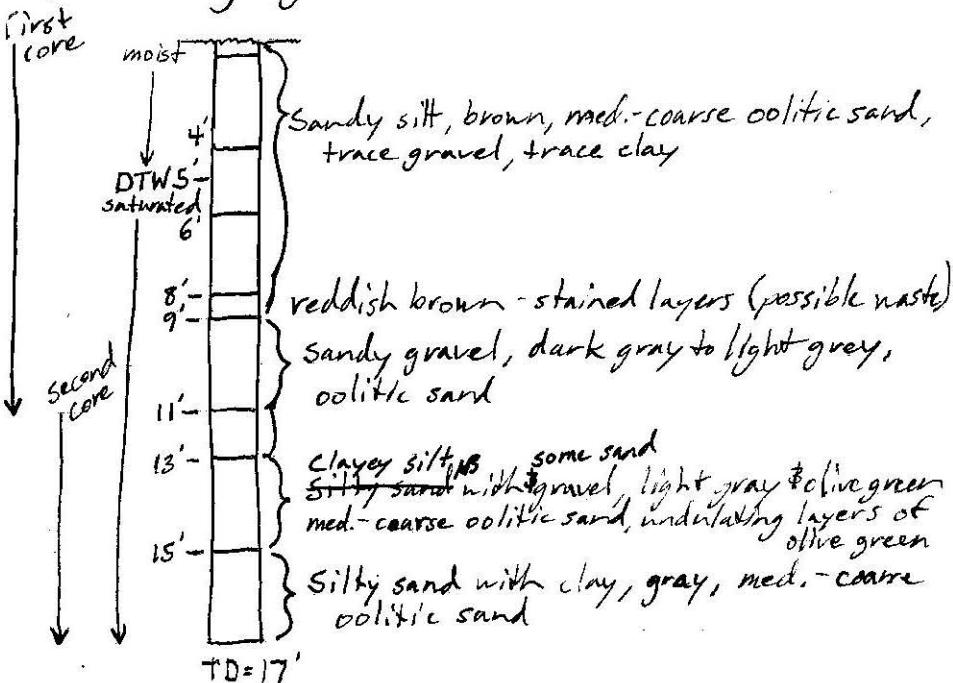
1-13 boring log:

A zone of olive green silt was observed in the 1-13 boring at a depth of 13 to 15 feet bgs, and because this interval appeared anomalous (based on color), samples were collected from these specific intervals. This olive-green interval was observed in the 1-13/7-04SB area during the 1970 Dames & Moore test pit programs and therefore appears to be associated with the lake deposits and is not an “anomalous waste/sediment layer” that requires sampling. Therefore, ERM did not analyze samples from 13 to 15 feet bgs because the olive-green layer is from deeper than 2 feet below the waste/native soil interface and is associated with lake deposits that pre-date magnesium plant operations. Since the EPA split sample from the 1-13 boring was collected from the 13 to 15 feet bgs interval, all analyses that had not already been run were cancelled, including PCBs, dioxins/furans, SVOCs, PAHs, and total metals.

I collected split sample from the 13-15'
interval: 1-13-SB-01-13-15-110015-ES01 - see
field data sheet.

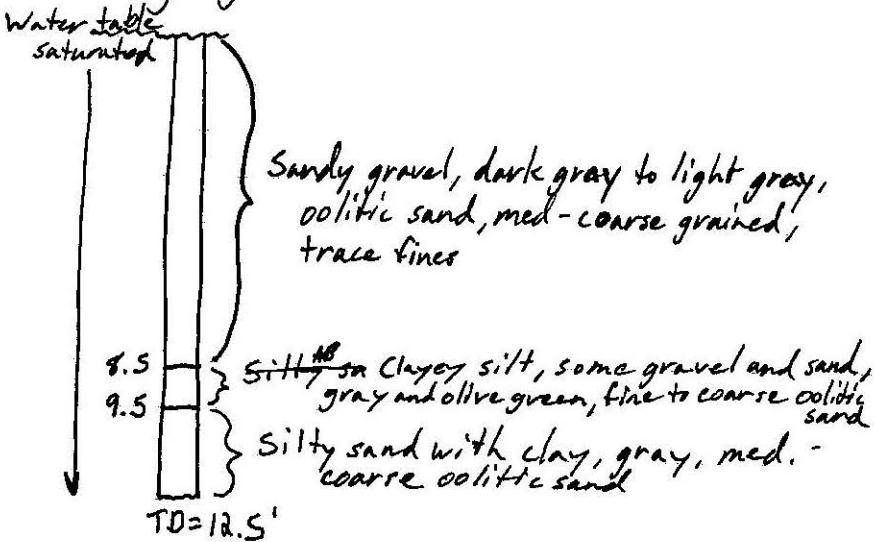
7-04 boring log:

A zone of olive green silt was observed at 8.5 to 9.5 feet bgs at 7-04SB, and because this interval appeared anomalous (based on color), samples were collected from these specific intervals. This olive-green interval was observed in the 1-13/7-04SB area during the 1970 Dames & Moore test pit programs and therefore appears to be associated with the lake deposits and is not an “anomalous waste/sediment layer” that requires sampling. Therefore, ERM did not analyze samples from at 8.5 to 9.5 feet bgs at 7-04SB because the olive-green layer is from deeper than 2 feet below the waste/native soil interface and is

Drilled boring 7-04 to 12.5' bgs. Native encountered at ~9.5' bgs. Sample intervals set at 2.5-4.5, 4.5-6.5, 6.5-8.5, 8.5-9.5, and 9.5-11.5'. No recovery of saturated fines in upper 2.5' of boring. Similar lithology to 1-13, same olive green layer just above native, from 8.5-9.5'. I collected split from 8.5-9.5' layer/internal - 7-04-SB-01-8.5-9.5-111015-ES01 - see field data sheet.

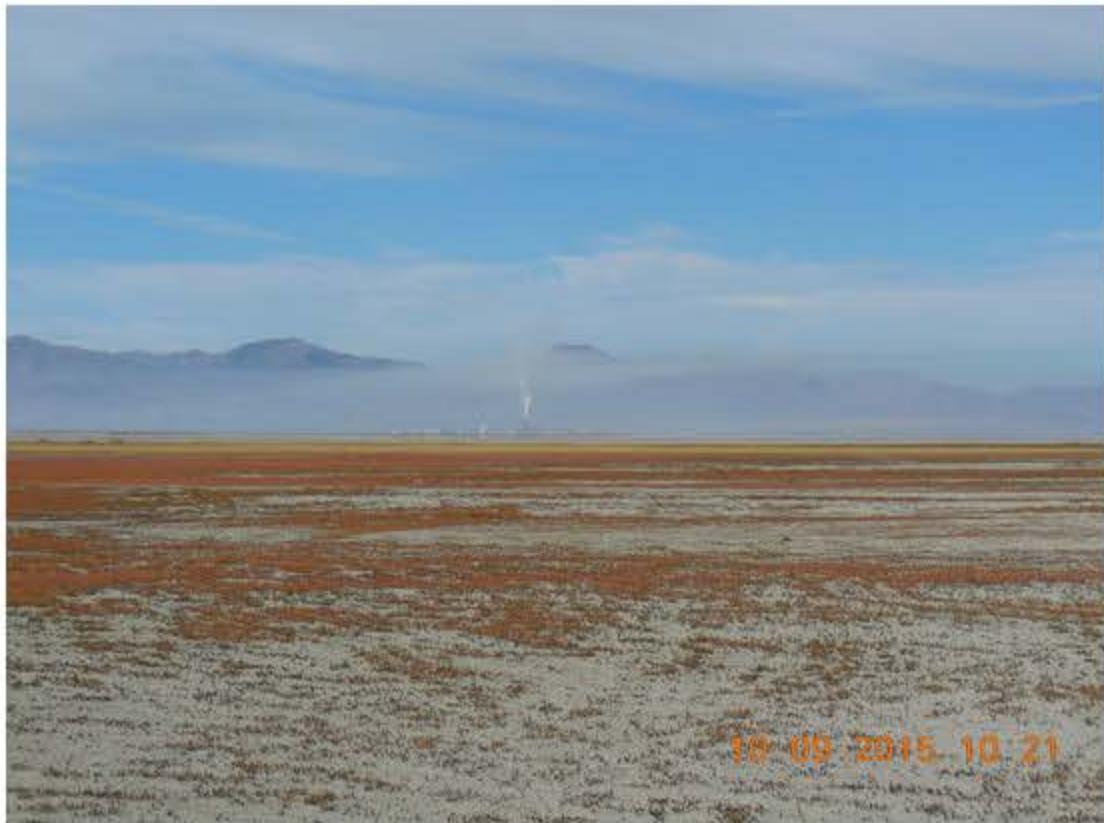
Photo 1 | Lakebed SE at Badger Island | 10/09/15
Stack plume spreading out and settling into the valleys of the Lakeside Mountains

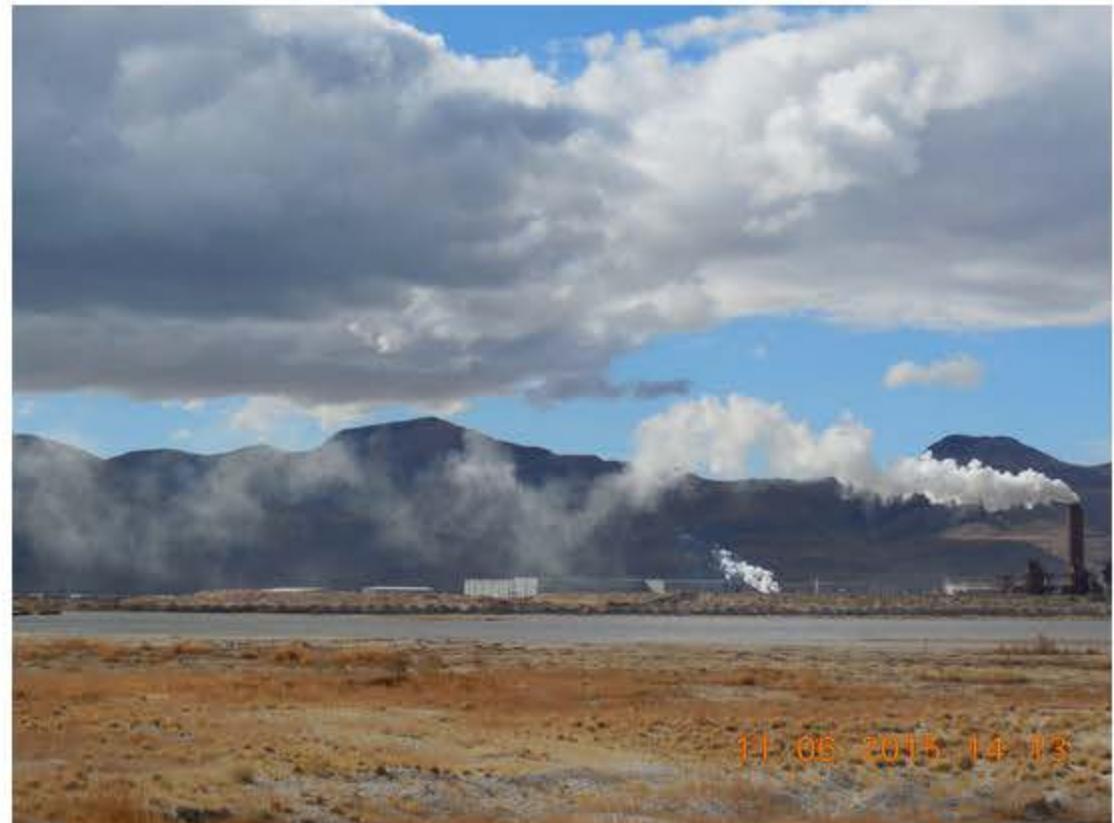
Photo 2 | PRI Area 5 | 11/06/15
Stack plume exhibiting "looping" behavior

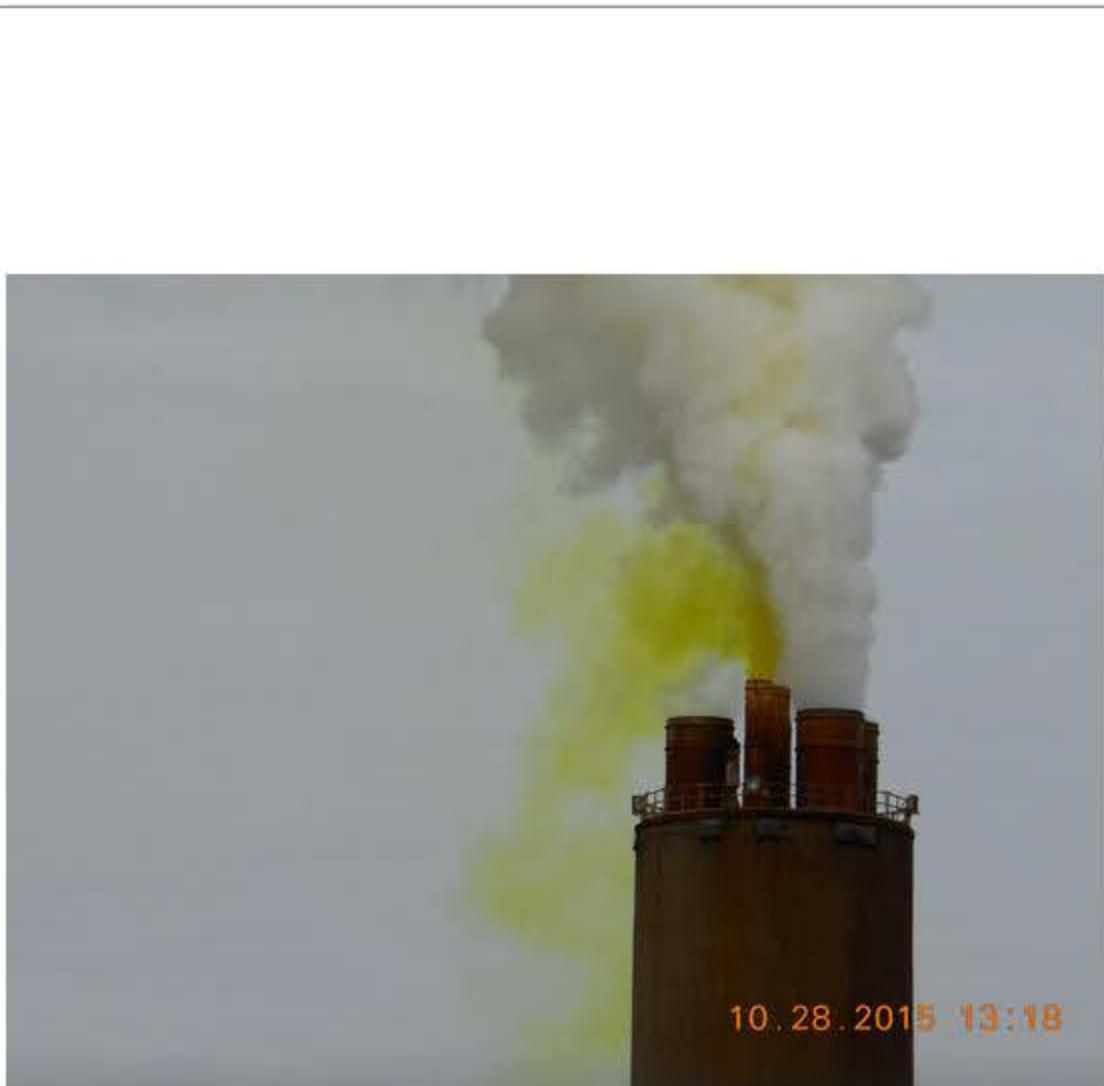
conditions. Visible dissipation of the stack plume was observed to range from approximately one mile downwind under windy conditions to over 20 miles under calm conditions. During easterly winds, the stack plume was also observed spreading out and settling into the valleys of the Lakeside Mountains (Photo 1, Appendix C). Chlorine gas readings from the stack plume were encountered on the gypsum pile. At times, the stack plume exhibited “looping” behavior whereby the plume reaches the ground relatively near the stack (Photo 2, Appendix C) and on occasion, chlorine gas was observed falling straight down from the stack (Photo 3, Appendix C).

Photo 3 | USM Parking Lot | 10/28/15
Chlorine gas falling from the stack

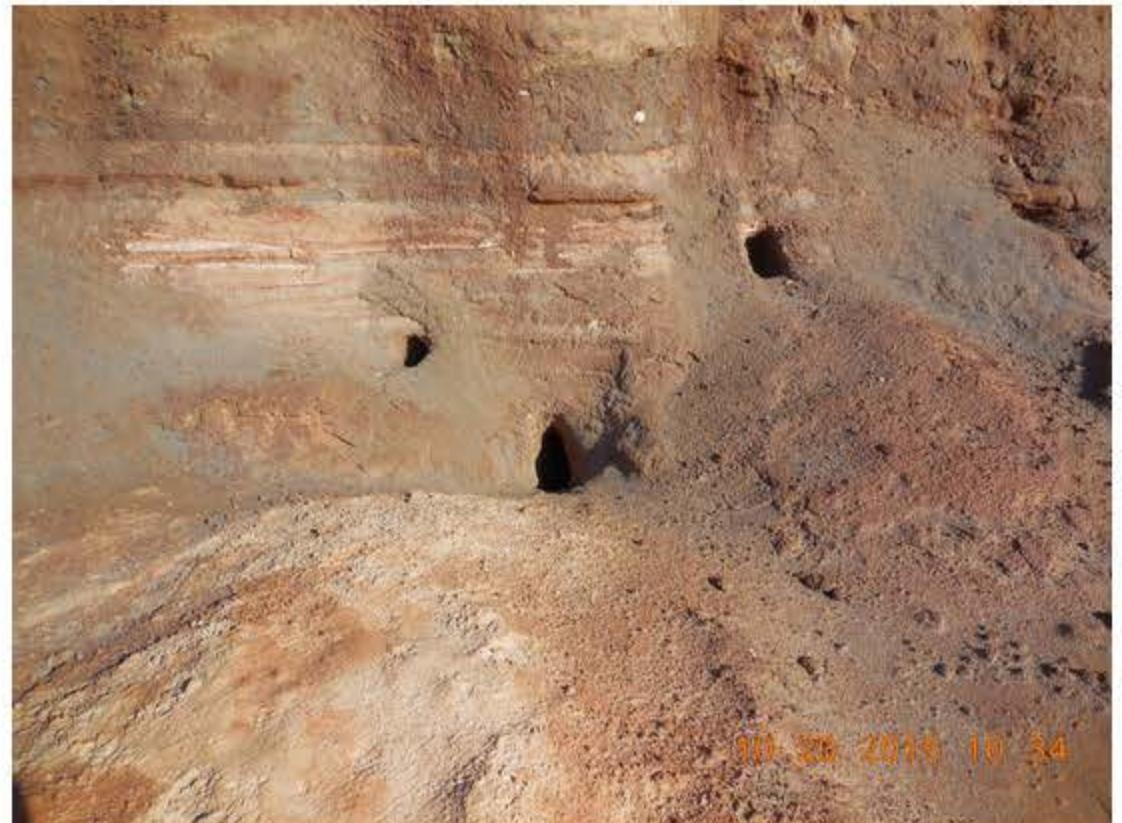
Photo 6 | PRI Area 4 | 10/20/15
Animal burrows in the gypsum stockpile on the southeast side of the Gypsum Pile

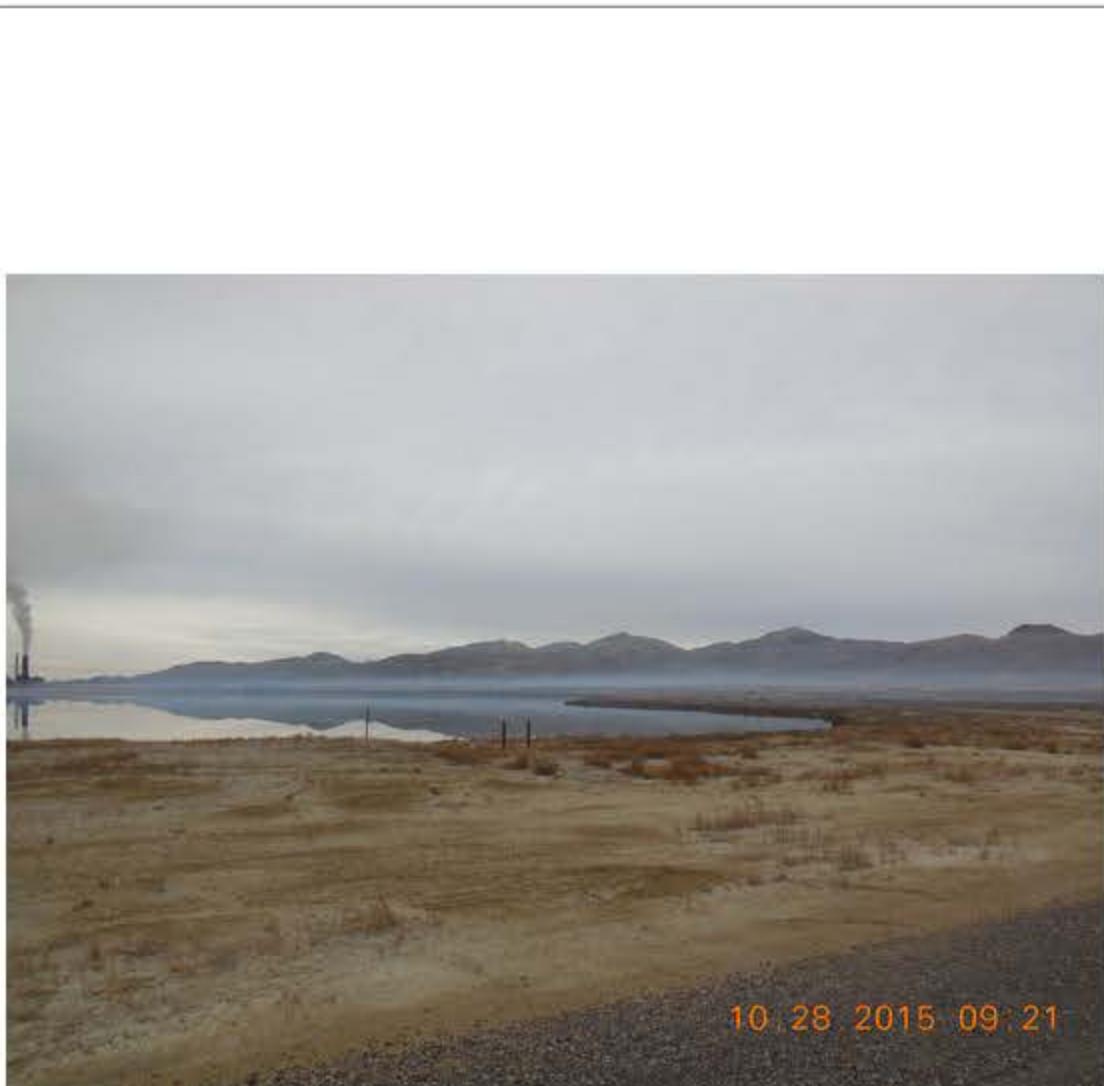
Chlorine gas plumes originating from locations other than the facility stack were observed on multiple occasions. On 28 October 2015 a low-lying white haze (chlorine gas) was observed extending from the facility north into PRI Area 8 (Photo 7, Appendix C). The highest chlorine gas concentrations were encountered on the morning of 2 December 2015, when concentrations were sustained above 5 ppm while mobilizing to subsurface sample location 1-08 near the confluence of the Chlorine Ditch and Main Ditch. ERM's drilling subcontractor arrived at the location prior to the ERM/PWT field team and recorded chlorine concentrations up to 13 ppm with a personal gas meter. These were the highest chlorine readings ever recorded by the PWT or ERM field teams. For reference, the NIOSH Immediately Dangerous to Life or Health (IDLH) concentration for chlorine gas is 10 ppm. The response actions listed in ERM and PWT Health and Safety Plans were followed. The field team left the area and returned two hours later when chlorine gas was detected at less than 1 ppm; therefore, the field team donned respirators and completed the sampling at location 1-08. On 2 December 2015, the air was relatively still and additional discharge of chlorine gas was evident; there was a dense white haze encompassing the entire facility (Photo 8, Appendix C).

Photo 7 | PRI Area 6 | 10/28/15
Low-lying white haze (chlorine gas) extending from the facility north into PRI Area 8

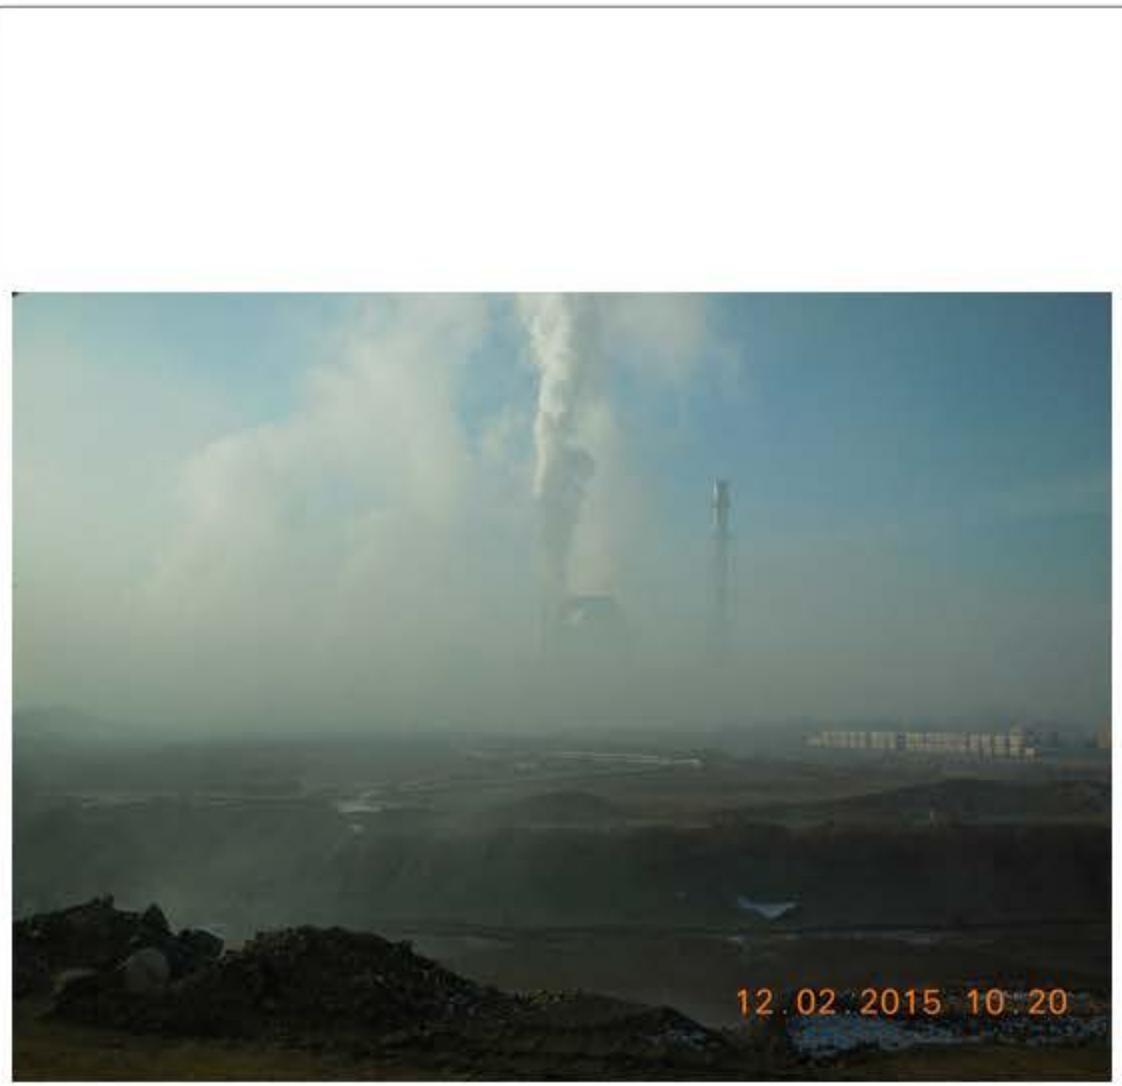
Photo 8 | PRI Area 1 | 12/02/15
Dense white haze (chlorine gas) encompassing the entire facility

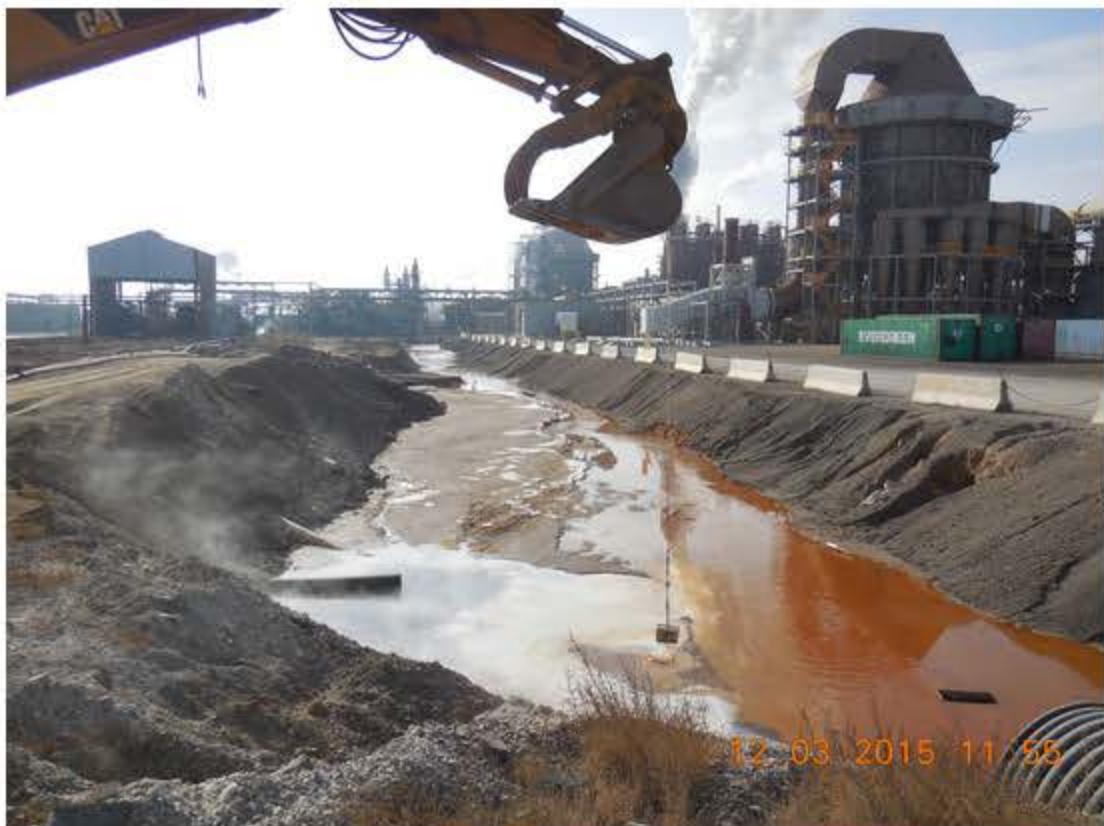
Photo 9 | PRI Area 1 | 12/03/15
Surface solids sampling at location 1-07 using an excavator-deployed Ponar sampler

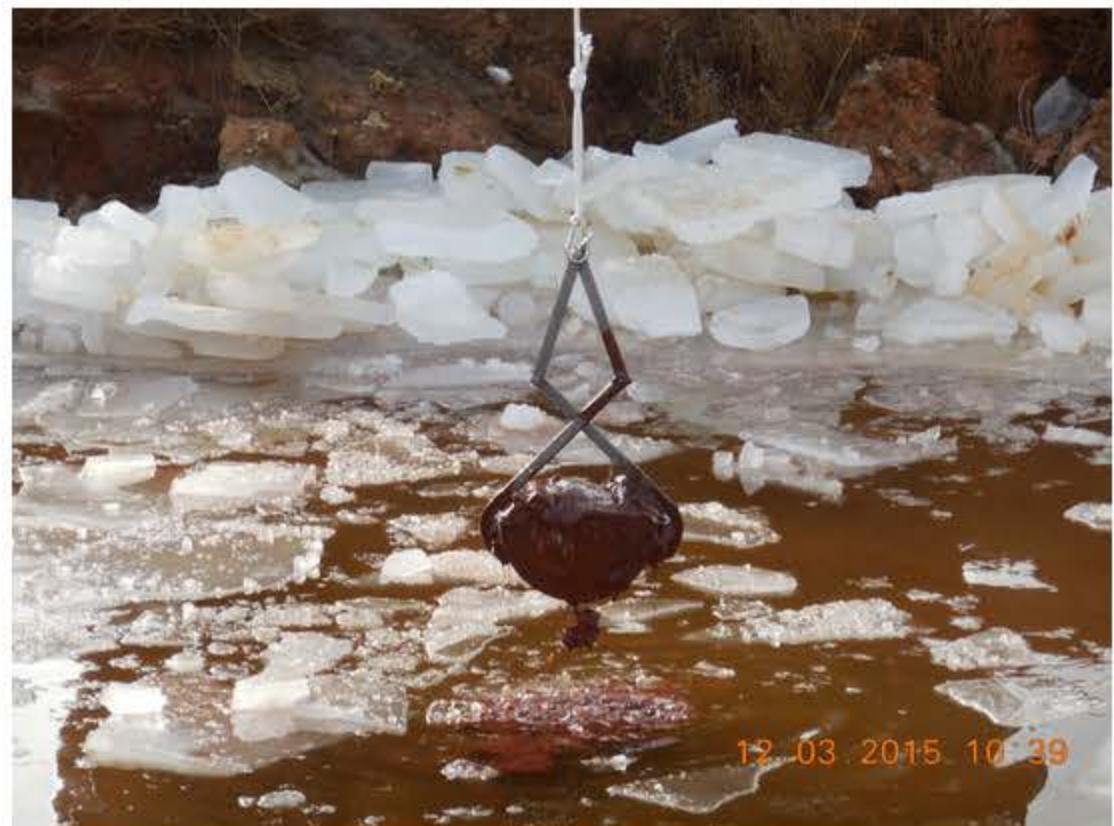
Photo 10 | PRI Area 1 | 12/03/15
Surface solids sampling at location 1-03 using a Ponar sampler. 6+ inches of penetration and full recovery of soft waste material in the Ponar bucket

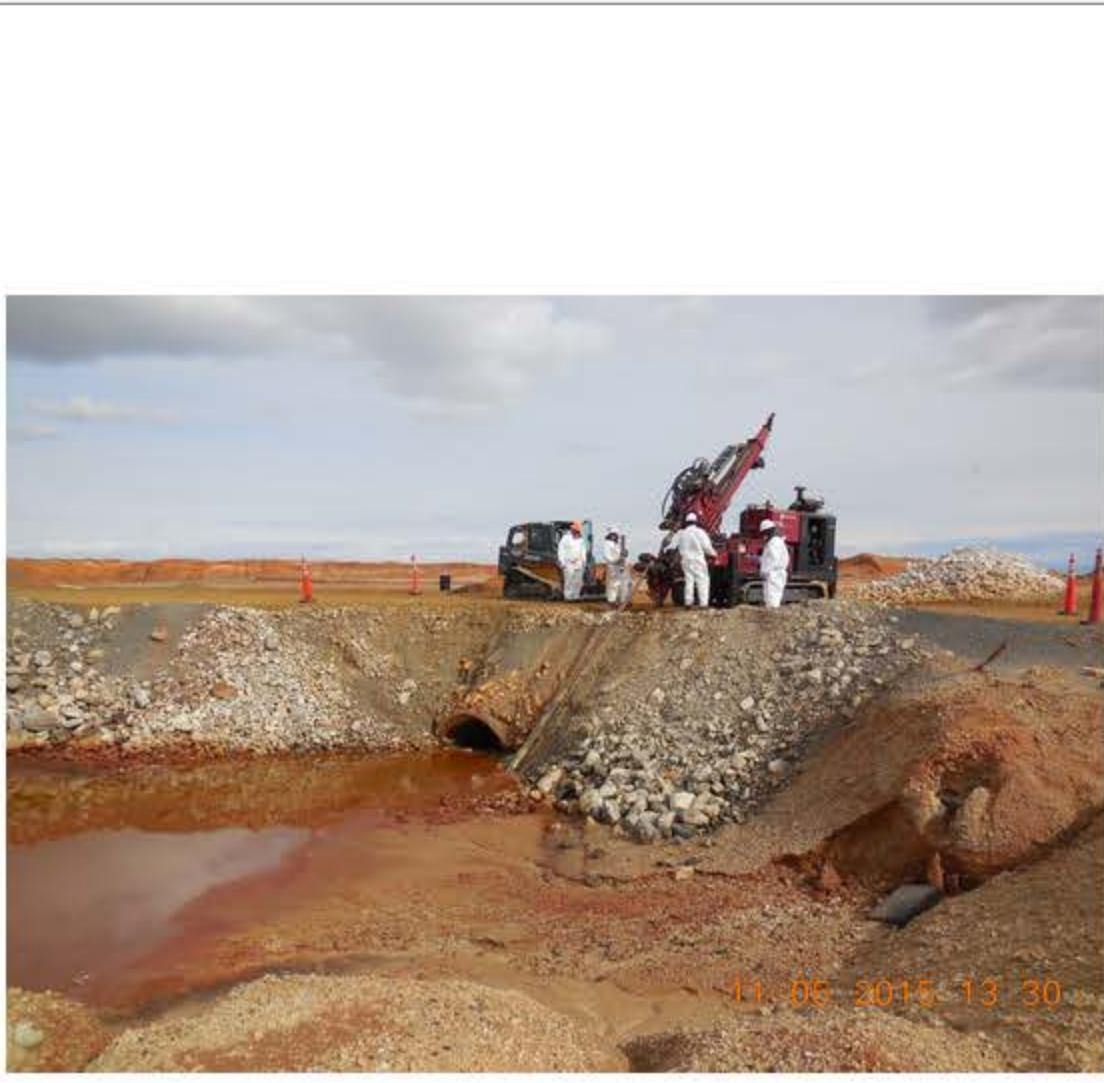
Photo 11 | PRI Area 1 | 11/05/15
Advancing 5-16 boring using a sonic drill rig with a 6-inch diameter core barrel at a 45 degree angle adjacent to the Main Ditch culvert

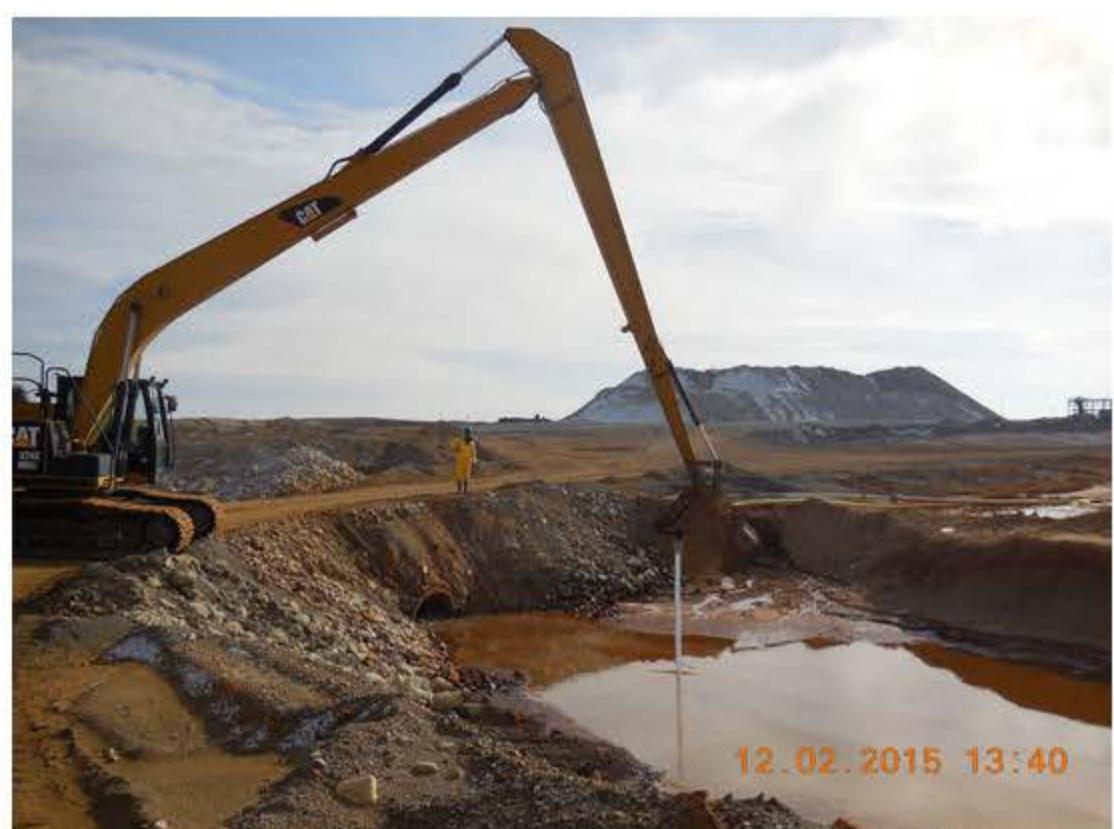
Since there was not full recovery in the first core, a second core was advanced in the center of the Main Ditch, approximately 15 feet west of the first core (Photo 12, Appendix C). The second core was advanced to 7 feet bgs and there was about 3 feet of recovery. What appeared to be black smut was observed in the bottom of the second core. A third core was advanced adjacent to the second core location, this time with no liner or soil catcher. The third core was advanced to 7 feet bgs and there was 6 feet of recovery. Black sandy gravel with a hydrocarbon odor was encountered from 5 to 6 feet bgs which was considered anomalous and therefore separated into its own sample interval. The top 1 foot of material in the core was stuck to the side of the Lexan™ tube and ERM was unable to recover it for sampling. Following inspection of the core, ERM collected three samples from the core:

Photo 12 | PRI Area 1 | 11/02/15
Advancing 5-16 core in the center of the Main Ditch using a 4-inch diameter Lexan tube

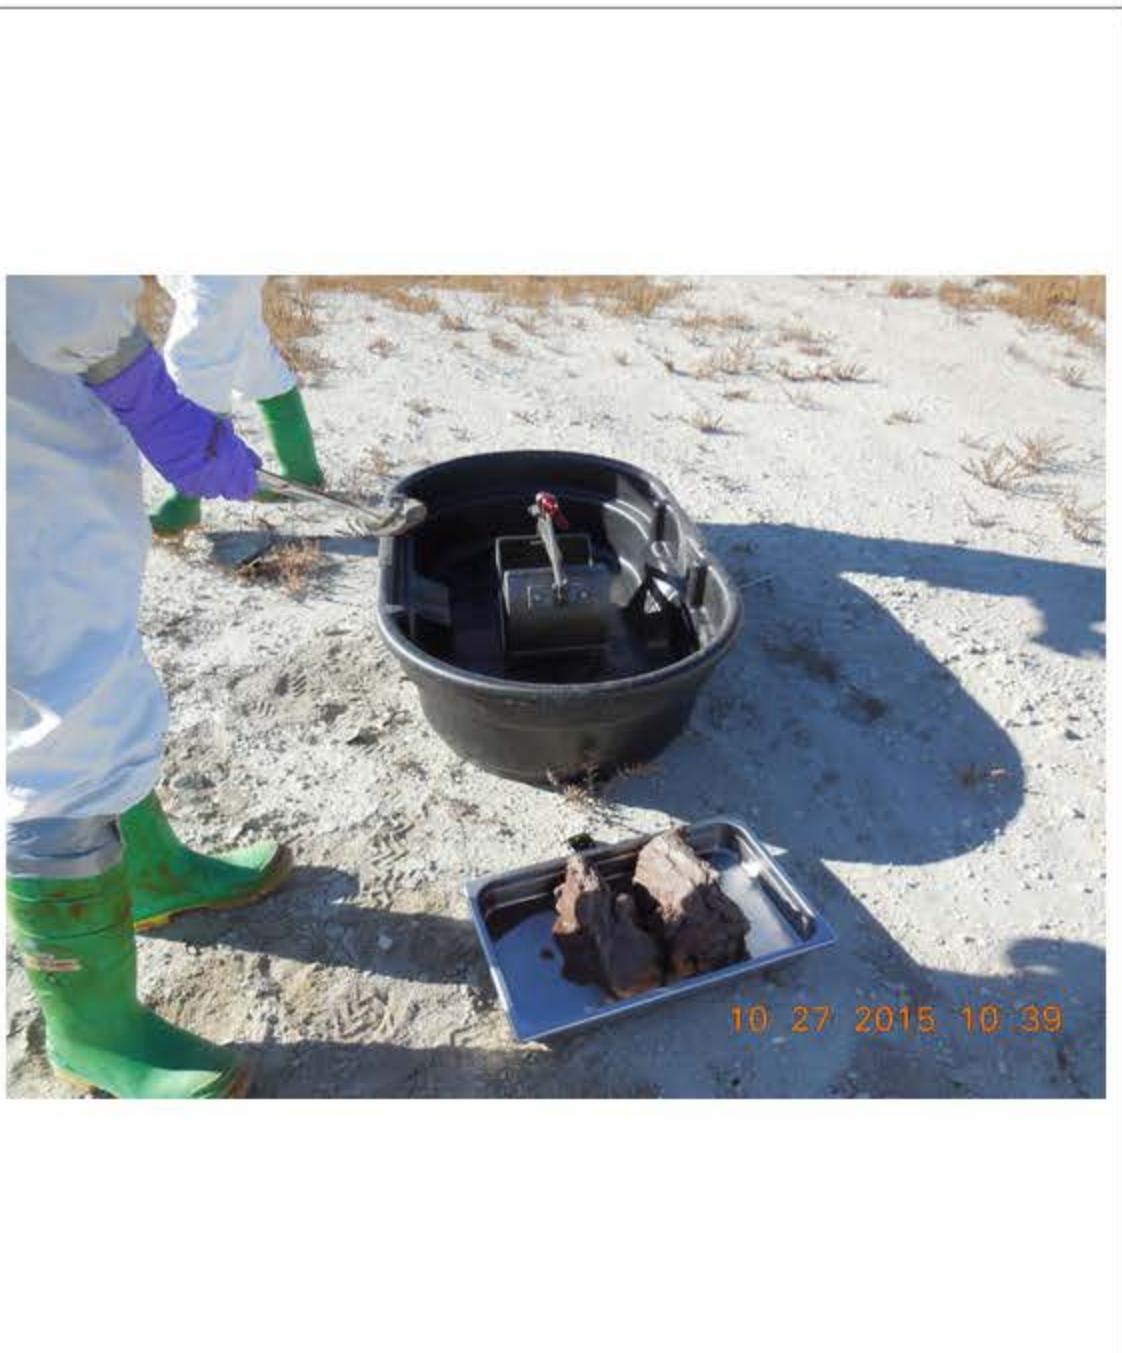
Photo 13 | PRI Area 5 | 10/27/15
Example of Ponar sample recovery with greater than 4 inches of penetration where
only one sample aliquot was required

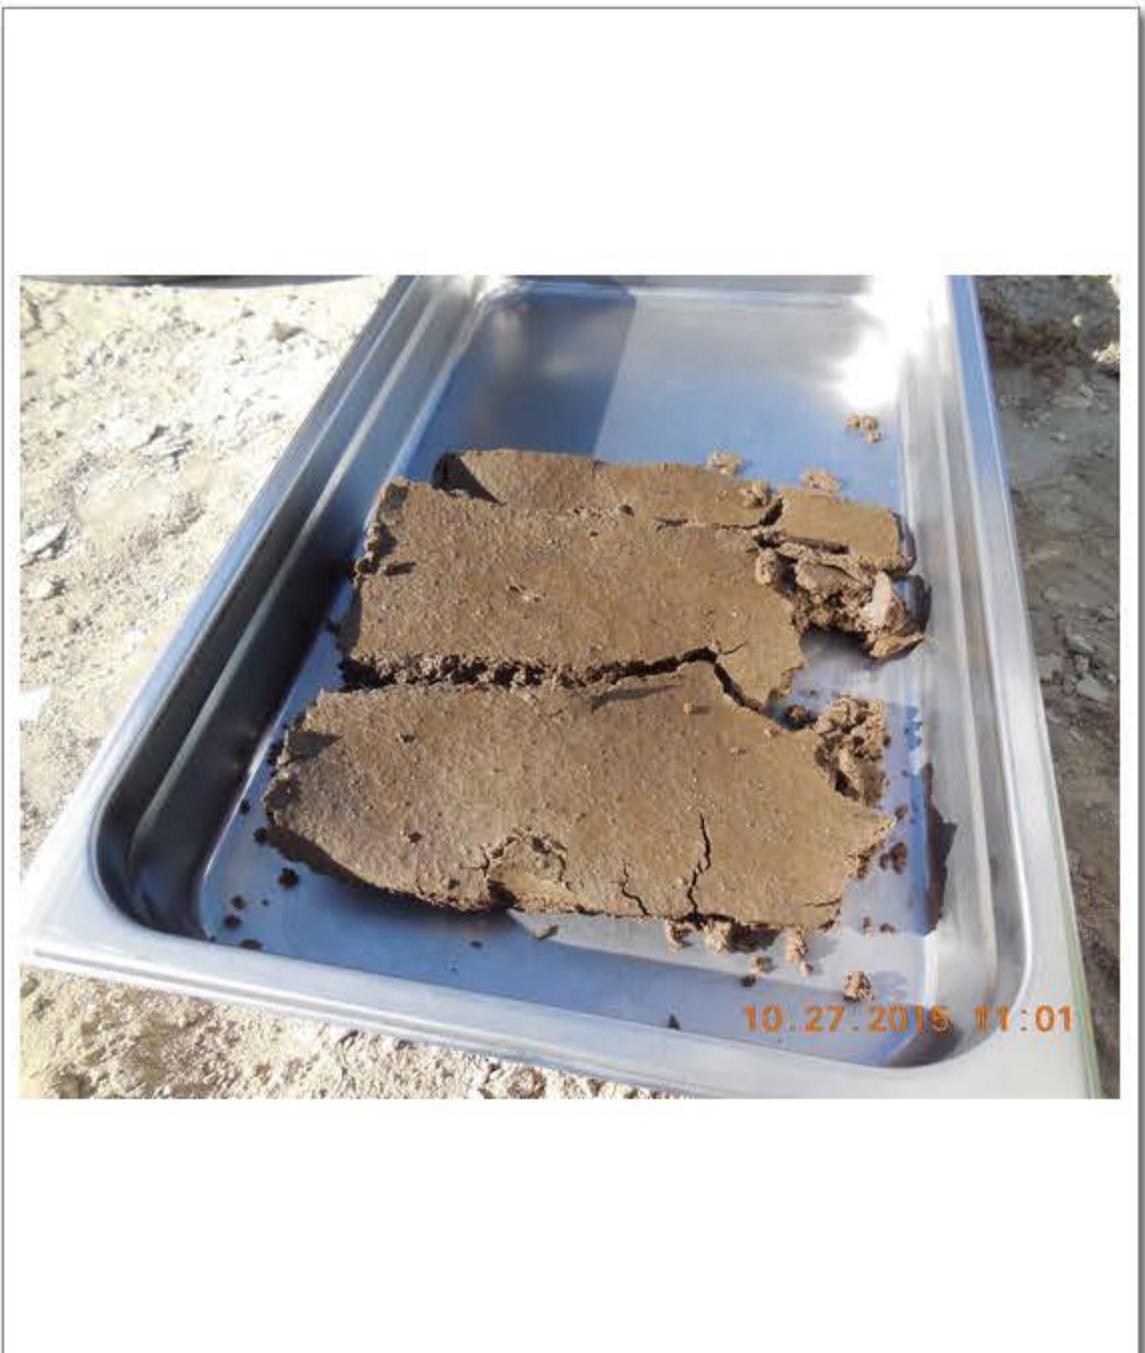
Photo 14 | PRI Area 5 | 10/27/15
Example of Ponar sample recovery with less than 4 inches of penetration where
multiple sample aliquots were required

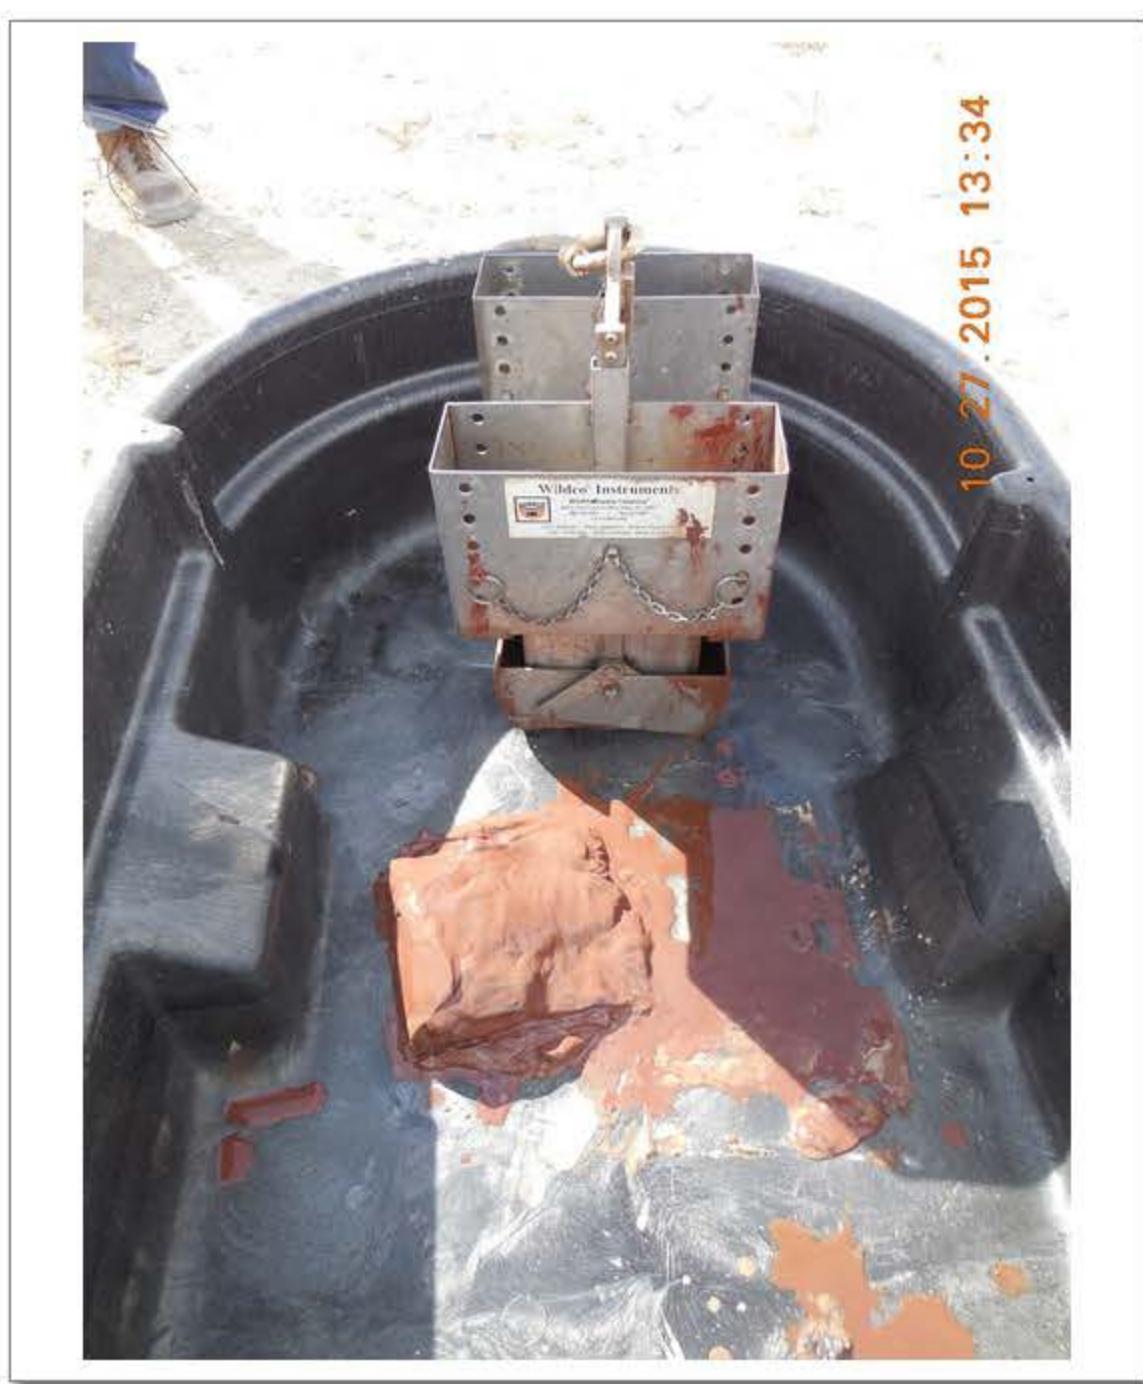
Due to access and health and safety issues caused by the ponded wastewater, a helicopter-deployed Ponar sampler was used at locations 5-02, 5-07, 5-08, 5-11, 5-12, 5-13, and 5-14. The number of Ponar sample aliquots required for each sample ranged from one aliquot in the soft saturated waste material to four aliquots in the non-saturated sandy material, depending on depth of penetration (Photos 13 and 14, Appendix C). Locations 5-07, 5-08, and 5-12 did not get adequate penetration (greater than or equal to 4 inches bgs) with the Ponar sampler. ERM submitted Field Modification No. 5 for not meeting the penetration acceptability requirement and for compositing sample aliquots, which was approved verbally by EPA on 27 October 2015 and signed on 29 October 2015. A box core sampler was tested at 5-14 achieving 2 inches of penetration, compared to 6-inch penetration with the Ponar (Photos 15 and 16,

Photo 15 | PRI Area 5 | 10/27/15
Sample recovery with box core sampler tested at 5-14 with about 2 inches of
penetration

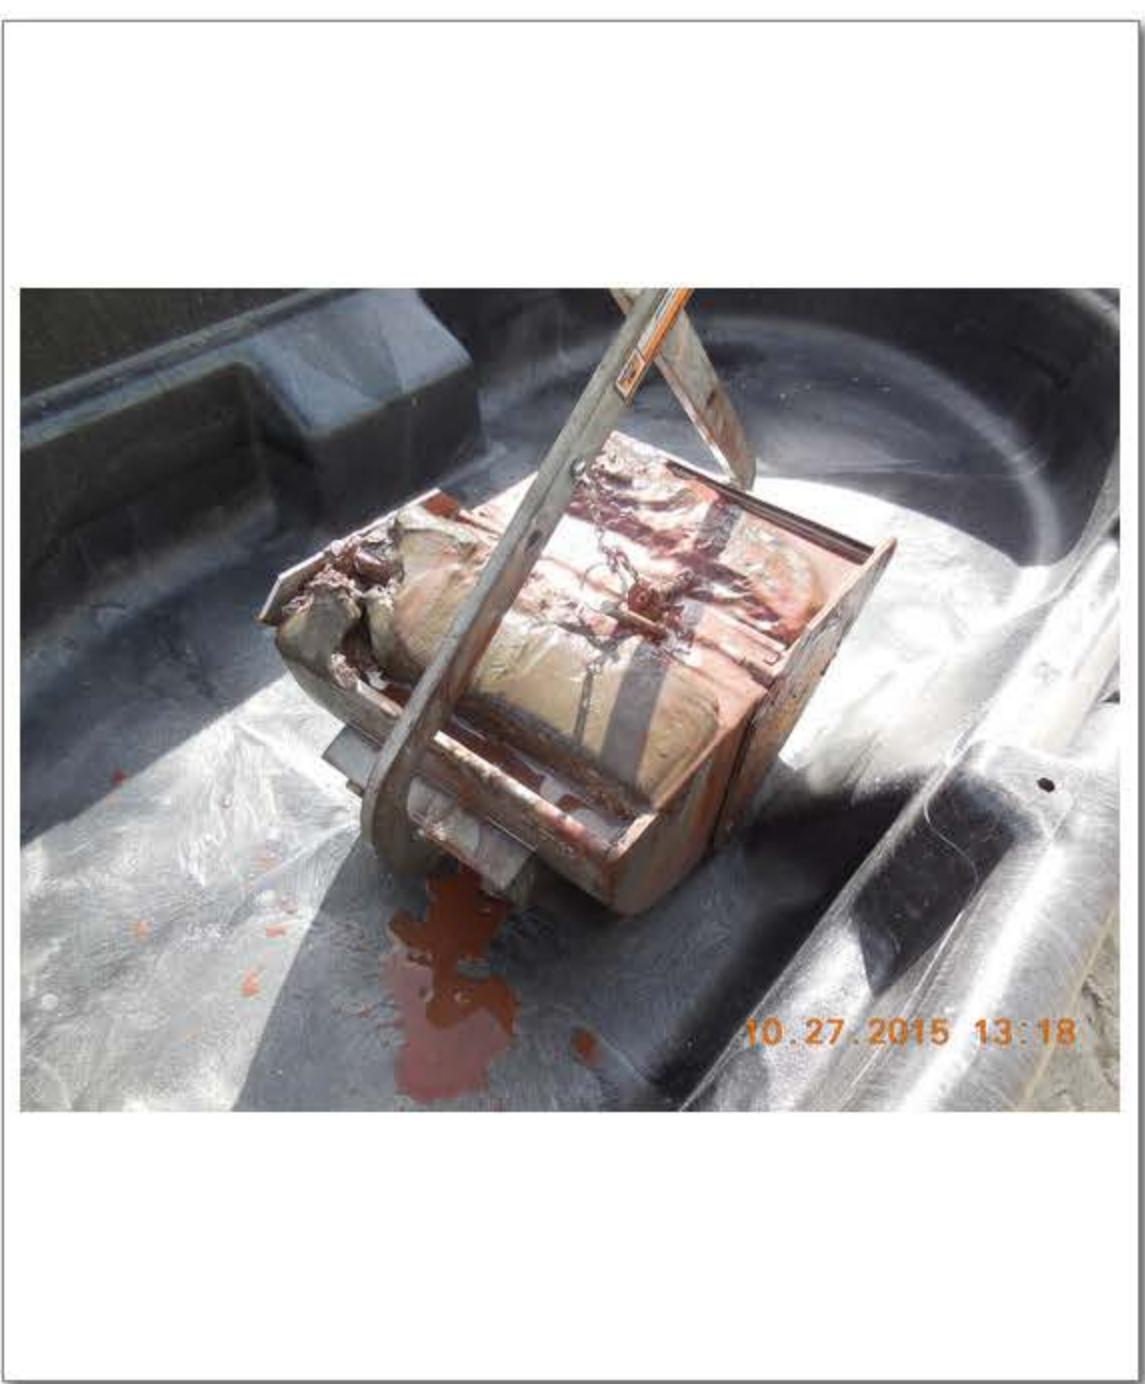
Photo 16 | PRI Area 5 | 10/27/15
Sample recovery with Ponar sampler at 5-14 with 6+ inches of penetration

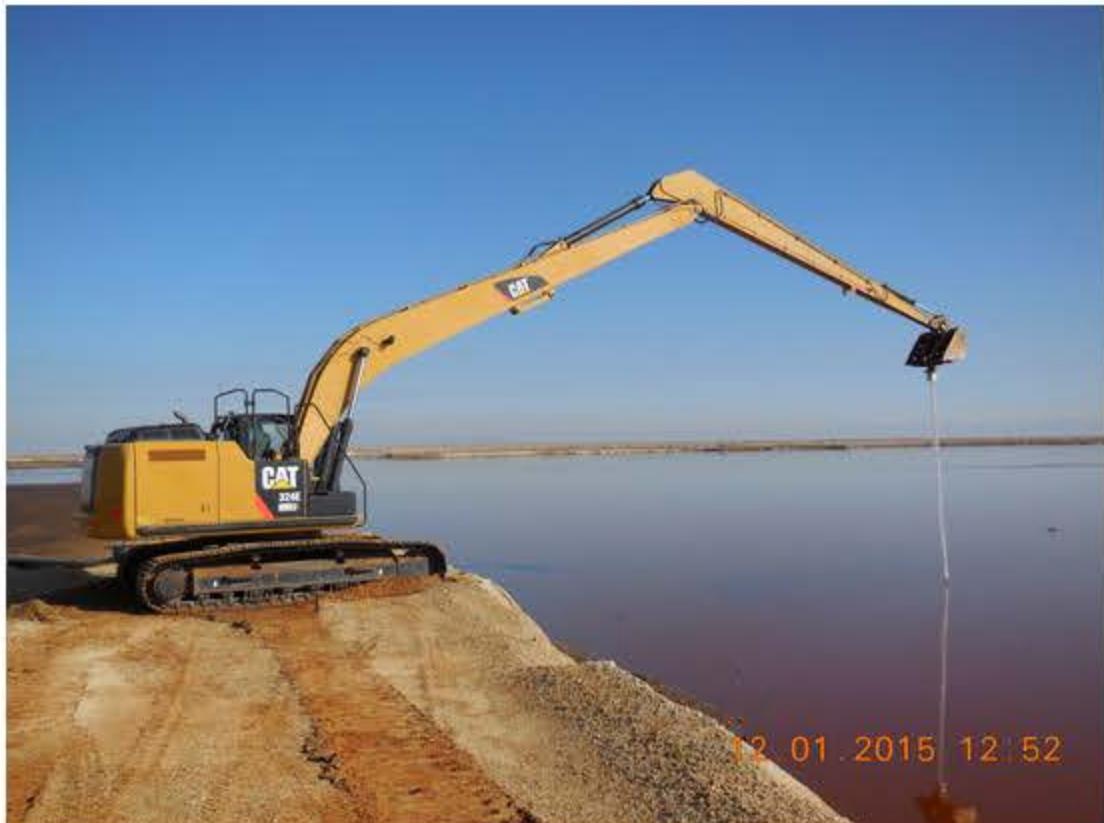
Photo 17 | PRI Area 1/5 | 12/01/15
Advancing 5-14 core from the gypsum pile using a 4-inch diameter Lexan tube

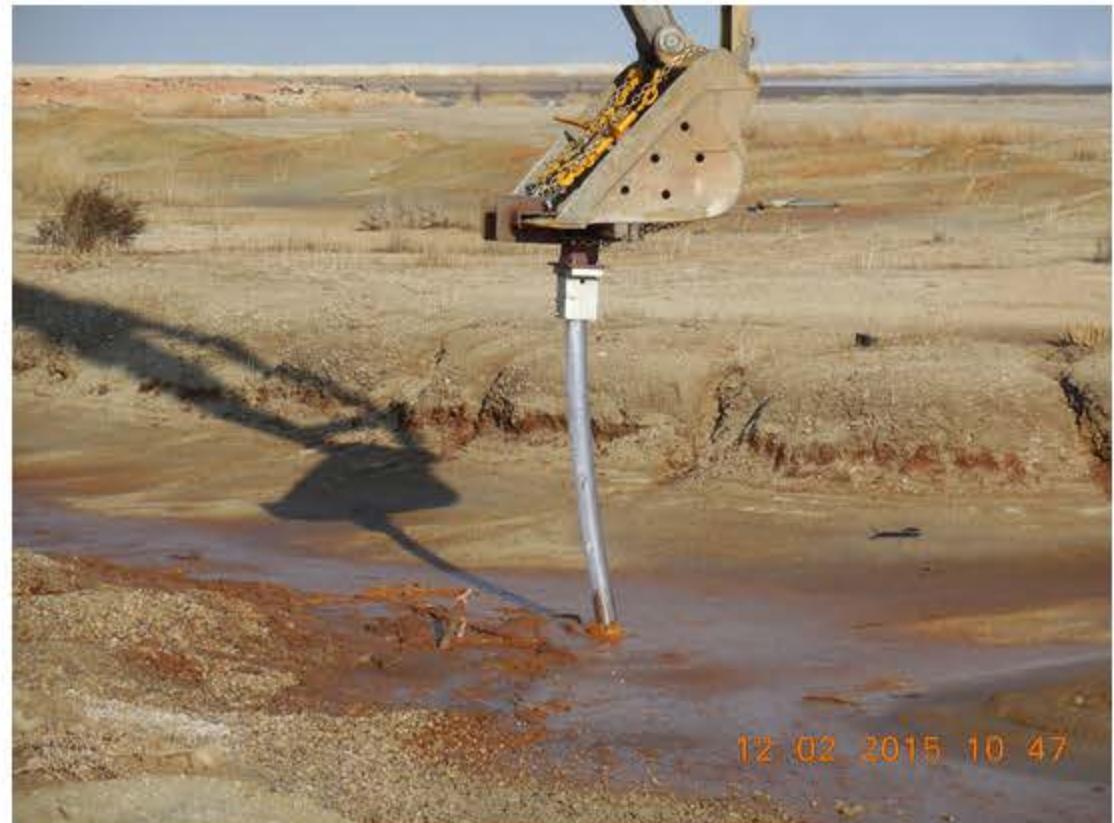
Photo 18 | PRI Area 1/5 | 12/02/15
Advancing 5-16 core in the center of the former wastewater diversion ditch using a 4-inch diameter Lexan tube

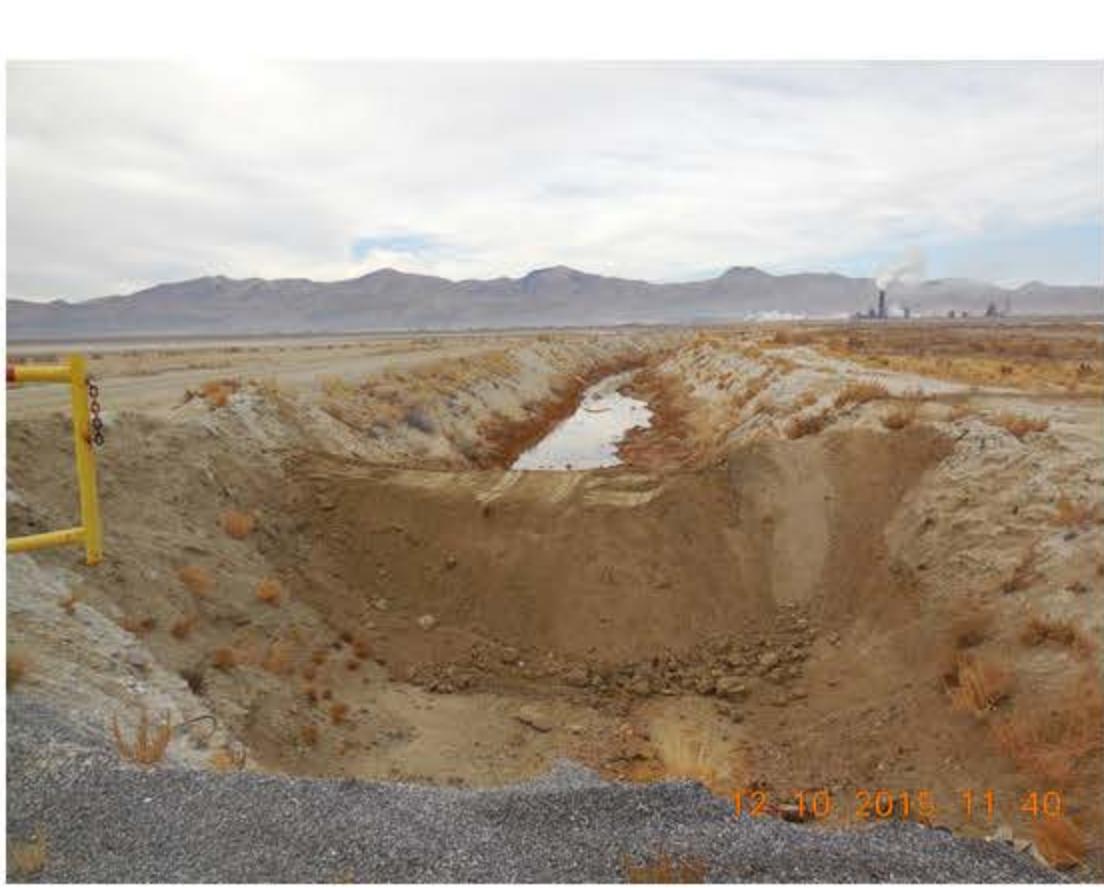
Photo 19 | Skull Creek Diversion Ditch | 12/10/15
New earthen dam constructed in the Skull Creek Diversion Ditch at the southeast corner of PRI Area 5
