**Technical Memorandum
for Oversight of the Phase 1A-B Remedial Investigation
in PRI Areas 1 and 3 through 7 and Background**

**US Magnesium NPL Site
EPA Site ID. NO. UTN000802704
Tooele County, Utah**

8 January 2016

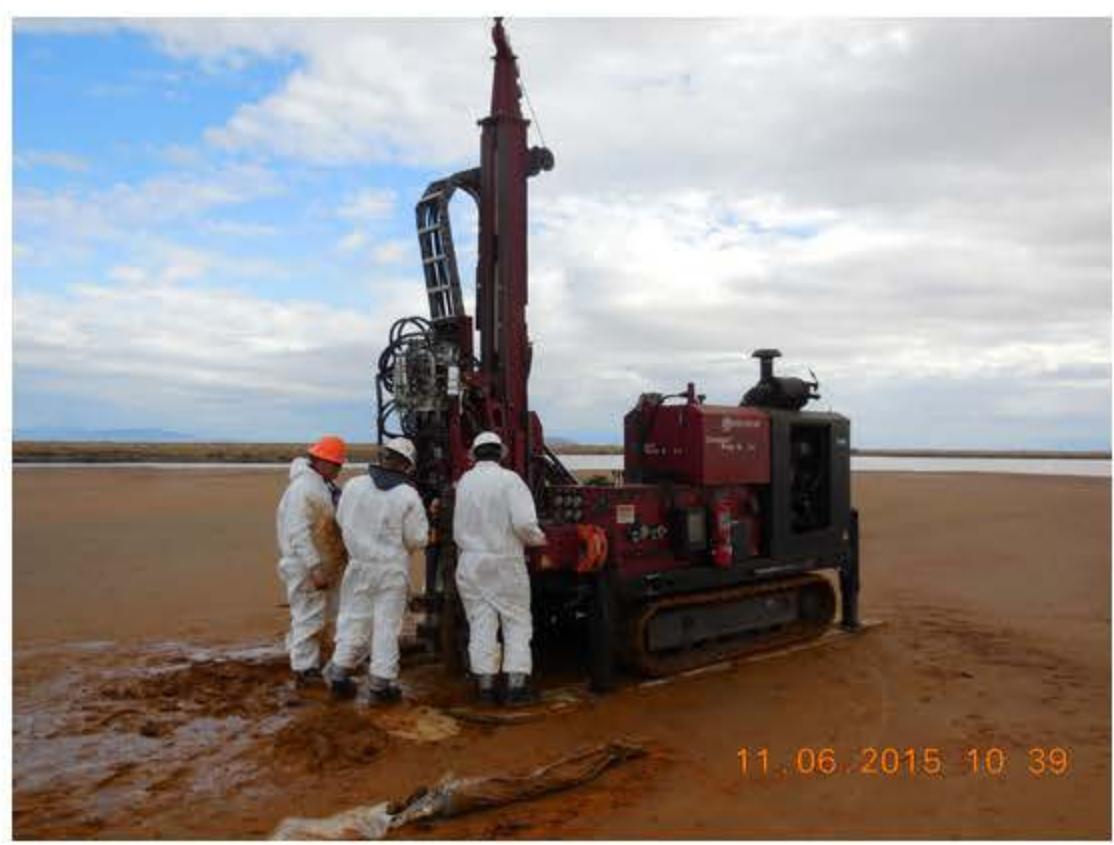
Photo 20 | PRI Area 4/6 | 11/06/15
Advancing 6-16 boring on the east side on the gypsum pile using a sonic drill rig with a 6-inch diameter core barrel

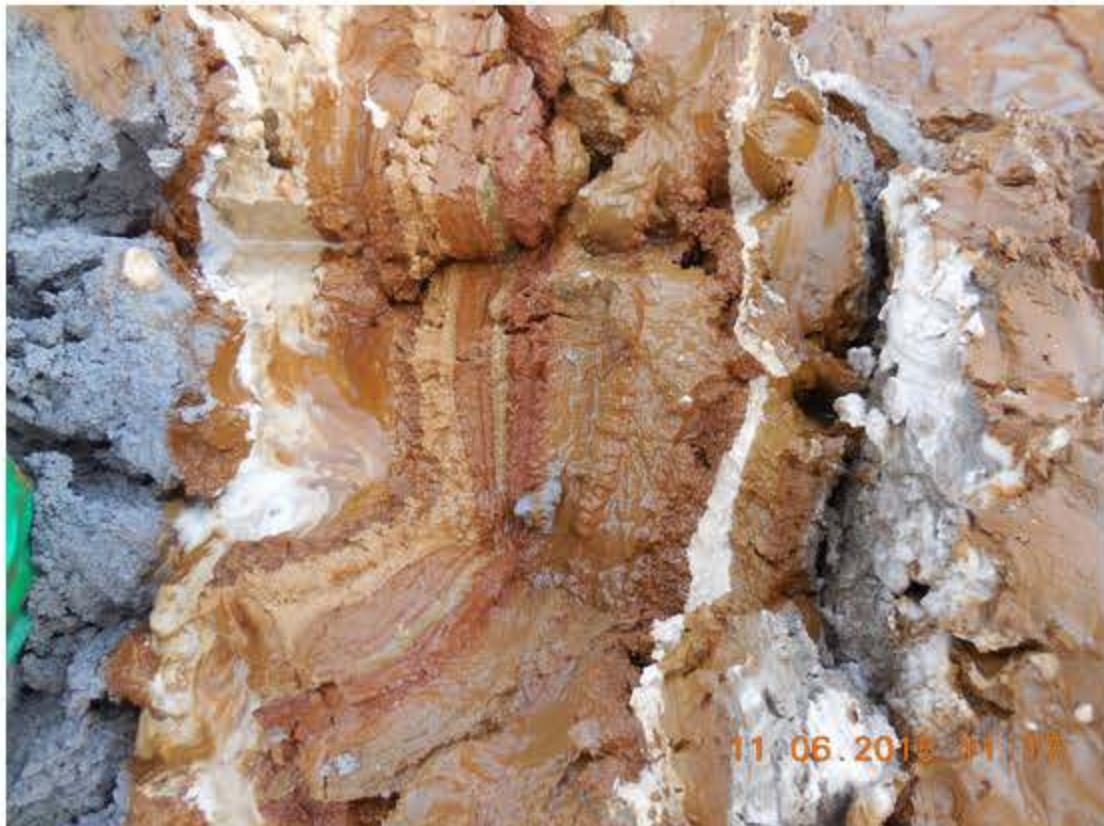
The grid and biased sample locations appear to represent each of the different areas within PRI Area 6. The gypsum waste at the 6-16 boring location was approximately 4.5 feet thick. The waste material is generally a reddish brown silt-like material though some white waste material was also observed (Photo 21, Appendix C). The wastewater from the Northwest Ponded Waste Lagoon continues to seep north through the berm road that separates PRI Area 6 from PRI Area 8.

Photo 21 | PRI Area 4/6 | 11/06/15
White waste material and depositional layering in the 6-16 core just above the native interface

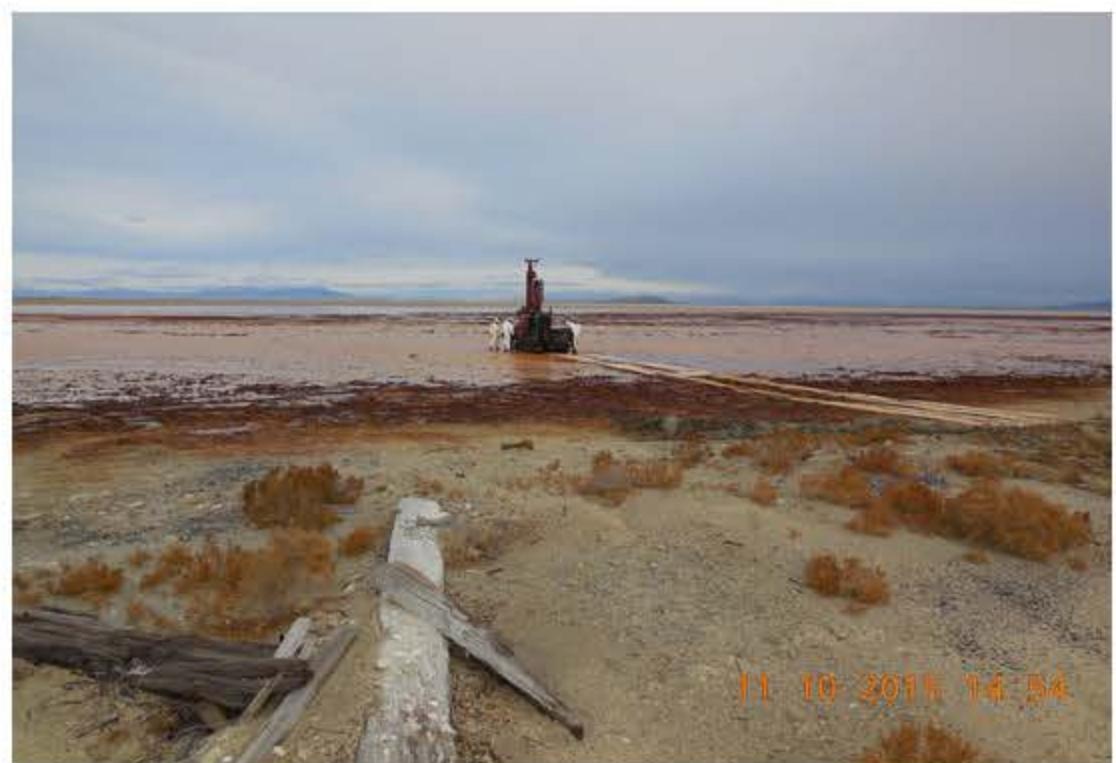
Photo 22 | PRI Area 7 | 11/10/15
Advancing 7-04SB boring at the end of a plywood ramp using a sonic drill rig with a 6-inch diameter core barrel

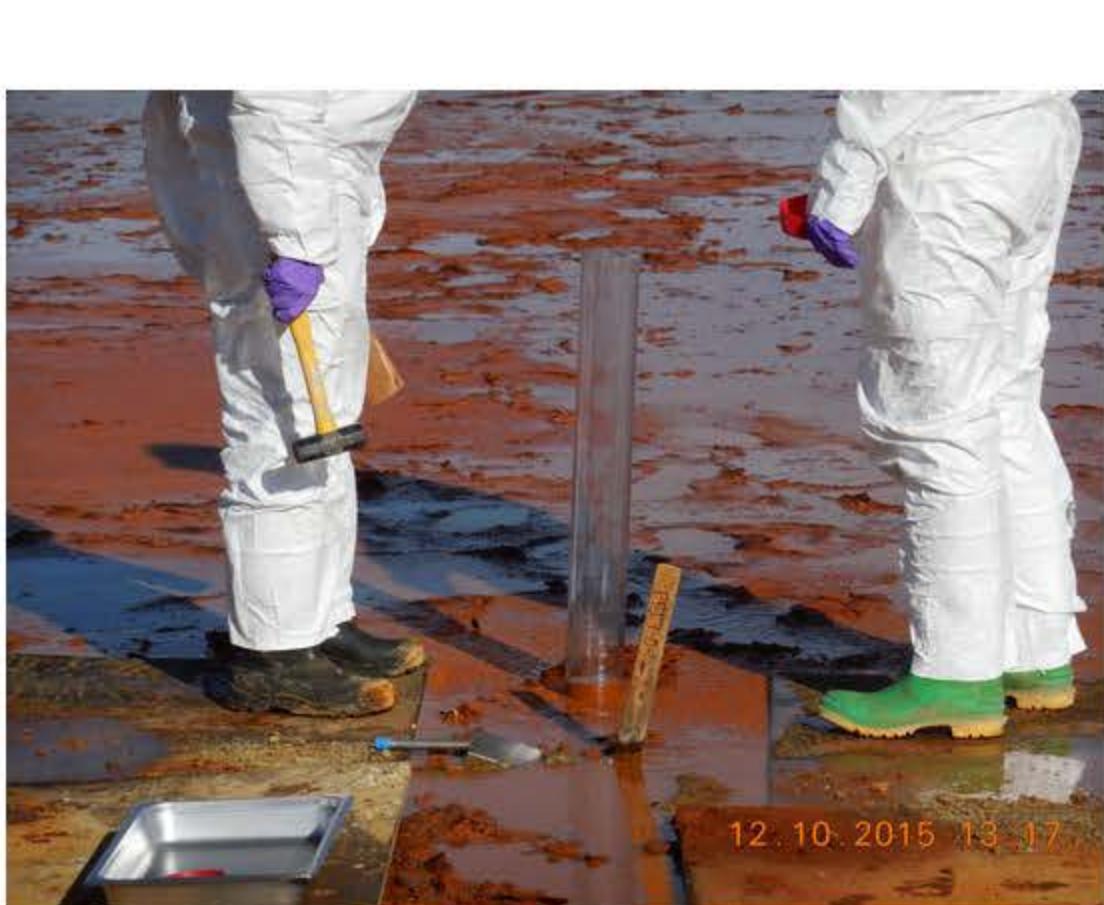
The subsurface solids samples obtained from location 7-04 using the sonic drilling method were collected on 10 November 2015 and the 7-04 samples obtained using the Lexan™ core method were collected on 10 December 2015. The Phase 1A-B RI SAP location for subsurface solids sampling at 7-04 was modified due to drill rig access limitations caused by the soft saturated sediment. The subsurface solids sample location was moved approximately 150 feet west-southwest of the SAP location to the nearest location the drill rig could access while meeting the objective for the samples. Since the 7-04 sample location was a collocated surface and subsurface sample location and the surface sample had already been collected, ERM referred to the subsurface sample location as 7-04SB. ERM submitted Field Modification No. 8 for the change in sample location and identification, which was approved verbally by EPA on 10 November 2015 and signed on 12 November 2015.

Photo 23 | PRI Area 7 | 12/10/15
Advancing 7-04SB core by hand using a 4-inch diameter Lexan tube

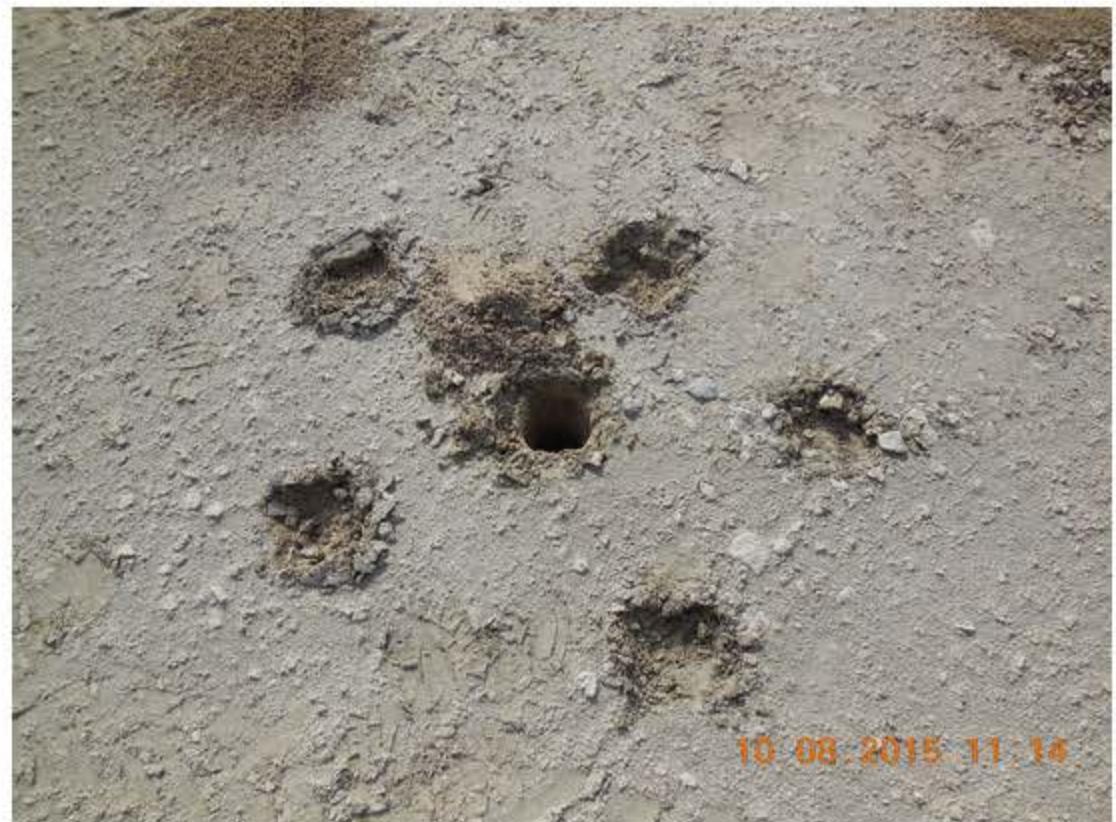
Photo 24 | Lakebed SE at Badger Island | 10/08/15
Example of collocated surface and subsurface solids sample collection in a background area
