Final Removal Action Close-Out Report Smelertown Superfund Site Operable Unit No. 1 Salida, Colorado

**FINAL REMOVAL ACTION CLOSE-OUT REPORT
SMELTERTOWN SUPERFUND SITE – OPERABLE UNIT NO. 1
SALIDA, COLORADO**

- Sheet 1 - Title Sheet;
- Sheet 2 - As-Built Site Conditions;
- Sheet 3 - As-Built Soil Removal Areas and Revegetation Documentation;
- Sheet 4 - As-Built Profile, Cross-Sections and Details; and
- Sheet 5 - As-Built Consolidation Area Plan View, Soil Cover Thickness and Test Pit Documentation.

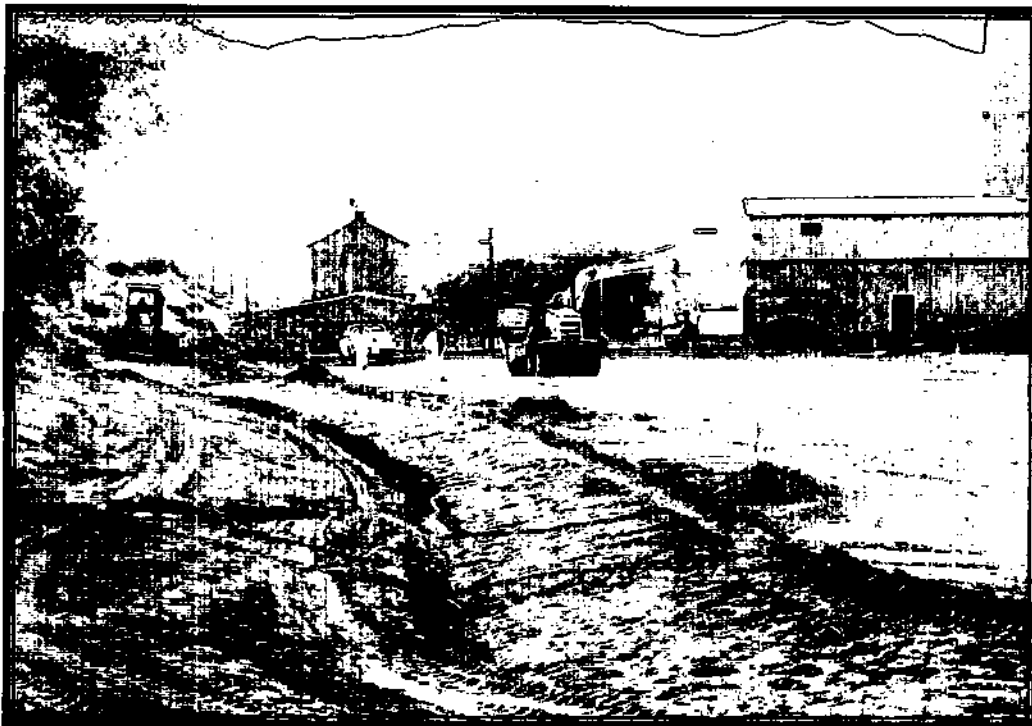
Photo 10: Consolidation Area— Looking East (July 1, 2003—During Surface Water Channel Construction)

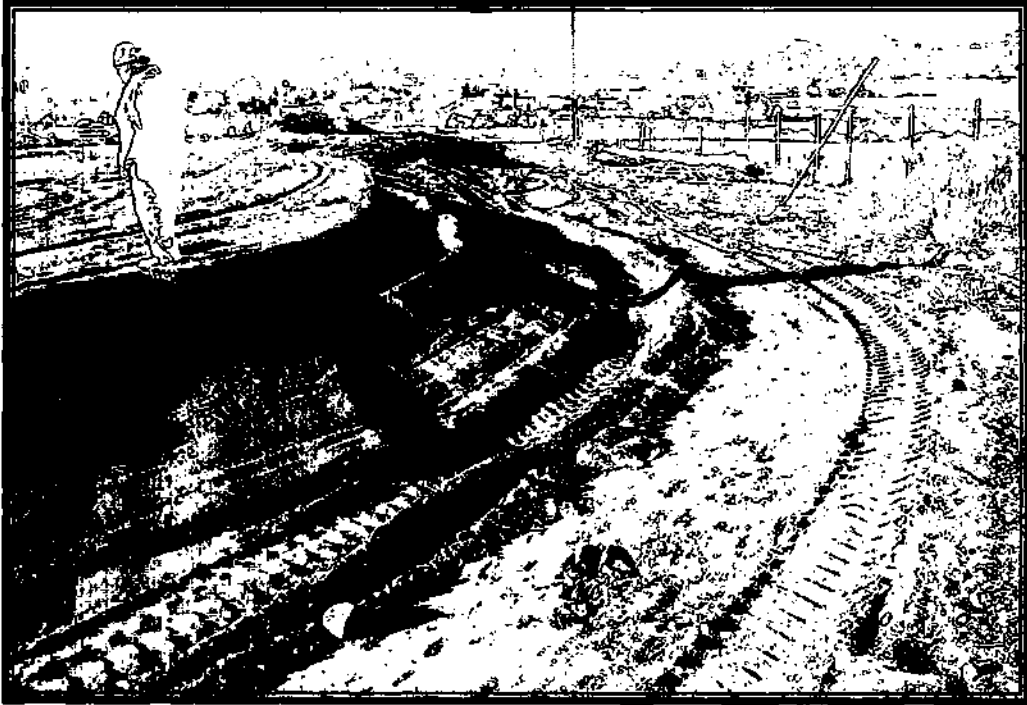
Photo 17: Surface Water Channel—Looking South (July 2, 2003—During Construction)

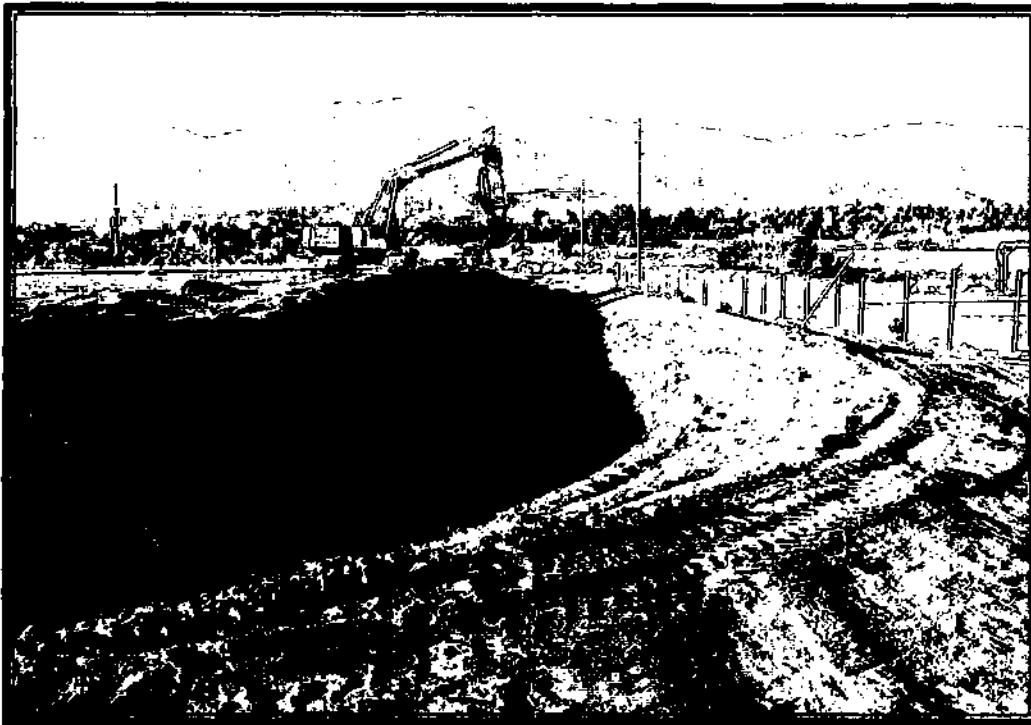
Photo 18: Surface Water Channel—Looking South (August 7, 2003—After Construction)

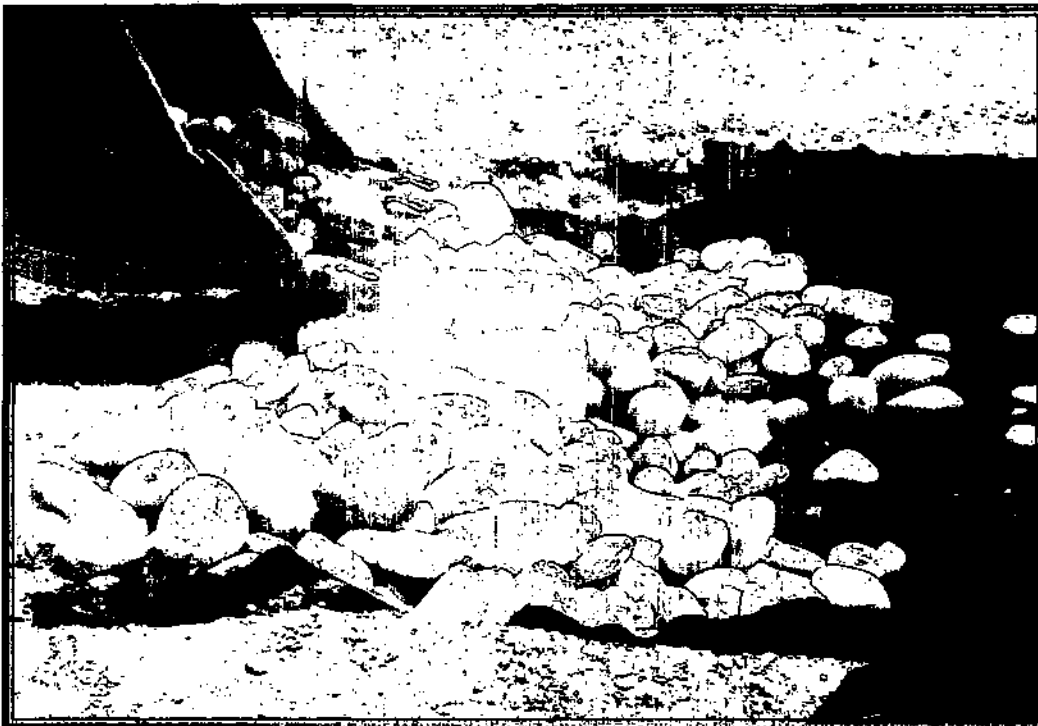
Photo 20: Discharge Apron—Looking East (August 7, 2003—During Placement of 6-Inch D50 Rock Riprap Material)

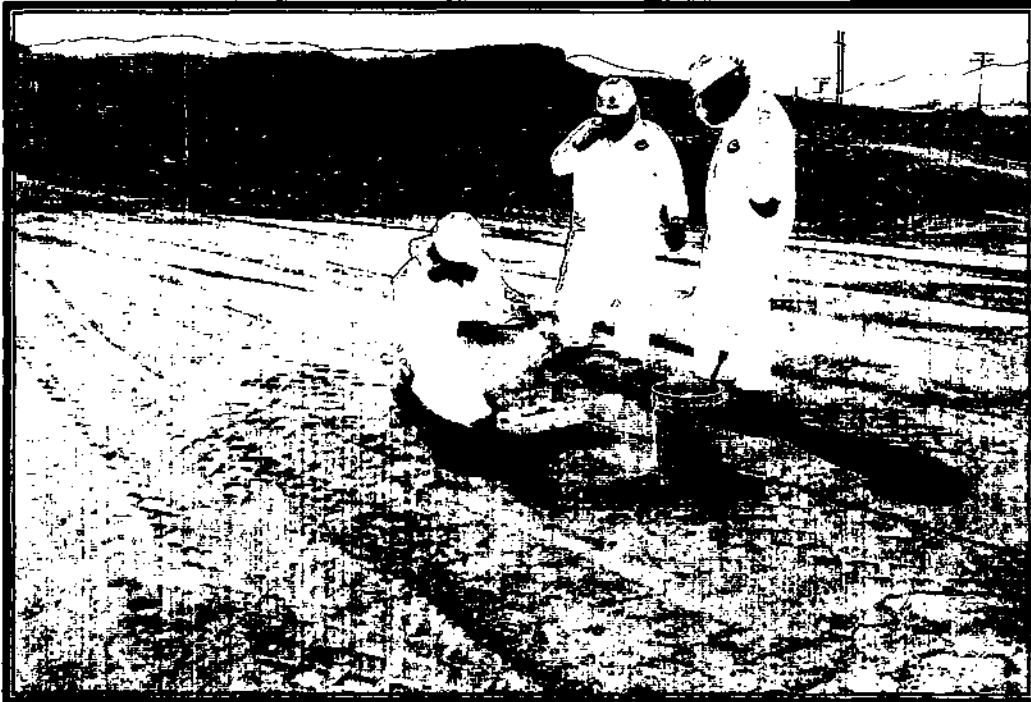
Photo 21: Consolidation Area —Looking East (June 19, 2003—During Field Compaction Testing of Initial Lift of Impacted Material)

Field compaction testing was performed by Mountain Engineering and Testing, Inc. of Salida, Colorado using a Troxler nuclear density gauge. Prior to field compaction testing, four Standard Proctor tests were performed to determine the maximum dry density and optimum moisture content of the four visually-distinct types of impacted material to be placed in the Consolidation Area. The measured field dry densities and moisture contents were then compared to the proctor results for the applicable soil type in order to determine the percent compaction.
