**FOURTH FIVE-YEAR REVIEW REPORT FOR
McCOLL SUPERFUND SITE
Orange County, California**

PREPARED BY
USACE Seattle District
FOR
U.S. Environmental Protection Agency
Region IX

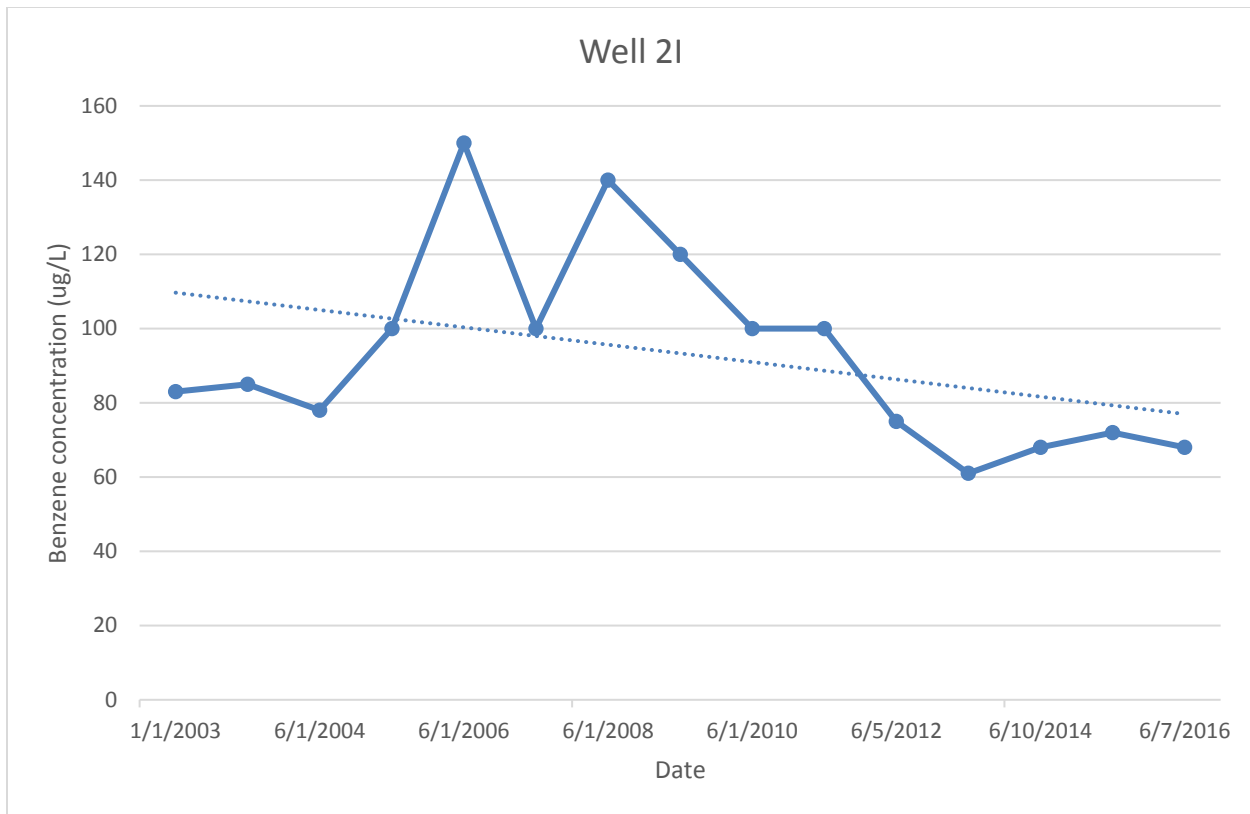
Figure 4-1. P-21 Benzene Data 2003 thru 2016

Over the past five years, the benzene plume has been stable and overall concentrations are decreasing. Figure 4-1 presents the benzene data for well P-2I gradually decreasing with time.

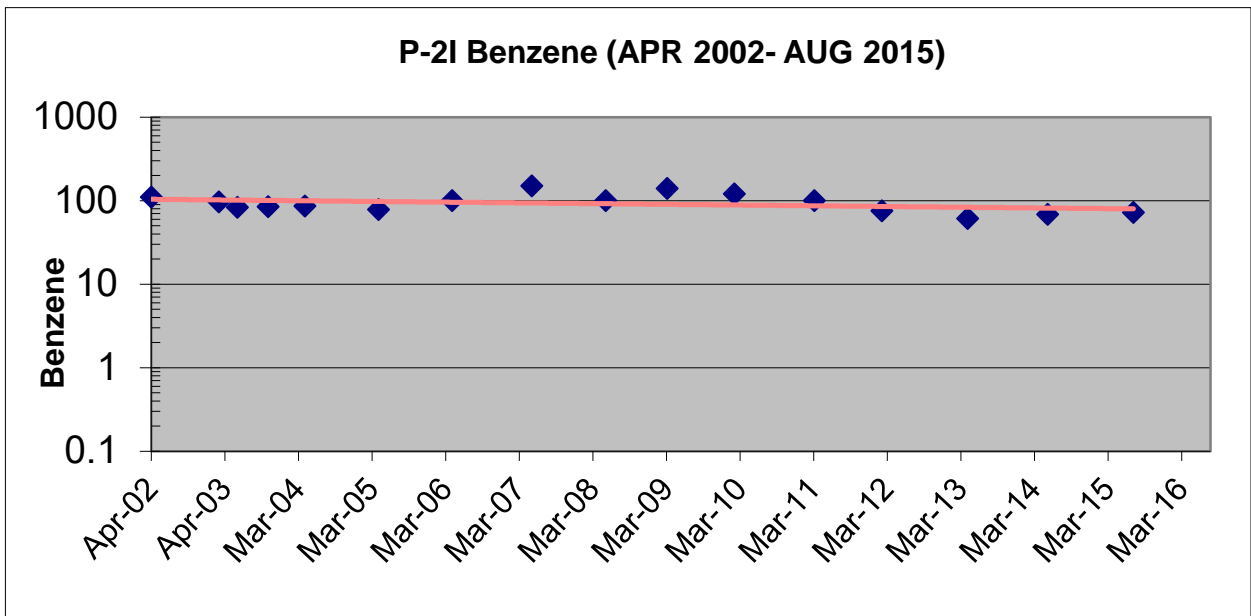
The following graph depicts Benzene time-series data evaluated for this Five-Year Review.

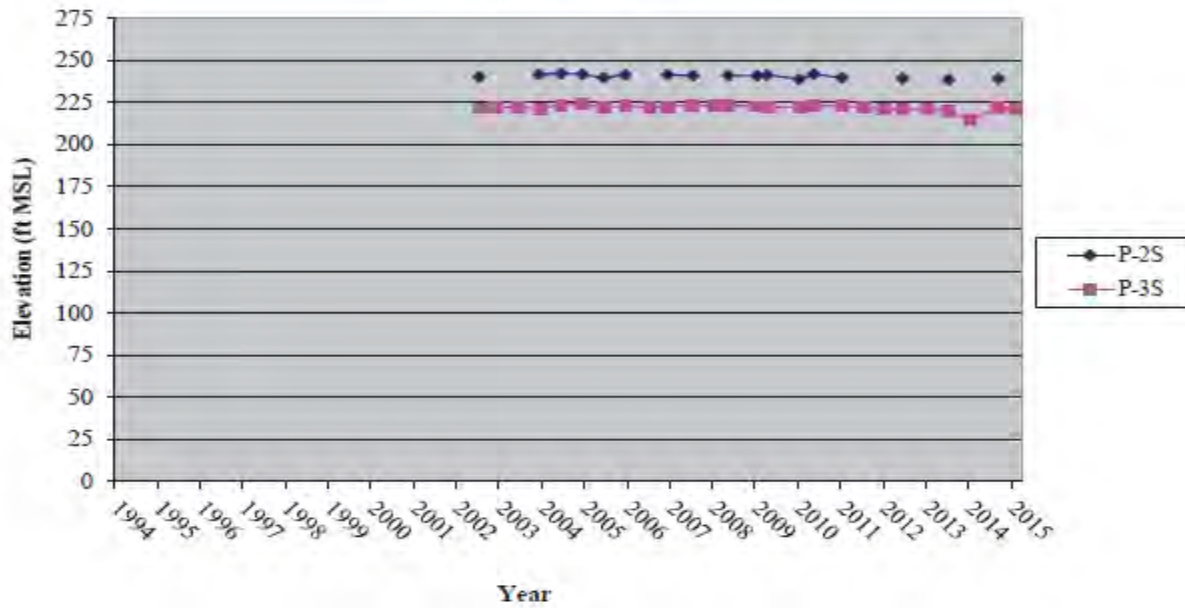
A-Zone Groundwater Elevations

Water table elevations for each water bearing zone from 1994 through 2015.

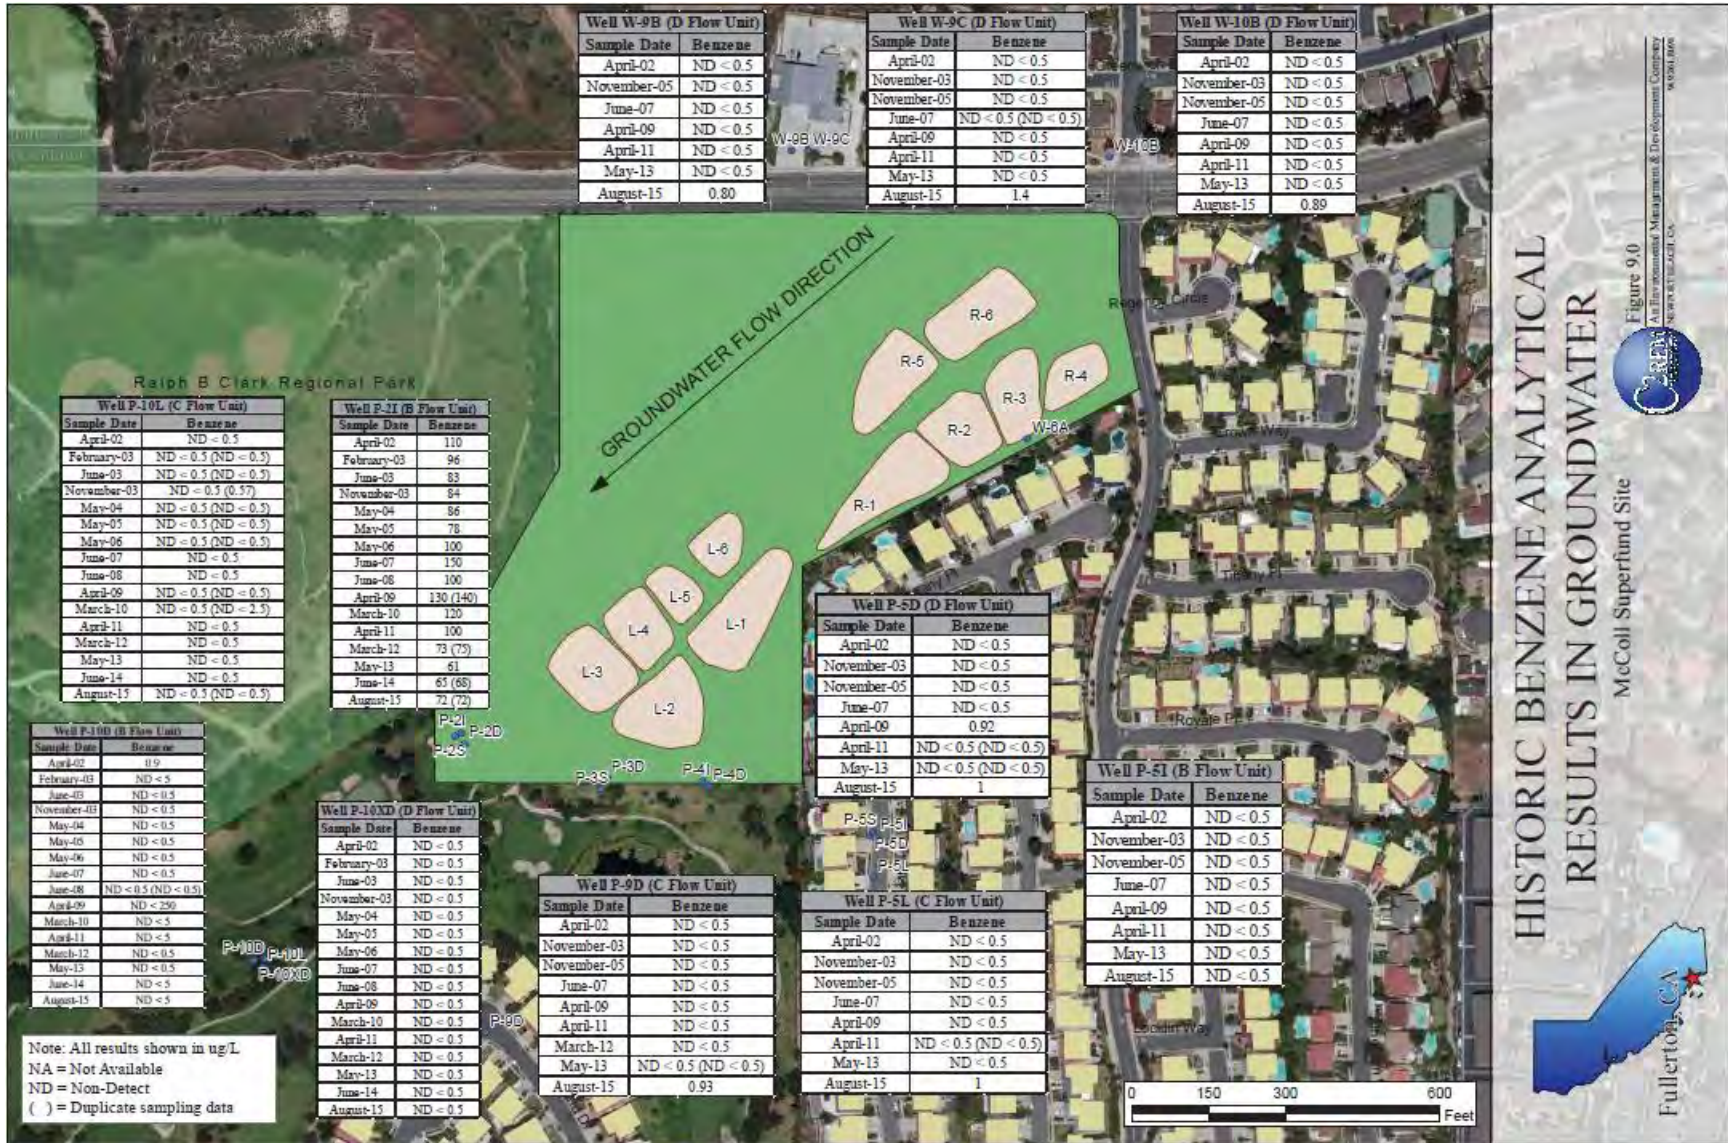
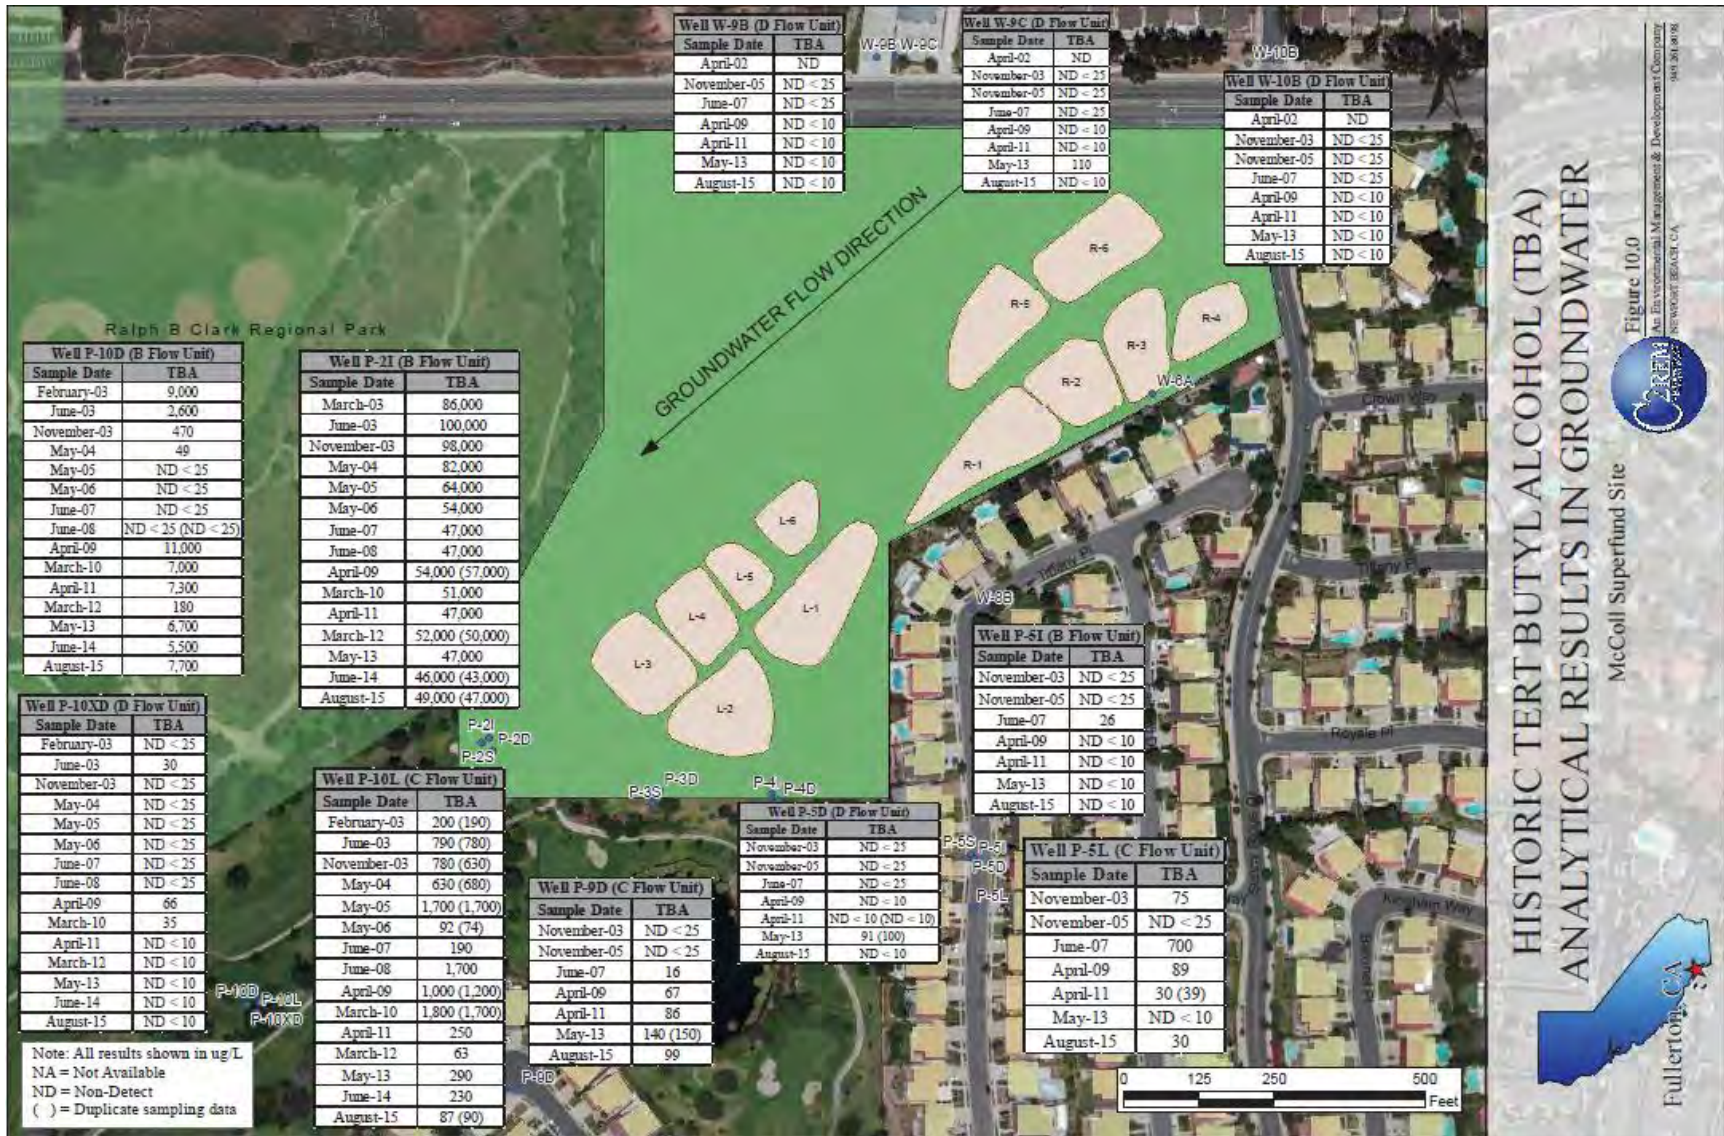
Figure 10.0
 Air Environmental Management & Development Company
 NEWPORT BEACH, CA 92659-0808

**HISTORIC TERT BUTYL ALCOHOL (TBA)
 ANALYTICAL RESULTS IN GROUNDWATER**

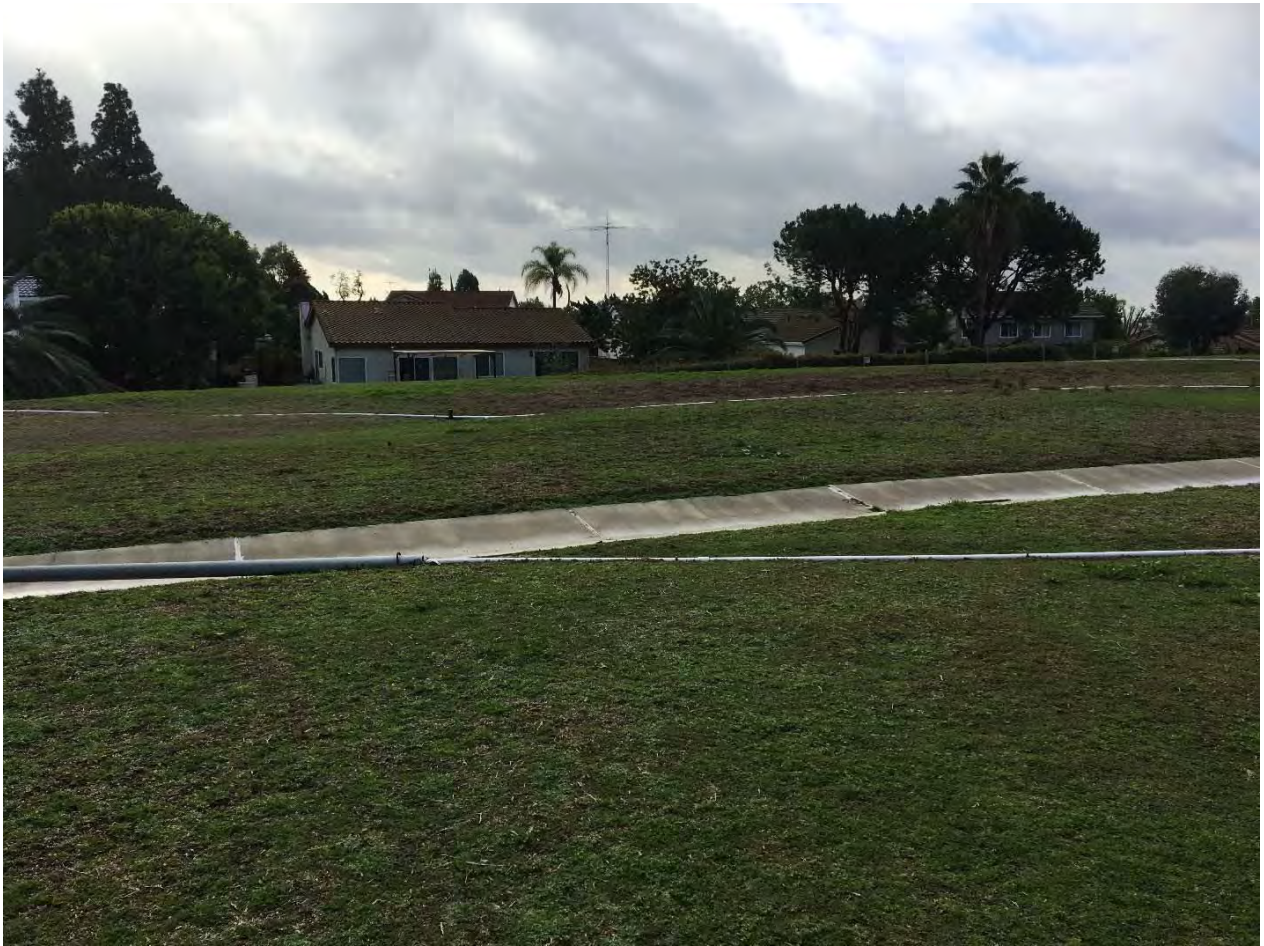
Photograph 1. Surface drainage system with landscaping sprinkler system for the surface of the Ramparts sumps and cap. Appeared to be in good condition.

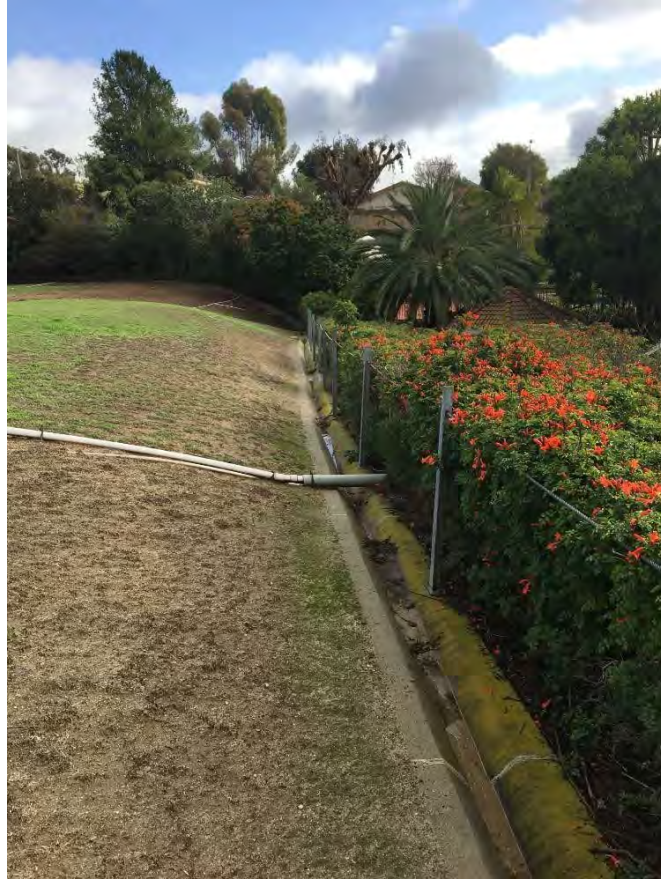
Photograph 2. Drainage ditch surrounding the Ramparts sumps.

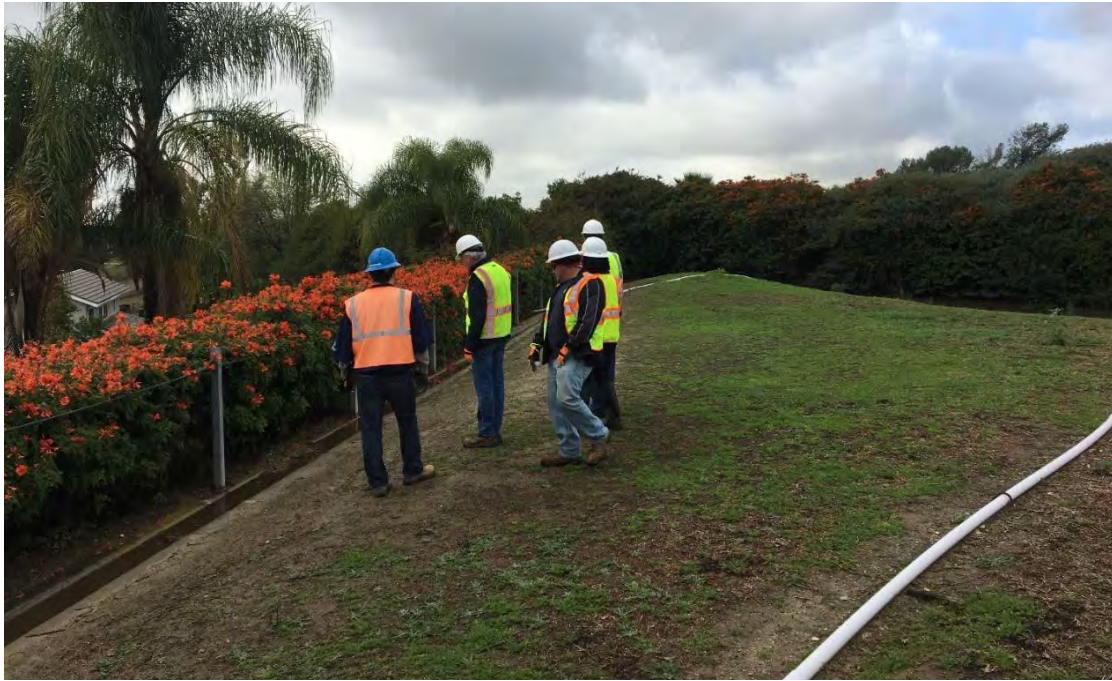
USACE observed slight erosion of the uppermost cap on the southern portion of R-1 in the Ramparts Sumps Area and sediment in the drainage surrounding the cap area. The C2 REM representative informed the Site visit participants of the planned drainage clearing. The Site experienced heavy rainfall the night before, causing the observed sediment build up in the V ditches surrounding the Ramparts sumps.

Photograph 3. C2 REM and EPA officials observing area of stressed vegetation and filling of surface water drainage ditch after heavy rainstorm.

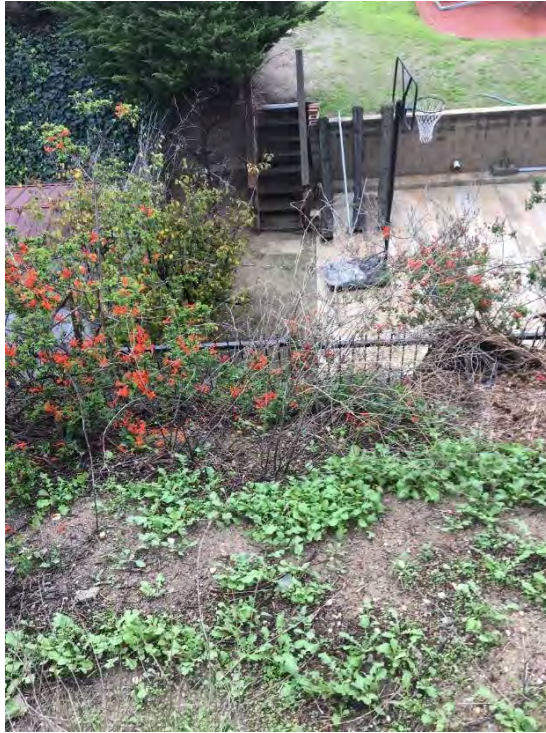
Photograph 4. Standing on the edge of the Ramparts cap looking downward to adjacent residential property. C2 REM indicates that the retaining walls are functioning as designed and no issues have been encountered since the 2012 five-year review.

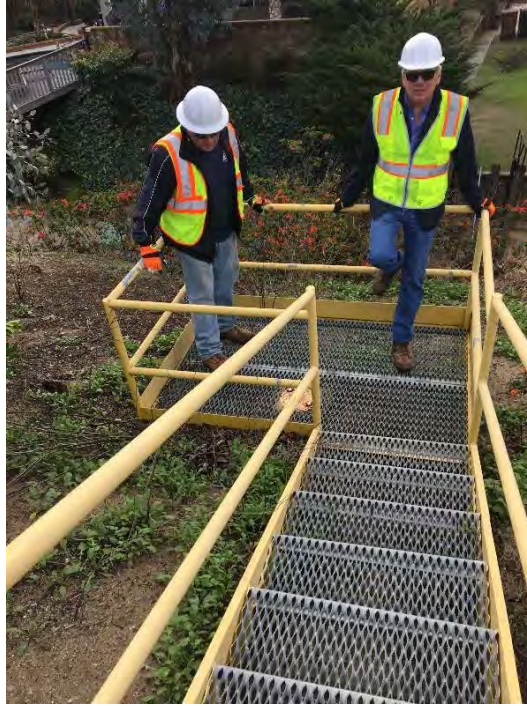
Photograph 5. Sampling platform installed for a well on the steep slope of the Ramparts Sump Area. Platform was installed to protect worker safety when sampling.

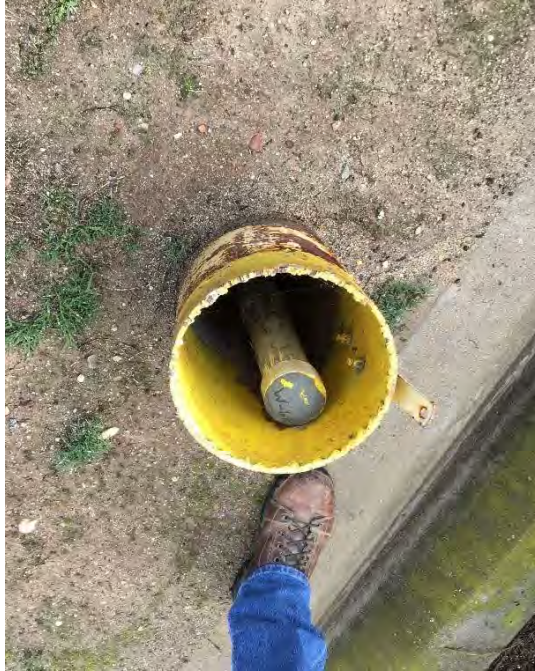
Photograph 6. Well W-6D observed in the Ramparts Sumps Area, typical of the above ground monument installed on the Site.

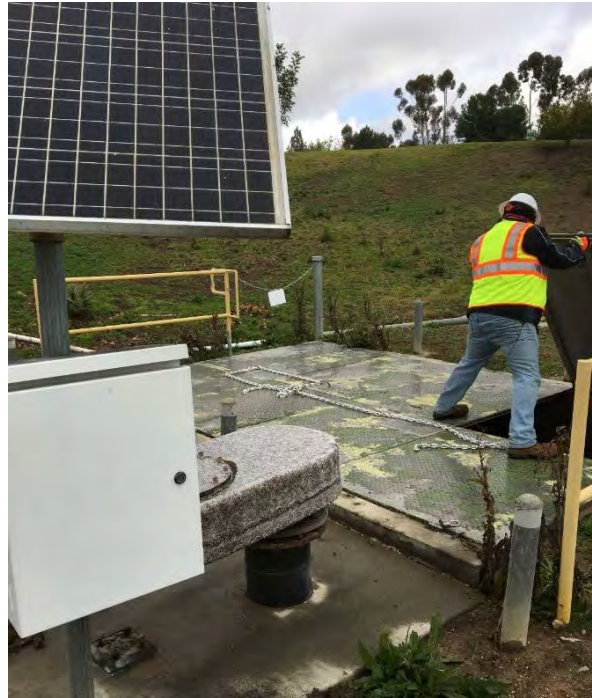
Photograph 7. Access hatch for the manifold for the Gas Collection Treatment System (GCTS) installed to manage vapor extending from the Los Coyotes and Ramparts Sumps.

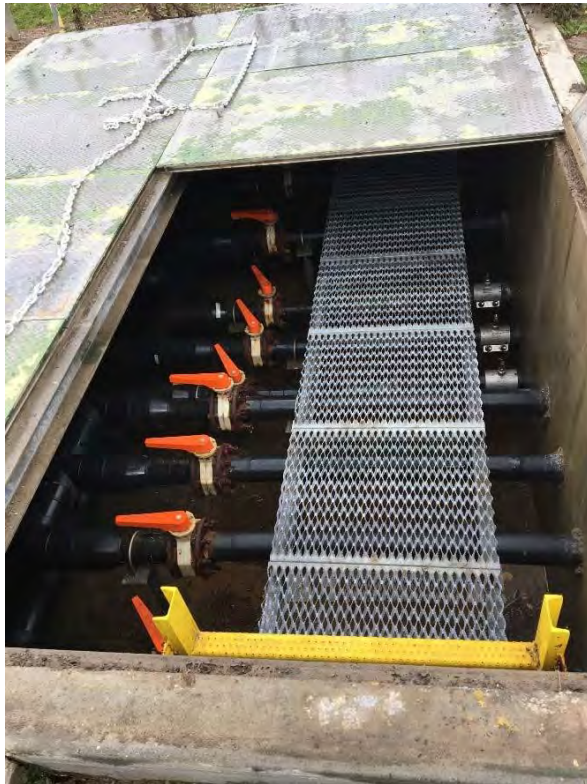
Photograph 8. Piping and valves for the GCTS for the Los Coyotes and Ramparts Sump areas. Catwalk installed for worker safety.

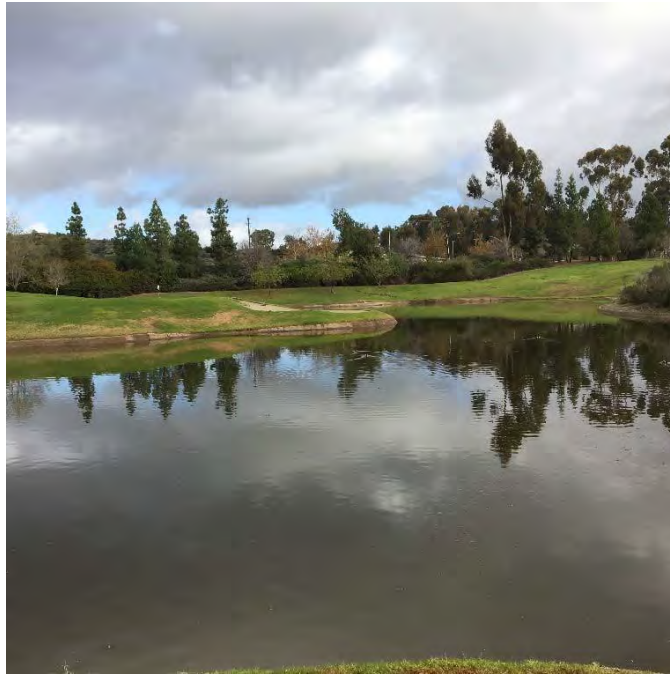
In April 2016, the detention pond located at the north end of the golf course contained approximately 2.3 feet of sediment, which was approaching the 30% storage capacity². The sediment was sampled prior to removal, and all laboratory analytical results demonstrated that contaminants of concern were below regulatory levels. C2 REM drained the detention pond and removed sediment during 2016. C2 REM placed the sediment to the southeast of Los Coyotes Sumps L-1 and L-2 to aerate and reduce in moisture content.

Photograph 9. Retention pond located on the northern portion of the Property to the west of the Los Coyotes and Ramparts Sumps. Sediment was removed from retention pond and stockpile in the southeast corner of the site.

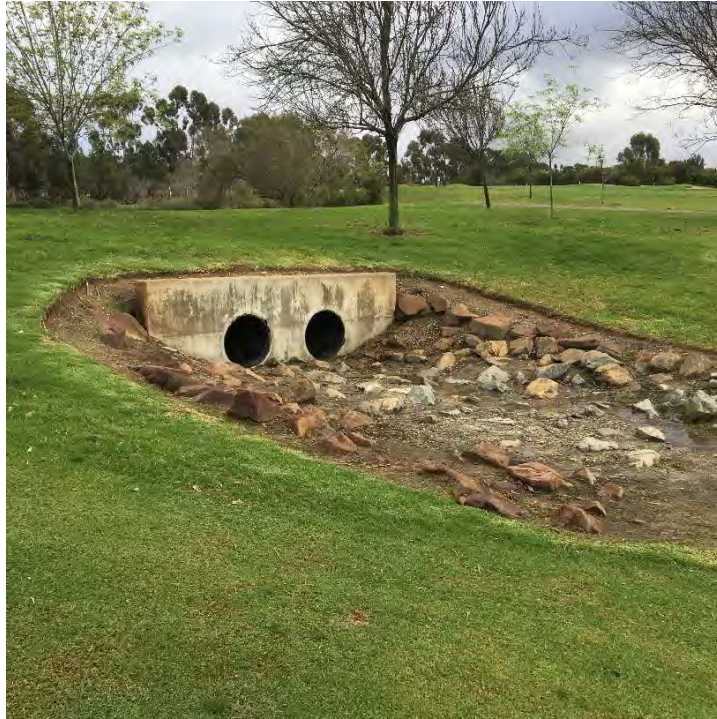
Photograph 10. Stormwater outlet from the retention pond. Outlet is armored with large rock and appears to be functioning as designed.

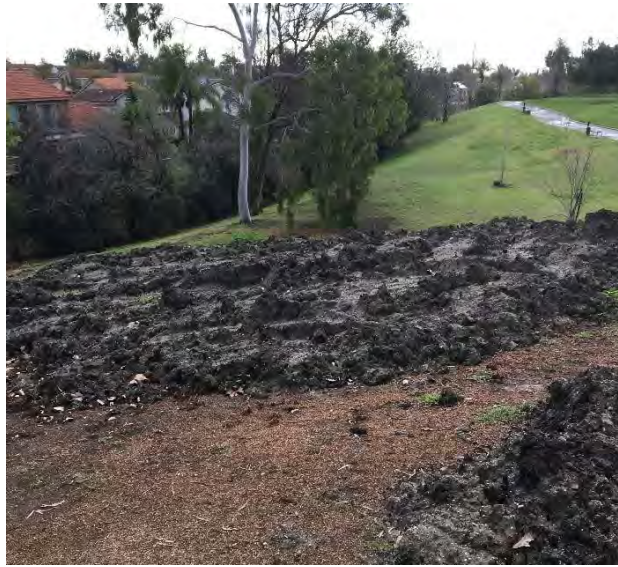
Photograph 11. Pond sediment aerating until it reaches an appropriate moisture content to place as landscaped fill on the property. The soil contains abundant golf balls and organic material. No odors were observed during the Site visit.

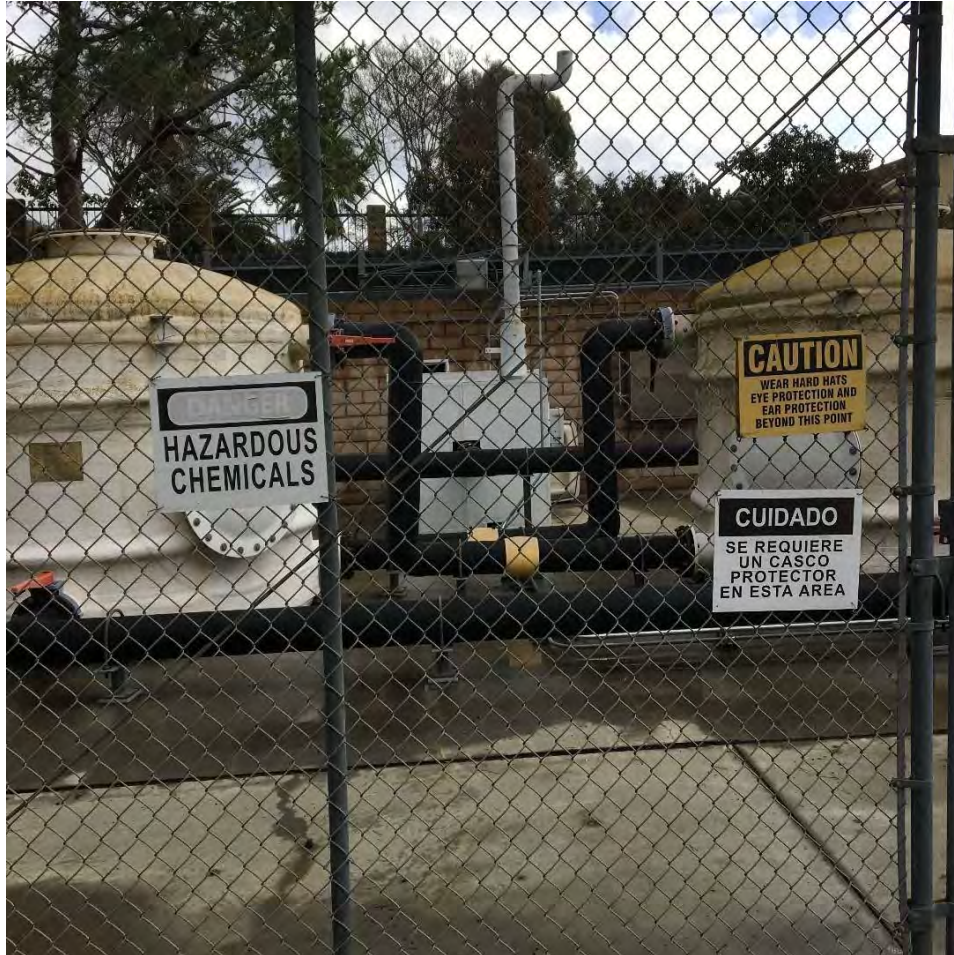
Photograph 12. Remediation enclosure with appropriate signage displayed on the fencing. Remediation enclosure is located in the northwest corner of the property near Rosencranz Avenue and Sunny Ridge Drive.
