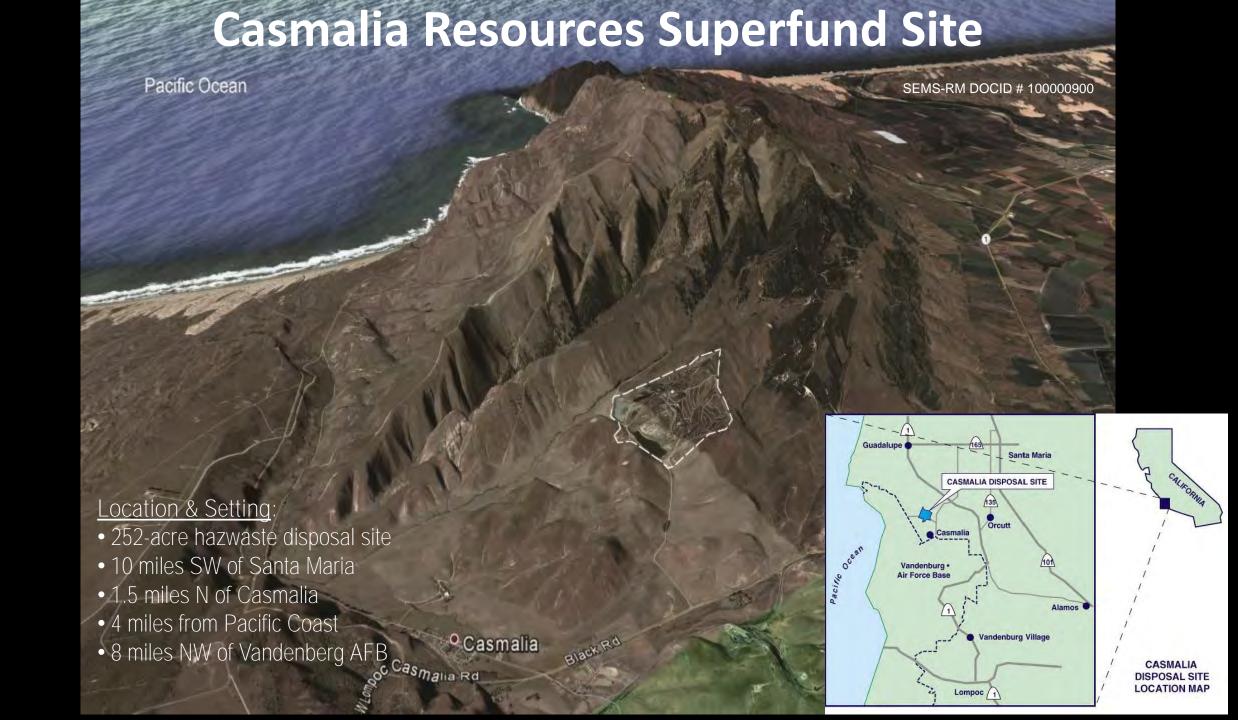
Aerial photo (1984) shows historic site layout. Multiple former waste management units (WMUs) included landfills, spreading areas, pits, ponds, and trenches used for hazardous waste disposal.
