FINAL FIVE-YEAR REVIEW FOR OPERABLE UNITS 1 THROUGH 5, MARINE CORPS BASE CAMP PENDLETON, CALIFORNIA

Document Control Number: SW-2014-0001

March 19, 2014

FIVE-YEAR REVIEW REPORT

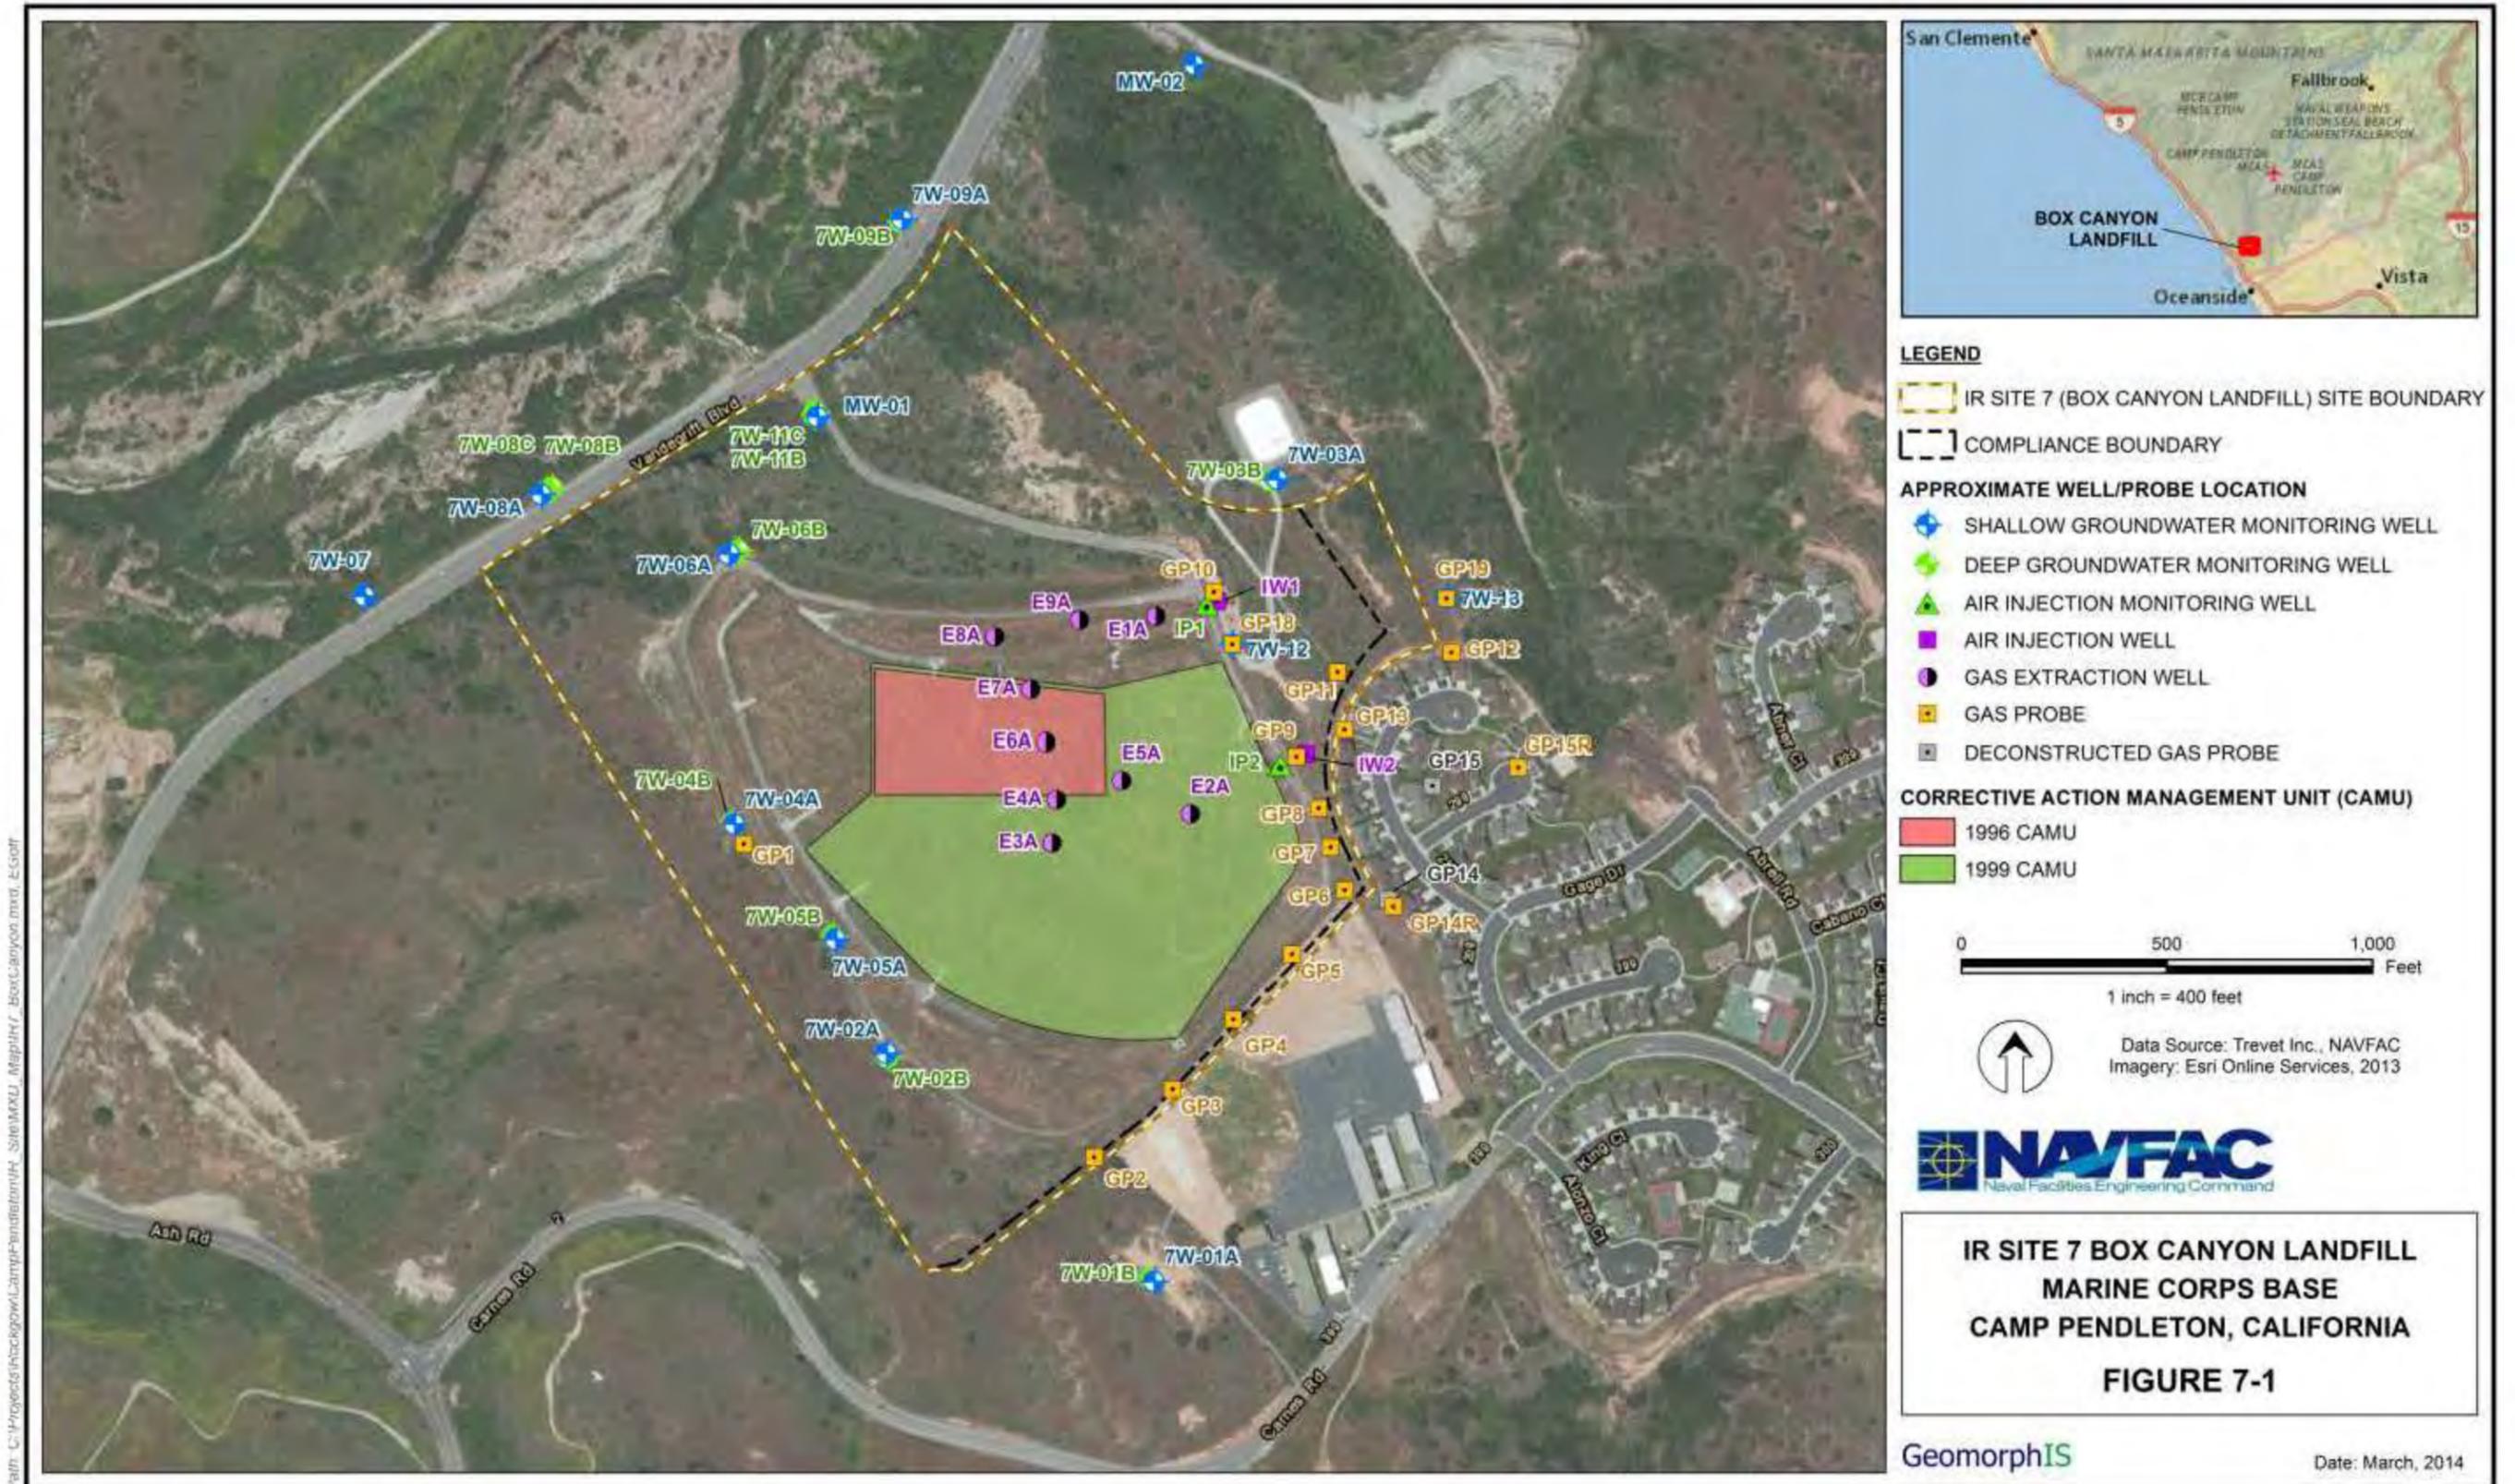
Figure 7-1: Box Canyon Landfill Layout

- Installation of an evapotranspiration (ET) cover consisting of a vegetated topsoil layer (minimum thickness of 12 inches), a minimally compacted middle soil layer (minimum thickness of 48 inches), and a compacted low-permeability bottom layer (minimum thickness of 12 inches).
- Installation of lined surface water drainage structures and erosion control measures.
- Construction of an access road.
- Implementation of a post-construction monitoring and maintenance plan.
- Documentation of the remedial action process, quality control confirmation test data, and final as-built conditions.

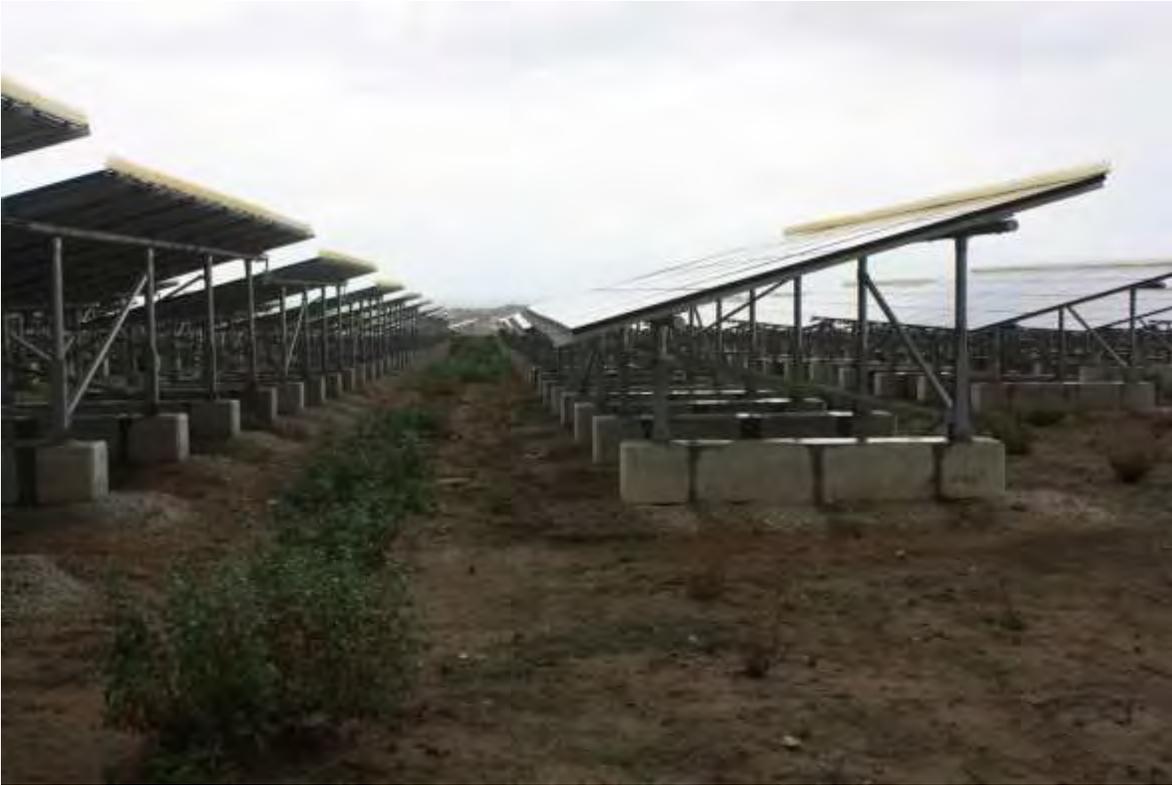
Site 7 (Box Canyon Landfill) PV Panels Phase I

- Vegetation in the Phase I area of the PV panels was replaced in the winter of 2012, and continues to mature. Phase II is currently undergoing re-vegetation. Both areas will need several years of biological monitoring and vegetation maintenance to ensure establishment of a successful ET cover.

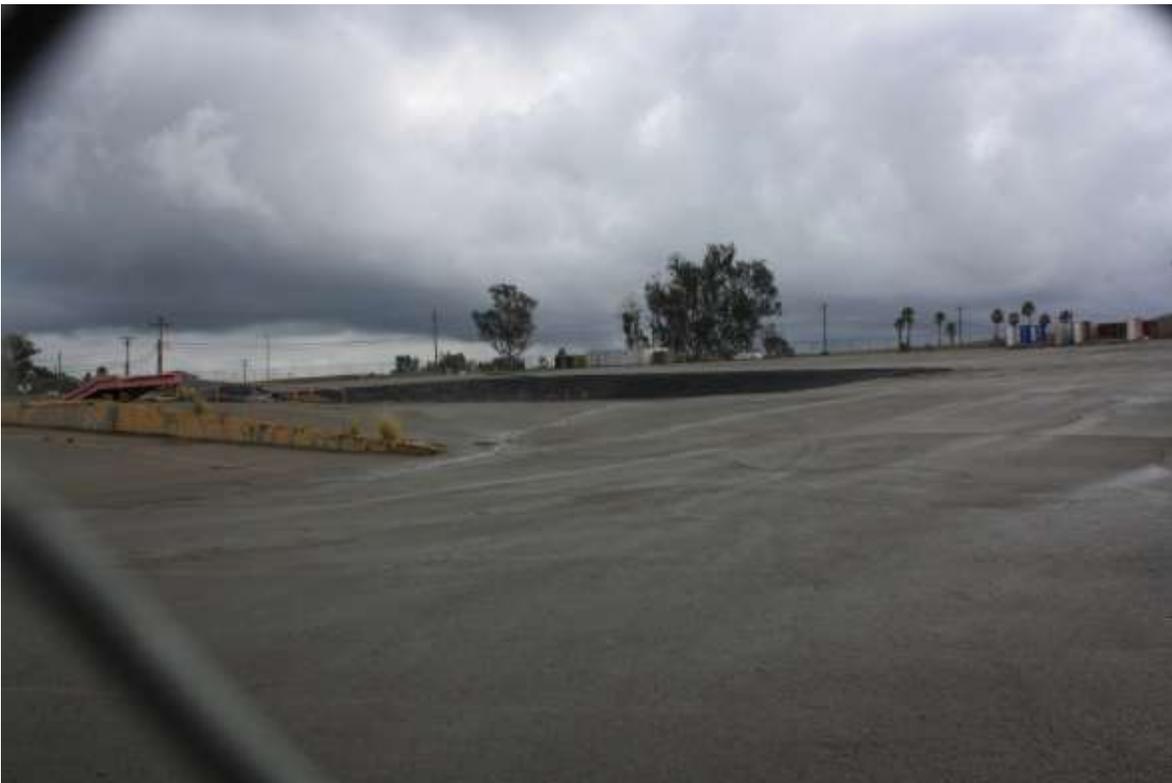
Site 1115 (13 Area FSSG lot)

Pilot studies are being conducted at 12 Area Site 13, 21, 22/23 Area groundwater and will begin soon at Site 1115. The first phase of a Removal Action (excavation) has been completed at Site 33 and a second phase is schedule to begin in early 2014. No concerns were noted.

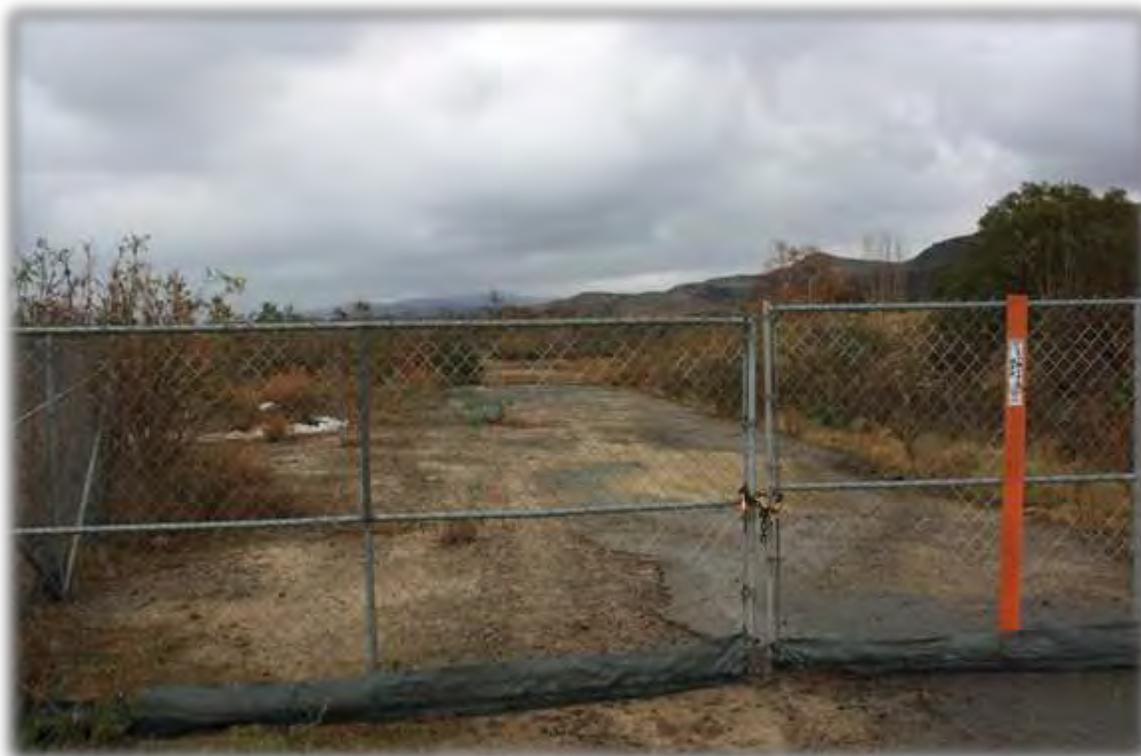
Site 62 (Asphalt Batch Plant)

Site 62 is not undergoing any active remediation. Photos in Appendix B show the current conditions of these sites. No concerns were noted.

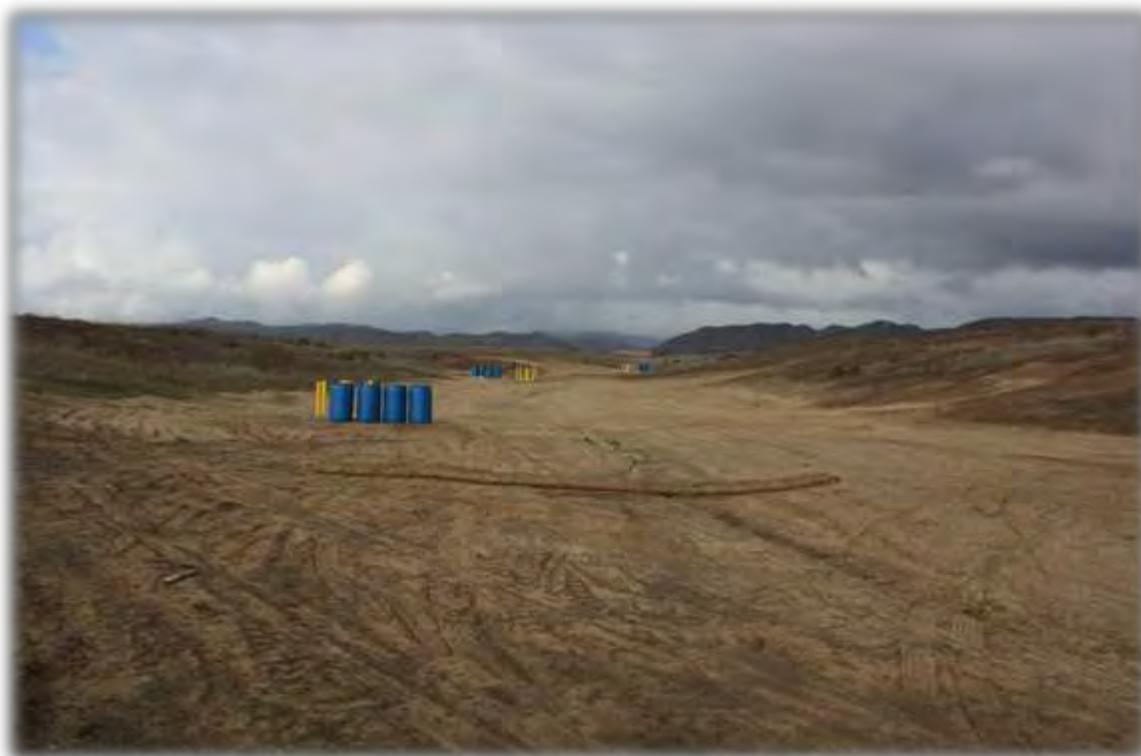
Site 1114 (41 Area Arroyo)

A Removal Action has been completed at Site 1114, the excavation has been backfilled, and bioremediation substrate was placed into the excavation before it was backfilled. Groundwater monitoring has been instituted at the site. The first phase of a Removal Action (excavation) has been completed at three of the nine subsites that comprise Site 1116; pilot studies are scheduled to begin at two of the three subsites in early 2014. Sites 1117 through 1122 were not undergoing any active remediation. No concerns were noted.
