# Montrose Superfund Site Los Angeles, California

## Final Electrical Resistance Heating (ERH) Pilot Test Report

**TRS**  
TRS Group, Inc.  
*Accelerating Value*

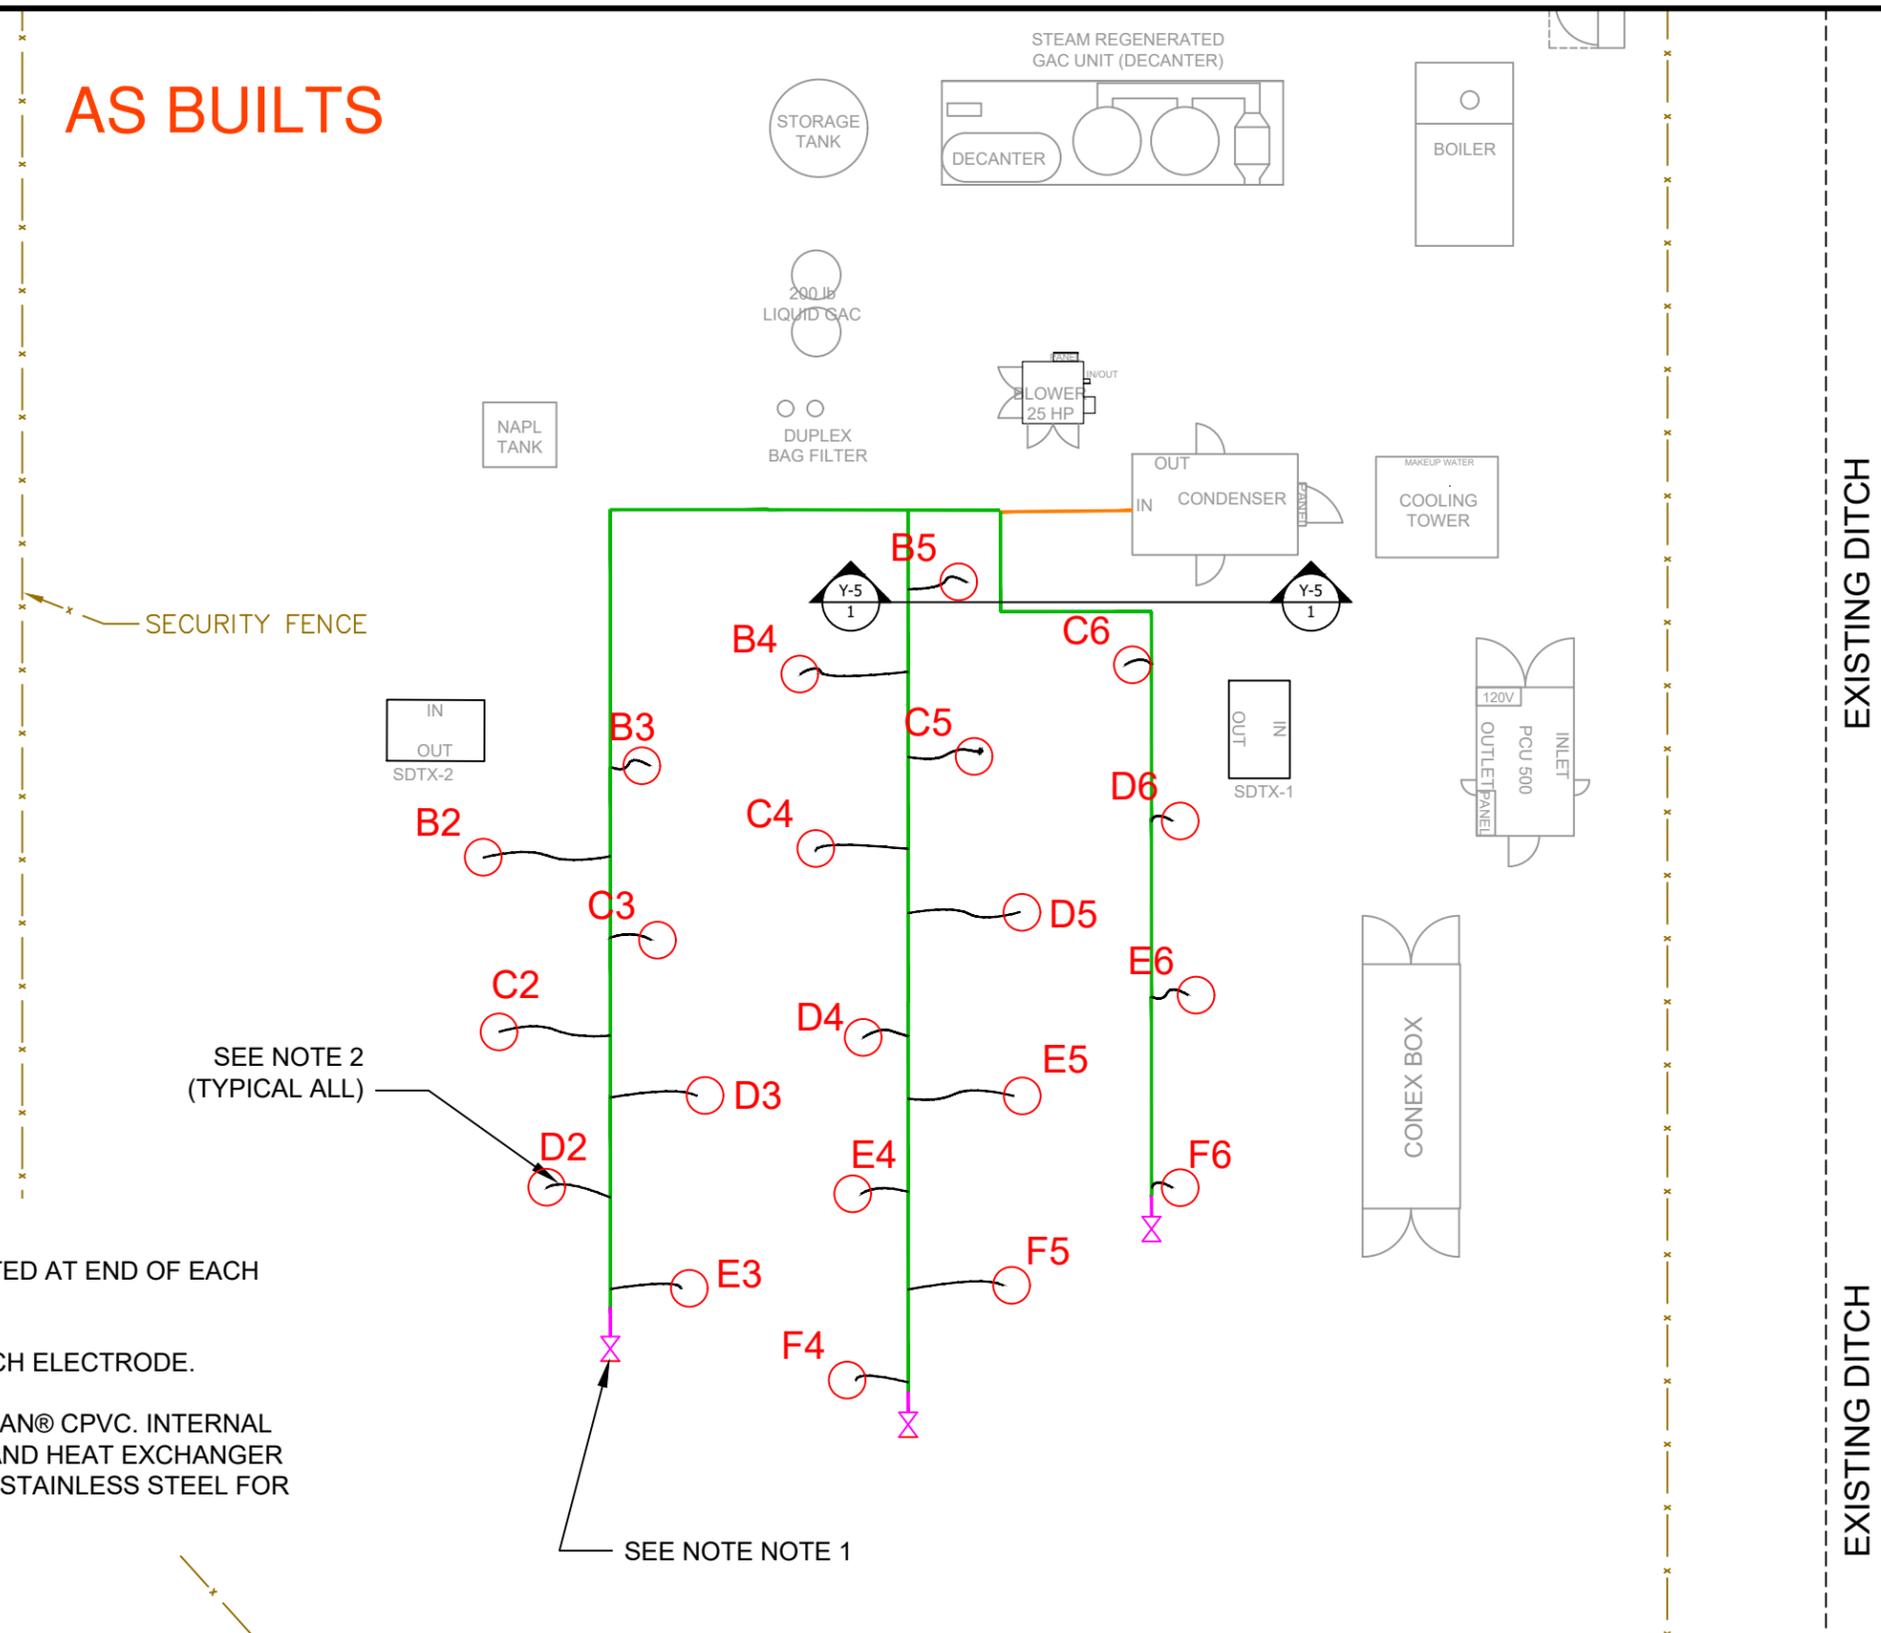
1. 1" BRASS BALL VALVES LOCATED AT END OF EACH HEADER.
2. INCLUDES BALL VALVE AT EACH ELECTRODE.
3. ALL CPVC PIPING TO BE CORZAN® CPVC. INTERNAL CONDENSER PIPING, VESSELS AND HEAT EXCHANGER PLATES ARE CONSTRUCTED OF STAINLESS STEEL FOR MATERIAL COMPATIBILITY

For the ERH Pilot, vapor recovery was performed using one 25-horsepower (hp) positive displacement blower. The combined steam and air recovery rate at full boiling conditions was estimated to be 400 standard cubic feet per minute (scfm) at design. See **Figures Y-5 and Y-11** for piping construction details.

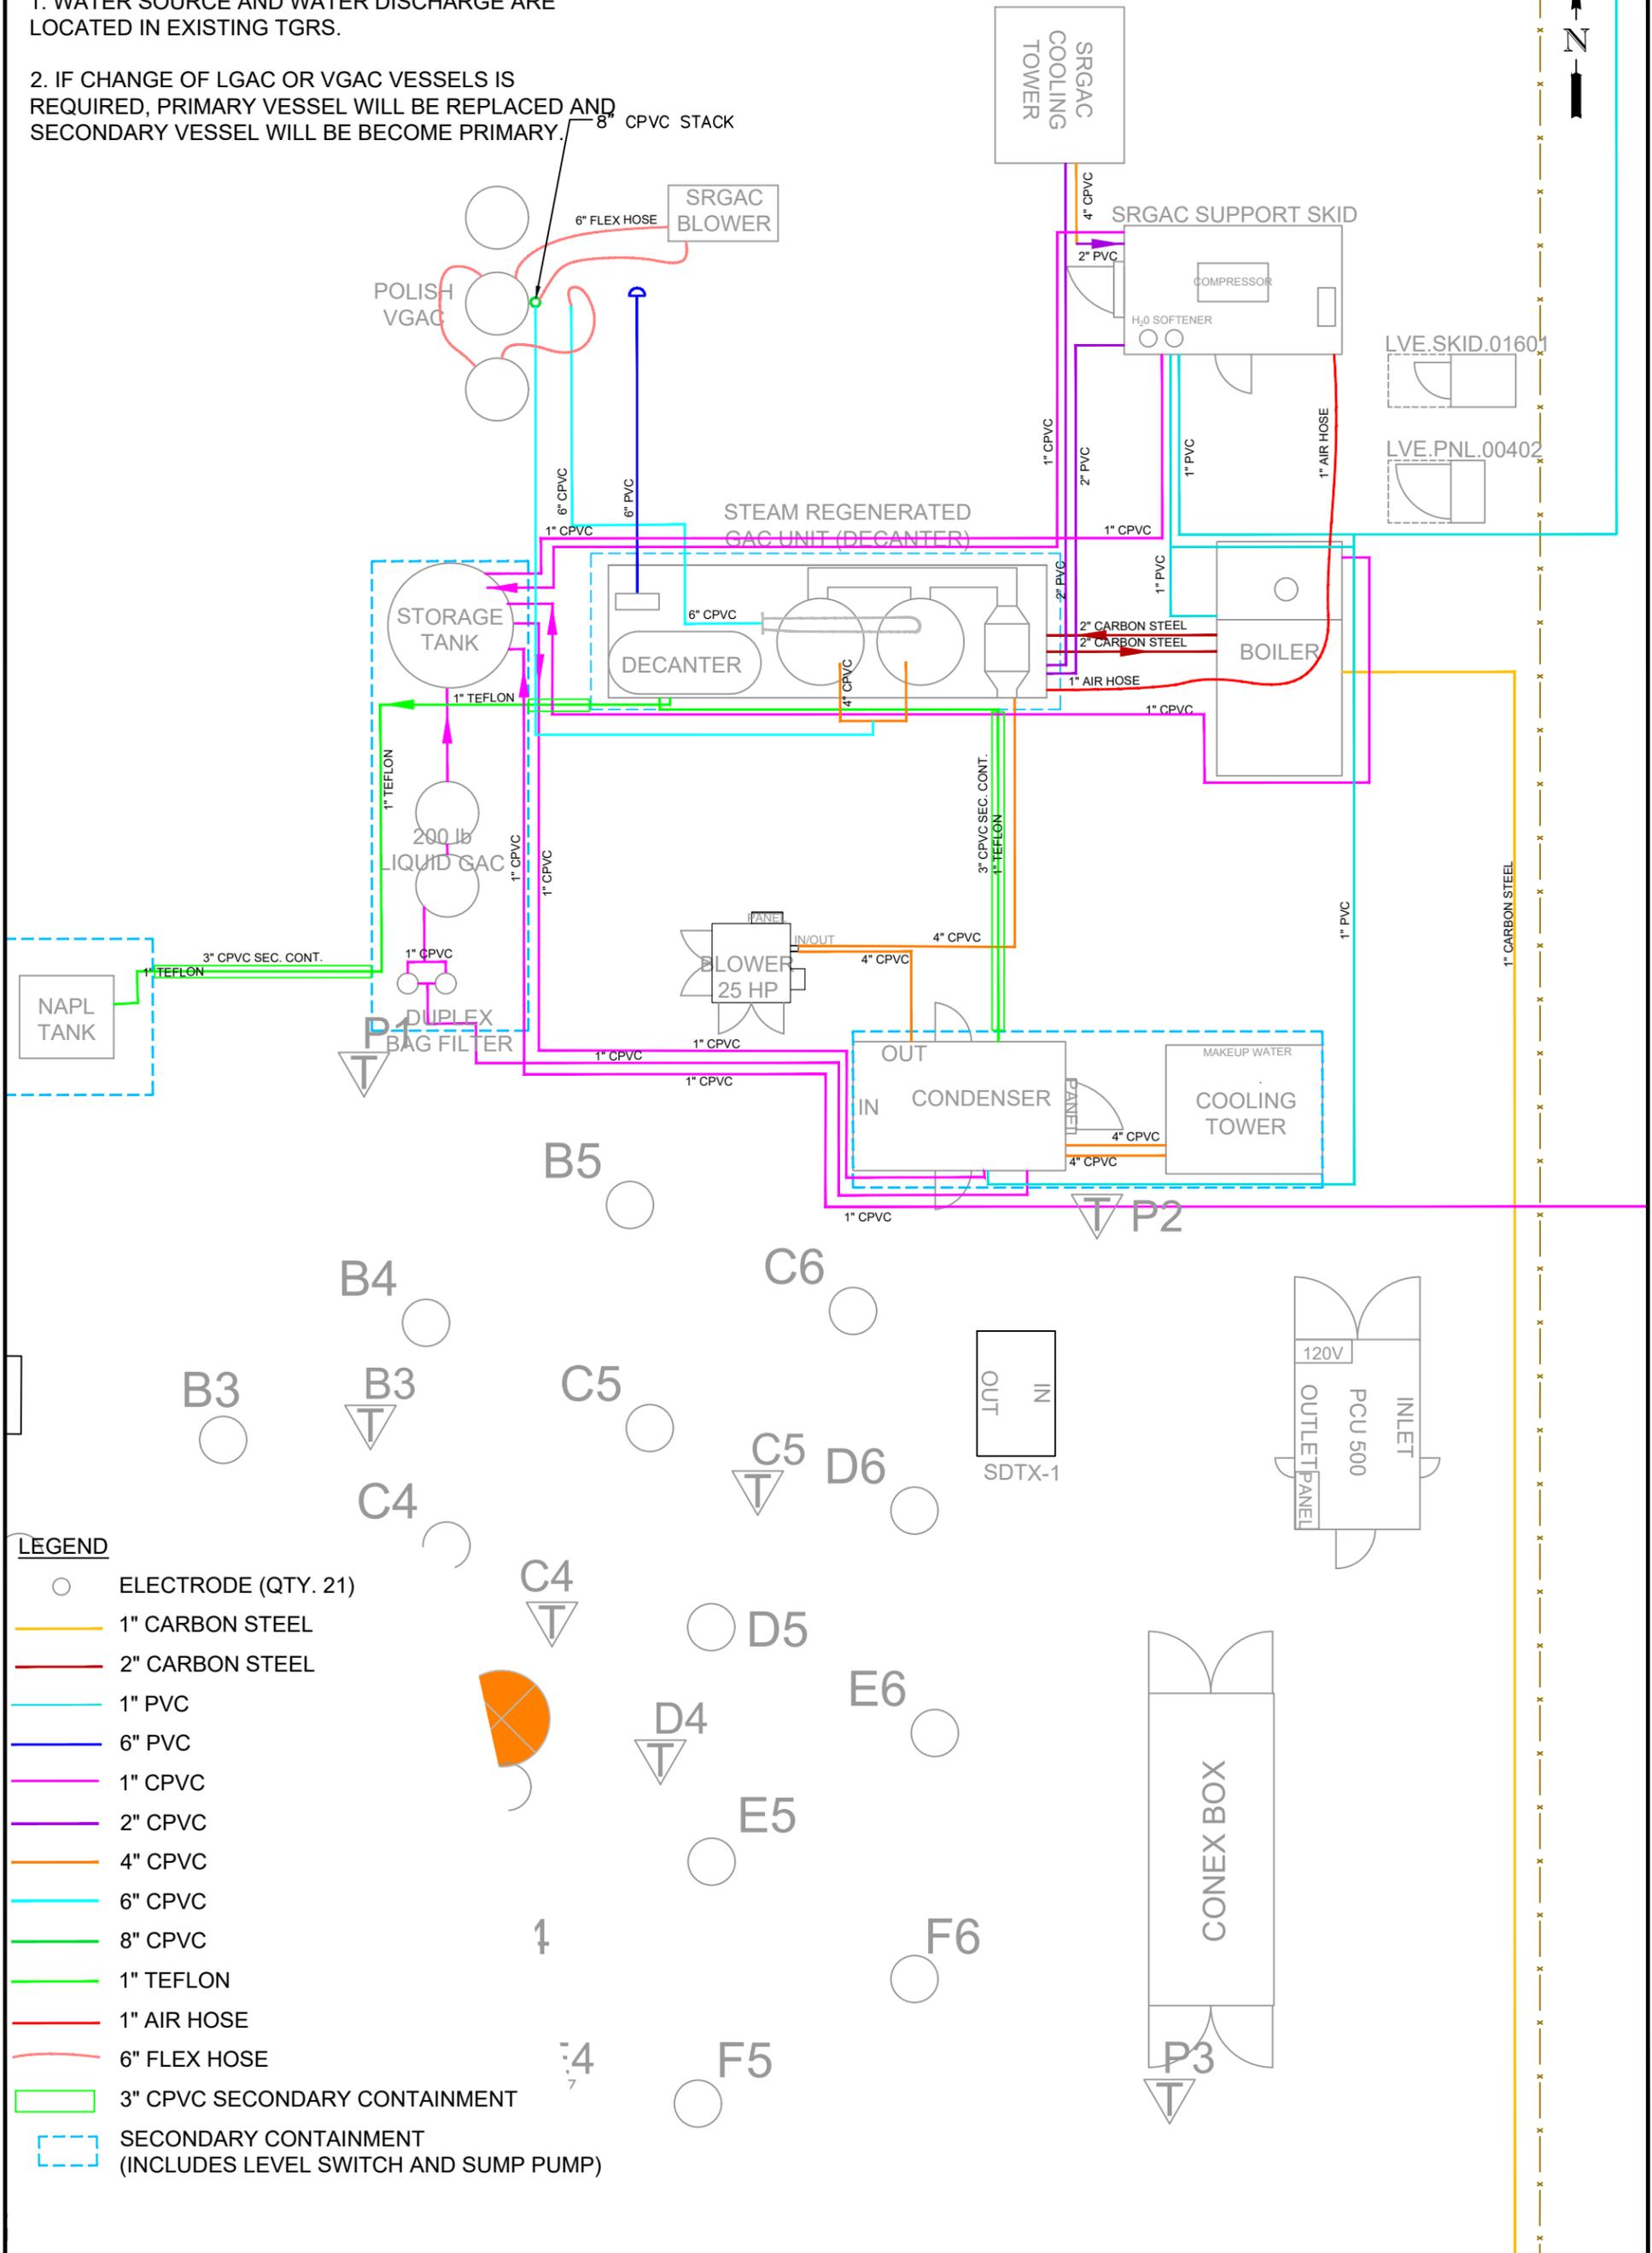
1. WATER SOURCE AND WATER DISCHARGE ARE LOCATED IN EXISTING TGRS.

2. IF CHANGE OF LGAC OR VGAC VESSELS IS REQUIRED, PRIMARY VESSEL WILL BE REPLACED AND SECONDARY VESSEL WILL BE BECOME PRIMARY.

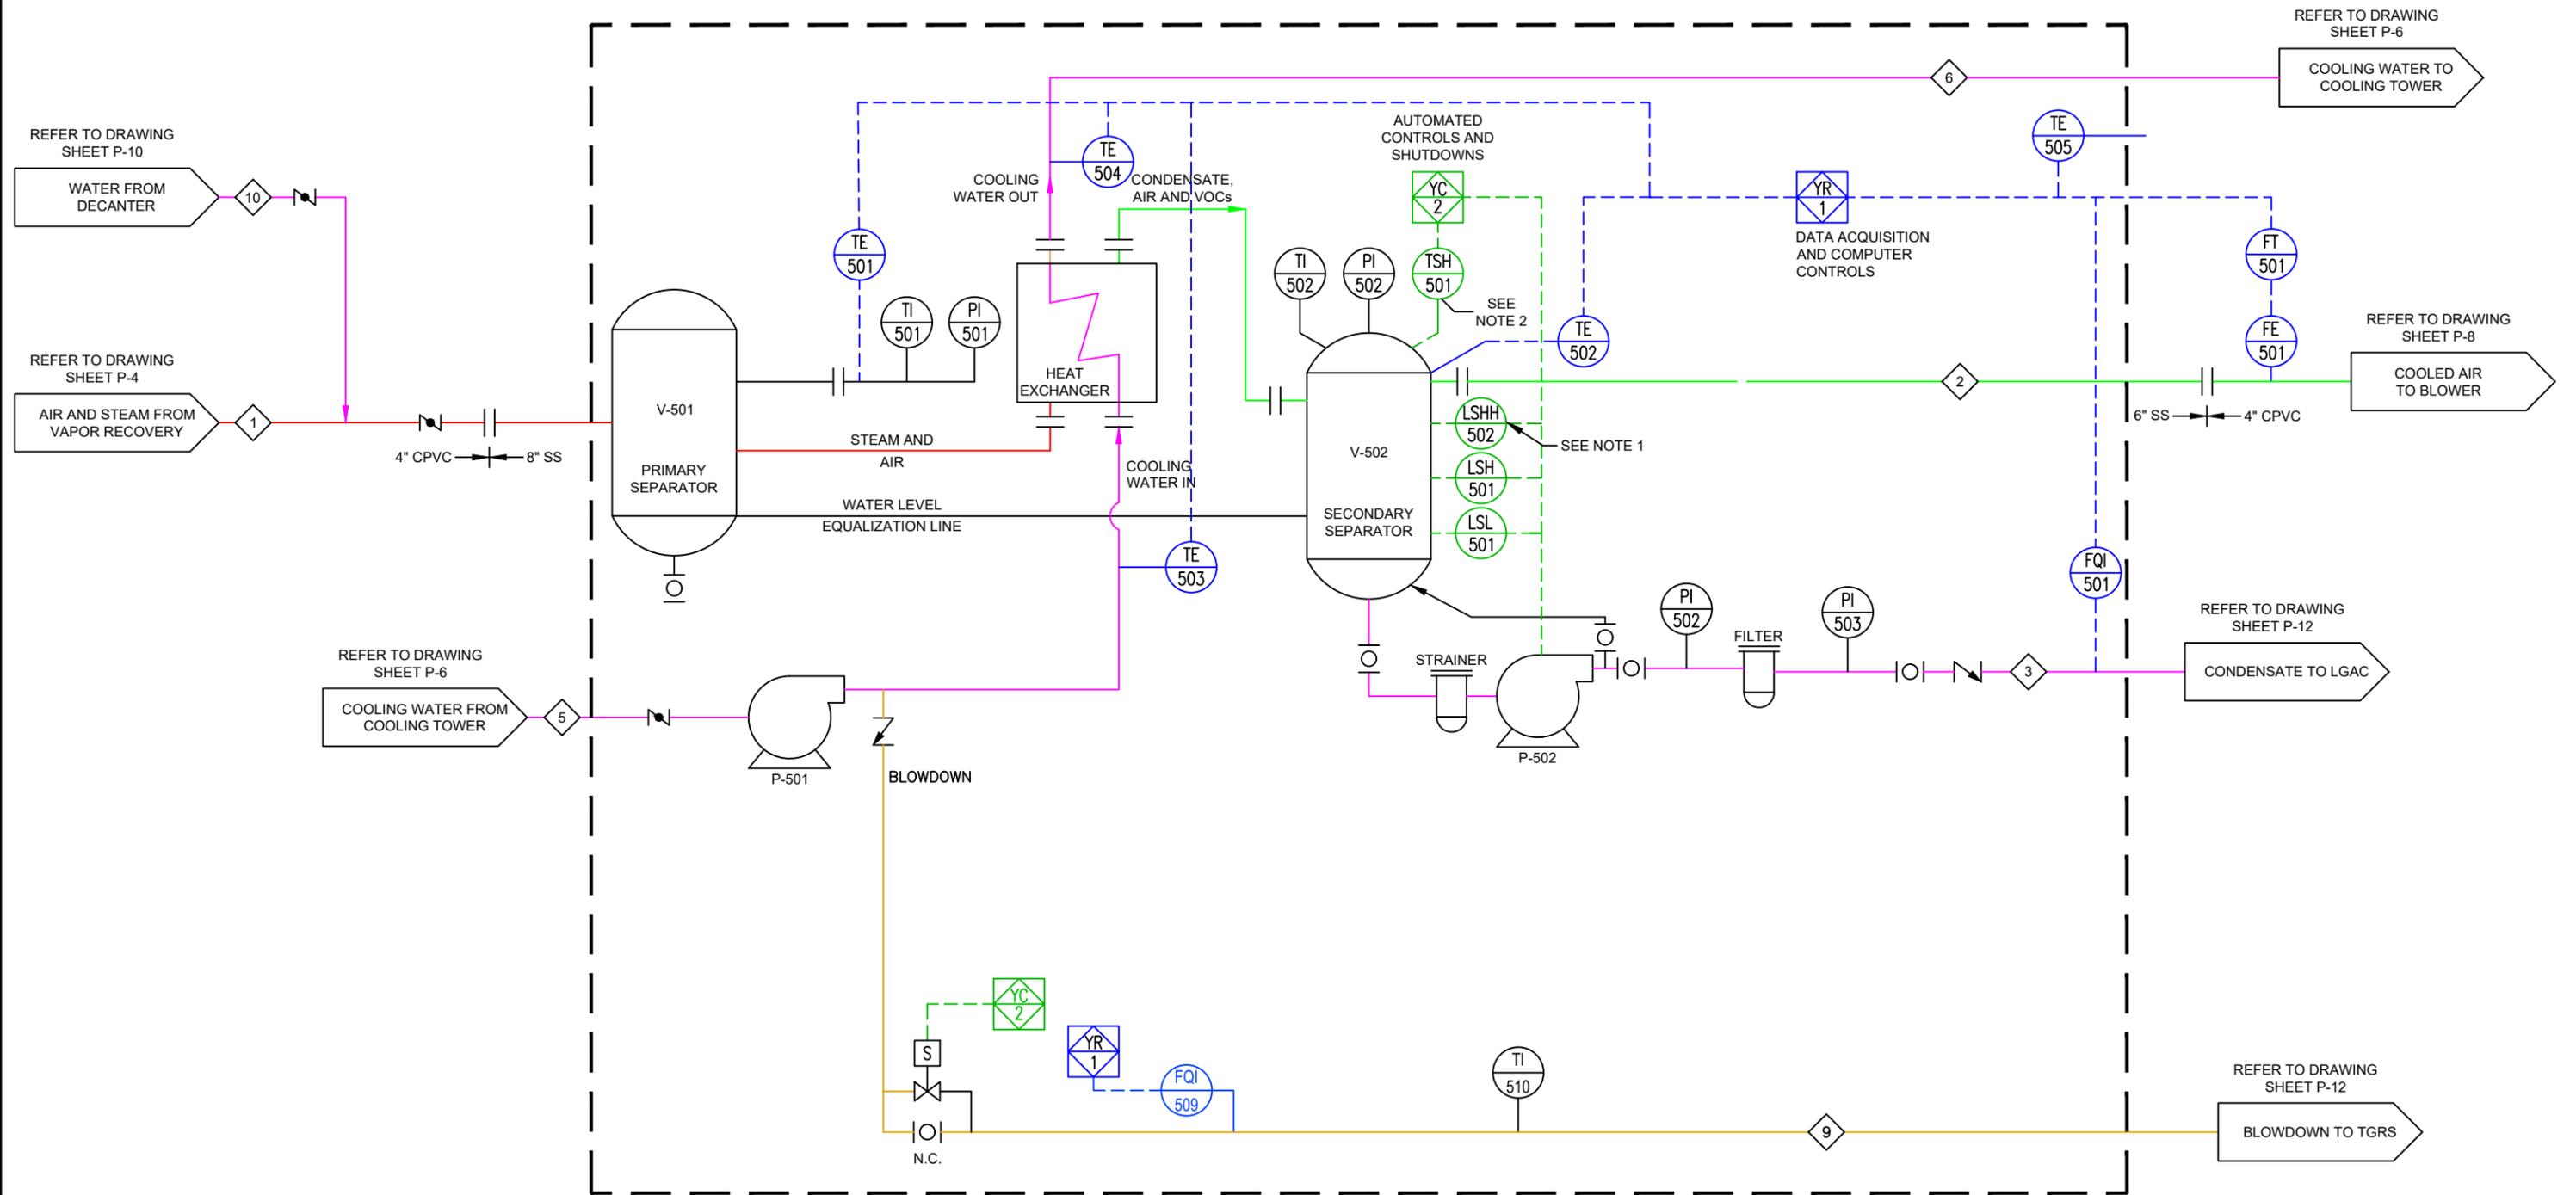
## CONDENSER SKID

- LSHH-501 WILL SHUT DOWN THE VAPOR RECOVERY BLOWER (B-801) AND THE ELECTRODES.
- TSH-501 WILL SHUT DOWN THE VAPOR RECOVERY BLOWER (B-801). TEMPERATURE SET POINT IS 140°F
- THE HEAT EXCHANGER IS ASME 2 RATED.
- PIPE, VESSELS AND HEAT EXCHANGER PLATES ARE STAINLESS STEEL.

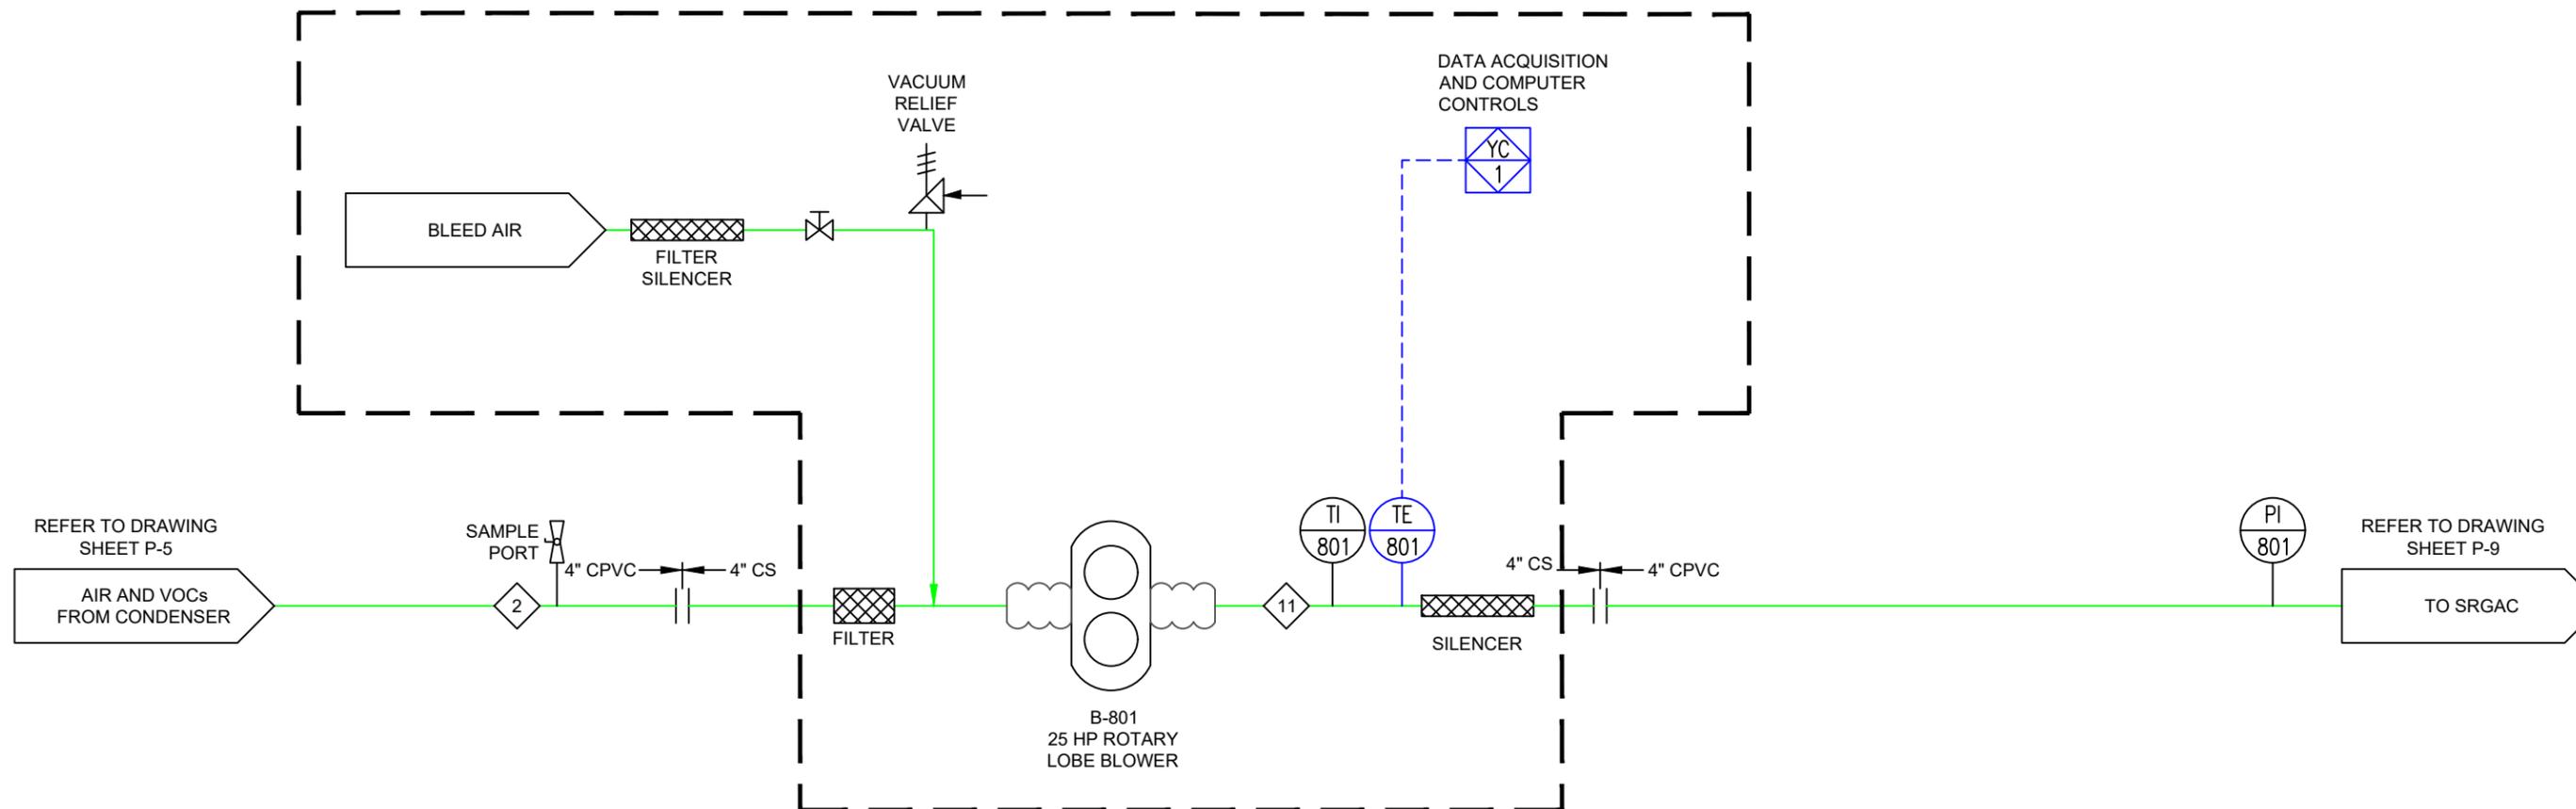
## BLOWER SKID

- PSH-801 AND PSL-801 WILL SHUT DOWN THE BLOWER IN THE EVENT OF A HIGH OR LOW BLOWER DISCHARGE PRESSURE. PSL-801 WILL HAVE A SET POINT OF 1" WC AND PSH-801 WILL HAVE A SET POINT OF 2 PSIG.
- THE KUNKLE VALVE WILL BE SET AT 11" HG.
- BLEED AIR NOT ANTICIPATED DURING THIS PROJECT.

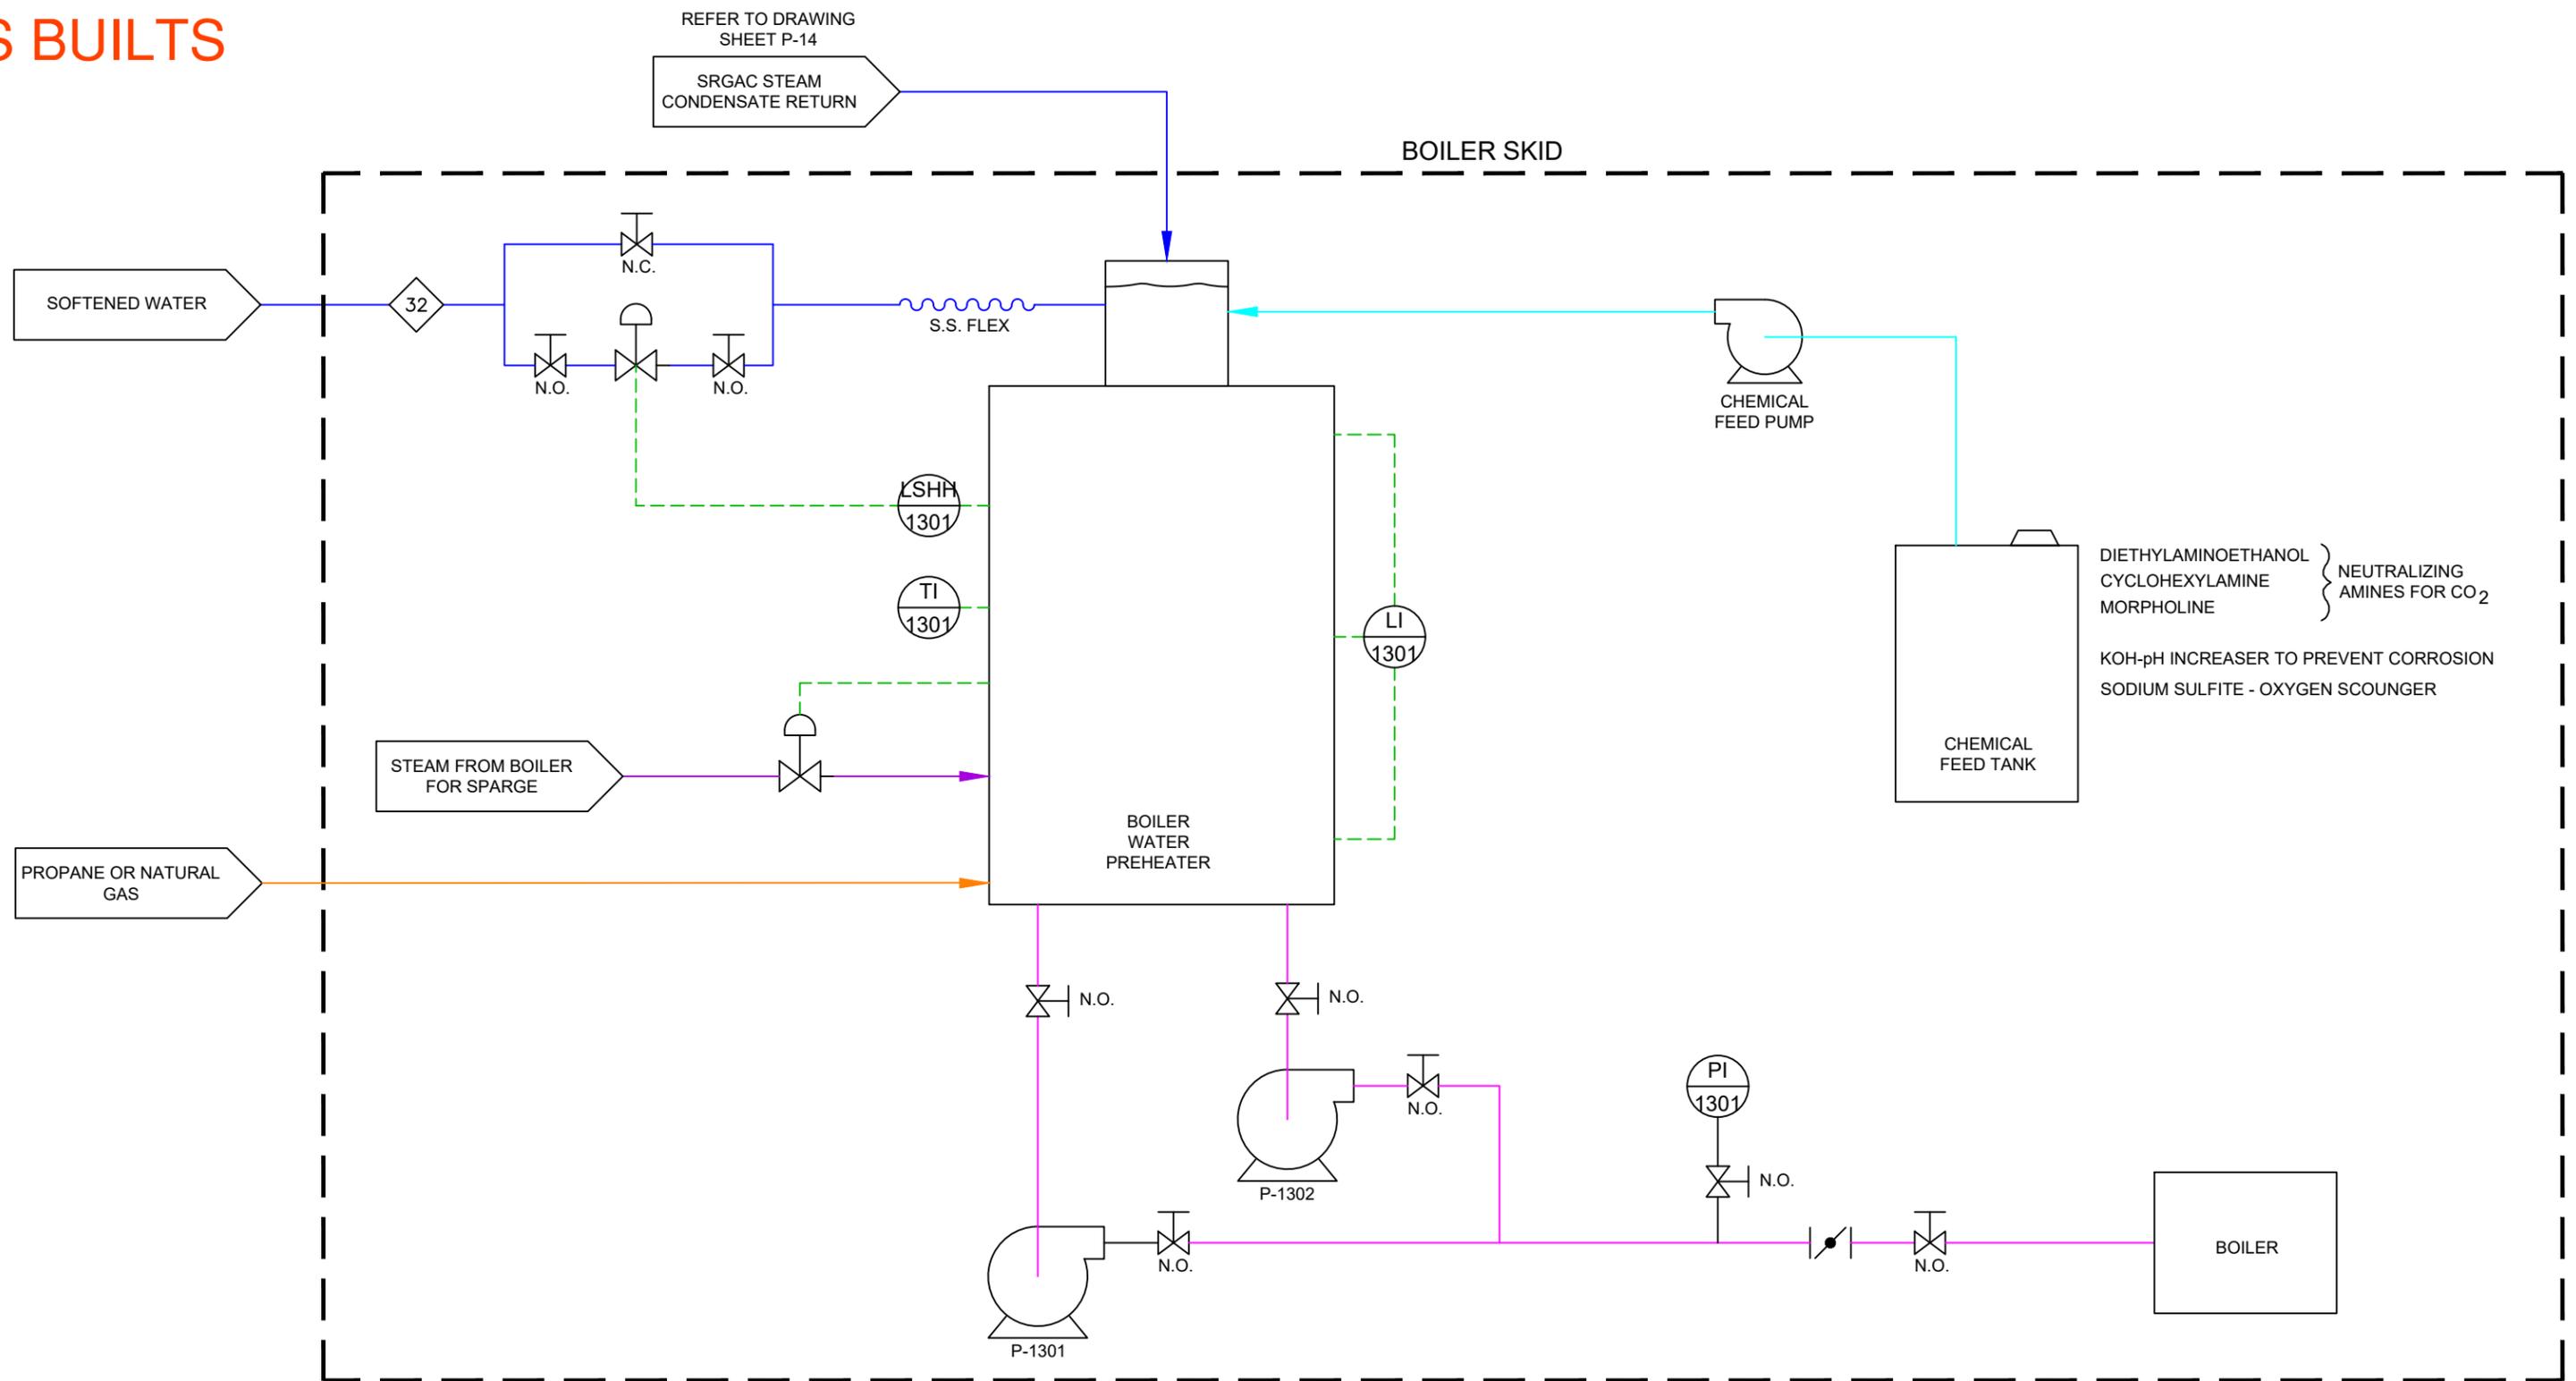
1. ALL COMPONENTS SHOWN ARE PART OF A VENDOR-SUPPLIED BOILER SYSTEM.
2. P-1301 AND P-1302 ARE PART OF A DUPLEX PUMP SYSTEM CONTROLLED BY LEVEL SWITCHES IN THE BOILER.

The SRGAC system requires a dedicated boiler and cooling tower. The boiler is contained within a 20-foot International Organization for Standardization (ISO) container. The boiler requires a propane or natural gas fuel source and a water supply. A chemical feed tank located inside the boiler container supplies neutralizing amines for carbon dioxide control, potassium hydroxide to prevent corrosion, and sodium sulfite as an oxygen scavenger. Steam is supplied to the SGRAC via carbon steel piping and fed to the decanter after GAC vessel regeneration, as described above. Boiler start-up and maintenance was conducted by a local, licensed boiler vendor. TRS field staff attended a Boiler Operations course prior to start-up of the boiler system, and only trained field staff are permitted to operate the boiler. Details of boiler process and design are shown on **Figures P-13 to P-15**.
