19 March 2010  
File No. 36067-004

Subject: After-Hours Air Sampling Results  
464 Ellis Street  
Mountain View, California

LOCATION OF AIR SAMPLES  
AND TCE RESULTS -  
464 ELLIS STREET

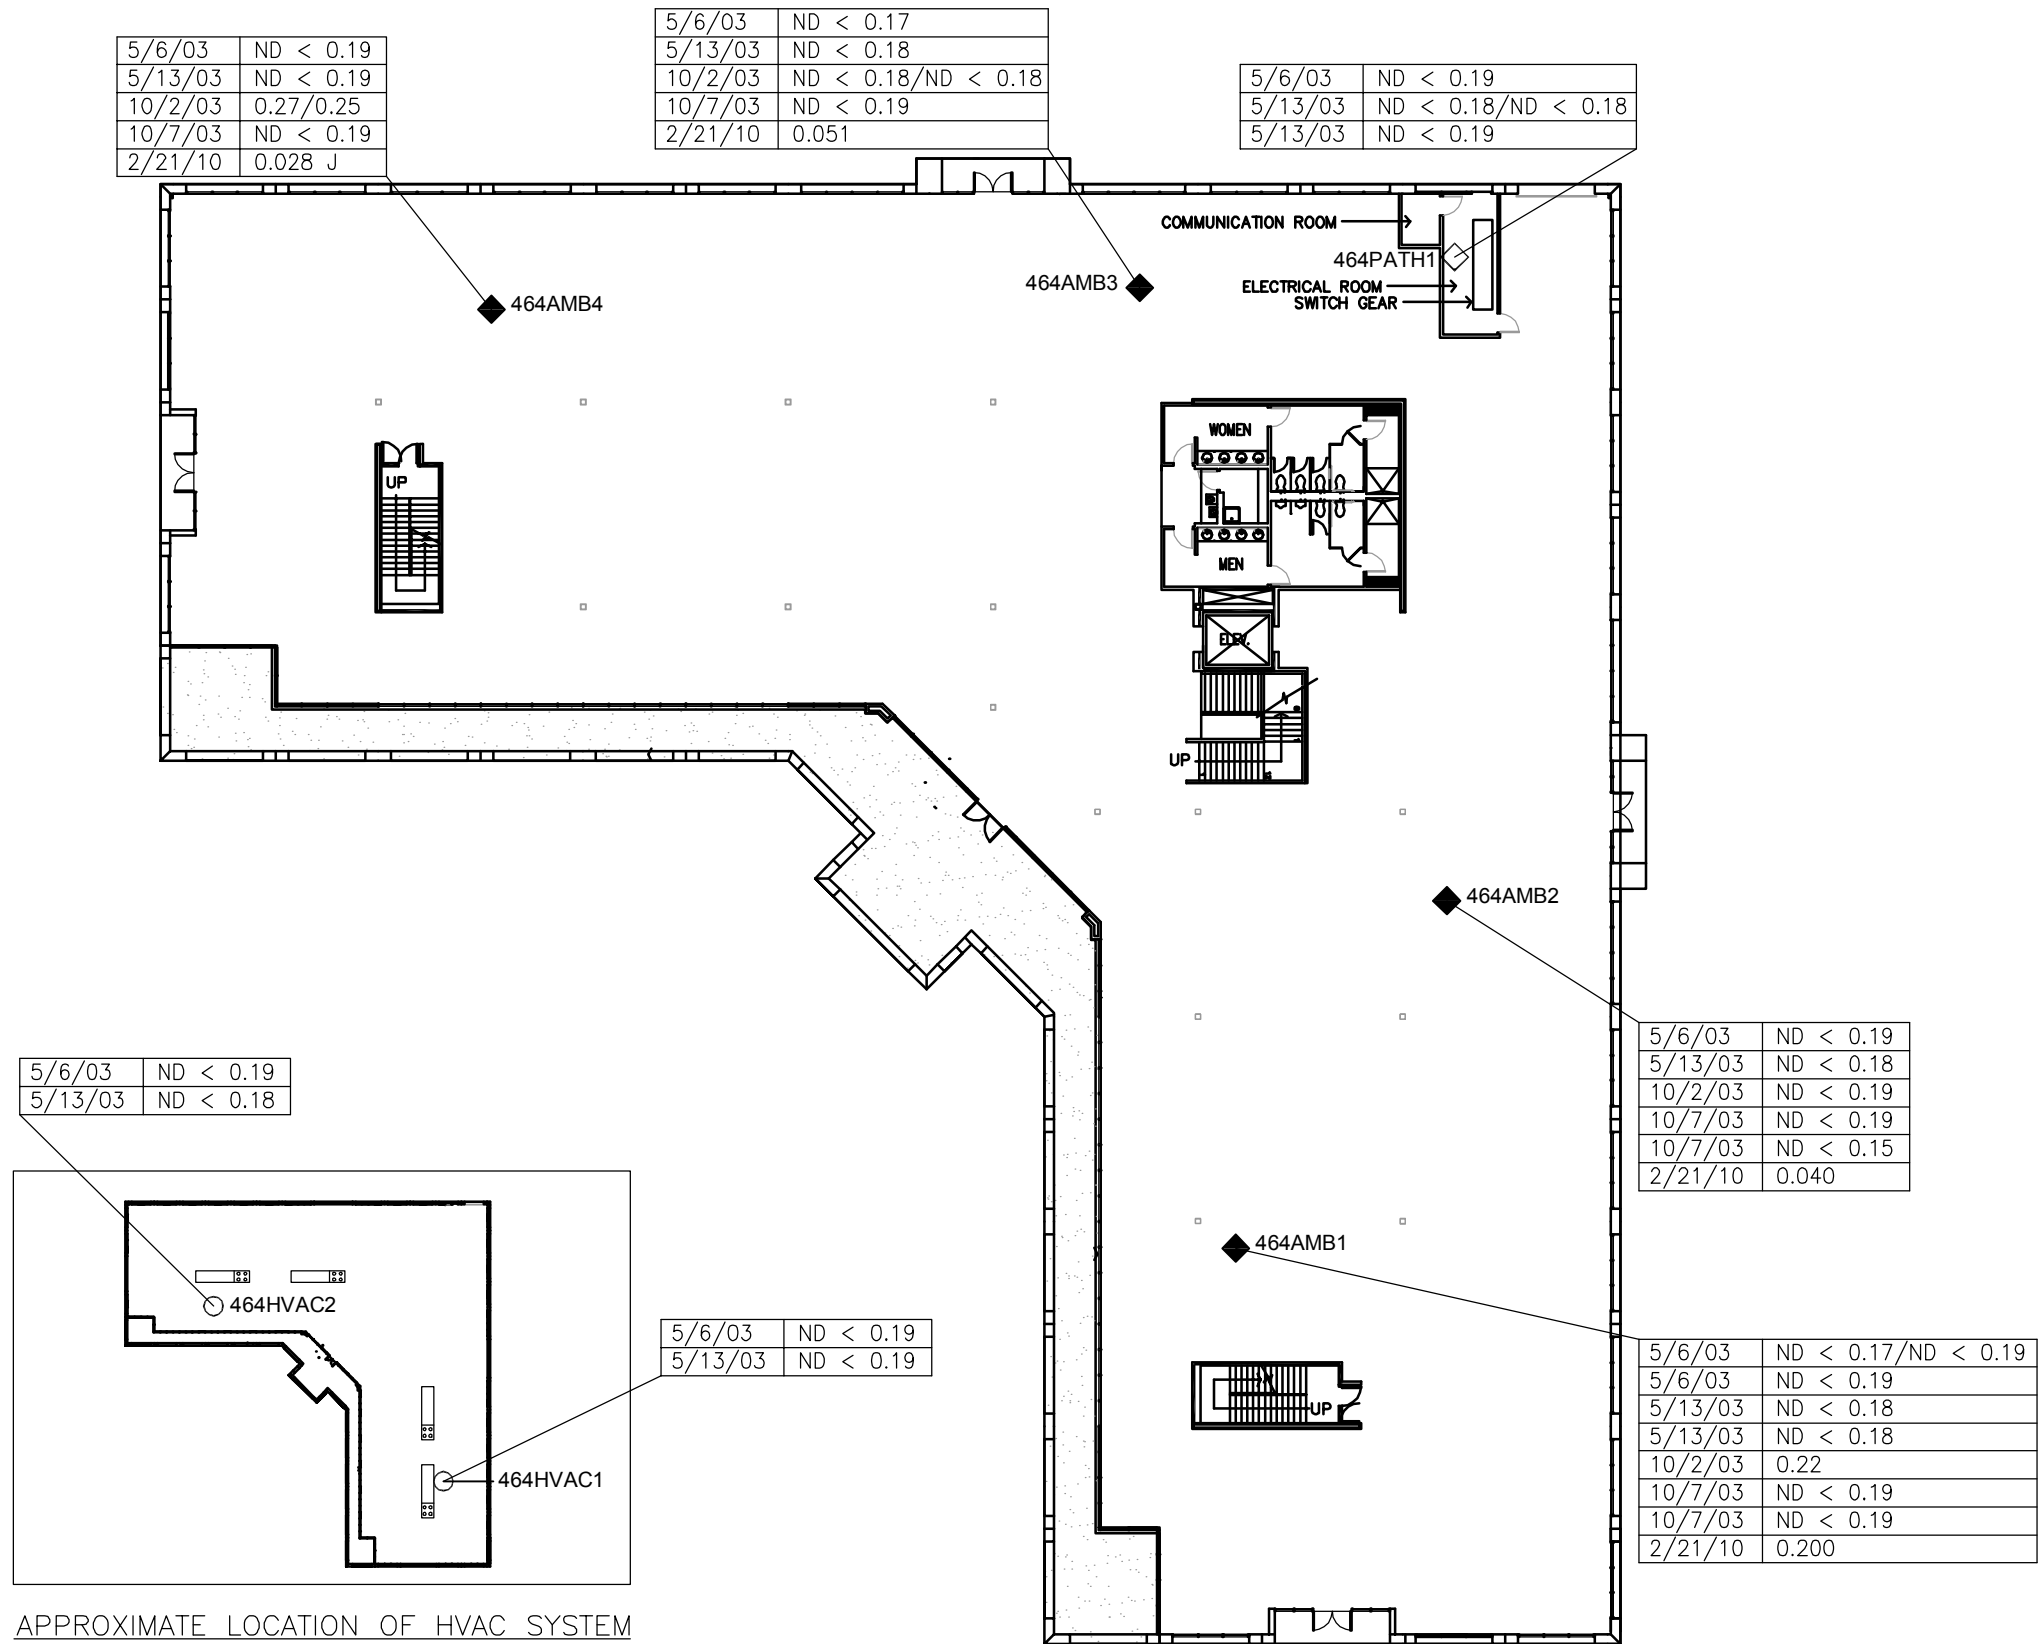
FIGURE 1

Four after-hours indoor air samples were collected at 464 Ellis Street on 21 February from two cubicles and two open areas in accordance with the 8 January 2010 sampling plan. Sample locations are shown on Figure 1.

A total of four indoor samples were collected at 464 Ellis Street over a 10-hour period on 21 February 2010. An outdoor sample was collected over a 24-hour period from 6:00 PM on 20 February 2010 to 6:00 PM on 21 February 2010. The four indoor air samples were collected from two cubicles and two open areas (464AMB1, 464AMB2, 464AMB3, and 464AMB4) at the same locations sampled in 2003; one outdoor air sample (466OUT1) was collected outside the main entrance of the 466 Ellis Street. The results of the air samples are shown in Table I. TCE concentrations are posted on Figure 1. The laboratory report is attached as Appendix B.

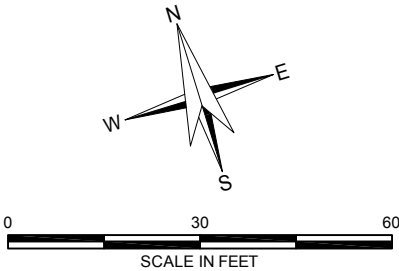
- THIS FIGURE IS BASED ON AN AUTOCAD DRAWING PROVIDED BY LOCUS TECHNOLOGIES.
- ALL LOCATIONS ARE APPROXIMATE.
- TCE = TRICHLOROETHENE.
- TCE CONCENTRATIONS IN MICROGRAMS PER CUBIC METER (ug/m<sup>3</sup>).
- ND DENOTES TCE WAS NOT DETECTED AT THE LEVEL SHOWN, J DENOTES AN ESTIMATED VALUE.
- AFTER-HOUR INDOOR SAMPLES WERE COLLECTED ON 21 FEBRUARY 2010 FROM 8:00AM UNTIL 21 FEBRUARY 2010 AT 6:00PM. ALL OTHER SAMPLES WERE COLLECTED DURNING NORMAL OCCUPANCY HOURS.

***Comparison to EPA's Proposed Long-Term Action Levels:*** The after-hours indoor air results showed VOCs concentrations lower than EPA's action levels, as shown in Table I. Figure 2 shows a comparison of TCE concentrations in the after-hours to proposed long-term action levels and short-term exposure goals. The results of the recent after-hours samples, combined with the regular samples collected in 2003 (see Figure 1), show that there are no long-term potential risk concerns from vapor intrusion pathway under current conditions.

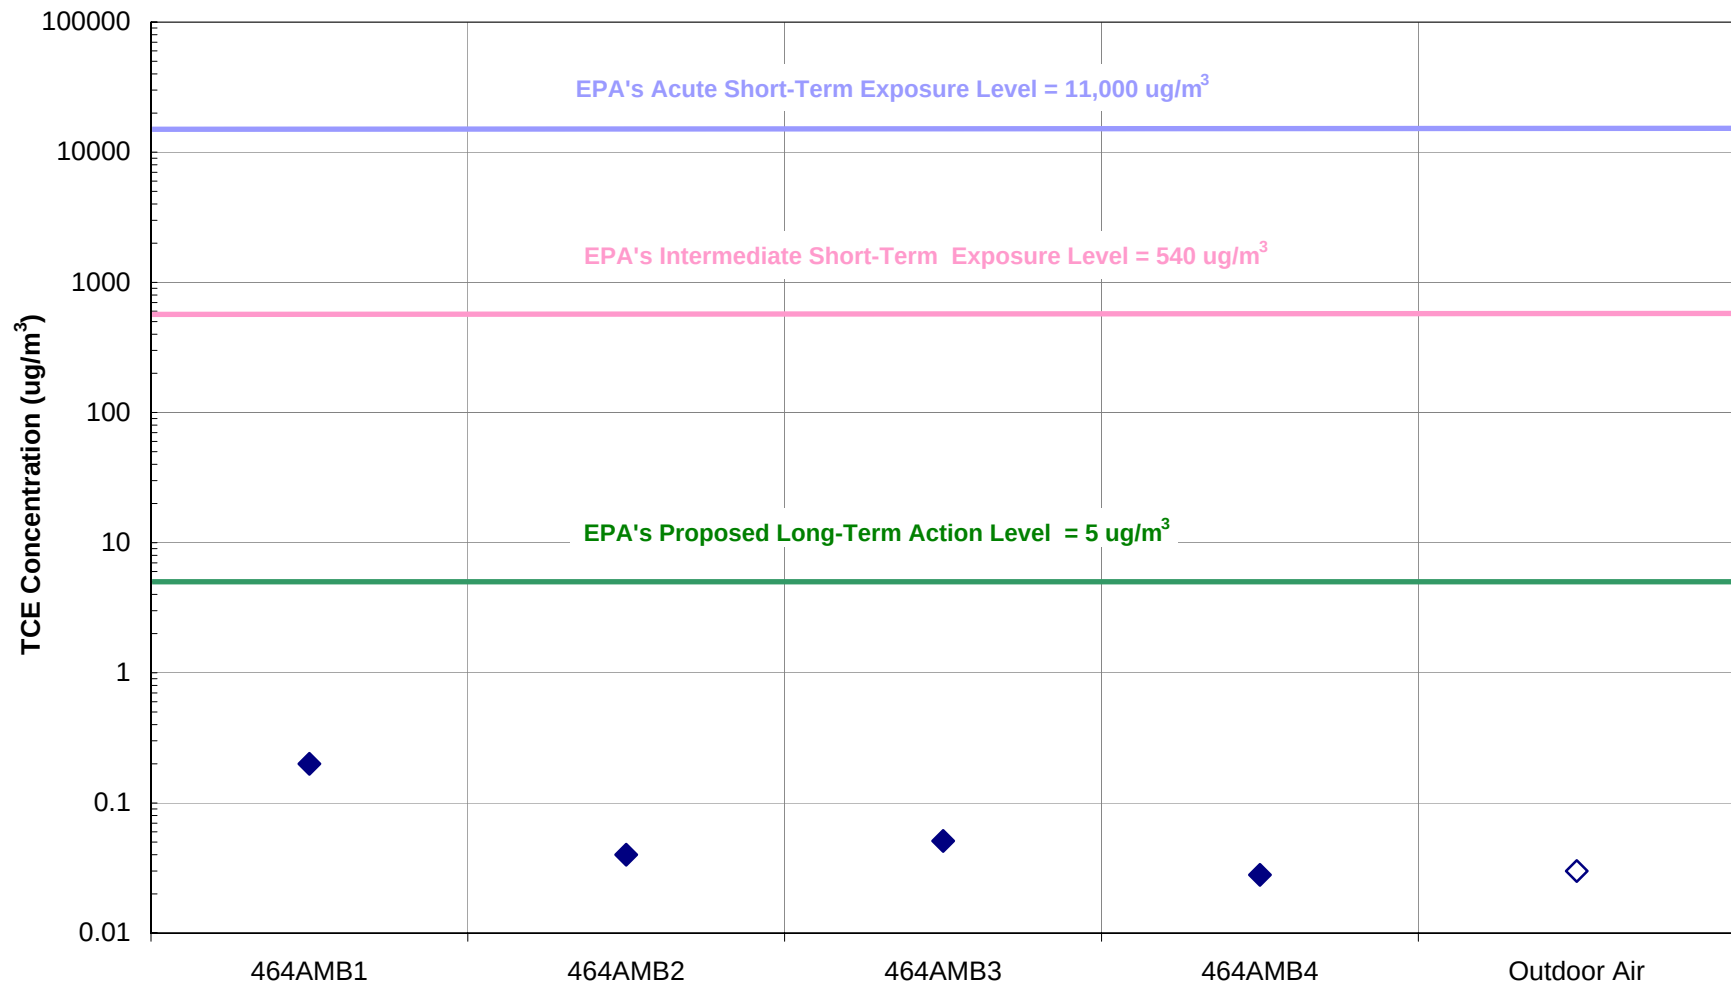
**Figure 2: TCE Concentrations in Air - 21 February 2010, 464 Ellis Street**

"Outdoor Air" sample was collected at the adjacent 466 Ellis Street property from 20 February 2010 at 6:00 pm until 21 February 2010 at 6:00 pm
