# LOWER DUWAMISH WATERWAY SLIP 4 EARLY ACTION AREA

## Removal Action Completion Report

July 26, 2012

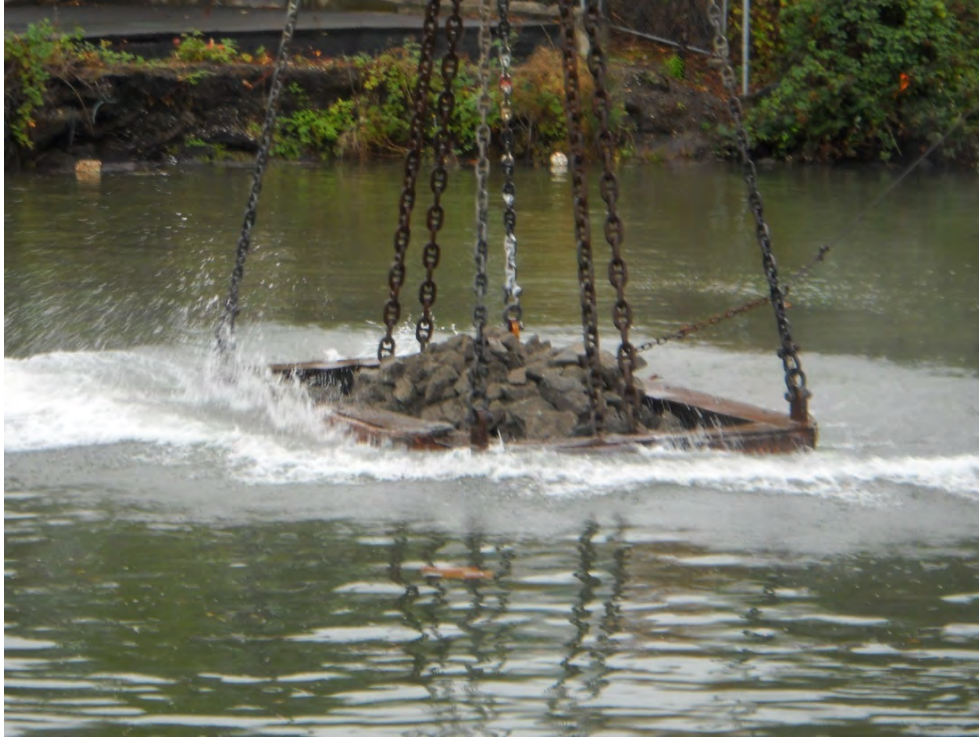
Photograph 3-1. Placement of Boundary Berm with "Bombay Box"  
(October 3, 2011)

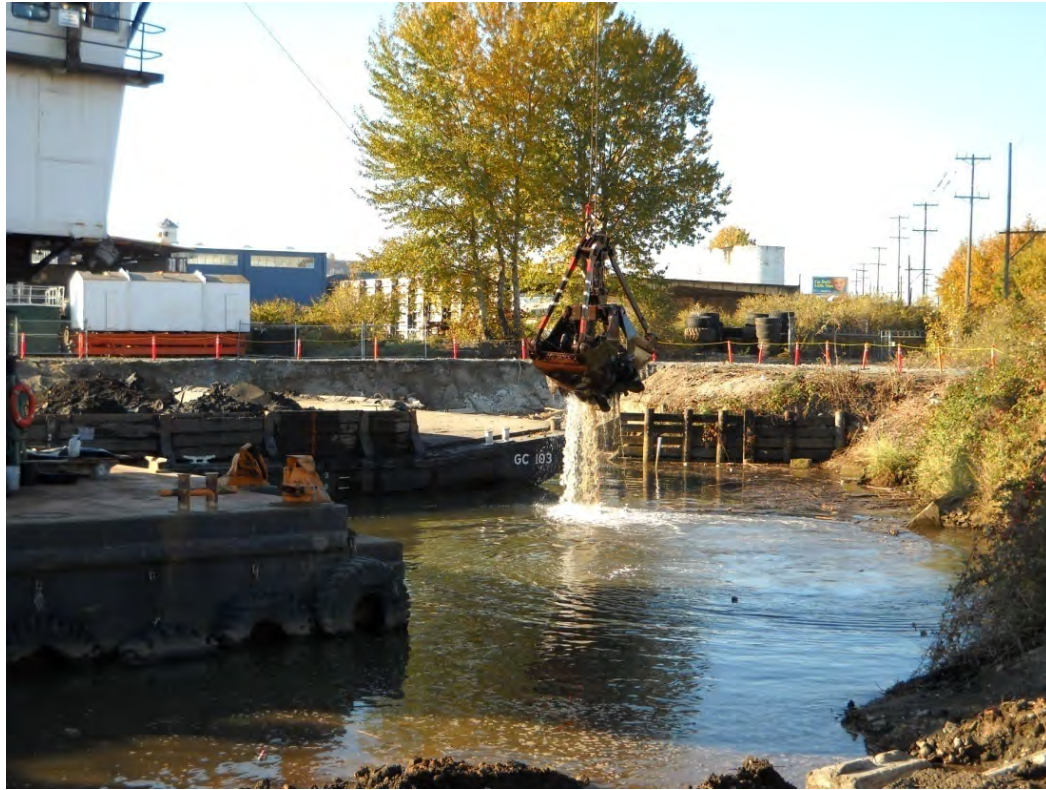
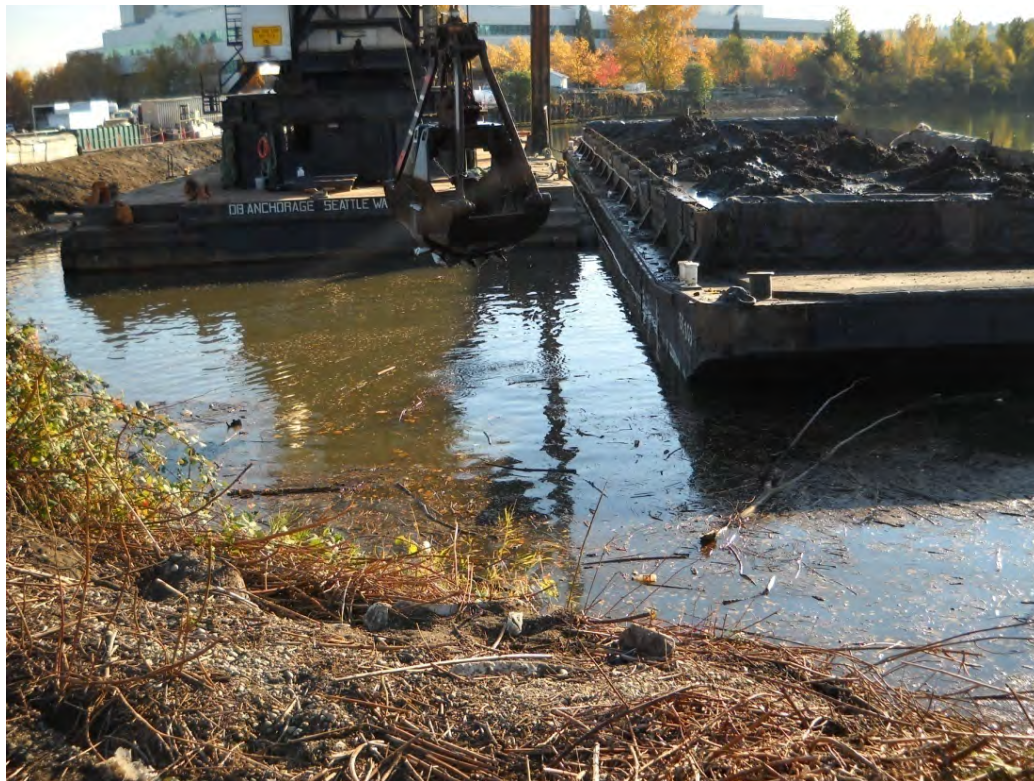
Photograph 3-3. Dredging of Sediment (November 10, 2011)

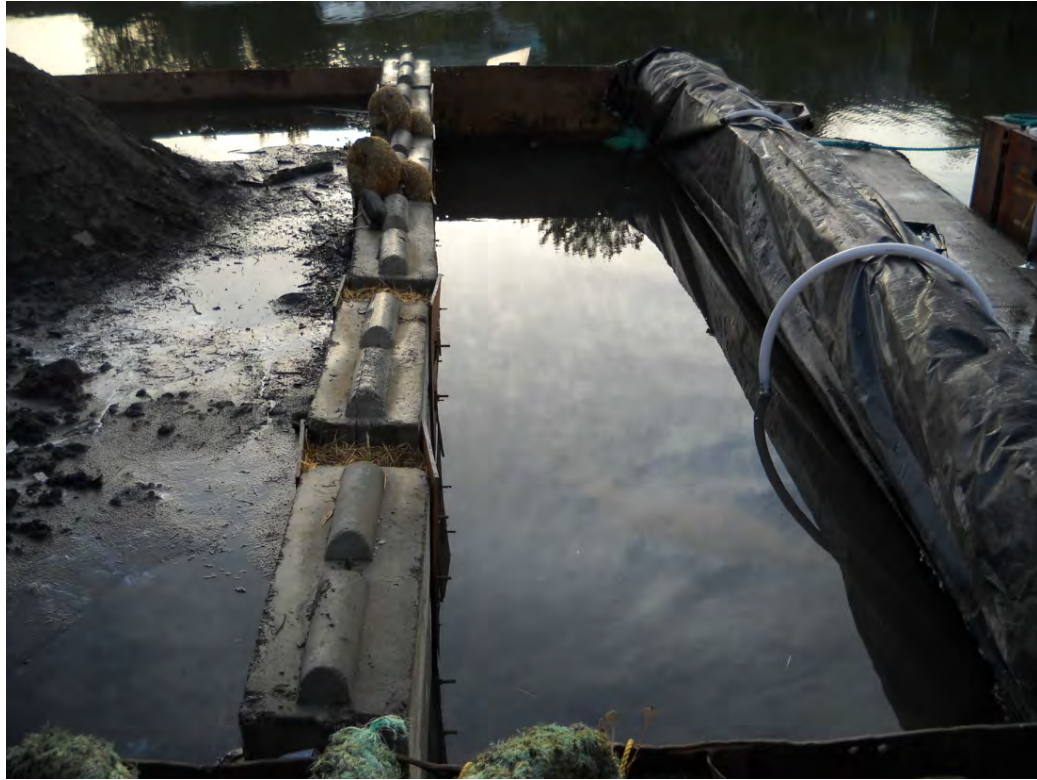
Photograph 3-4. Barge Dewatering (*top*: October 12, 2011; *bottom*: October 27, 2011)

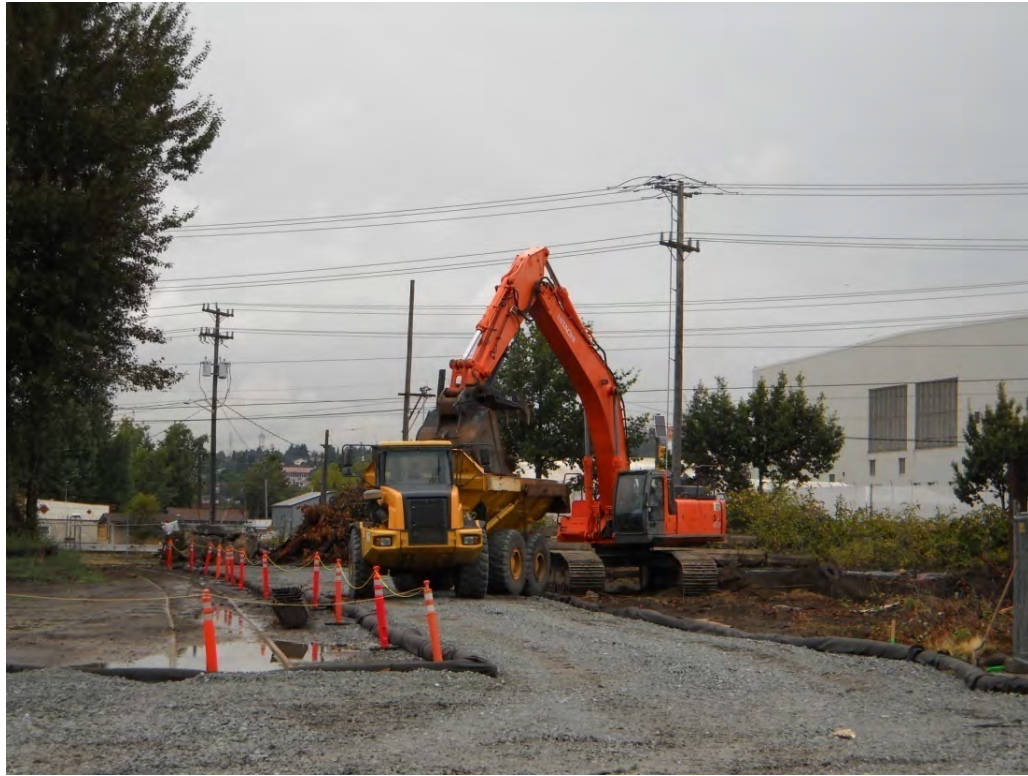
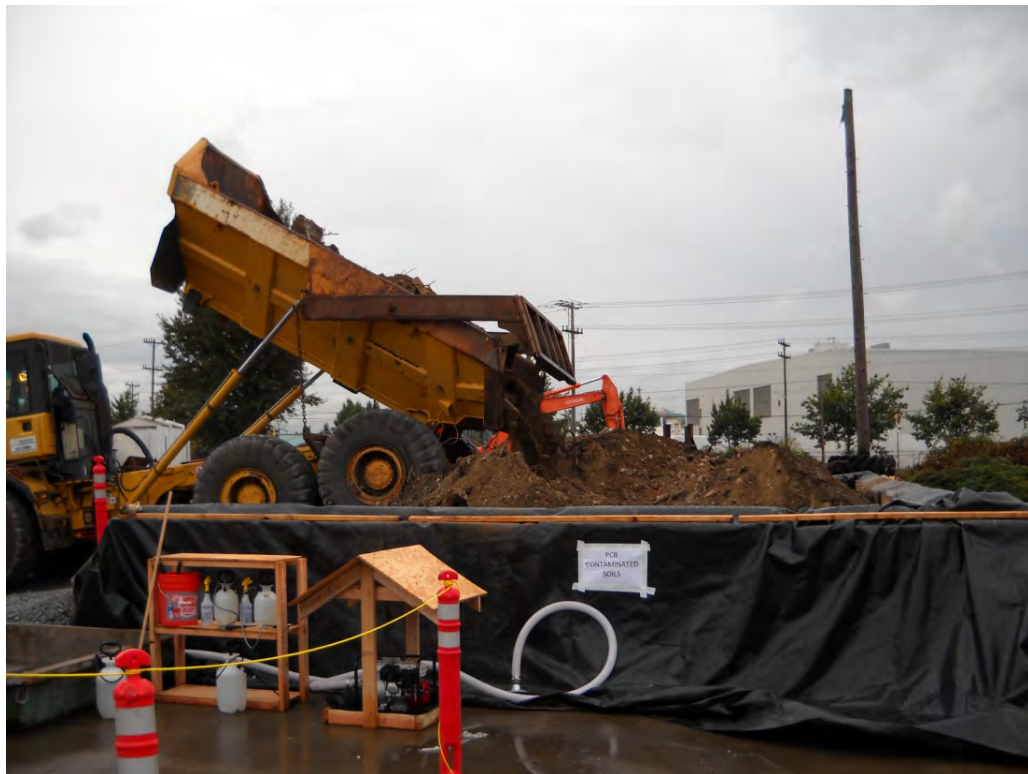
Photograph 3-5. Bank Excavation (October 5, 2011)

On October 5, 2011, it was noted that excavator bucket swing arcs along the haul road at Removal Area 1 extended beyond the demarcation of the exclusion zone. As a result, an additional 8-ft wide swath of filter fabric and exclusion zone demarcation was provided to extend the zone to the railroad tracks. This created an additional buffer area to prevent existing soil from being contaminated by loose material from the dump truck or excavator bucket.

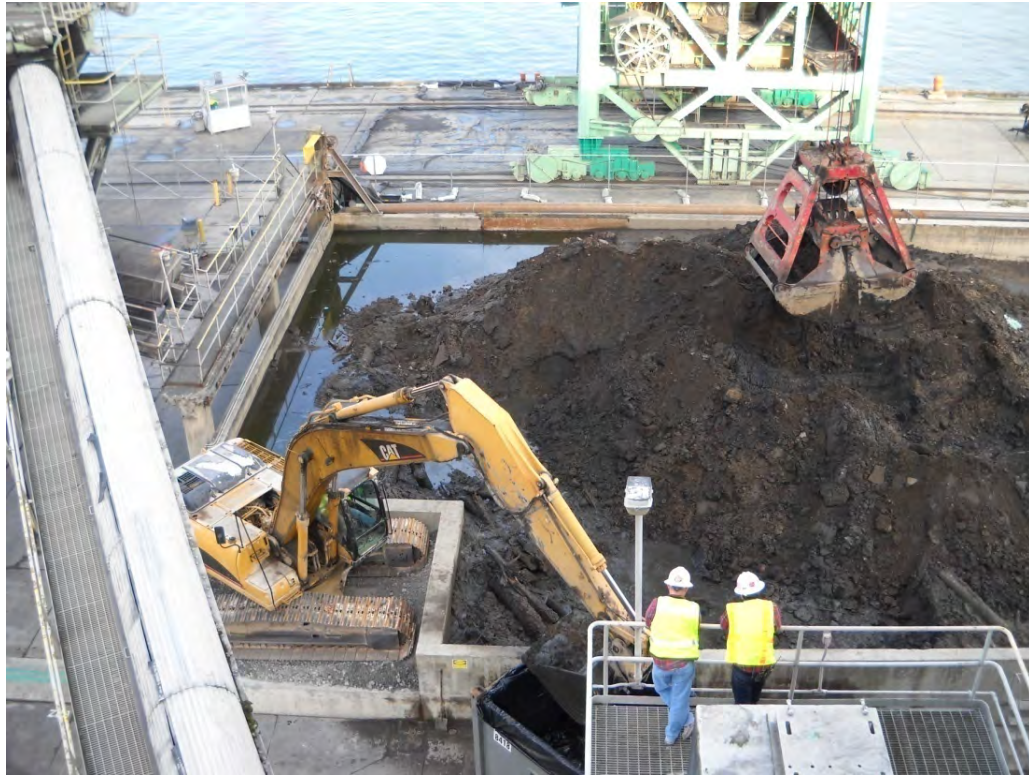
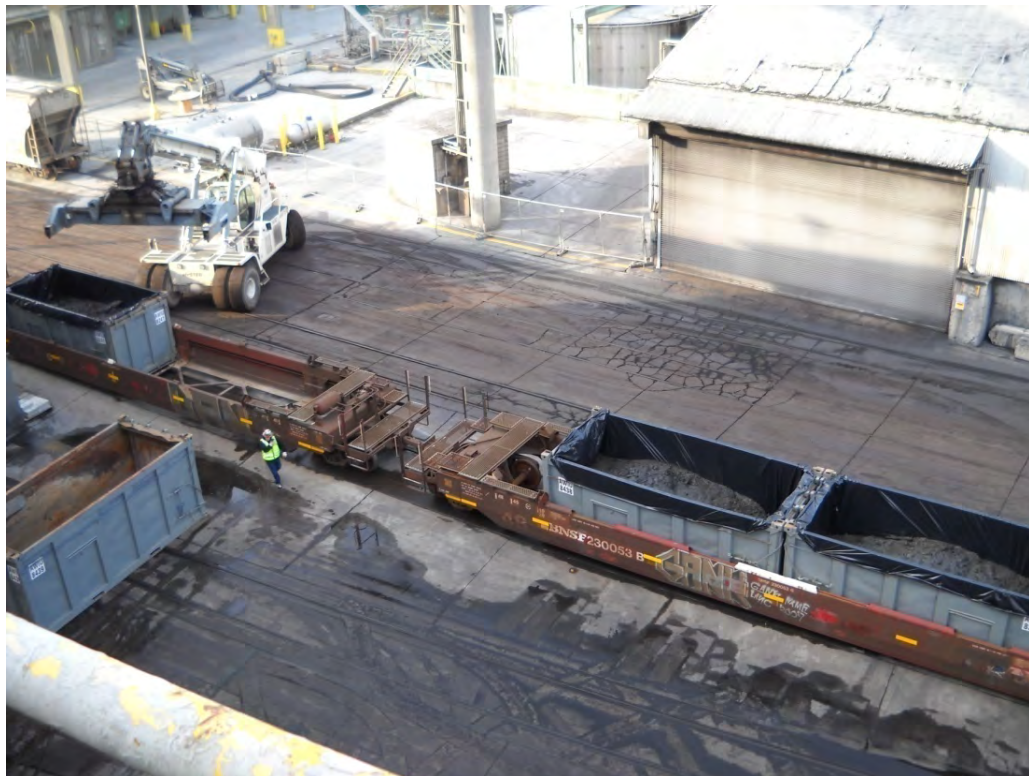
Photograph 3-7. Transloading from Vault to Containers (November 9, 2011)

Based on early observations of rail container loading, there were initial concerns regarding tears that formed at locations where the liners were affixed to the containers. These were first observed on October 14, 2011, at the tie wires near the top of each container. Photo documentation of the containers arriving at Rabanco indicated that the tears had not worsened and had not been compromised by material movement during transport. Nevertheless, Lafarge refined the liner installation process to correct the problem. Revisions to the transloading plan and standard operating procedures on liner installation and liner tears were submitted in Addendum 1 to the RAWP on November 1, 2011.

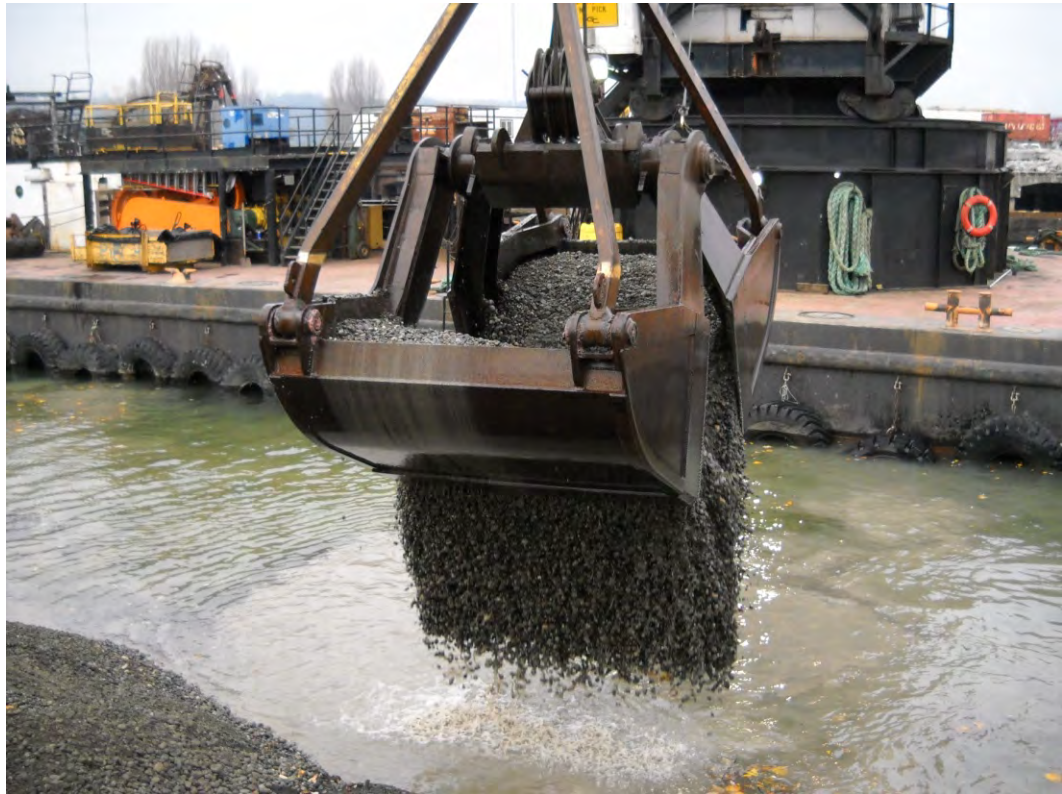
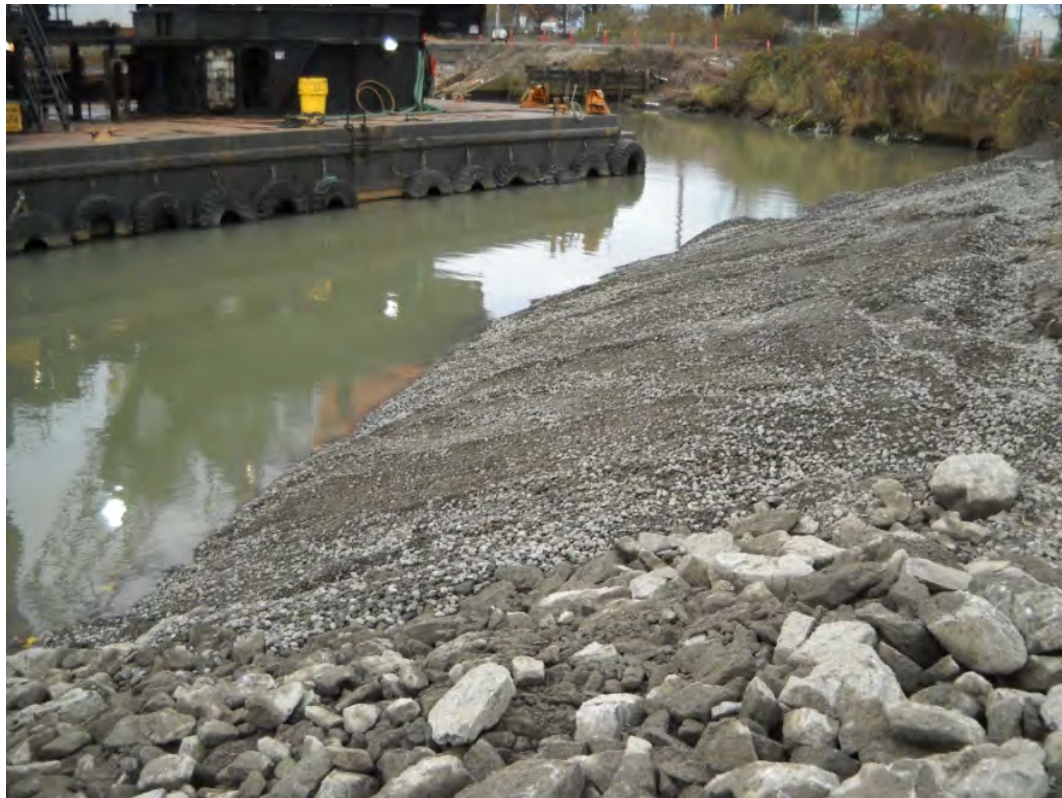
Photograph 3-8. Bank Capping—Filter Material (*top*: December 6, 2011;  
*bottom*: December 8, 2011)

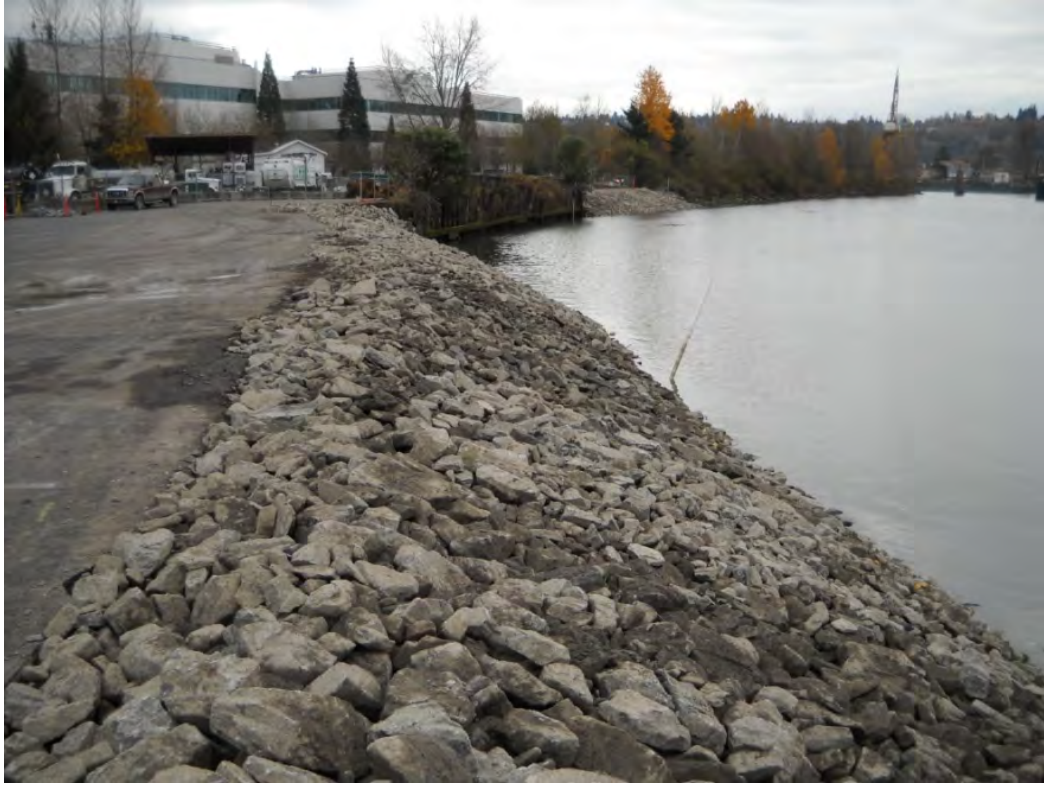
Photograph 3-9. Bank Capping—Cap Armor (December 8, 2011)

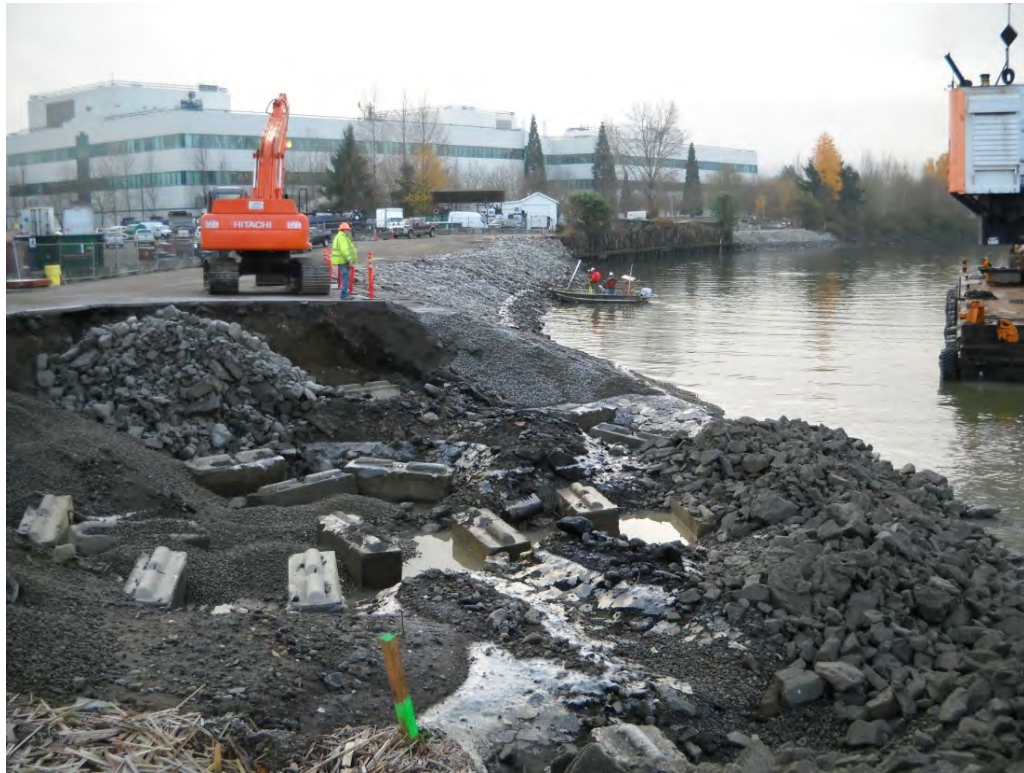
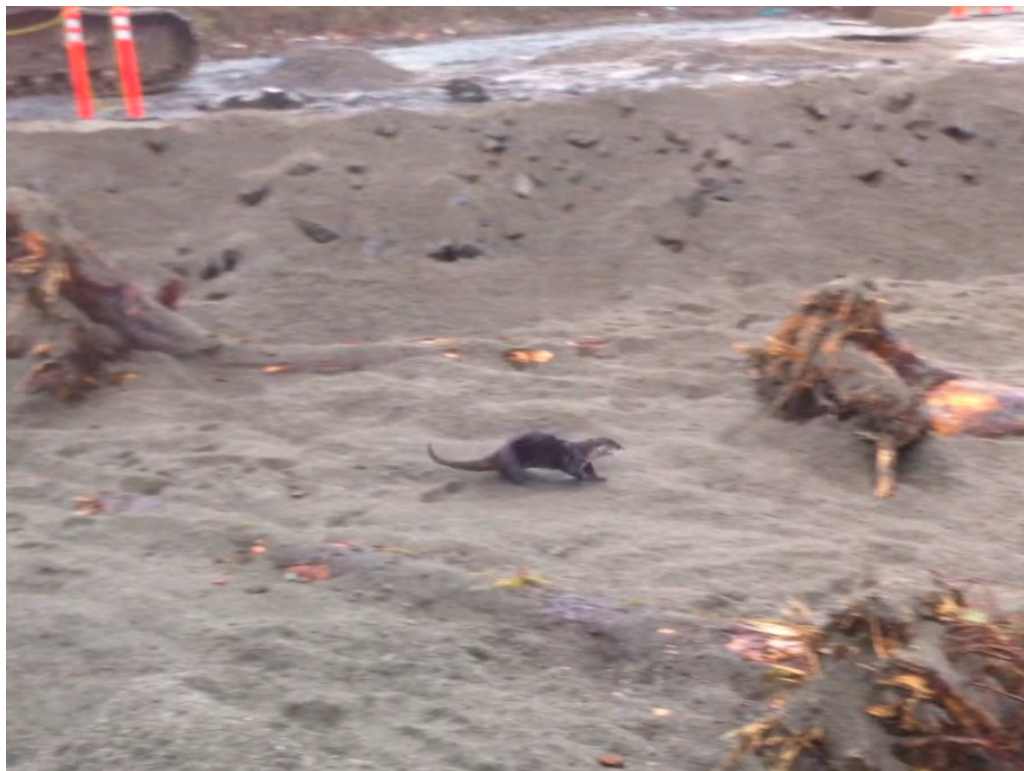
Photograph 3-10. Bank Capping—Habitat Enhancement (*top*: December 9, 2011; *bottom*: January 4, 2012)

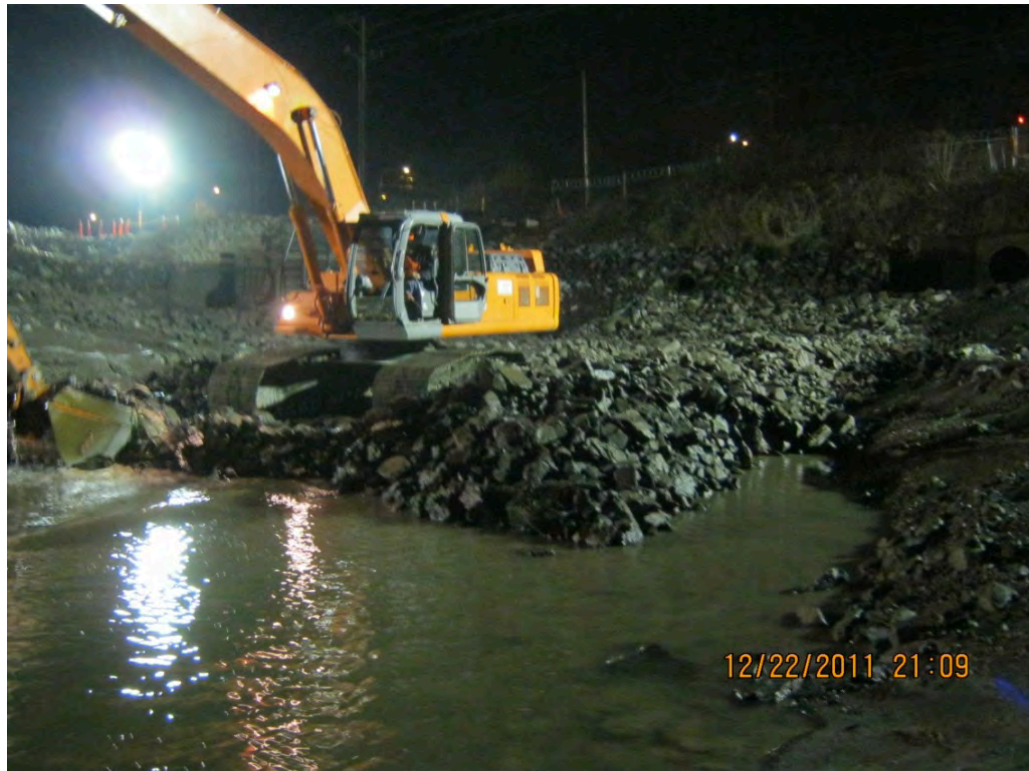
Photograph 3-11. Outfall Area Capping (December 22, 2011)

Filter material, cap armor, and heavy loose riprap were placed at the outfalls on December 12, 2011, in accordance with the contract documents. Filter material was placed using the McGinnis bucket. Cap armor and rip-rap were placed using the Bombay box.

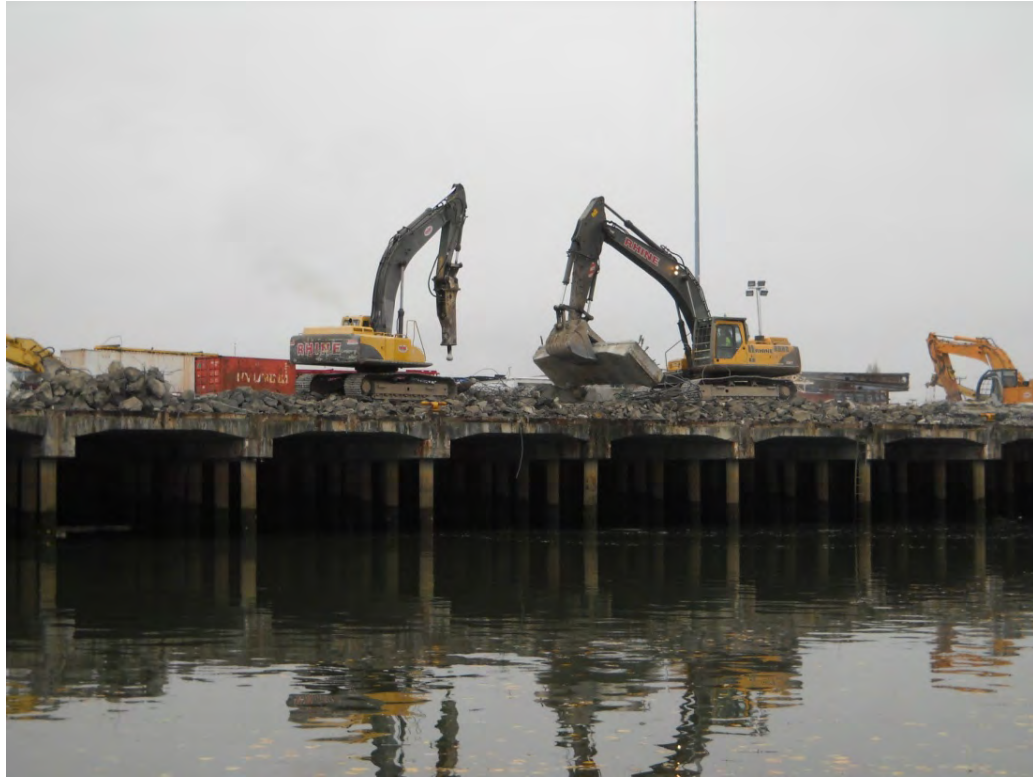
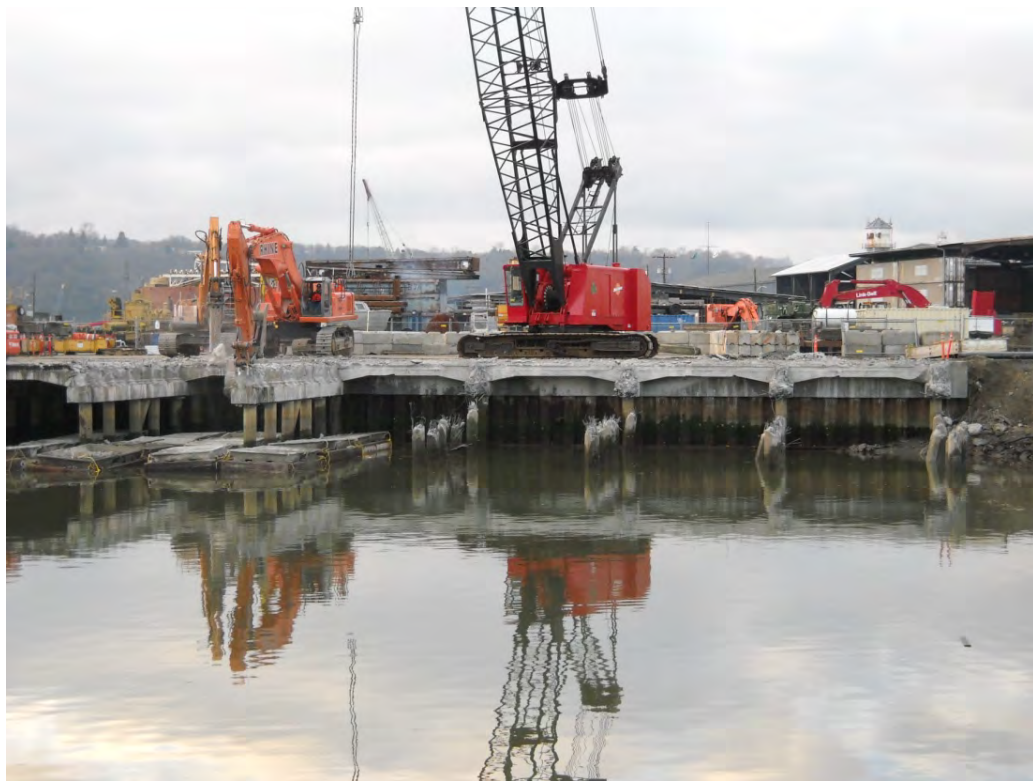
Photograph 3-12. Pier Demolition (*top*: December 7, 2011; *bottom*: December 5, 2012)

The concrete pier was demolished and removed in accordance with the contract documents and Section 4.2 of the RAWP. Concrete panels, bents, and piers were broken up on site and transported to recycling facilities by trucks, in accordance with Section 4.7 of the RAWP.

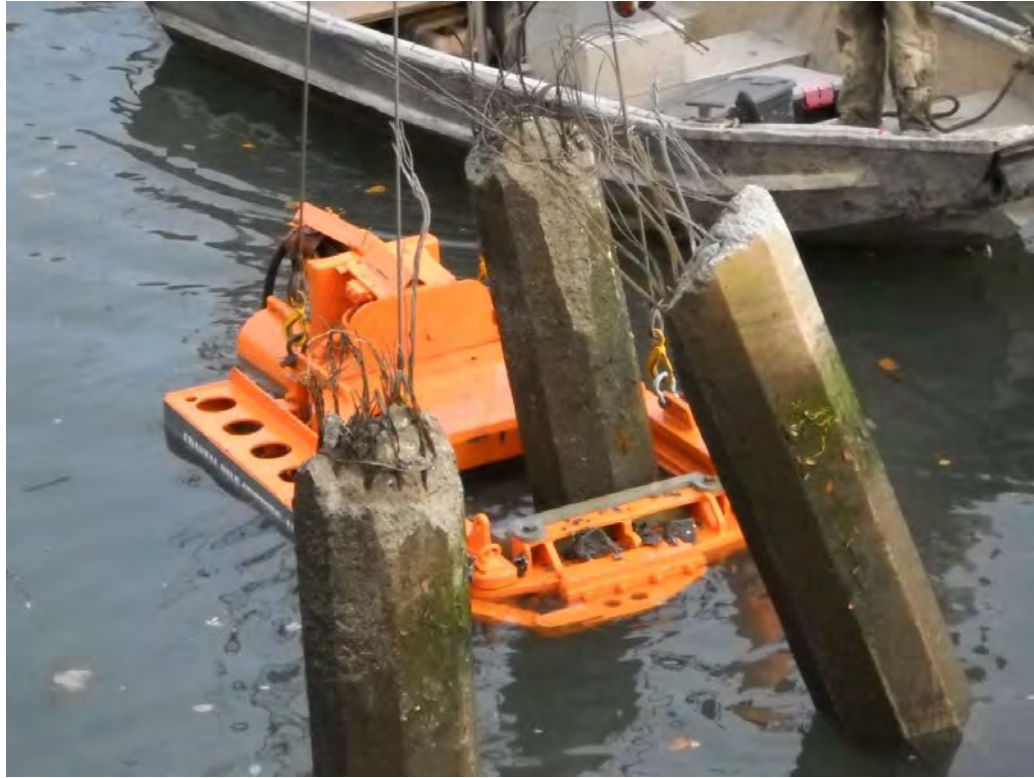
Photograph 3-13. Pier Demolition—Pile Cutting with Shear (December 16, 2011)

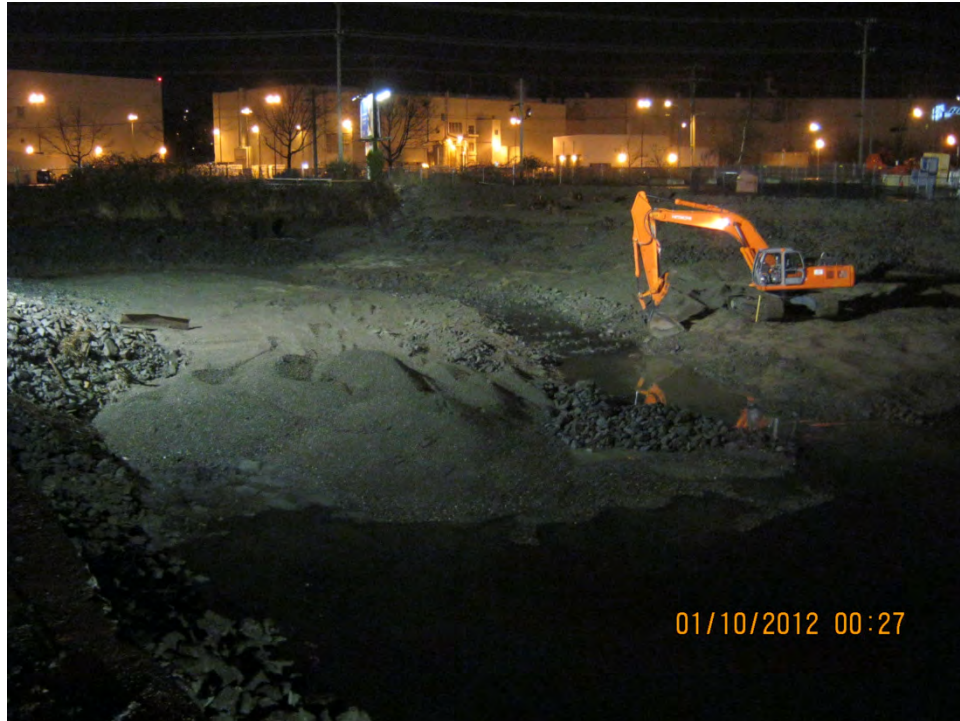
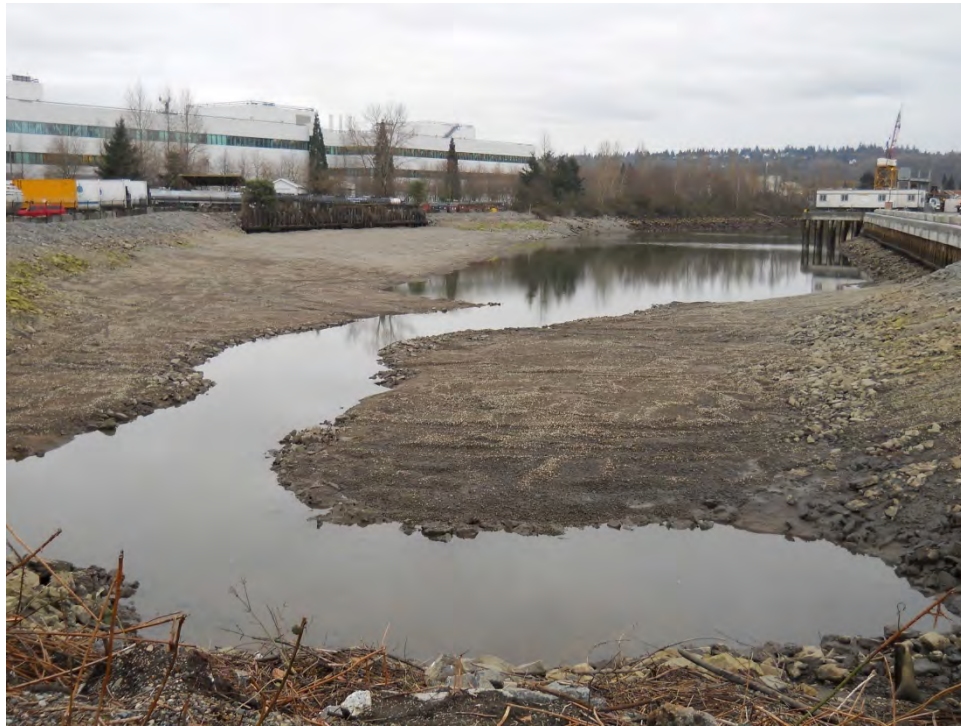
Photograph 3-14. Waterway Capping (*top*: January 10, 2012; *bottom*: February 13, 2012)

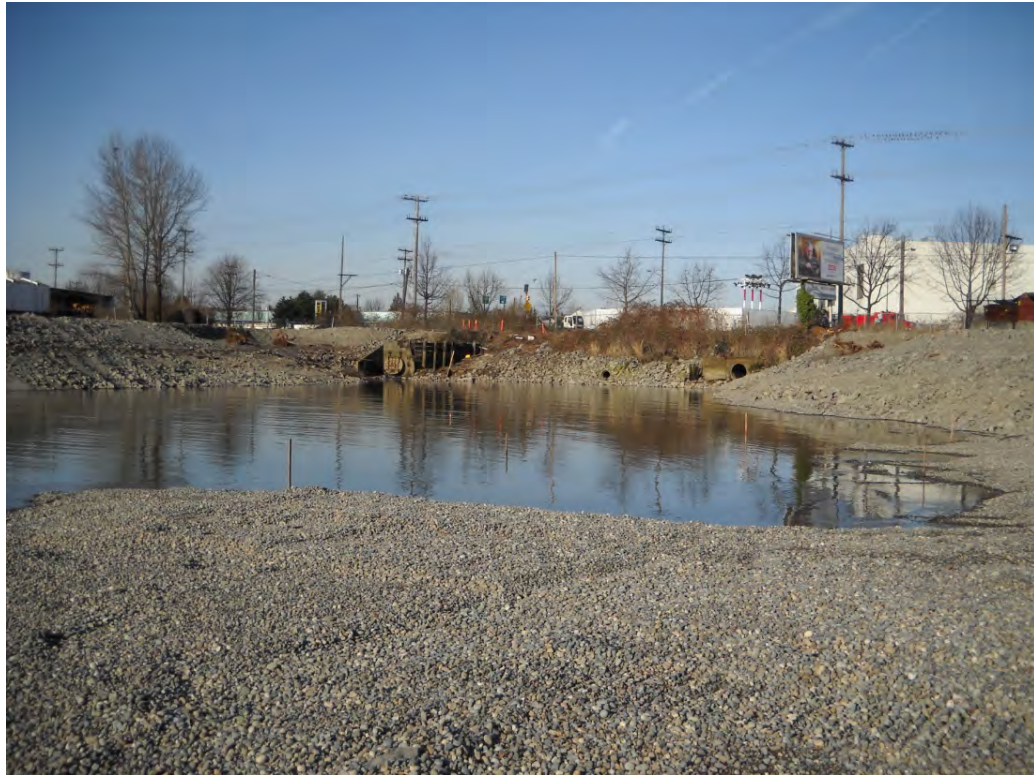
Photograph 3-15. Waterway Capping (January 27, 2012)

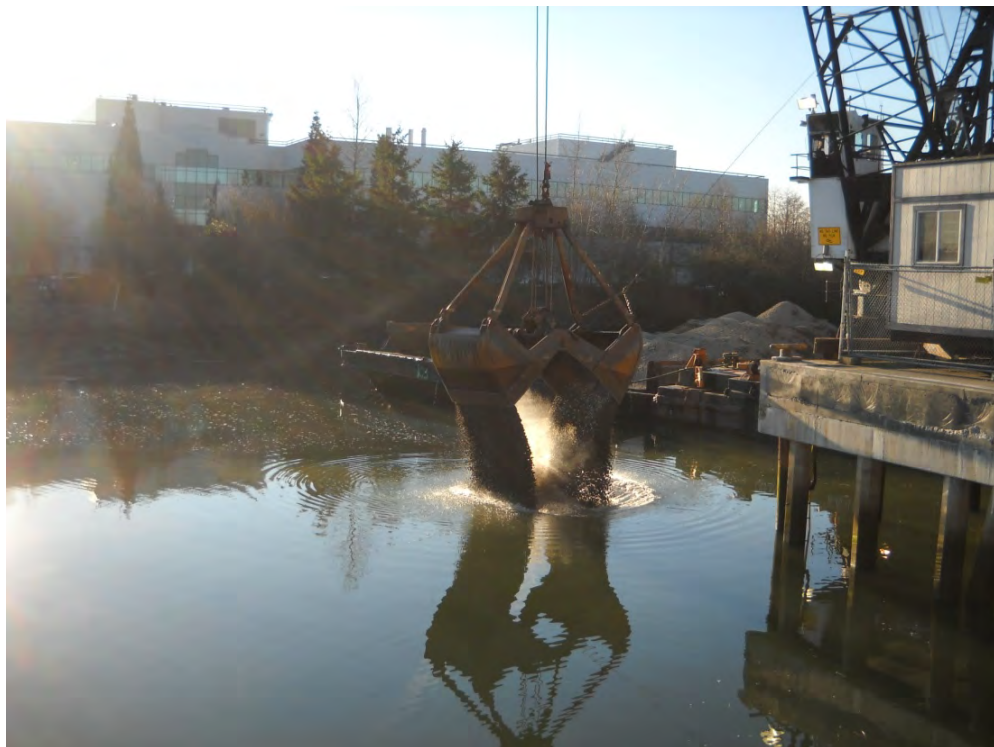
Photograph 3-16. Boundary Area Material Placement (February 7, 2012)

Subsequent boundary area sampling was performed on February 14, 2012 to document surface conditions following boundary area material placement. Review of laboratory results revealed that after boundary area material placement, sediment characteristics met the removal action objectives. The post-boundary area capping documentation sampling activities are described in Appendix A, SSAR.

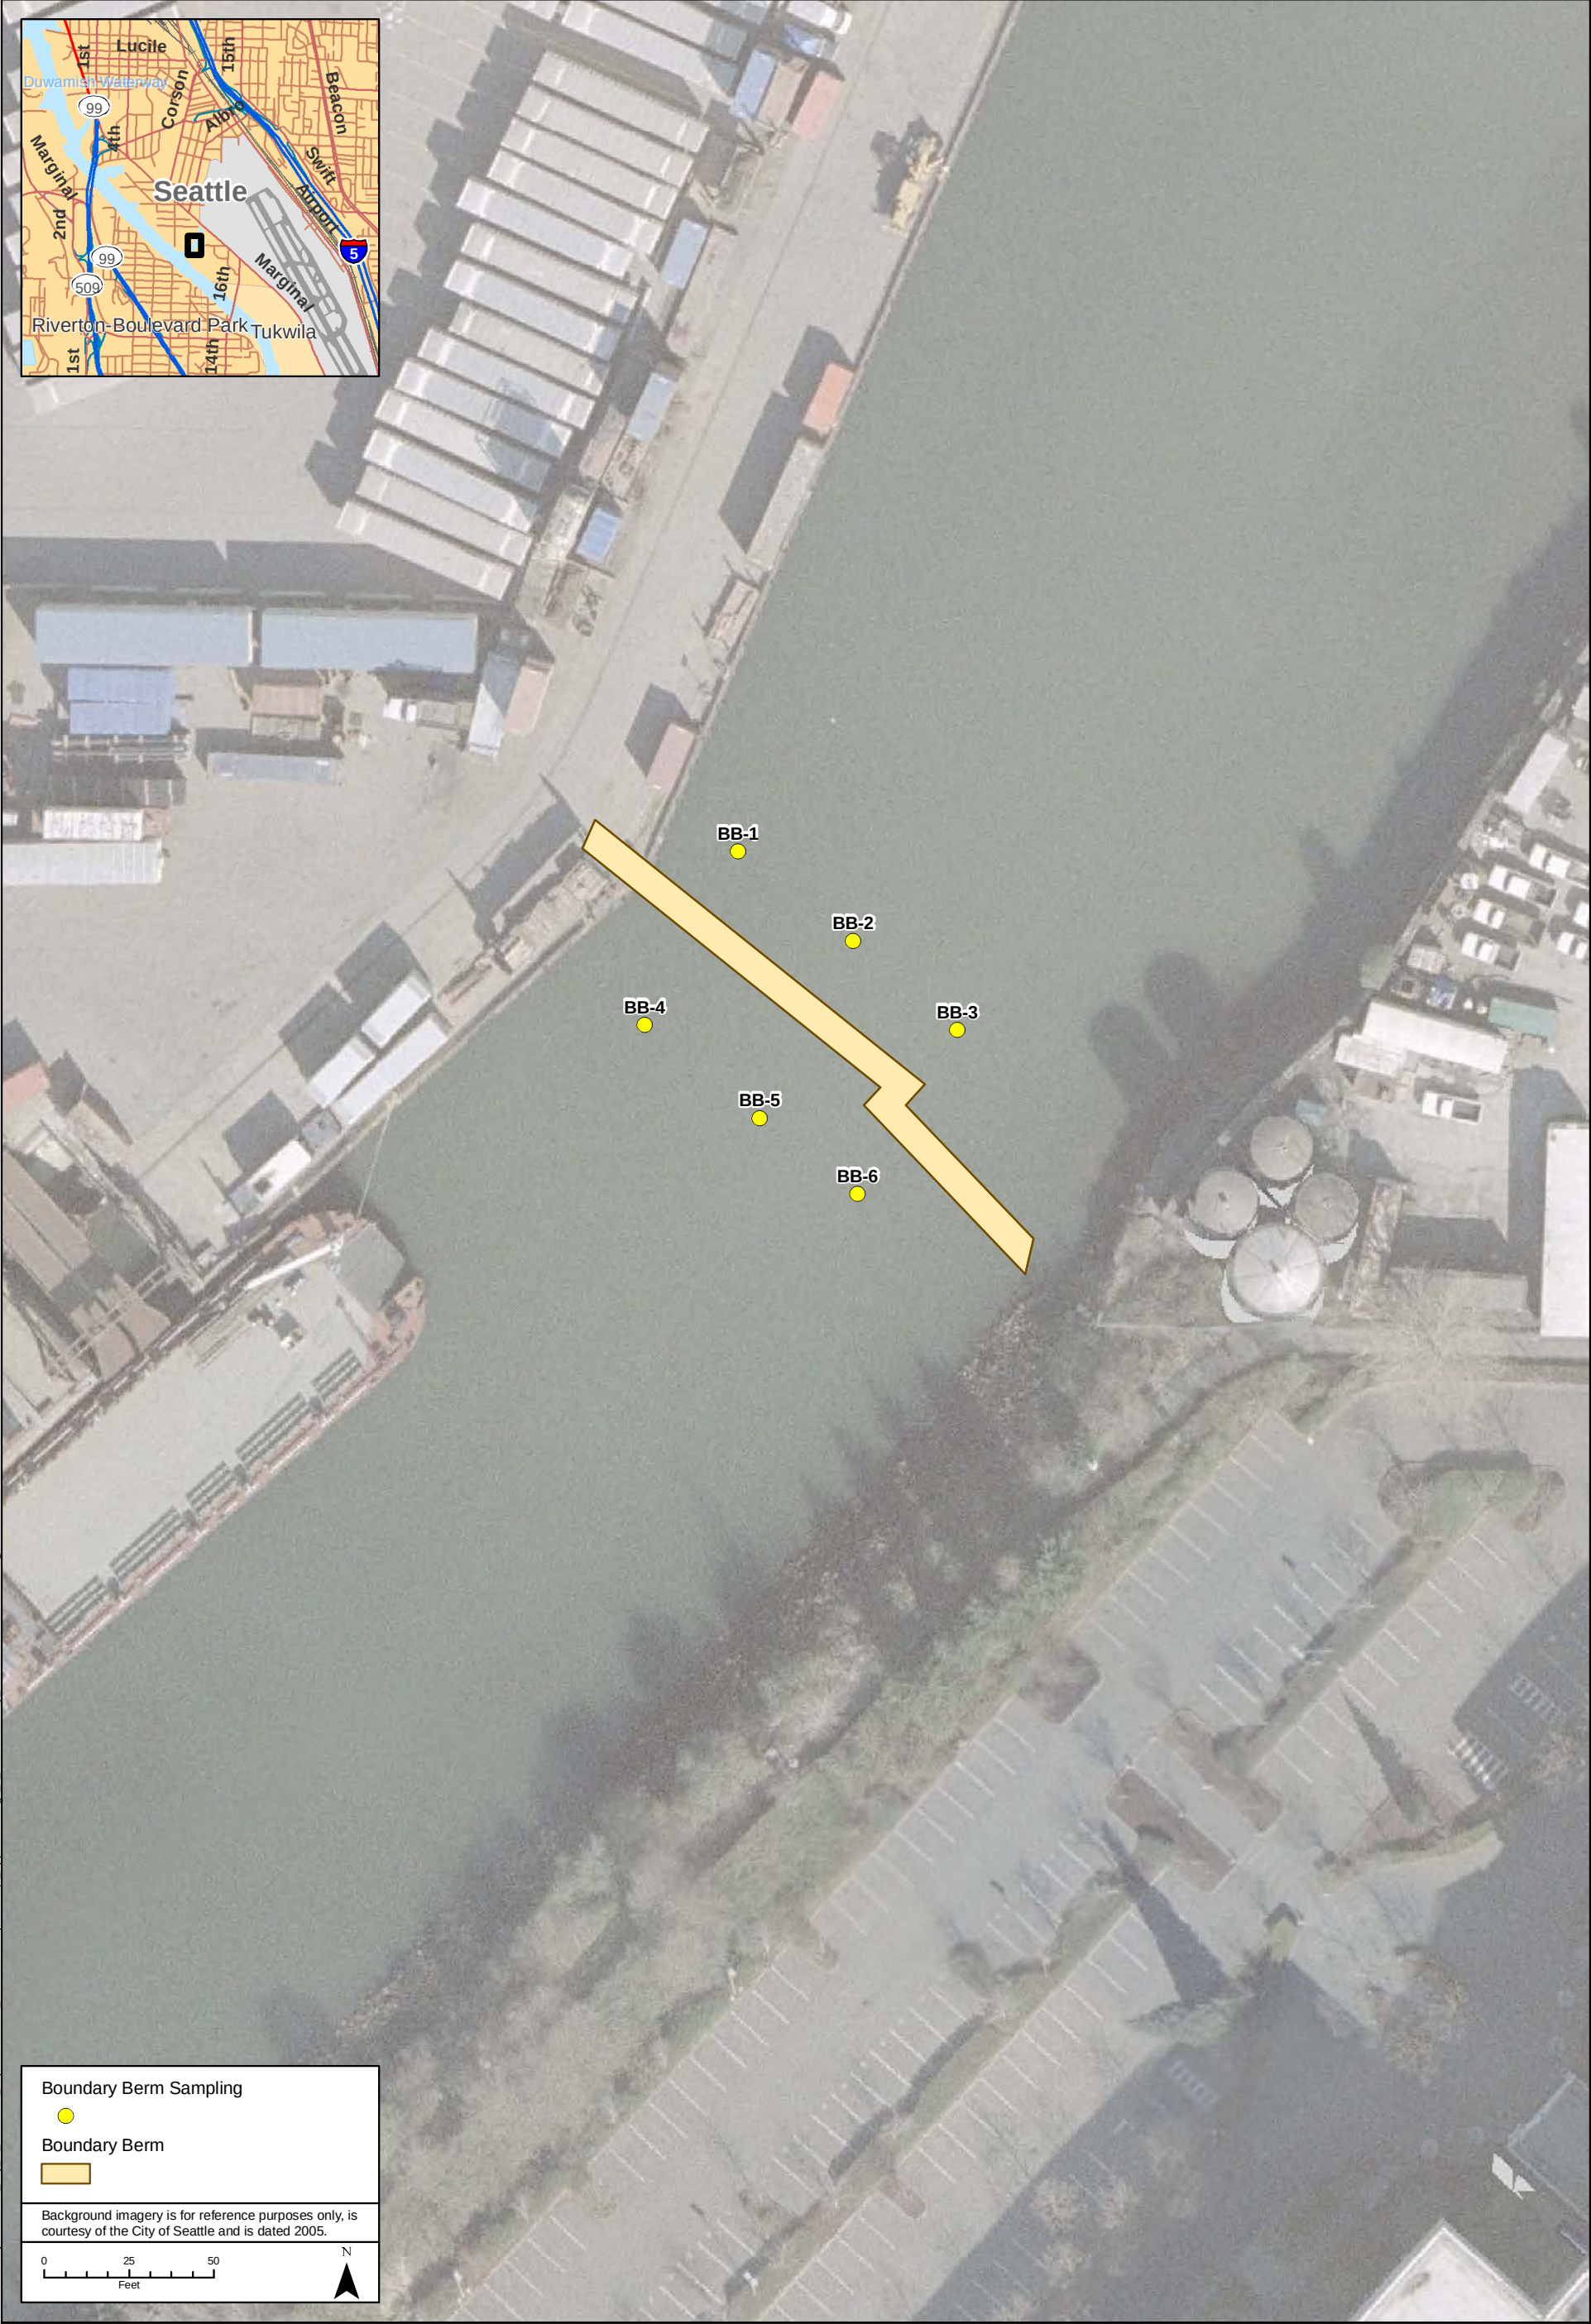
**Figure 3-3.**  
Boundary Berm Turbidity Sampling  
Slip 4 Removal Action
