SUBJECT: First Five-Year Review Report
Cedartown Municipal Landfill Site
Cedartown, Georgia
GAD980495402

Five-Year Review Report

**Cedartown Municipal Landfill Site
(EPA ID #: GAD980495402)**

West of N. Tenth Street and Girard Avenue
Cedartown, Polk County, Georgia

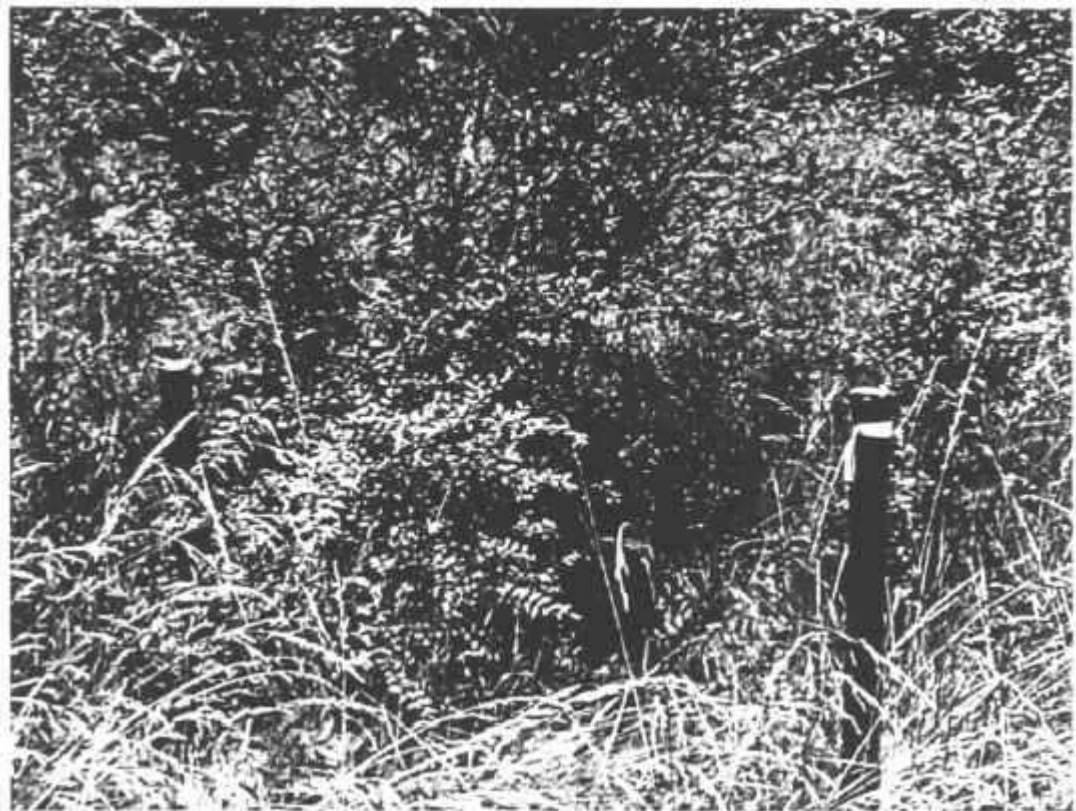
Photograph: Monitoring Well LW-3
Project Name: Cedartown Municipal Landfill Superfund Site

The Record of Decision required periodic inspection and surface-water sampling of a seep west of the Coke Pond. The seep could not be located during the inspection. It is believed that the seep may be dry or much less visible than in the past due to very low rainfall over the last two years. It is also possible, the seep has been hidden by woody vegetation. Many of the monitoring wells were observed during the inspection. The protective casings appeared to be in good condition. The protective casings for monitoring wells LW-3, LW-4, OW-5, and OW-4 are shown on the photos in attachment B.

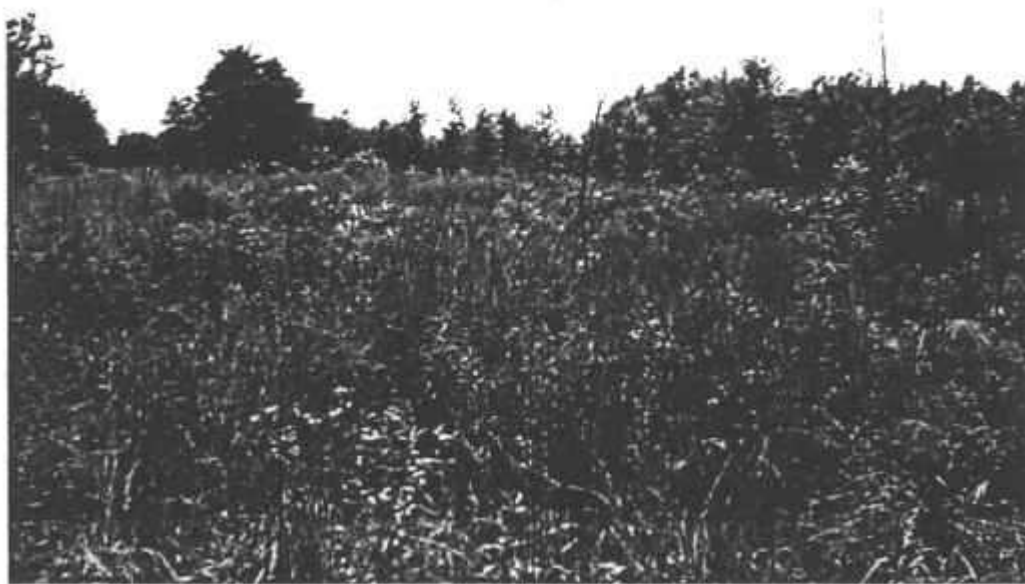
Photograph: Landfill cover near LW-4
Project Name: Cedartown Municipal Landfill Superfund Site

An inspection of the Cedartown Municipal Landfill was performed by Steve Bath and Phil Smith on 13 June 01. We were provided access and accompanied by city personnel while at the site. The majority of the site was visually inspected. Some areas, even though within the limits of the landfill, were never used for filling. Most of these areas were heavily wooded and were not inspected. The areas inspected were generally those where the landfill cap had been placed. Most of the areas inspected were over grown with weeds, woody vegetation, and/or small trees. These conditions can be seen in some of the photos attached to this

report. See attachment B for photos. The areas with heavier vegetation were difficult to inspect for deficiencies such as cracks or depressions. Typically, landfill cover maintenance includes periodic cutting of vegetation and control of erosion. In areas that were easily visible for inspections, the cap appeared to be in good condition. No significant erosion was observed.

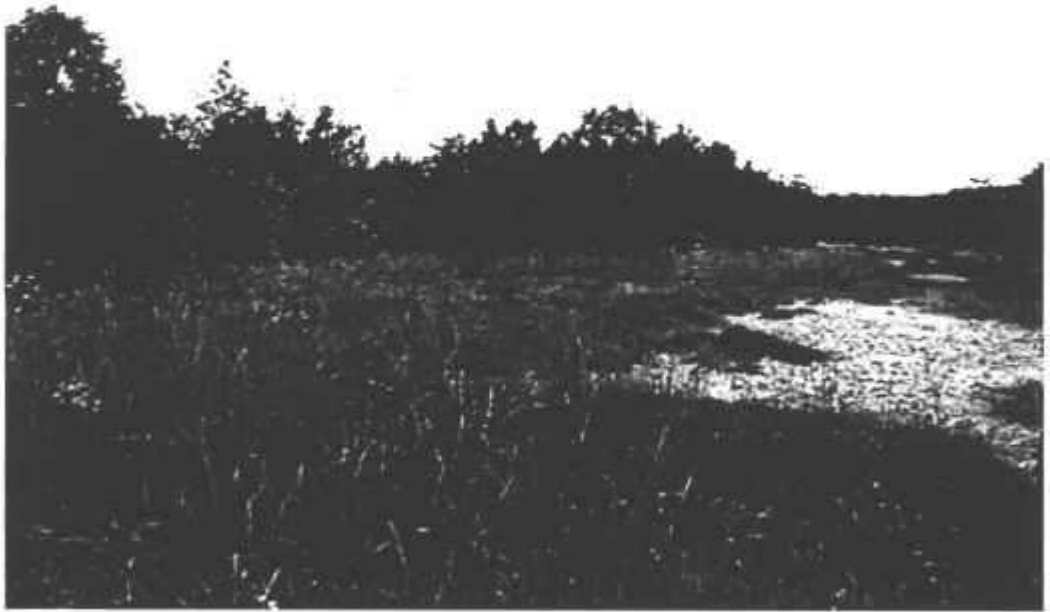
Photograph: Landfill cover near LW-2
Project Name: Cedartown Municipal Landfill Superfund Site

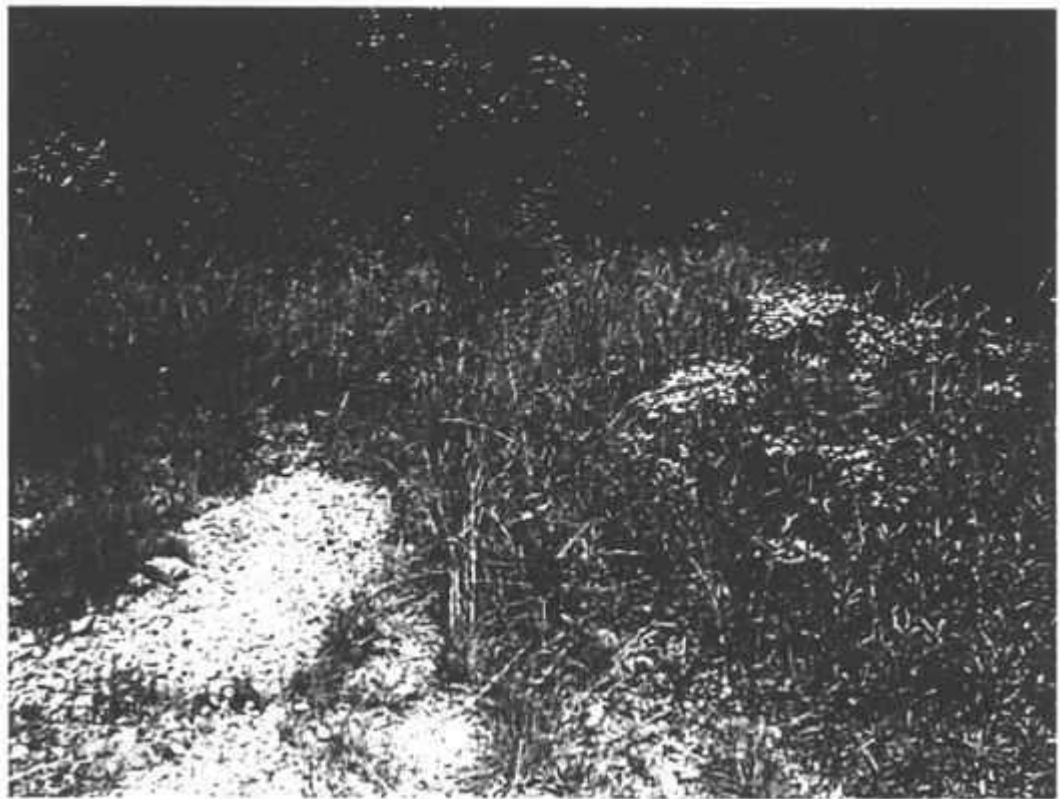
Several small bare areas were observed on the landfill cap. Two of the bare areas are shown on the photos in attachment B. These areas did not appear to be eroding to any significant degree. The bare areas are mostly located on access roads across the site. The largest bare area and several smaller bare areas are located between monitoring wells LW-4 and LW-2 (see figure 1.2). Other small bare areas were observed on the eastern slope in the vicinity of monitoring wells CL-08-WP and CL-08-WT. The lack of vegetation cover is believed to be due to the densely compacted cap material and vehicle traffic.

Photograph: Small area of surface erosion on eastern slope
Project Name: Cedartown Municipal Landfill Superfund Site
