**THIRD FIVE-YEAR REVIEW REPORT**

**WASTE DISPOSAL ENGINEERING LANDFILL  
SUPERFUND SITE**

City of Andover  
Anoka County, Minnesota

U.S. EPA Region 5  
Superfund Division  
Chicago, Illinois

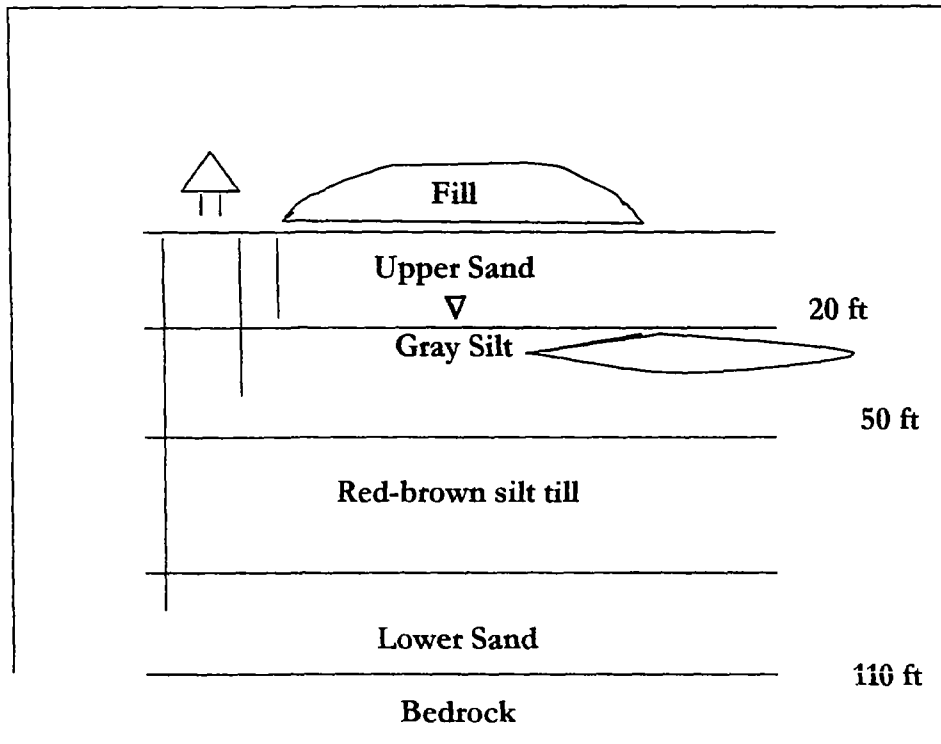
## General Geology of Site

(The vertical lines represent wells in D, B, and A horizons, from left to right.)

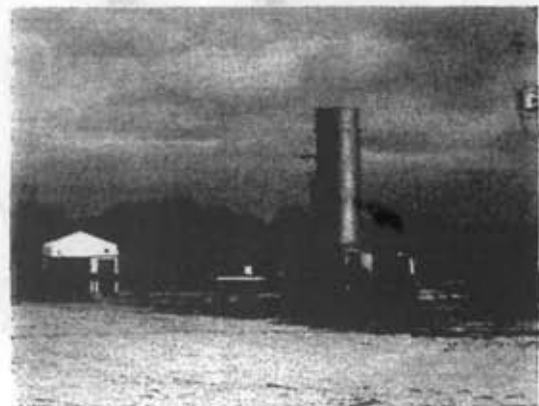
#### Ground Water Remediation Control Building

This building contains piping from each of the site's ground water extraction wells with corresponding valves, flow meters, and electrical control panels. Here, flow from each well can be directed to the treatment pond, storm water pond, or sanitary sewer. Inside, there is:

- potential for contact with contaminated ground water
- electrical hazard from the control panels

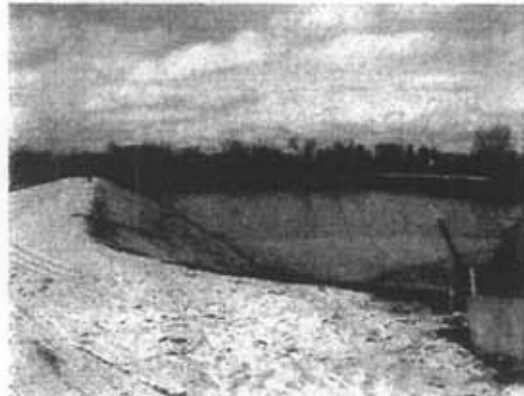
The ground water treatment pond detains and aerates contaminated ground water prior to discharge to the sanitary sewer. Within the fenced enclosure, there are:

- slip hazards associated with smooth geomembrane liner and formation of ice around pond perimeter during winter
- drowning hazard from deep aerated water and difficult egress up steep geomembrane covered slopes
- potential exposure to volatile organic compounds in air and water
- electrical hazard from aeration equipment control panels

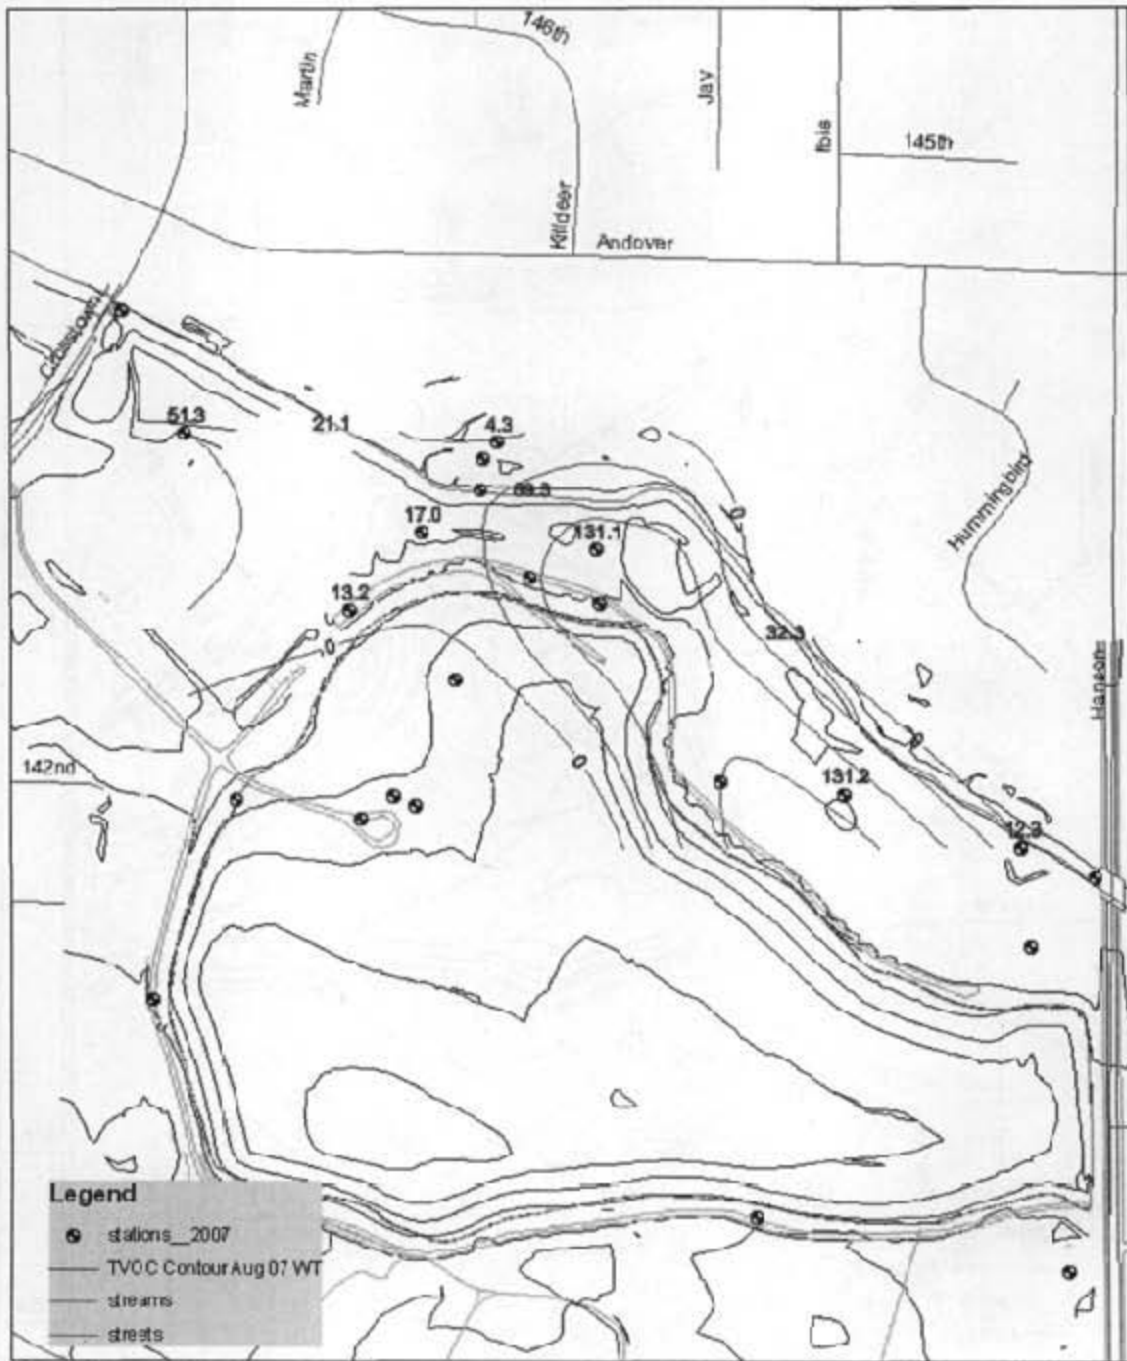
Figure 17 Contour map of Total VOCs at the water table (August 2007)

Contour interval is 50 ug/L.

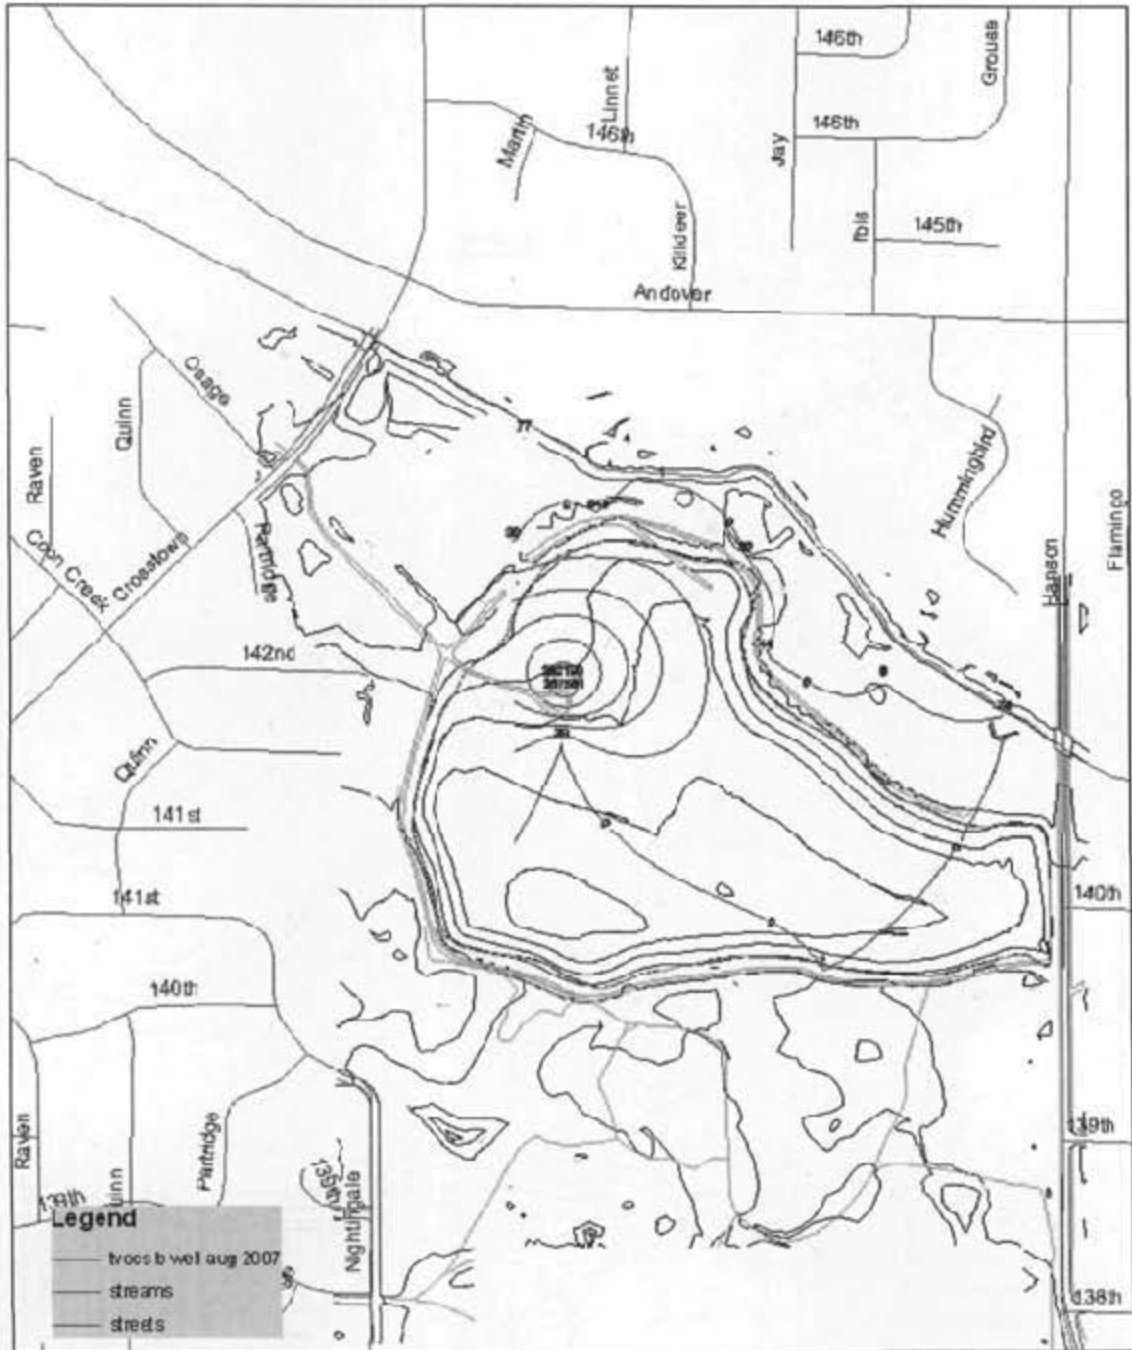
Figure 18 Contour map of Total VOCs at base of the Upper Sand (August 2007)

Contour interval is 50,000 ug/L

Highest Concentration is 292190  
EW-14 data from 27 Sep 07 included

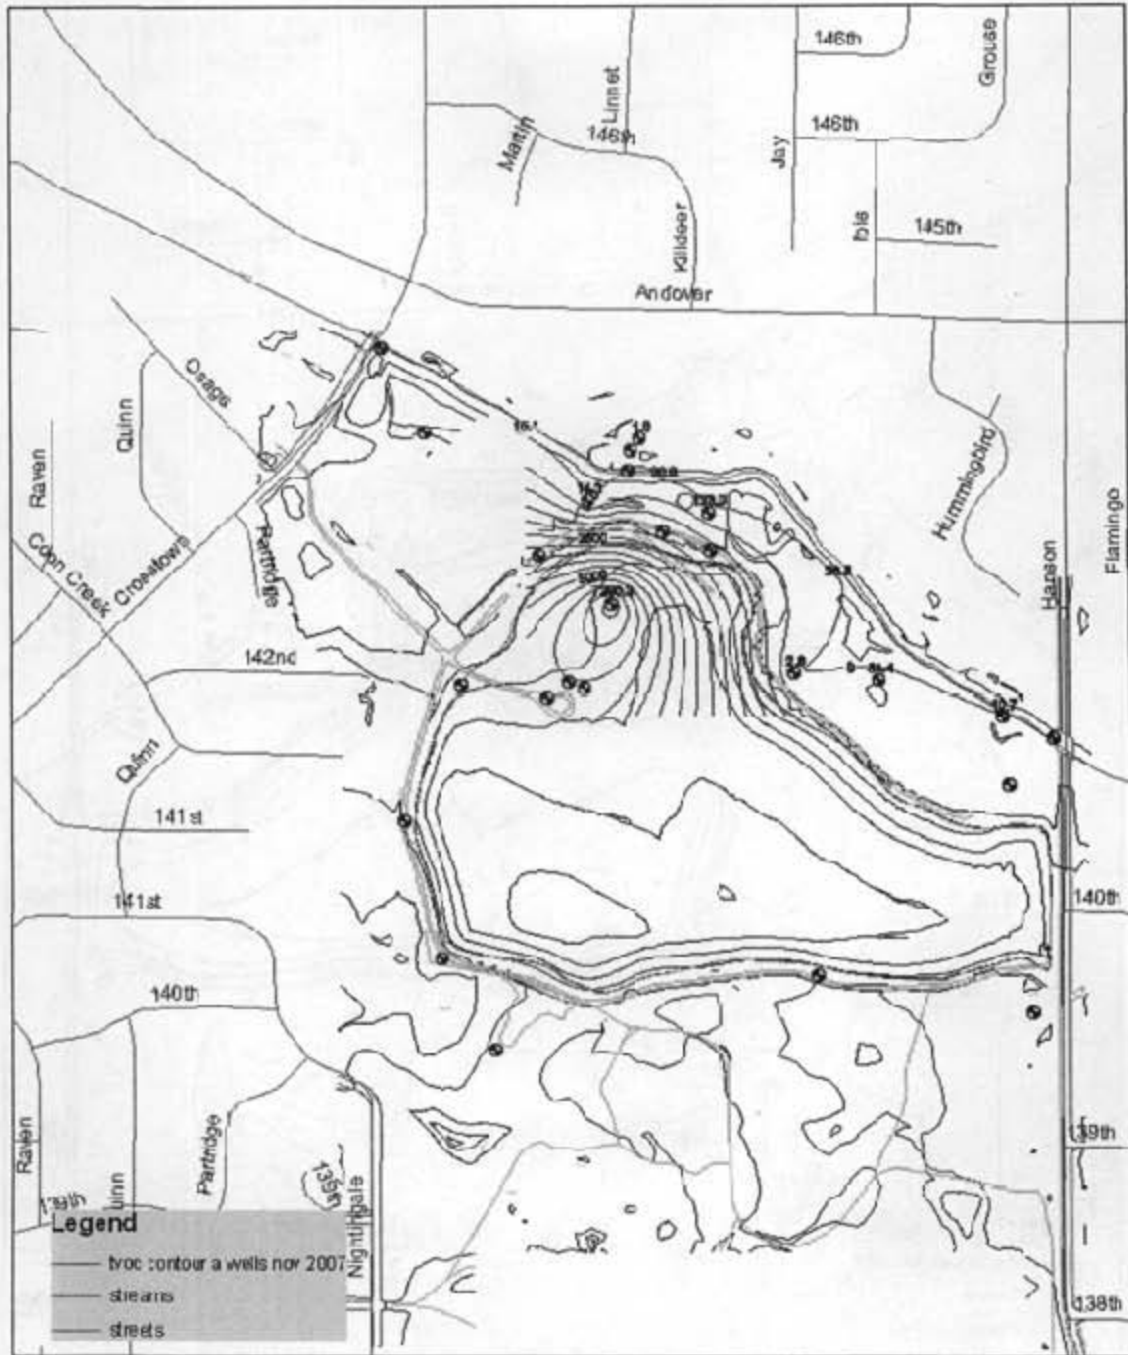
Figure 19 Contour map of Total VOCs at the water table (November 2007)

Contour interval is 500 ug/L

Highest concentration is 7280 ug/L

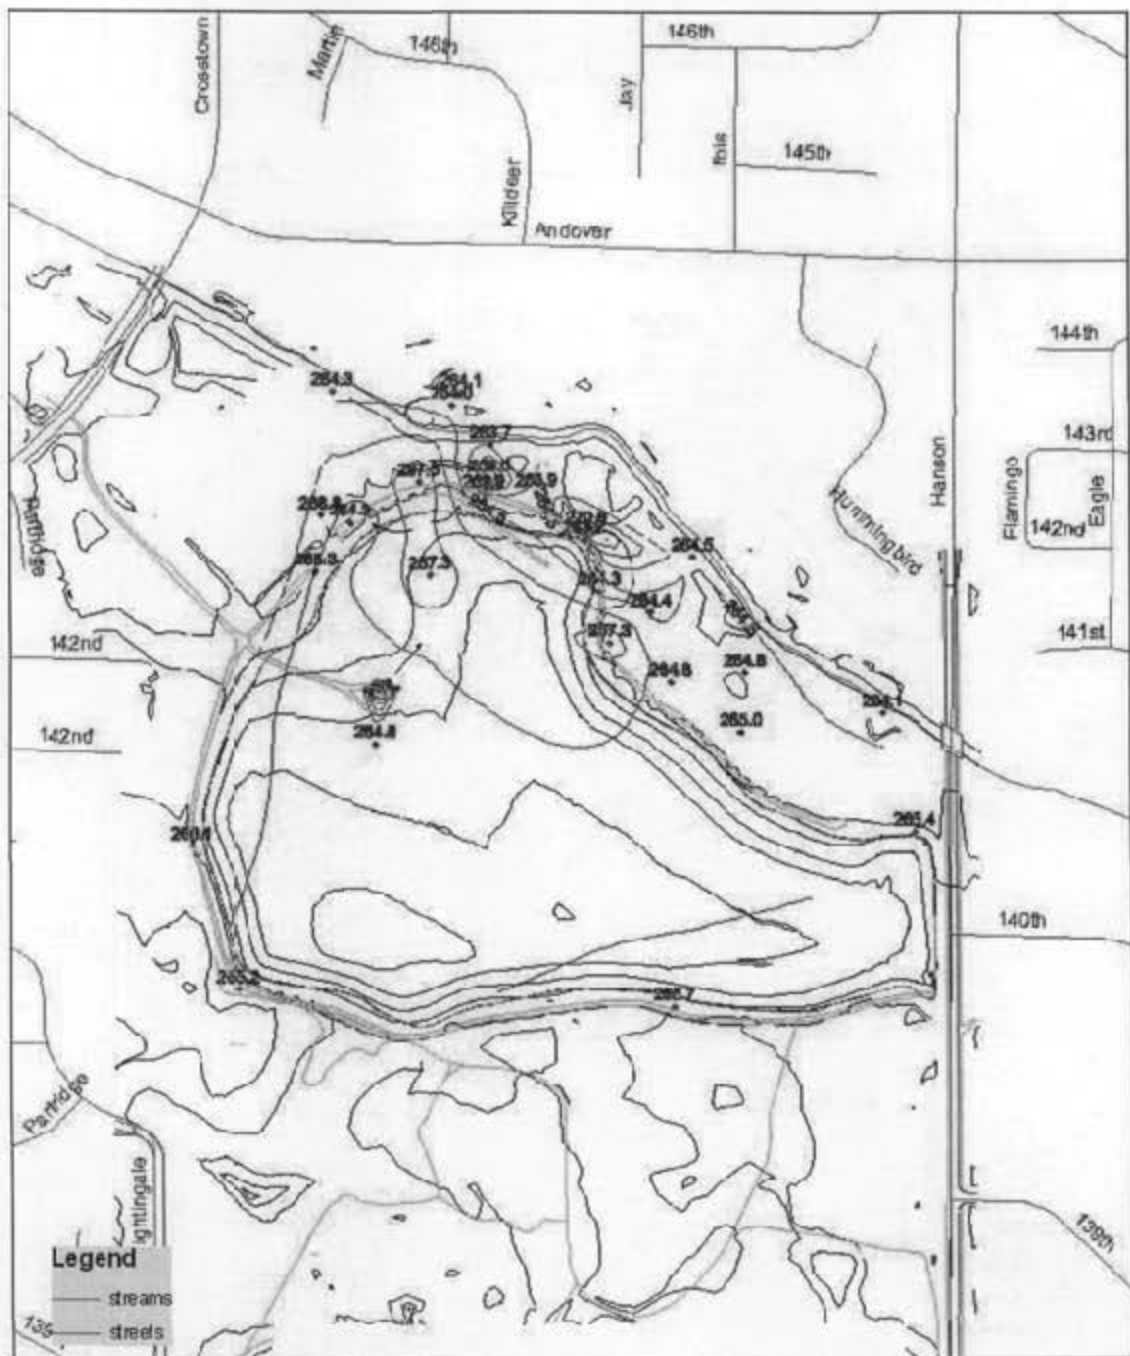
Figure 22 Contour map of flow at the base of the Upper Sand (August 2007)

Contour interval is 1 meter, Algorithm is natural neighbor

Flow is out of pit to IIE

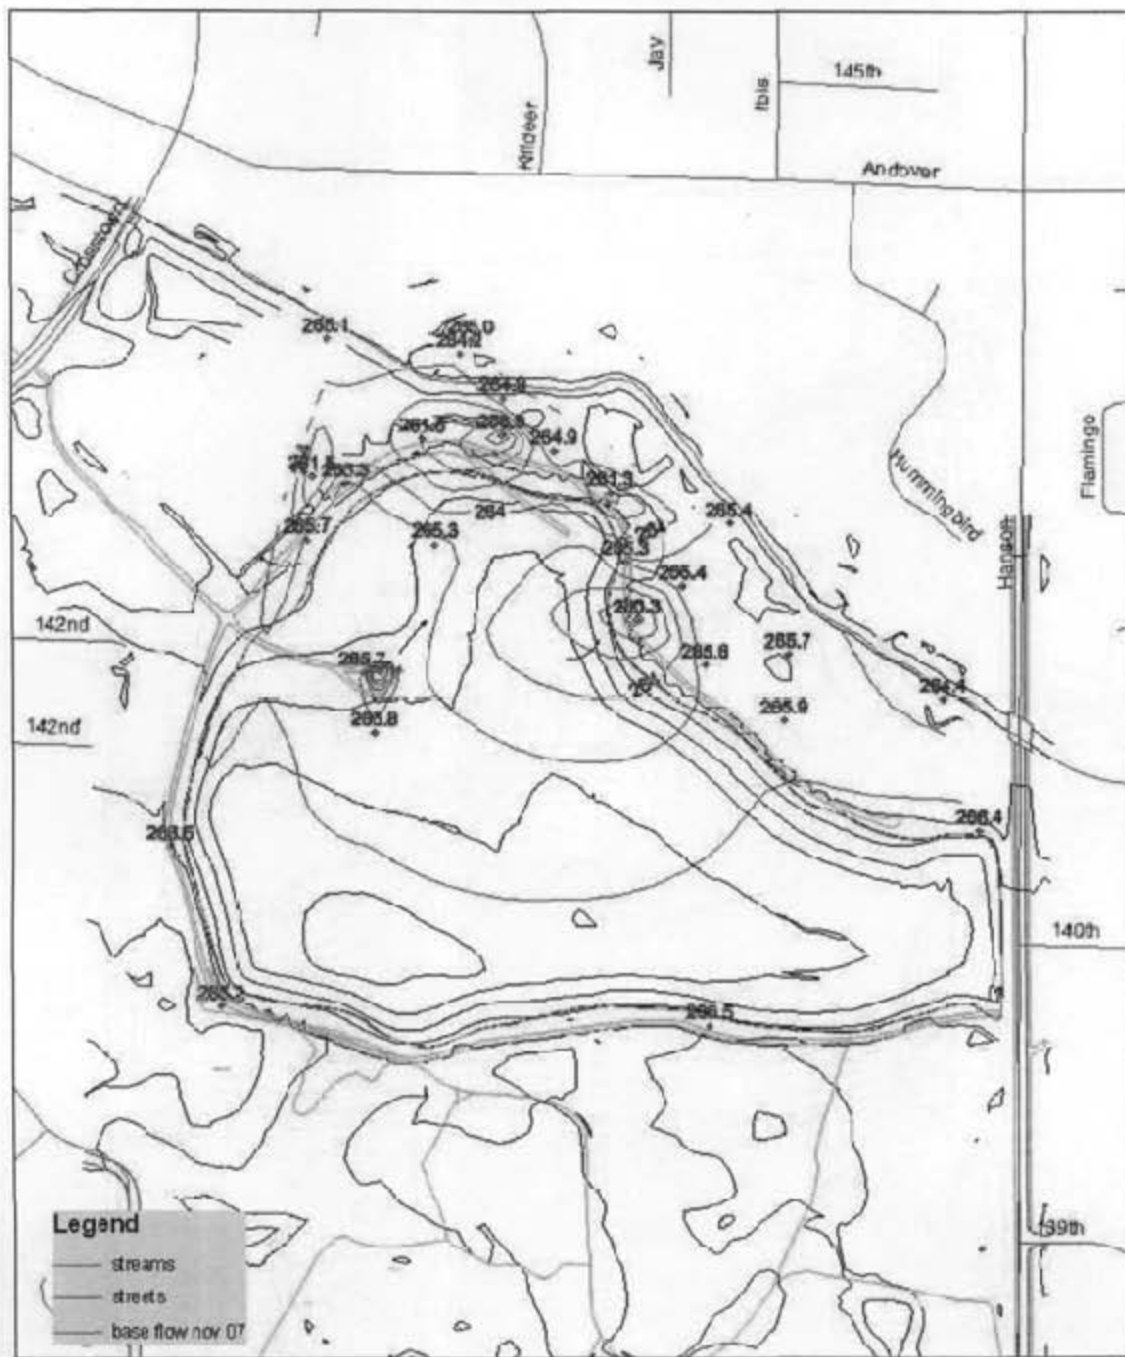
Figure 24 Contour map of flow at the base of the Upper Sand (November 2007)

Contour interval is 1 meter, Algorithm is natural neighbor

Flow is out of pit to NE

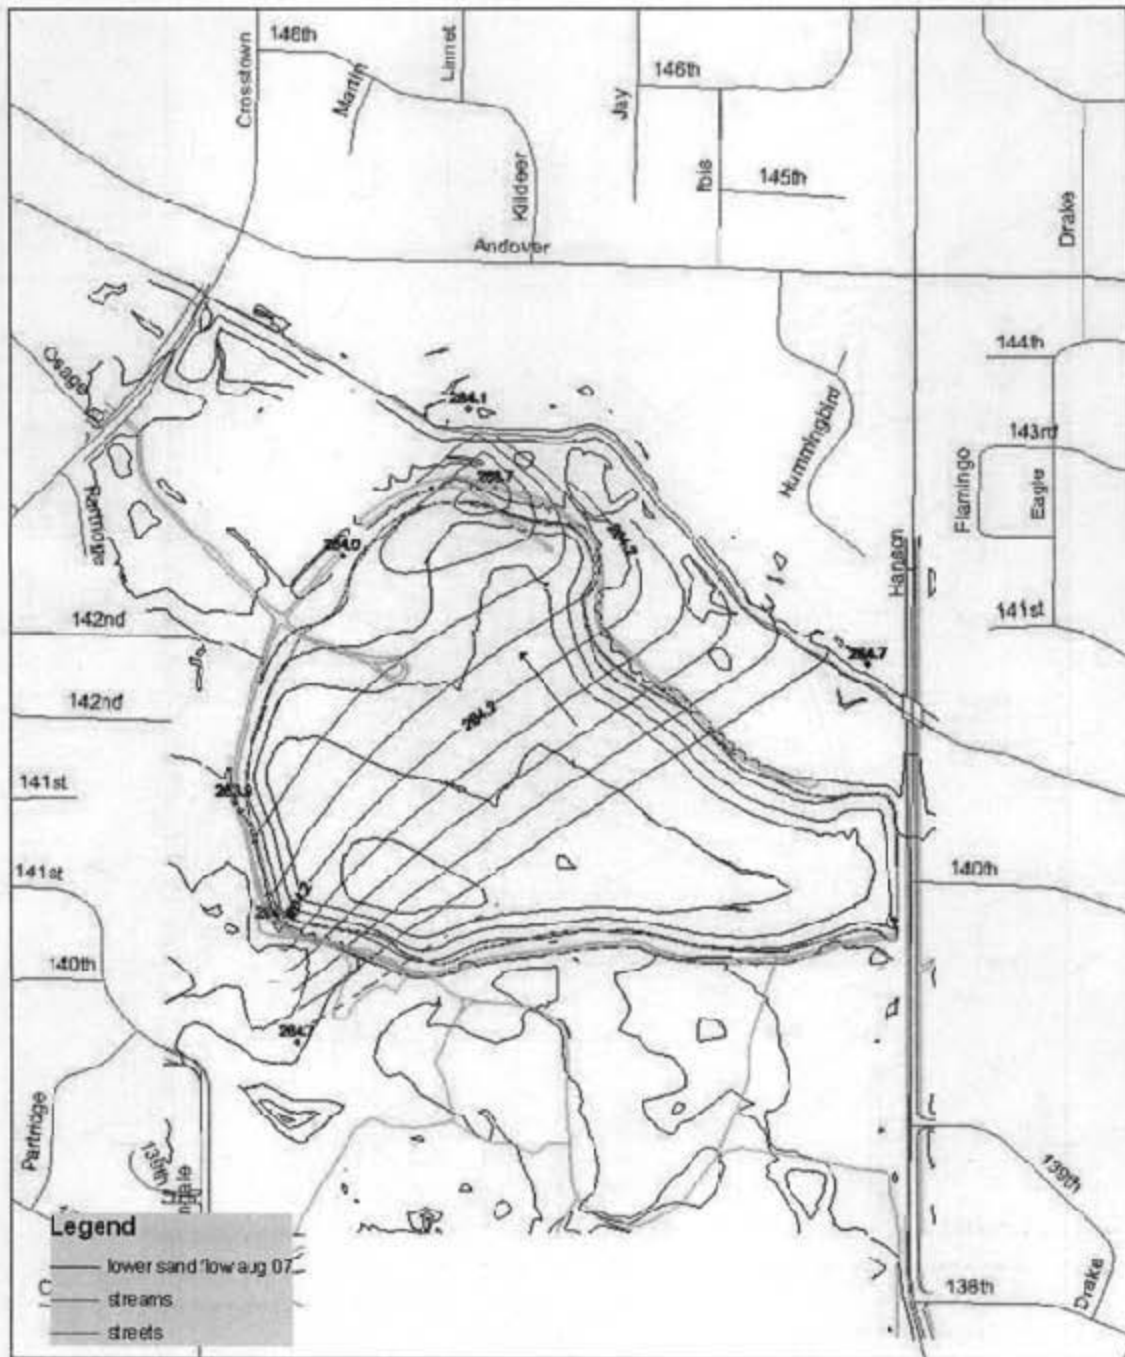
Figure 25 Contour map of flow in the Lower Sand (August 2007)

Contour interval is 0.1 meter, Algorithm is natural neighbor
