Fourth Five-Year Review Report
for the
Republic Steel Corporation Quarry Superfund Site
Elyria, Lorain County, Ohio

U.S. Environmental Protection Agency
Region 5
Chicago, Illinois

March 2013

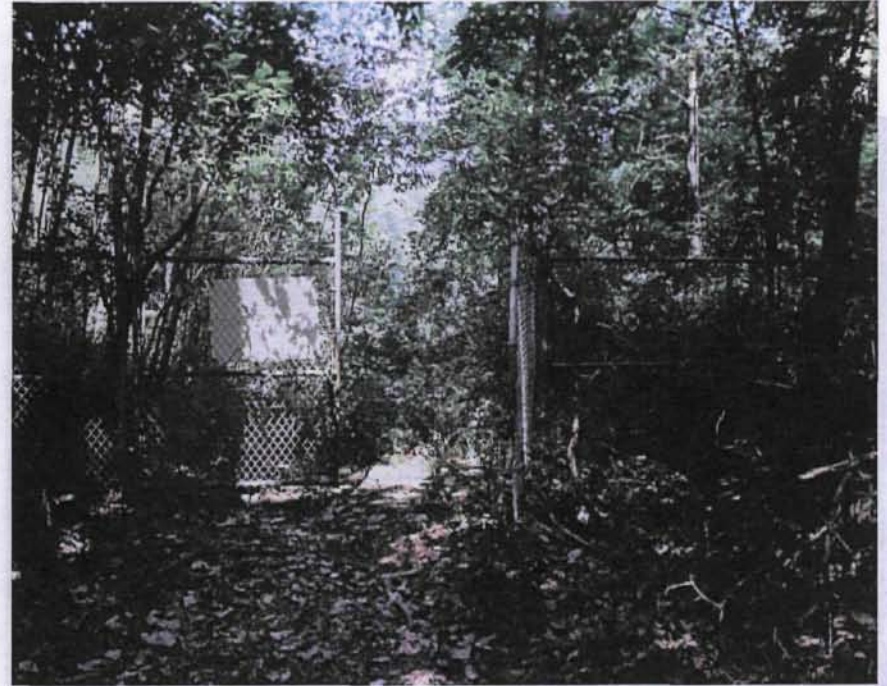
Photo 2: Approach to front gate of quarry property from the Maverick Tube yard. Note that the posted sign cannot be read from outside of the gate. Text of the sign reads the same as that in Photo 16.

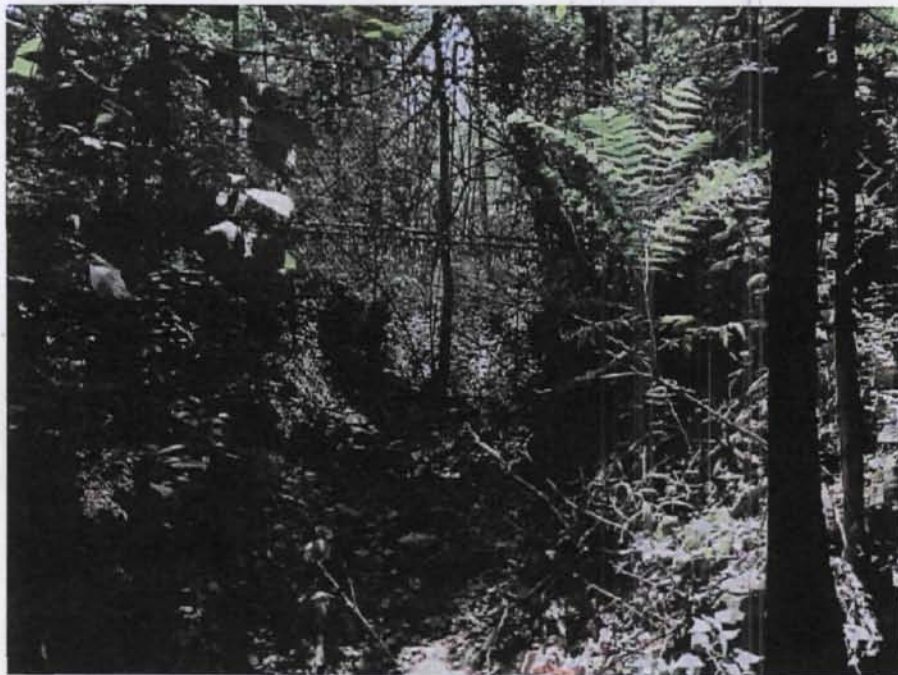
Photo 3: A view from inside the fence line of the RSQ Site. The photo was taken from inside the former pickle liquor ditch looking southeast upgradient toward plant discharge point.

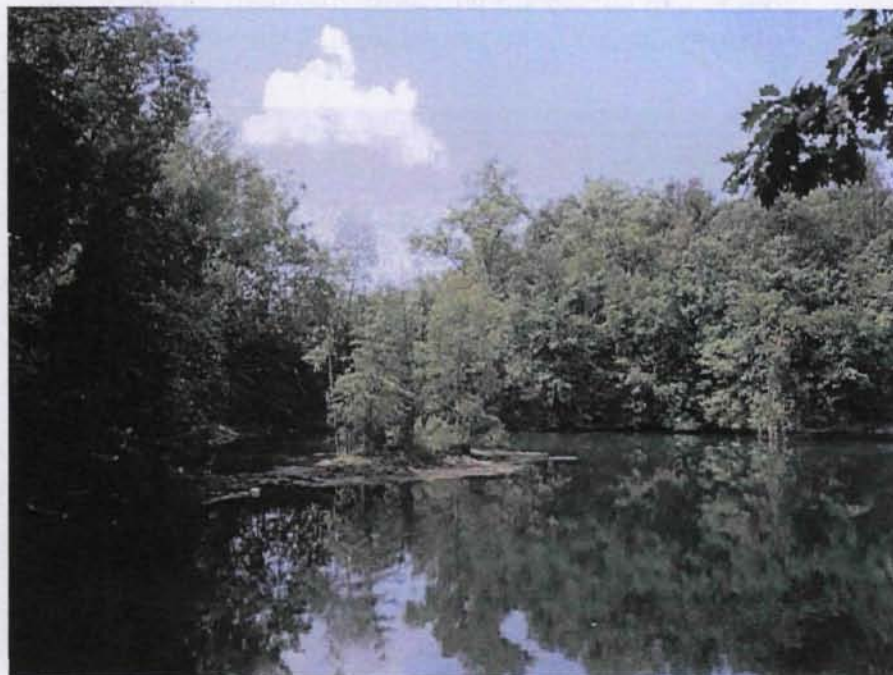
Photo 4: A view from the southeast edge of the quarry pond looking southwest. The former boat launch area is in the bottom left corner of the photo. The island is visible in the mid-ground.

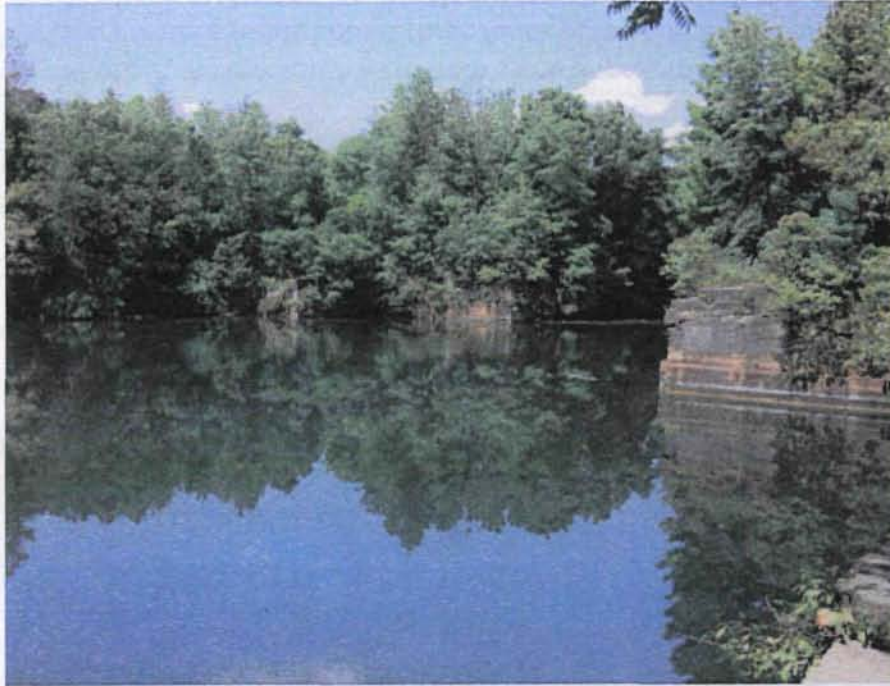
Photo 5: A view from the southeast edge of quarry near the outlet structure looking to the northwest. The right mid-ground shows the opening into the northern end of the quarry pond.

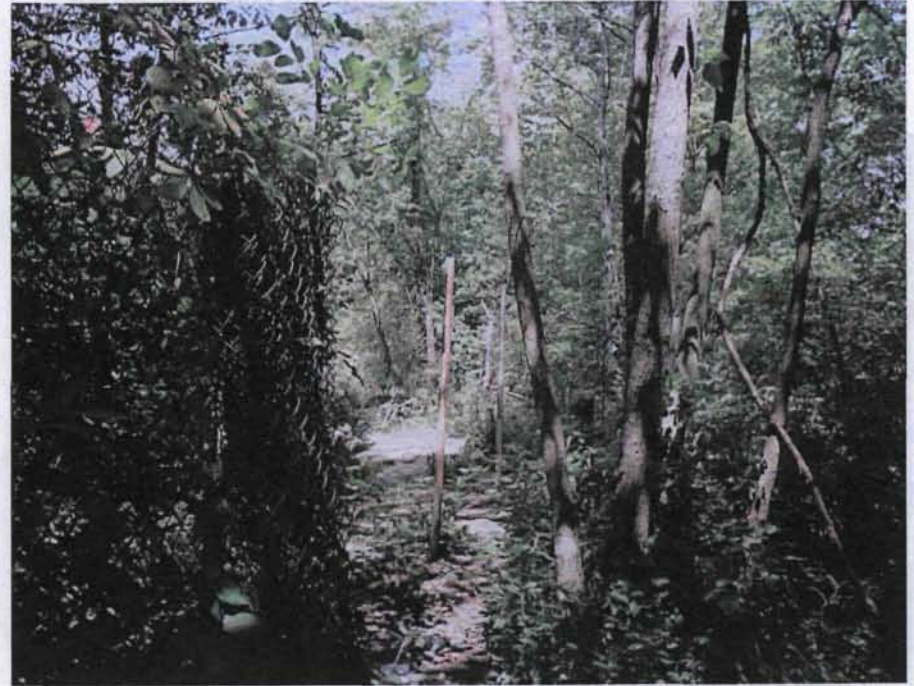
Photo 6: A view along southeast perimeter of RSQ Site looking northward. The Black River is immediately to the east (right) of the photo edge. The quarry bank is just left of the fence line. The photo shows a large breach where the fence was cut and rolled to enable access.

- 1) Repair the perimeter fence in such a way as to prevent human trespass;
- 2) Replace any illegible warning sign with legible signs;
- 3) Remove vegetation from both sides of the fence line in order to expose vandalism and signs; and
- 4) Post additional warning signs on the north perimeter fence due to the presence of the new single family housing units to the north of the Site.

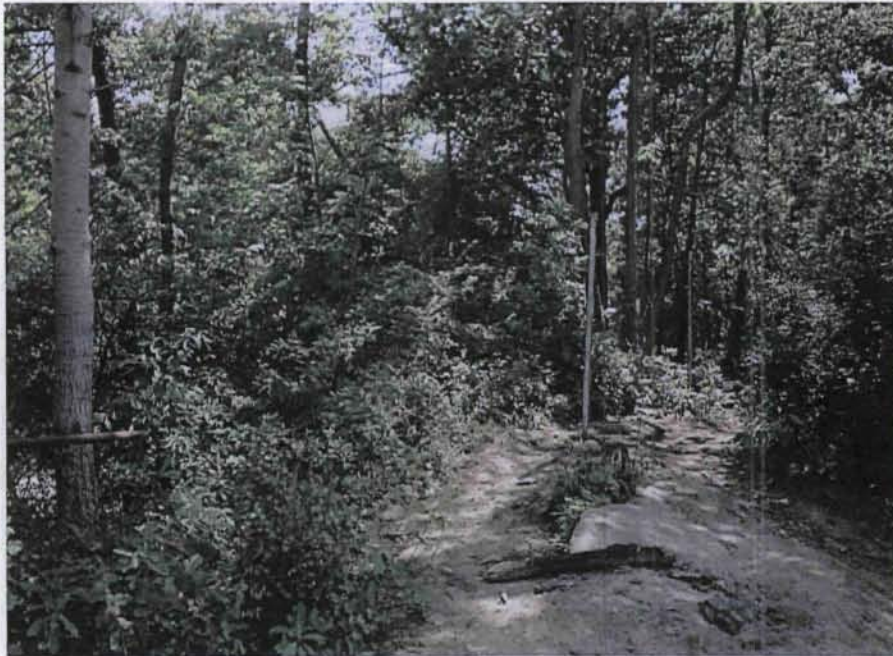
Photo 7: A view southward from same approximate area as the previous photo shows three fence poles where the fencing has been removed. The middle fence pole is visible in the mid-ground. The breach spans about 20 feet of perimeter length. The remains of a camp fire are visible in the foreground.

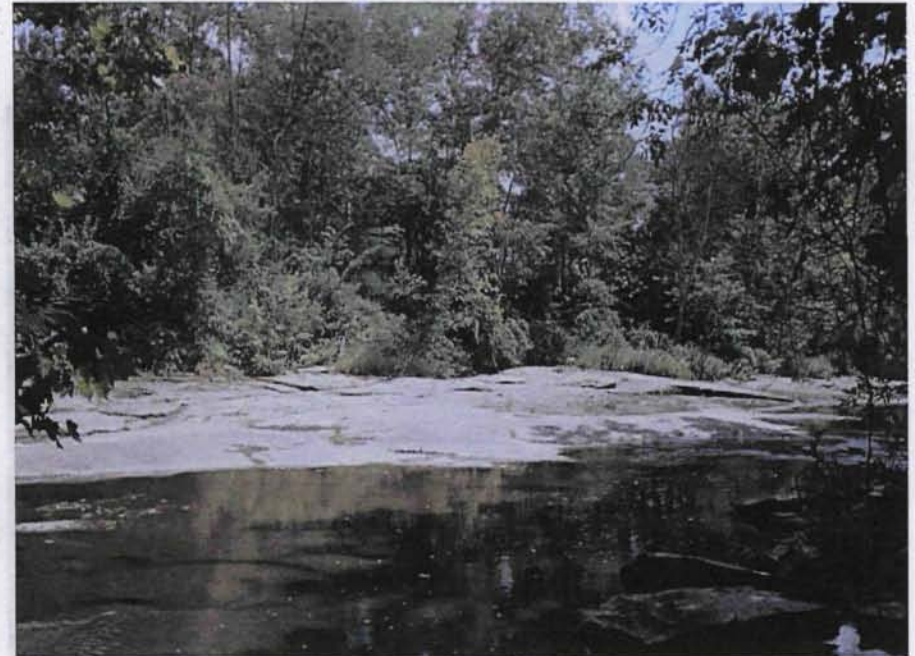
Photo 8: A view from outside of the RSQ Site eastern perimeter fence near the quarry outlet structure looking eastward across the Black River toward the subdivision. The homes are just beyond the trees in the background. The low level of the river makes it easily fordable.

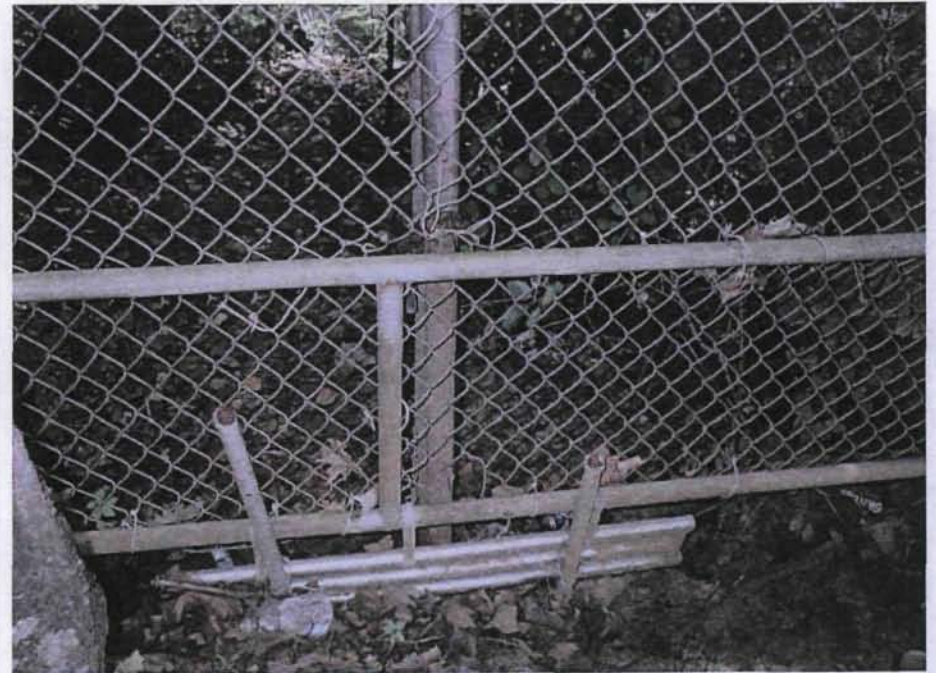
Photo 10: Area of fence line along the eastern perimeter where the city of Elyria was able to block access through the gap beneath fence line.

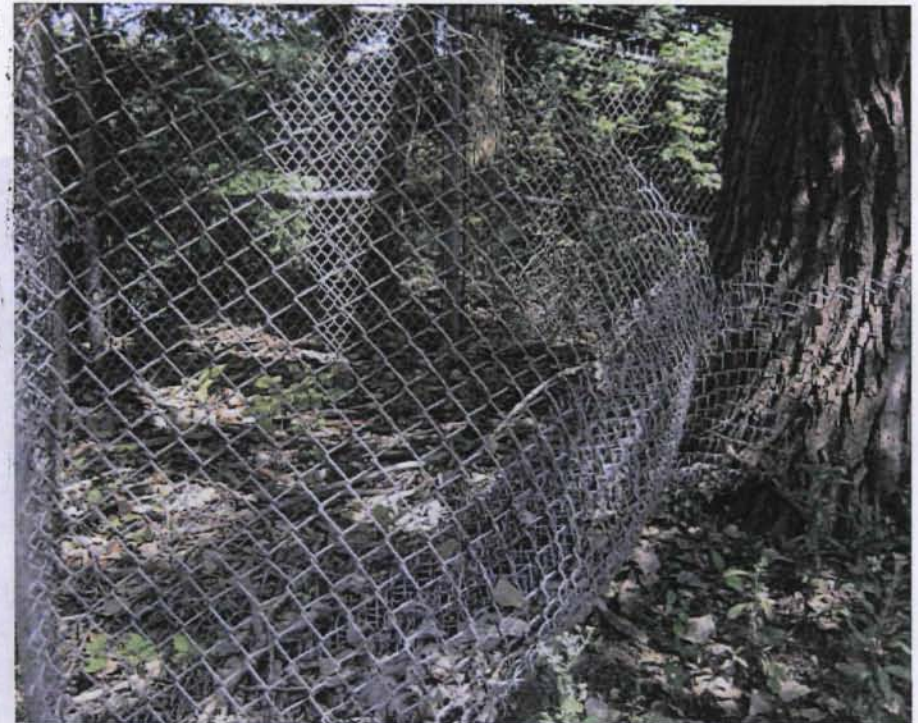
Photo 12: View of more vandalism to a large area of the RSQ Site perimeter fence.

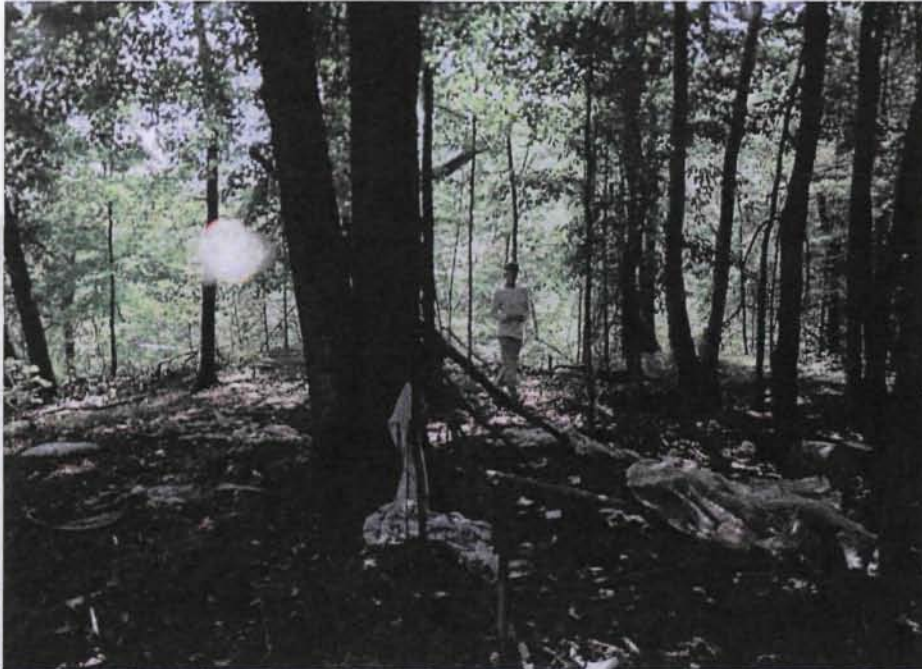
Photo 13: Remnants of a makeshift camp in the western yard of the RSQ Site property. The photo shows the deciduous tree growth and sparser foliage in the Western Yard, as compared to the eastern portion of the property.

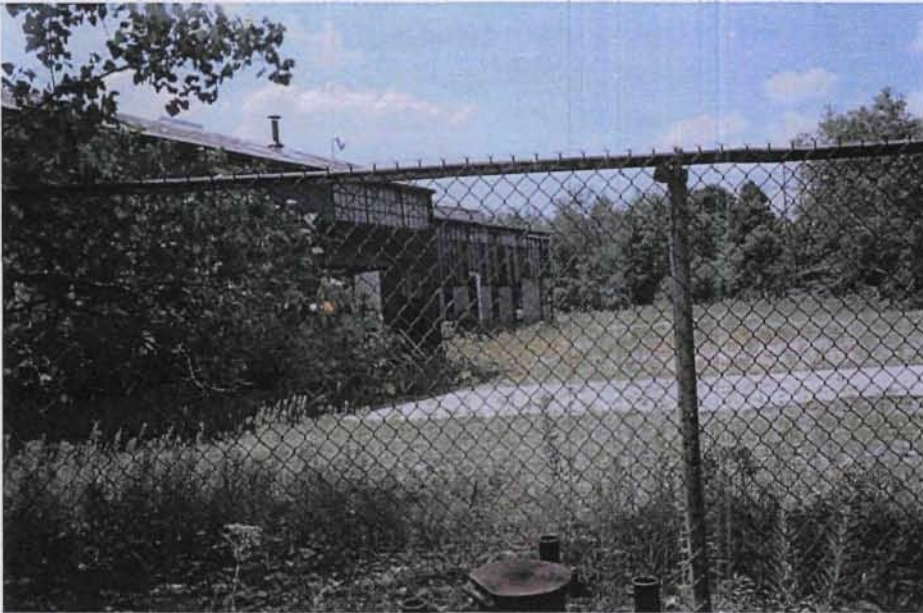
Photo 15: Southern perimeter fence line which separates the RSQ Site property from the former Maverick Tube facility property. The view is from inside the RSQ property looking southward. The top of MW B-6 is in the immediate foreground.

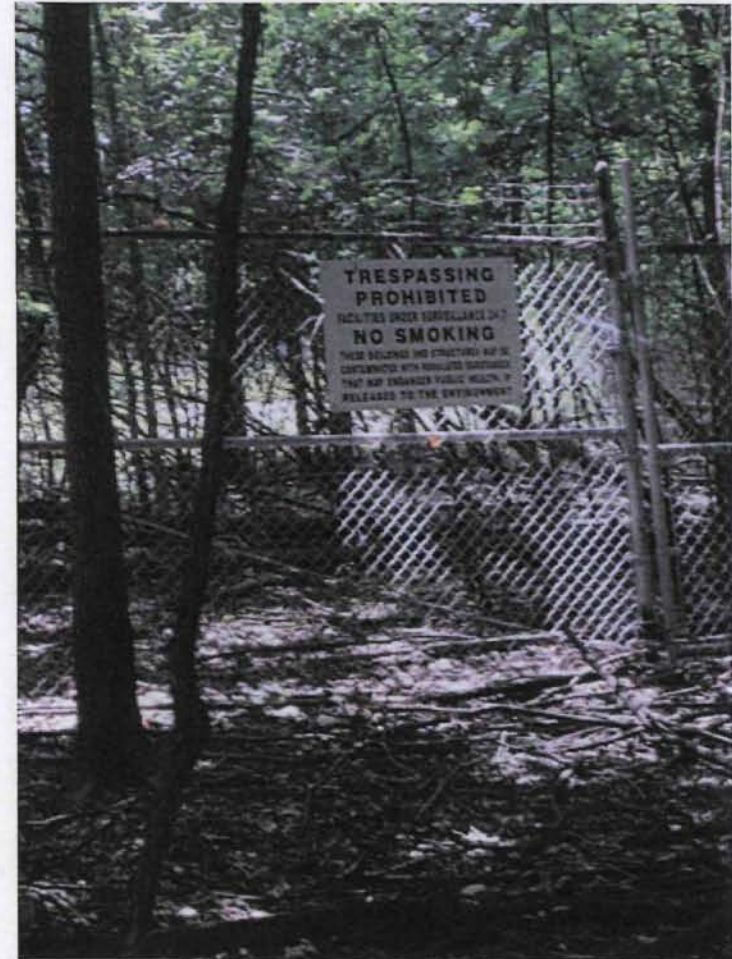
Photo 16: A view from inside the RSQ Site property at the south perimeter fence line. The sign posted on the gate separating the quarry site property from the adjacent Maverick Tube facility was posted by the steel mill security staff.

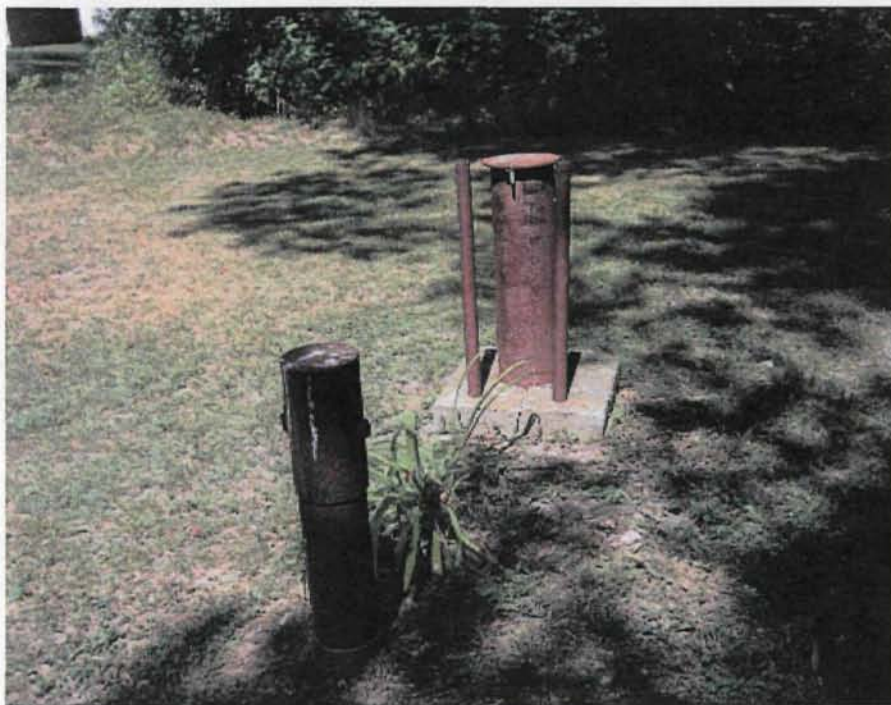
Photo 17: A view looking eastward toward MW B-2 located in the backyard of a resident of the New Riverbend Homes subdivision along West River Road. The residential lot is immediately adjacent to the RSQ Site northern property line. MW B-2 is representative of the condition of the other MWs.

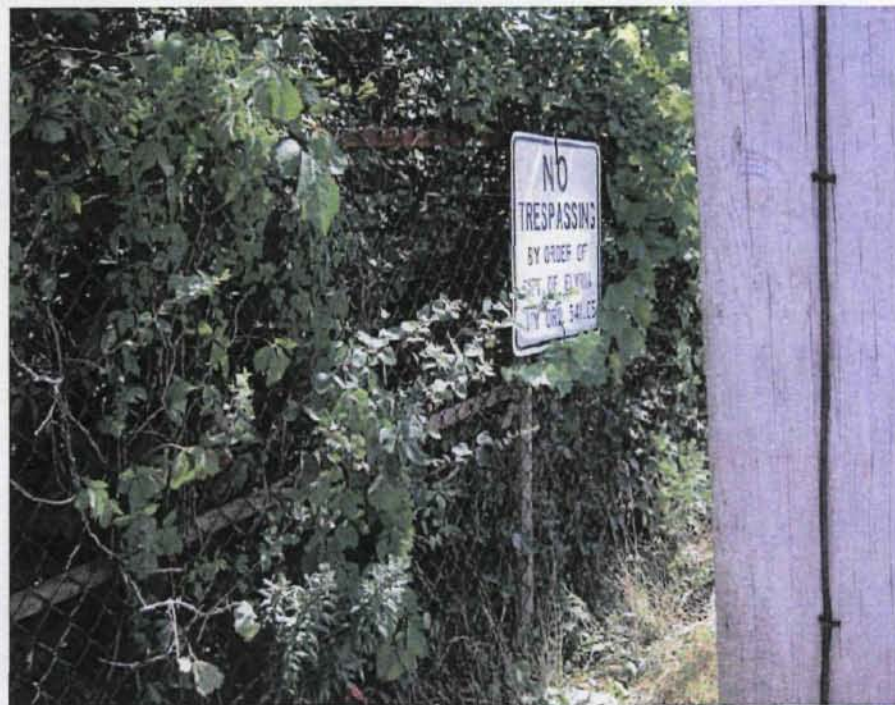
Photo 18: Warning sign posted by the city of Elyria along the western perimeter fence line which runs alongside West River Road. The sign reads: "No Trespassing by Order of City of Elyria Ord. 541.05." The dense foliage on the fence is evident.

The city has made a concerted effort to enforce the ICs, which in part restrict Site access and prohibit all uses of the quarry. The city asks surrounding residents to be aware of vandalism to the fence and to report any incidences to the city and police so they can prosecute these individuals. The city has asked the police to increase patrols on Riverside Drive. When damage to the fencing is detected, the city's Safety Director initiates fence repair within 24 hours. The city periodically fixes the fence along West River Road, but the fence along the river is not regularly fixed because it is vandalized again shortly thereafter. Signs reading "No Trespassing by Order of City of Elyria City Ord. 541.05" are posted along West River Road and the adjacent housing development (see Attachment 8, Photo 18).
