**FOURTH FIVE-YEAR REVIEW REPORT FOR
COMMENCEMENT BAY NEARSHORE/TIDEFLATS SUPERFUND
SITE
PIERCE COUNTY, WASHINGTON**

**U.S. Environmental Protection Agency
Region 10
SEATTLE, WASHINGTON**

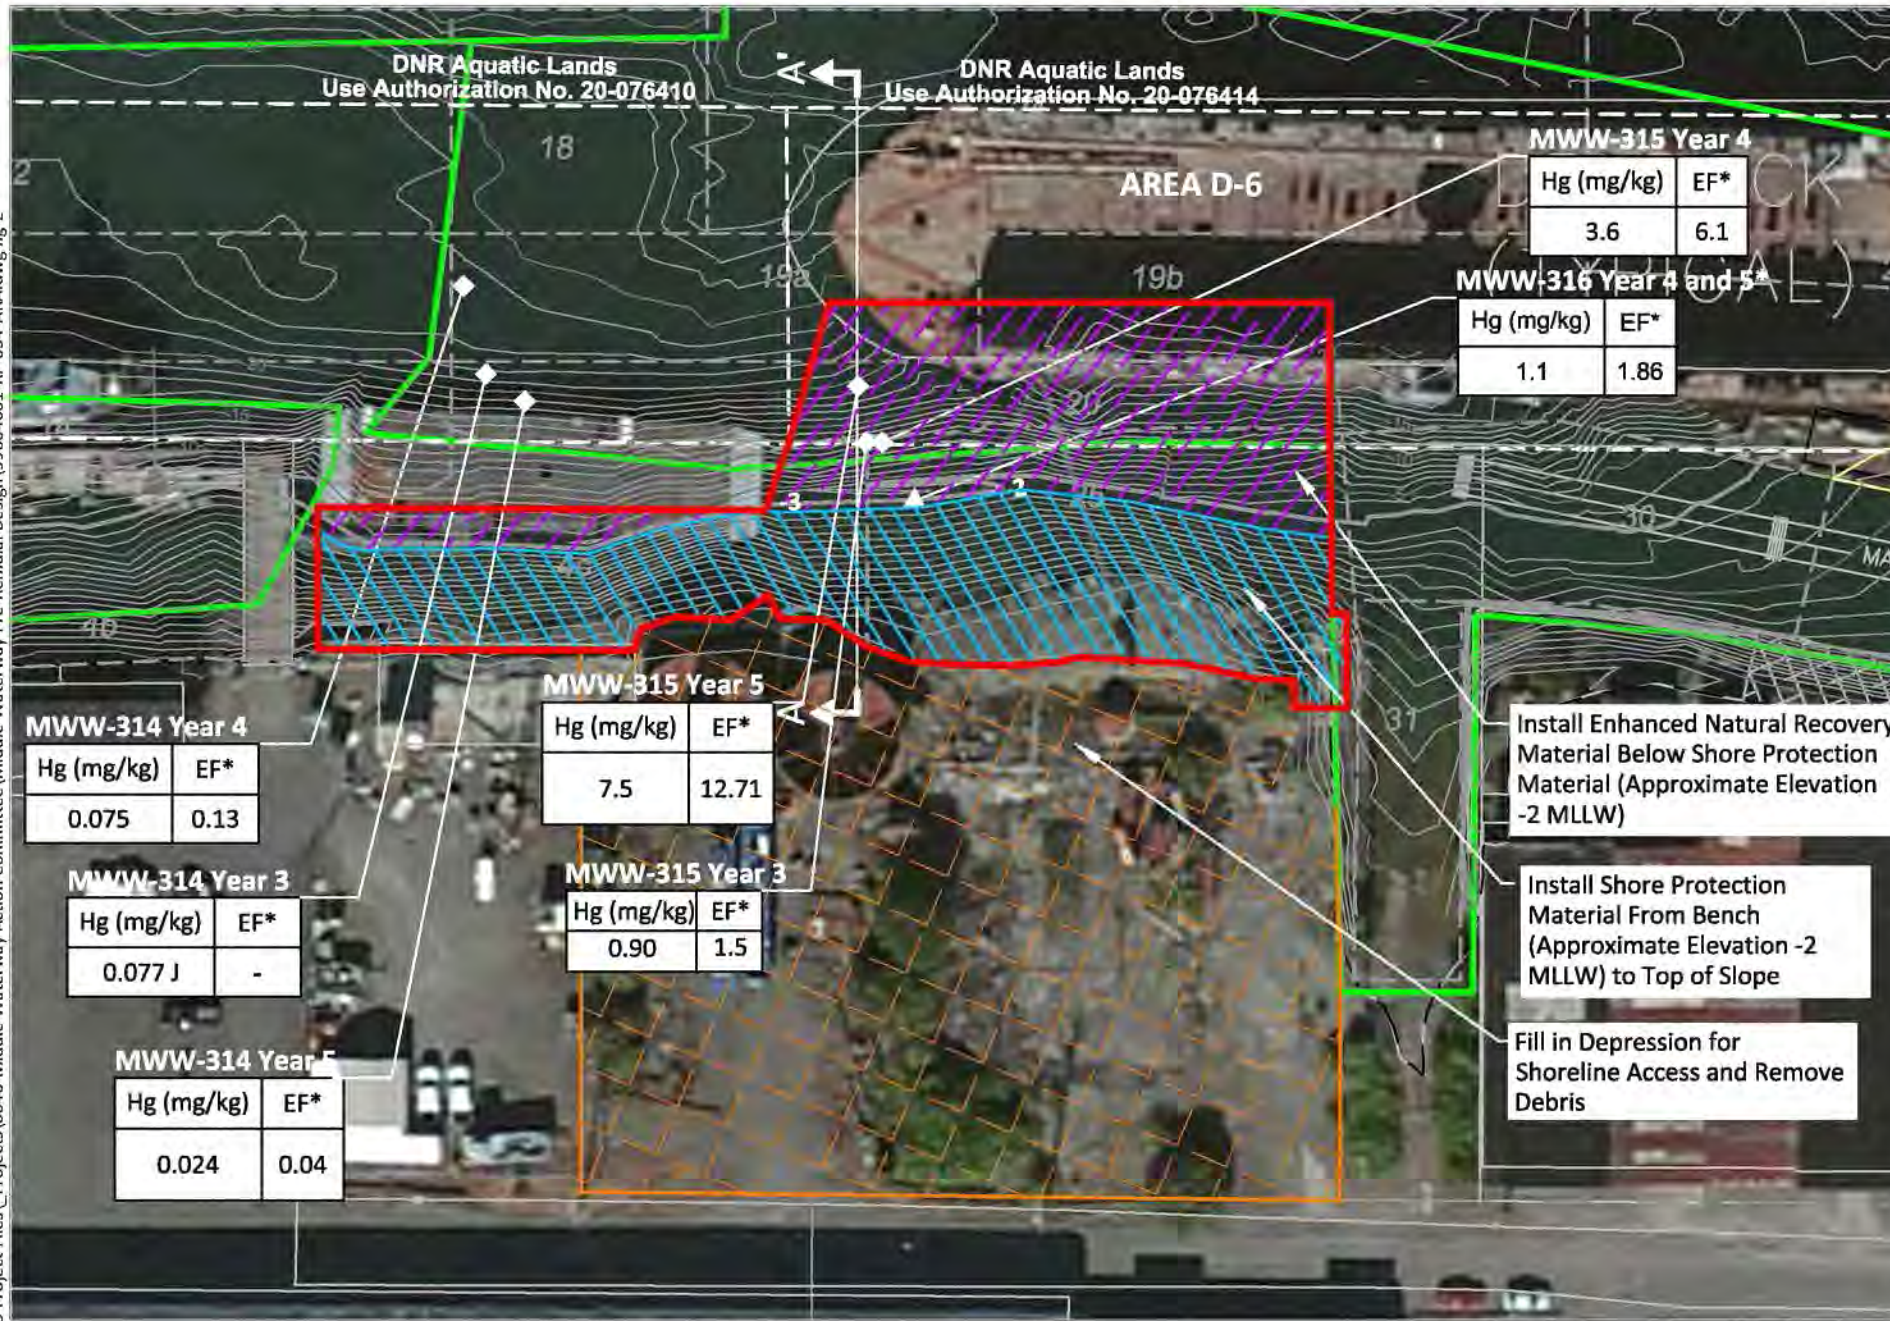
- NOTES:**
1. ENR Material is 1/2-inch minus gravel.
 2. Filter gravel is 4-inch minus cobble/gravel.
 3. Armor Stone is 3-inch to 21-inch rock.
 4. Surficial Cap is 2-inch minus gravel.

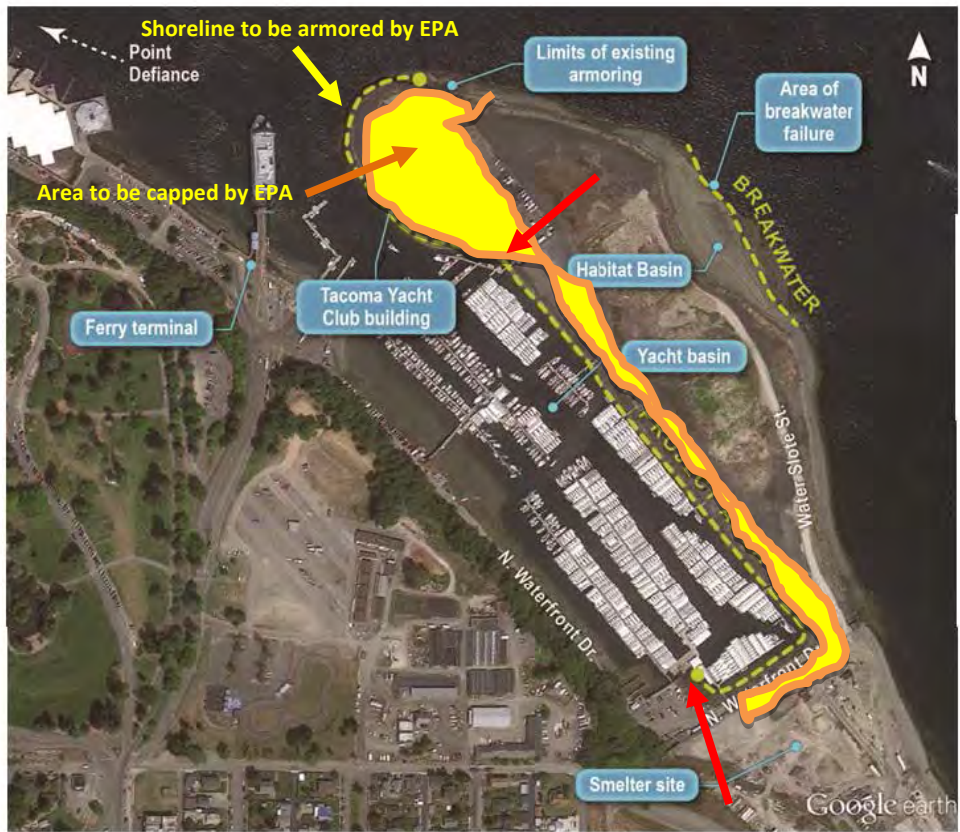
Figure 5-6. Map of Slag Peninsula Showing Areas Where Work is Planned (Source: CH2M Hill 2013b)

Note: The area of breakwater failure will be repaired. Shoreline to be armored by EPA is shown by the yellow-dashed line; the segment between the red arrows is not required by the ROD and may be done by Metro Parks. Area to be capped by EPA in 2015 is shown by the yellow area with the orange border.

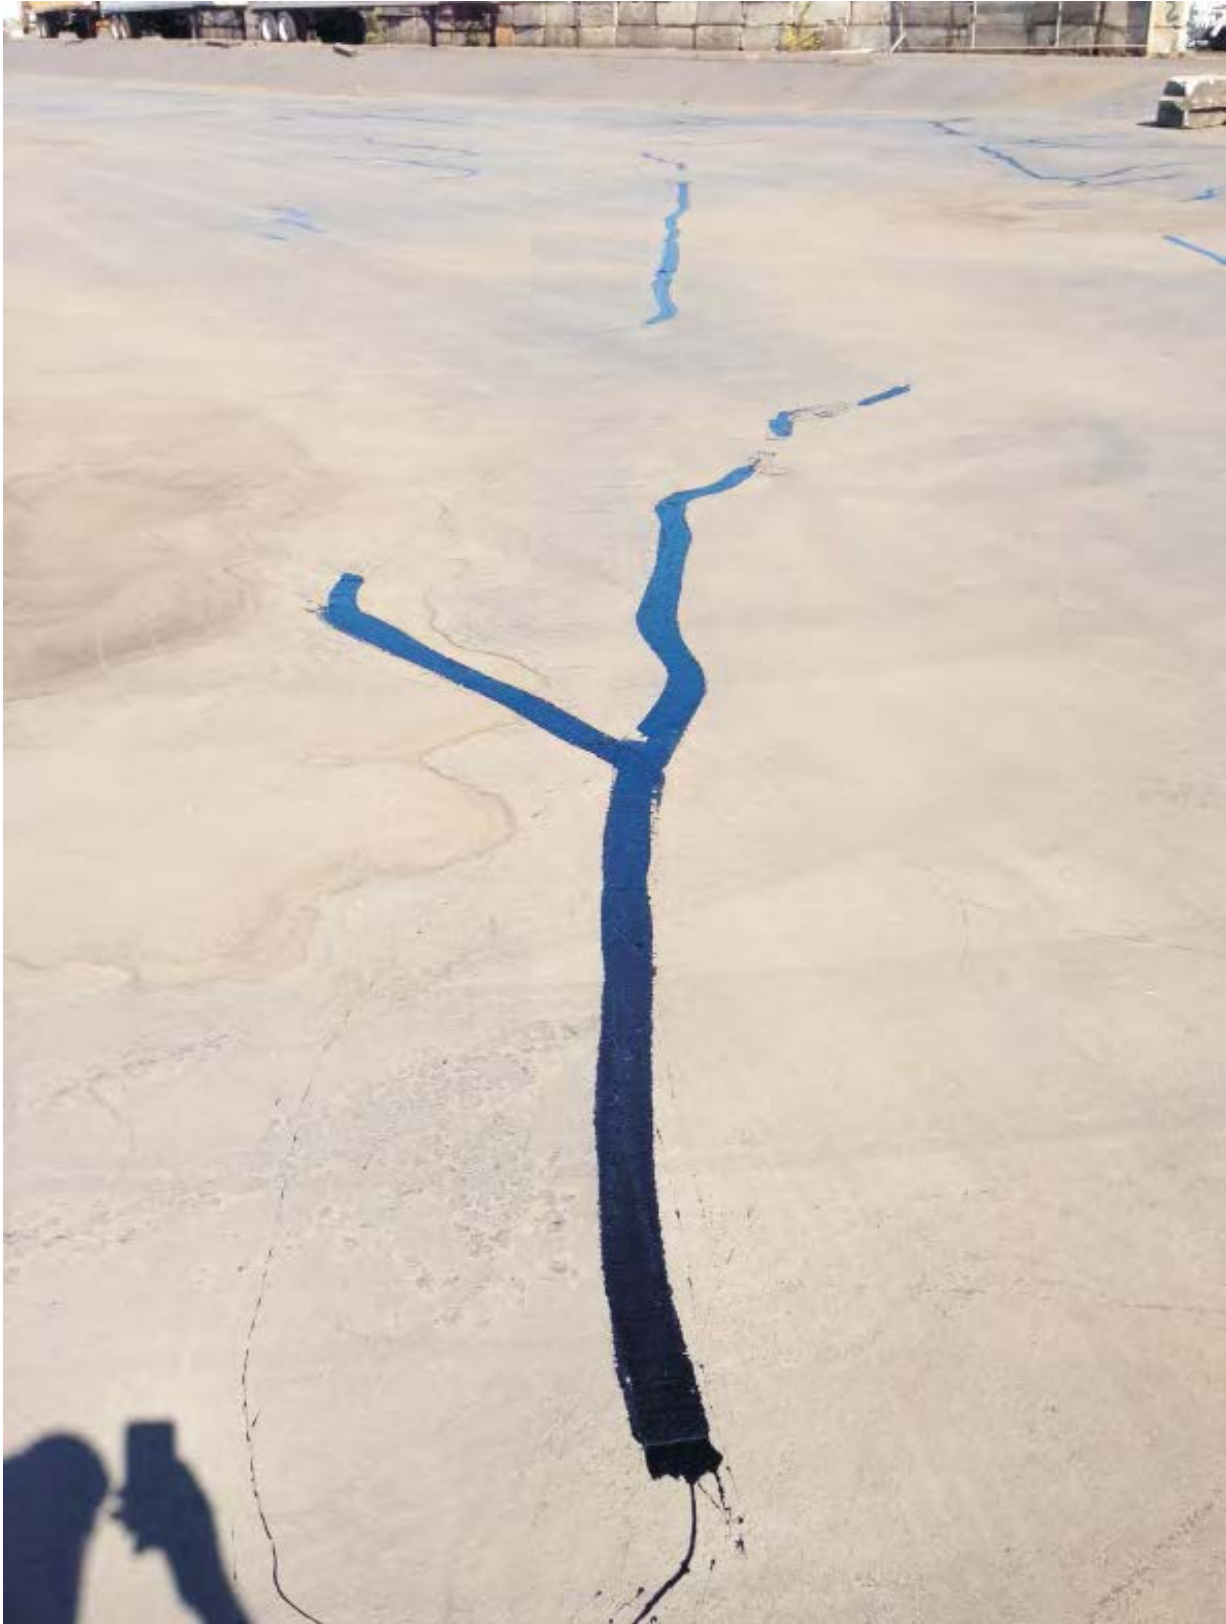
Figure 6-3. Photo of 2013 Asphalt Crack Repair in Detention Basin (Source: DOF 2014c)

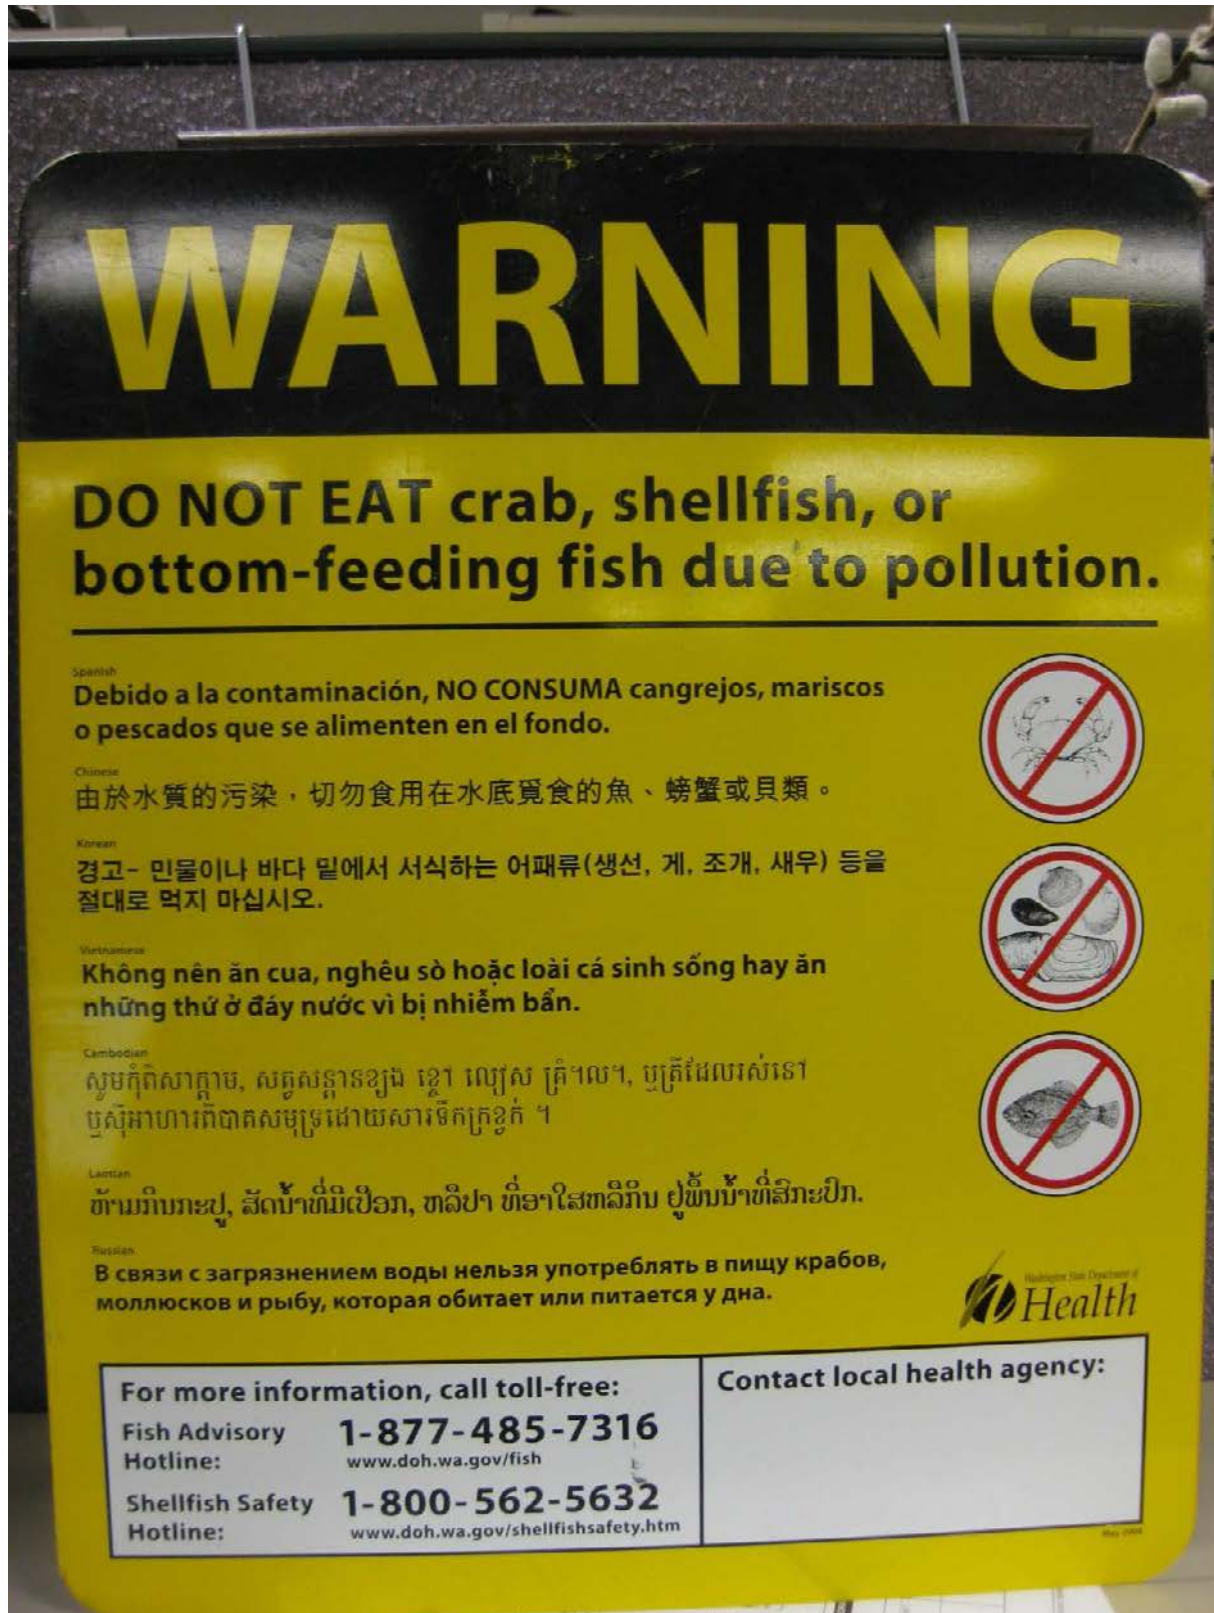
2012 Photograph of Advisory Warning Signs in Thea Foss Waterway, Commencement Bay.

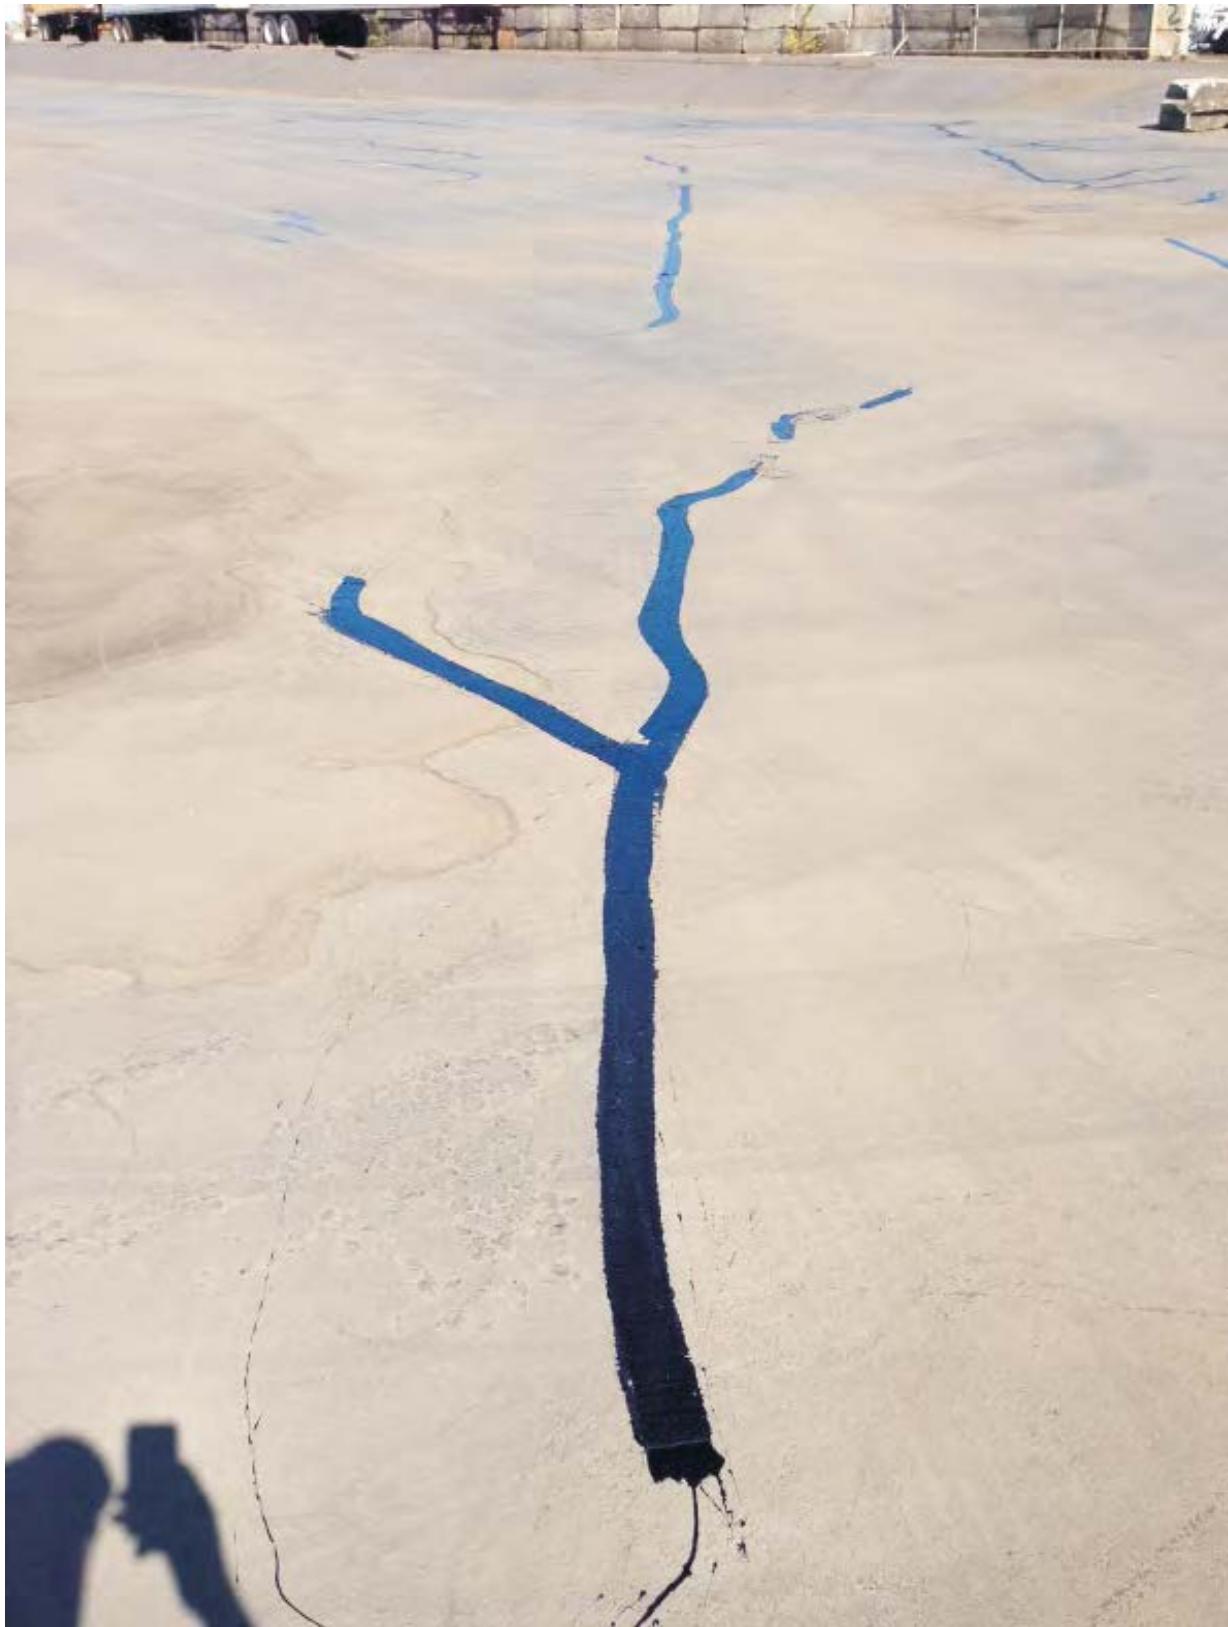
Figure 6-3. Photo of 2013 Asphalt Crack Repair in Detention Basin (Source: DOF 2014c)
