**Record of Decision  
for  
Site 4 - Operable Unit 2 (Area 4B), Operable Unit 3  
(Area 4C), Operable Unit 4 (Area 4D)**

**Naval Air Station Patuxent River  
St. Mary's County, Maryland**

**Naval Facilities Engineering Command  
Washington**

**September 2009**

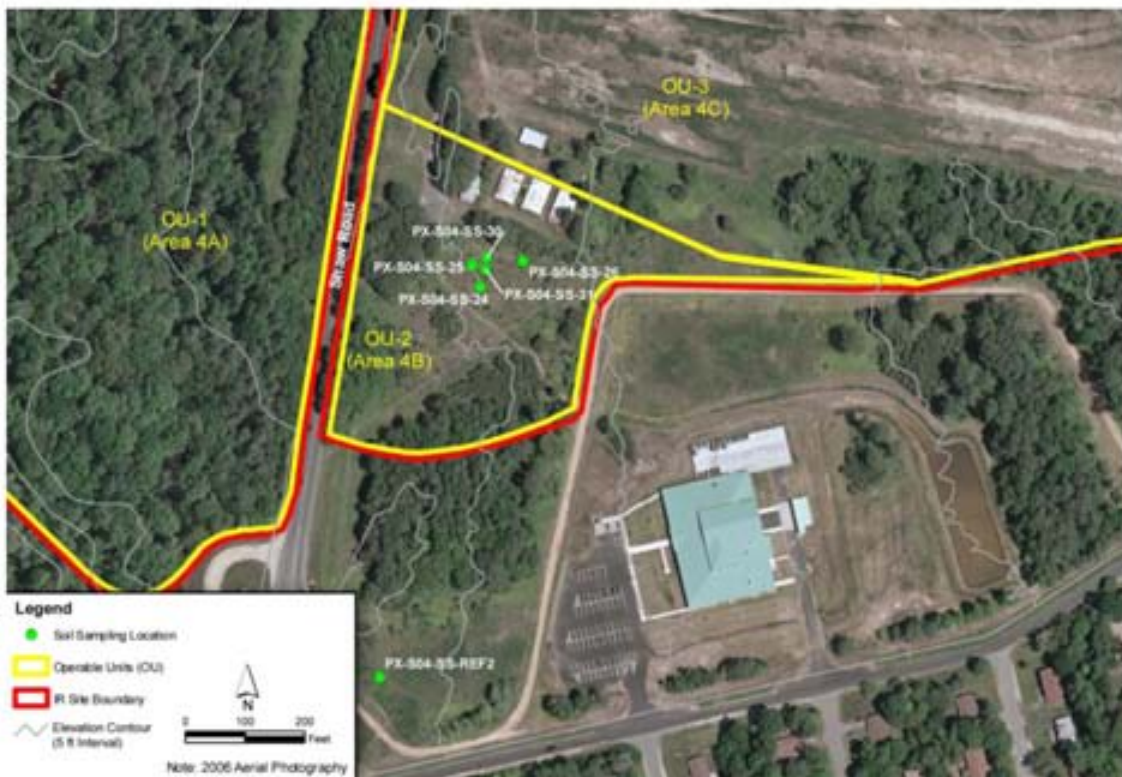
A summary of investigation efforts is presented in Table 1. Figures 2 through 4 present the sampling locations associated with these efforts.
