HAZARD RANKING SYSTEM (HRS) DOCUMENTATION RECORD COVER SHEET

Name of Site: Sporlan Valve Plant #1

HAZARD RANKING SYSTEM (HRS) DOCUMENTATION RECORD

Name of Site: Sporlan Valve Plant #1
EPA Region: 7
Date Prepared: September 2018
Street Address of Site*: 611 East 7th Street
City, County, State, Zip: Washington, Franklin County, Missouri 63090
General Location in the State: East-central portion of state
Topographic Maps: Washington West, Missouri 1973 and 2015
Latitude: 38.551900° North
Longitude: 91.006680° West

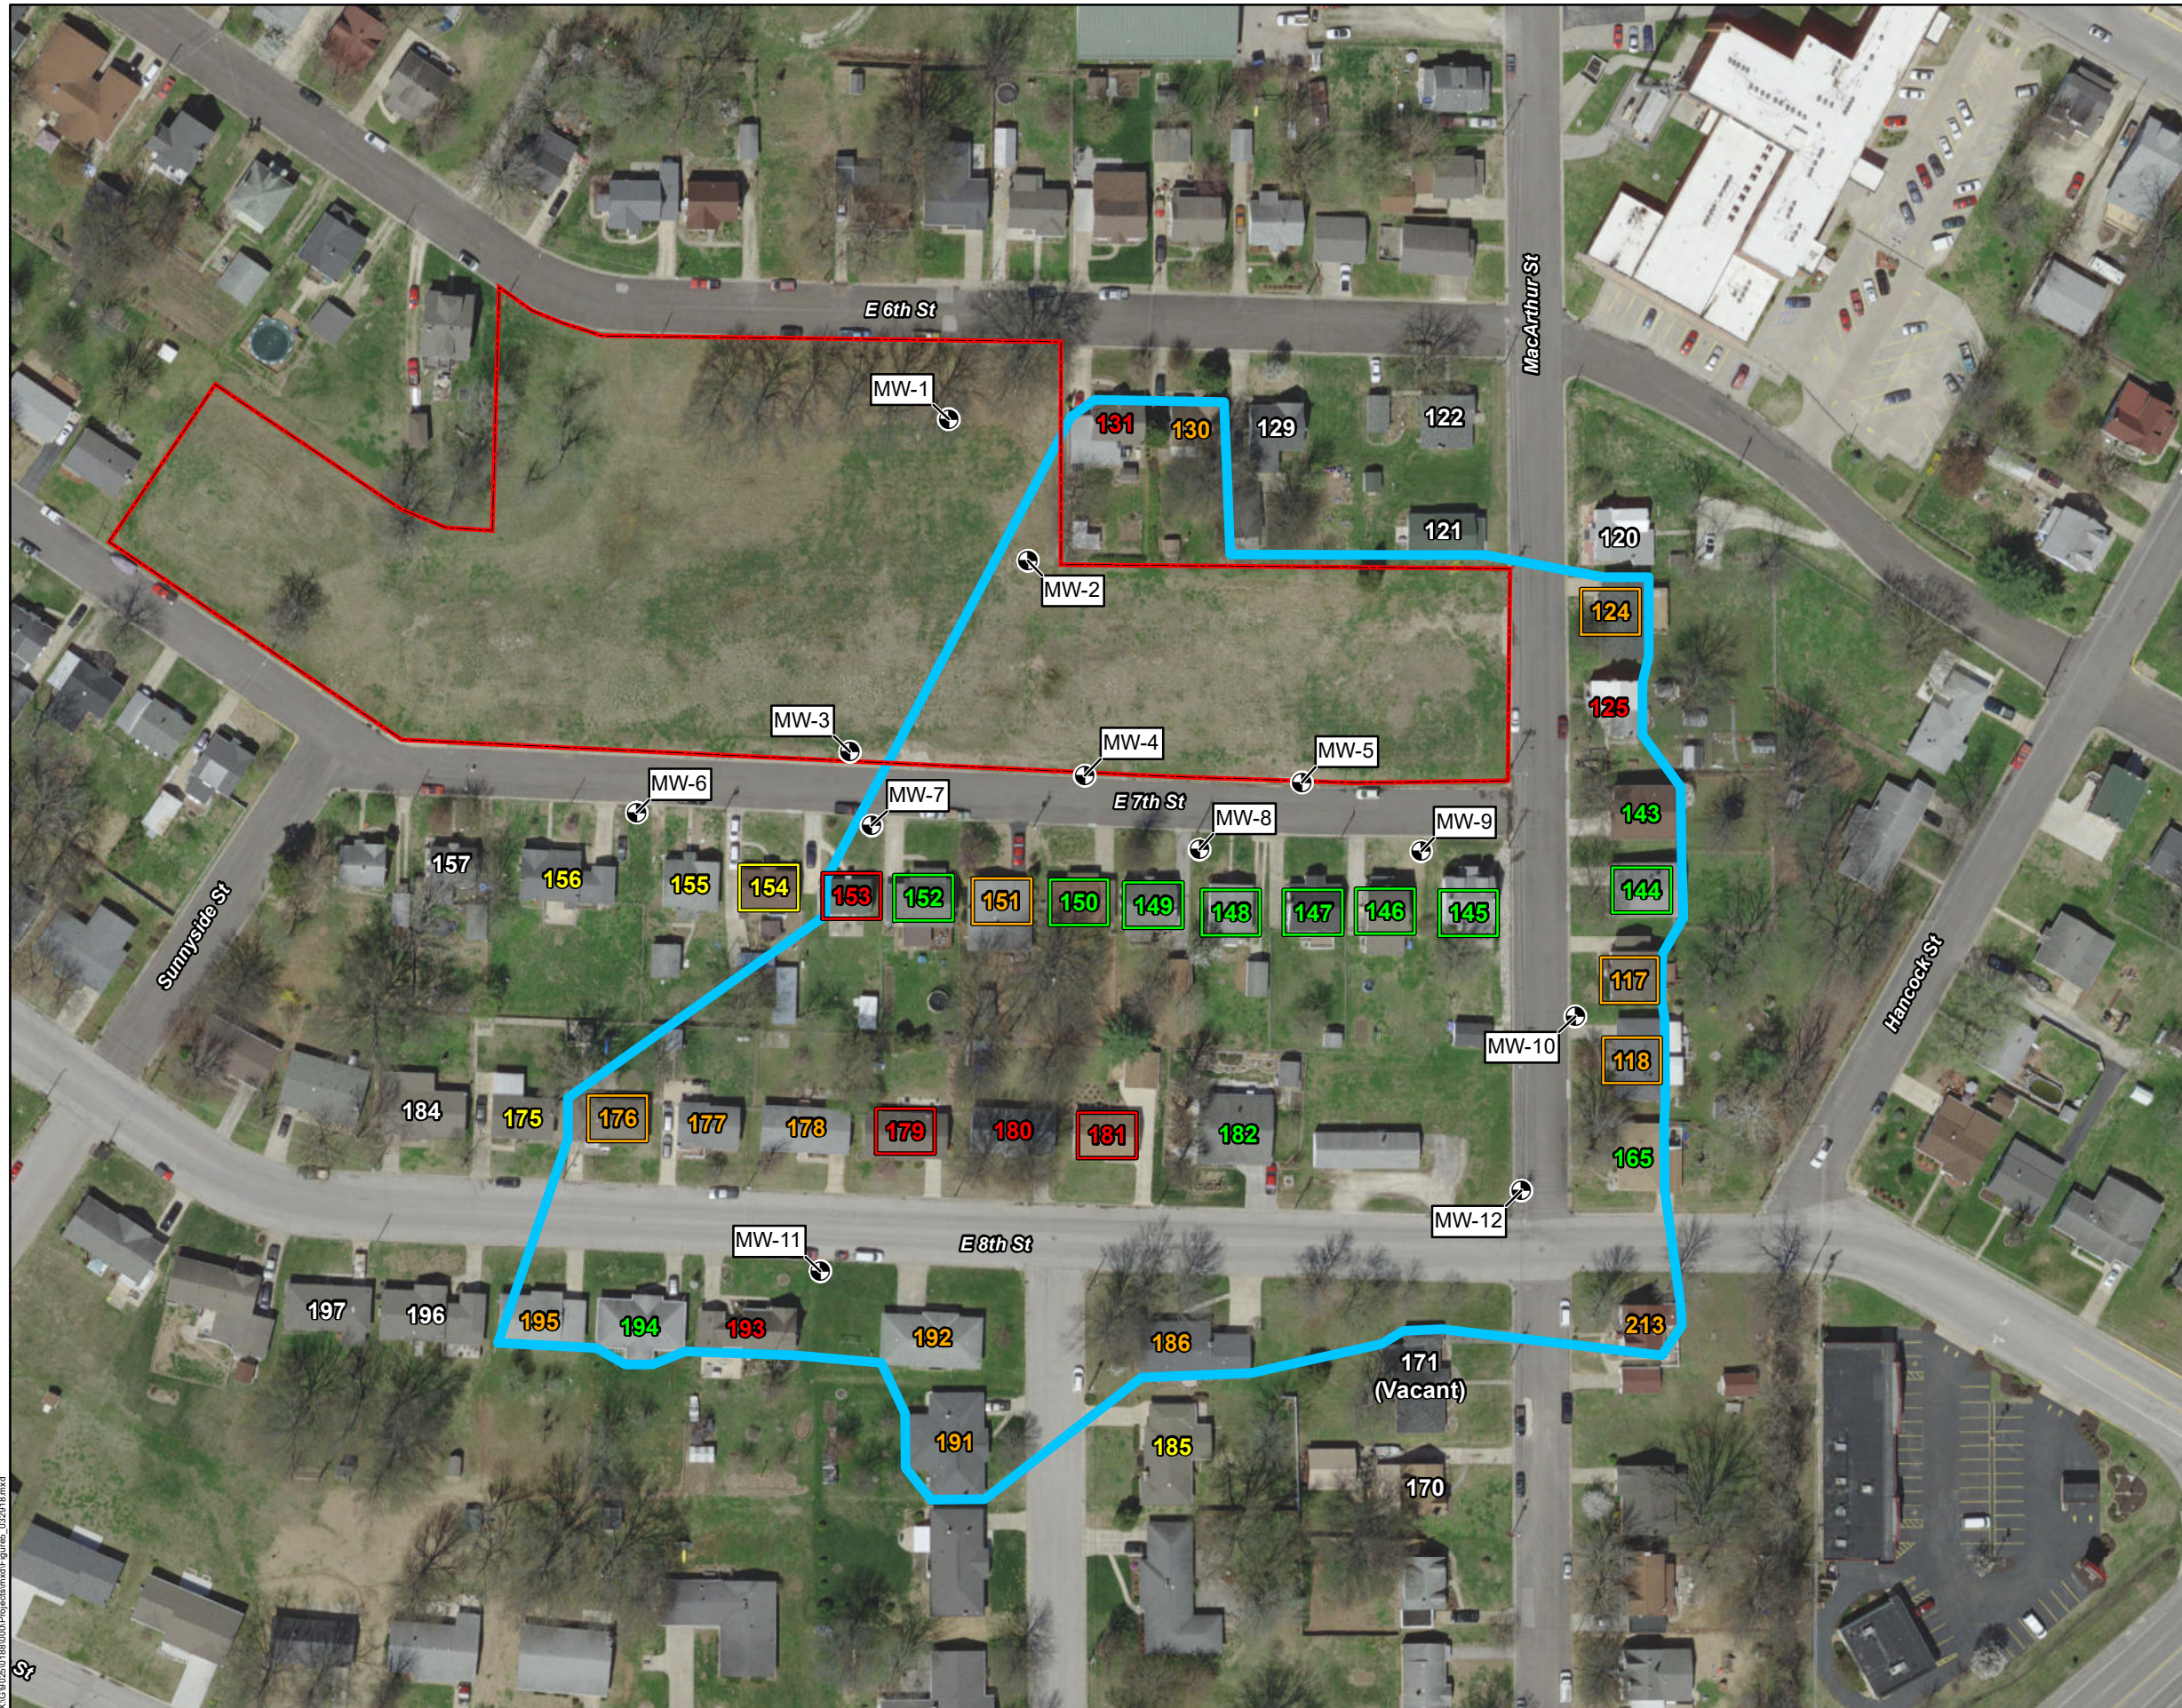
Figure 5
Area of Observed Exposure Map

AOE 1 consists of 32 regularly occupied residential structures in which indoor air is contaminated or inferred to be contaminated with TCE, PCE, and vinyl chloride (see Figure 5 of this HRS documentation record). As shown in Table 18 of this documentation record, all residences within AOE 1 are regularly occupied structures with no subunits. Regularly occupied structures with indoor air samples that met observed exposure criteria were used to delineate AOE 1 (see Tables 20 and 22 of this HRS documentation record). Regularly occupied structures without a documented observed exposure, but are located between structures with a documented observed exposure, are also inferred to be within the AOE (Ref. 1a, Section 5.2.0). Structures where contamination is inferred are located near Source 1 south of East. 7th Street, where a vapor mitigation system was installed preemptively (before indoor air samples were collected, between structures with documented contamination, or may have had CVOC concentrations in sub-slab soil gas or indoor air in the past, but results were inconclusive. Preferential pathways for subsurface intrusion into these residences include cracks, crevices, holes, pits, and floor drains in unsealed concrete floors and walls of the basements (Refs. 10, pp. 169-252; 24, pp. 23-97).

The AOE consists of 32 regularly occupied residential structures. Significant increases of hazardous substances (i.e., CVOCs) in indoor air samples have been identified within these structures as documented in Tables 22 and 23 in this section. Indoor air within these regularly occupied structures have been found to, or have been inferred to, be contaminated with TCE, PCE, or vinyl chloride.
