## HAZARD RANKING SYSTEM (HRS) DOCUMENTATION RECORD COVER SHEET

**Name of Site:** Federated Metals Corp Whiting

**EPA ID No.:** IND005444104

Date Prepared: March 2023

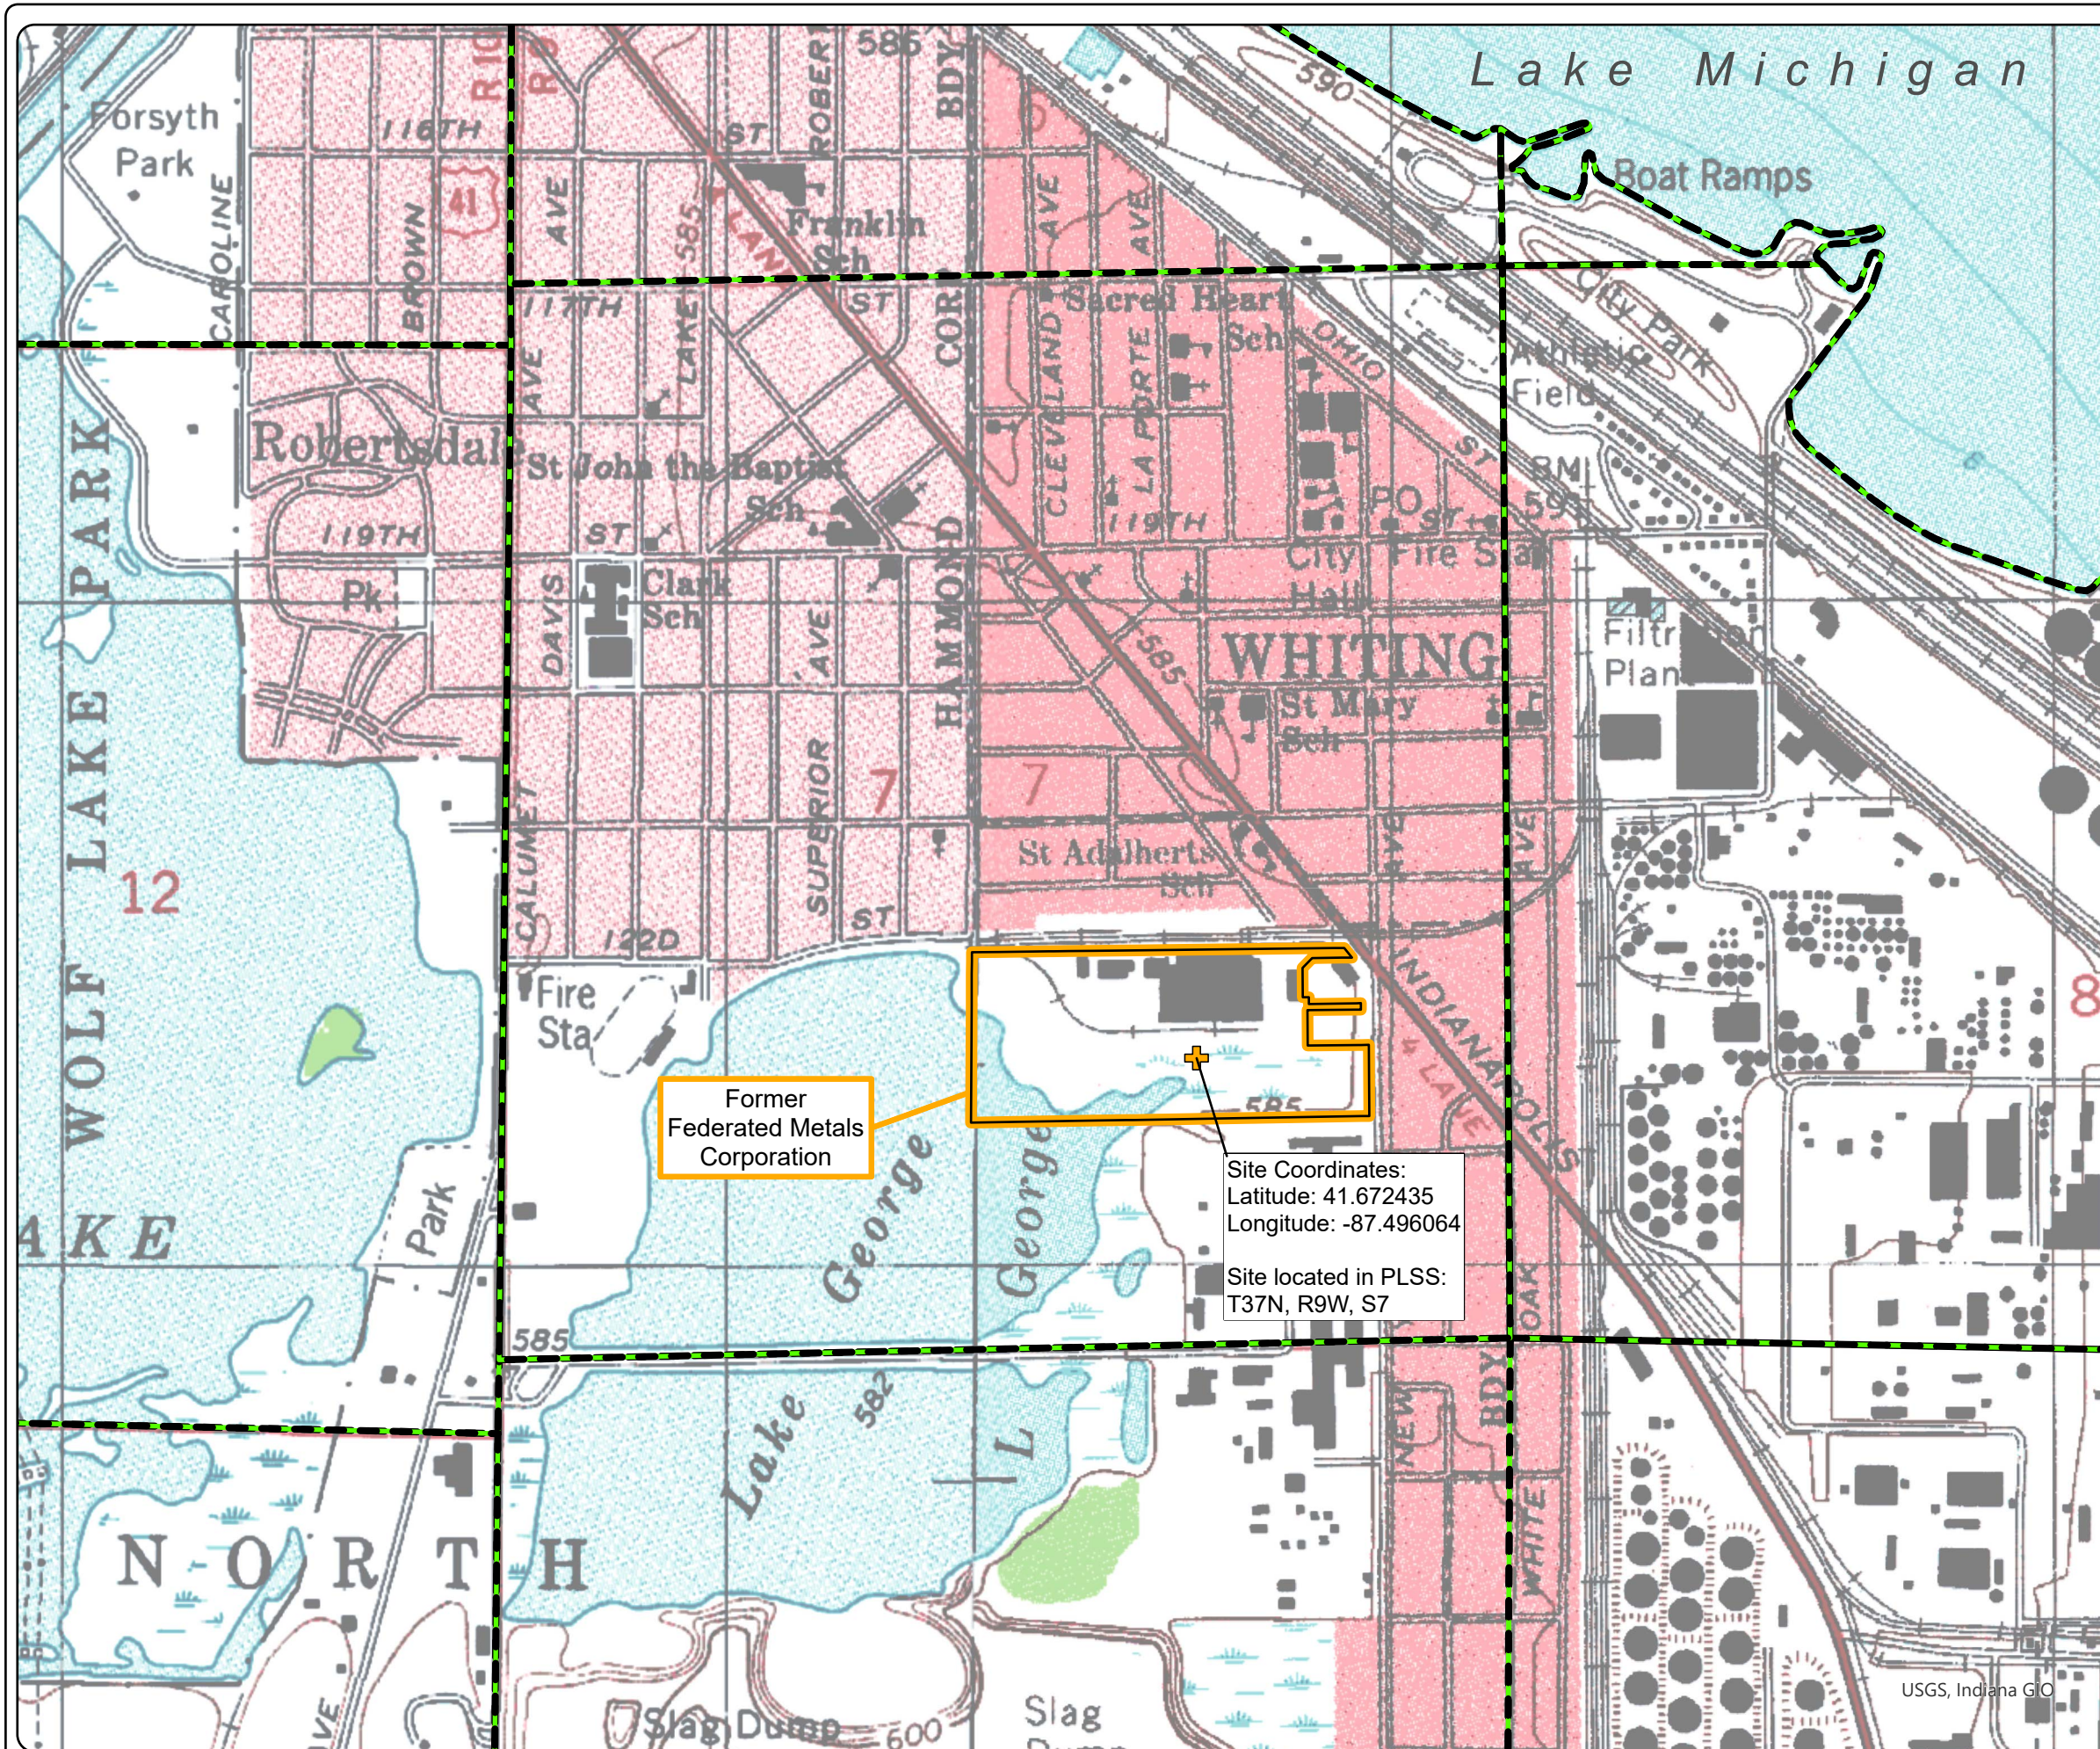
**Figure 1:**  
**Federated Metals Corp Whiting**  
**Site Location Topographic Map**  
**EPA ID # IND005444104**  
**2230 Indianapolis Blvd, Hammond**  
**Lake County, Indiana**

Latitude: 41.672435 North (Figure 1)

Longitude: -87.496064 West (Figure 1)

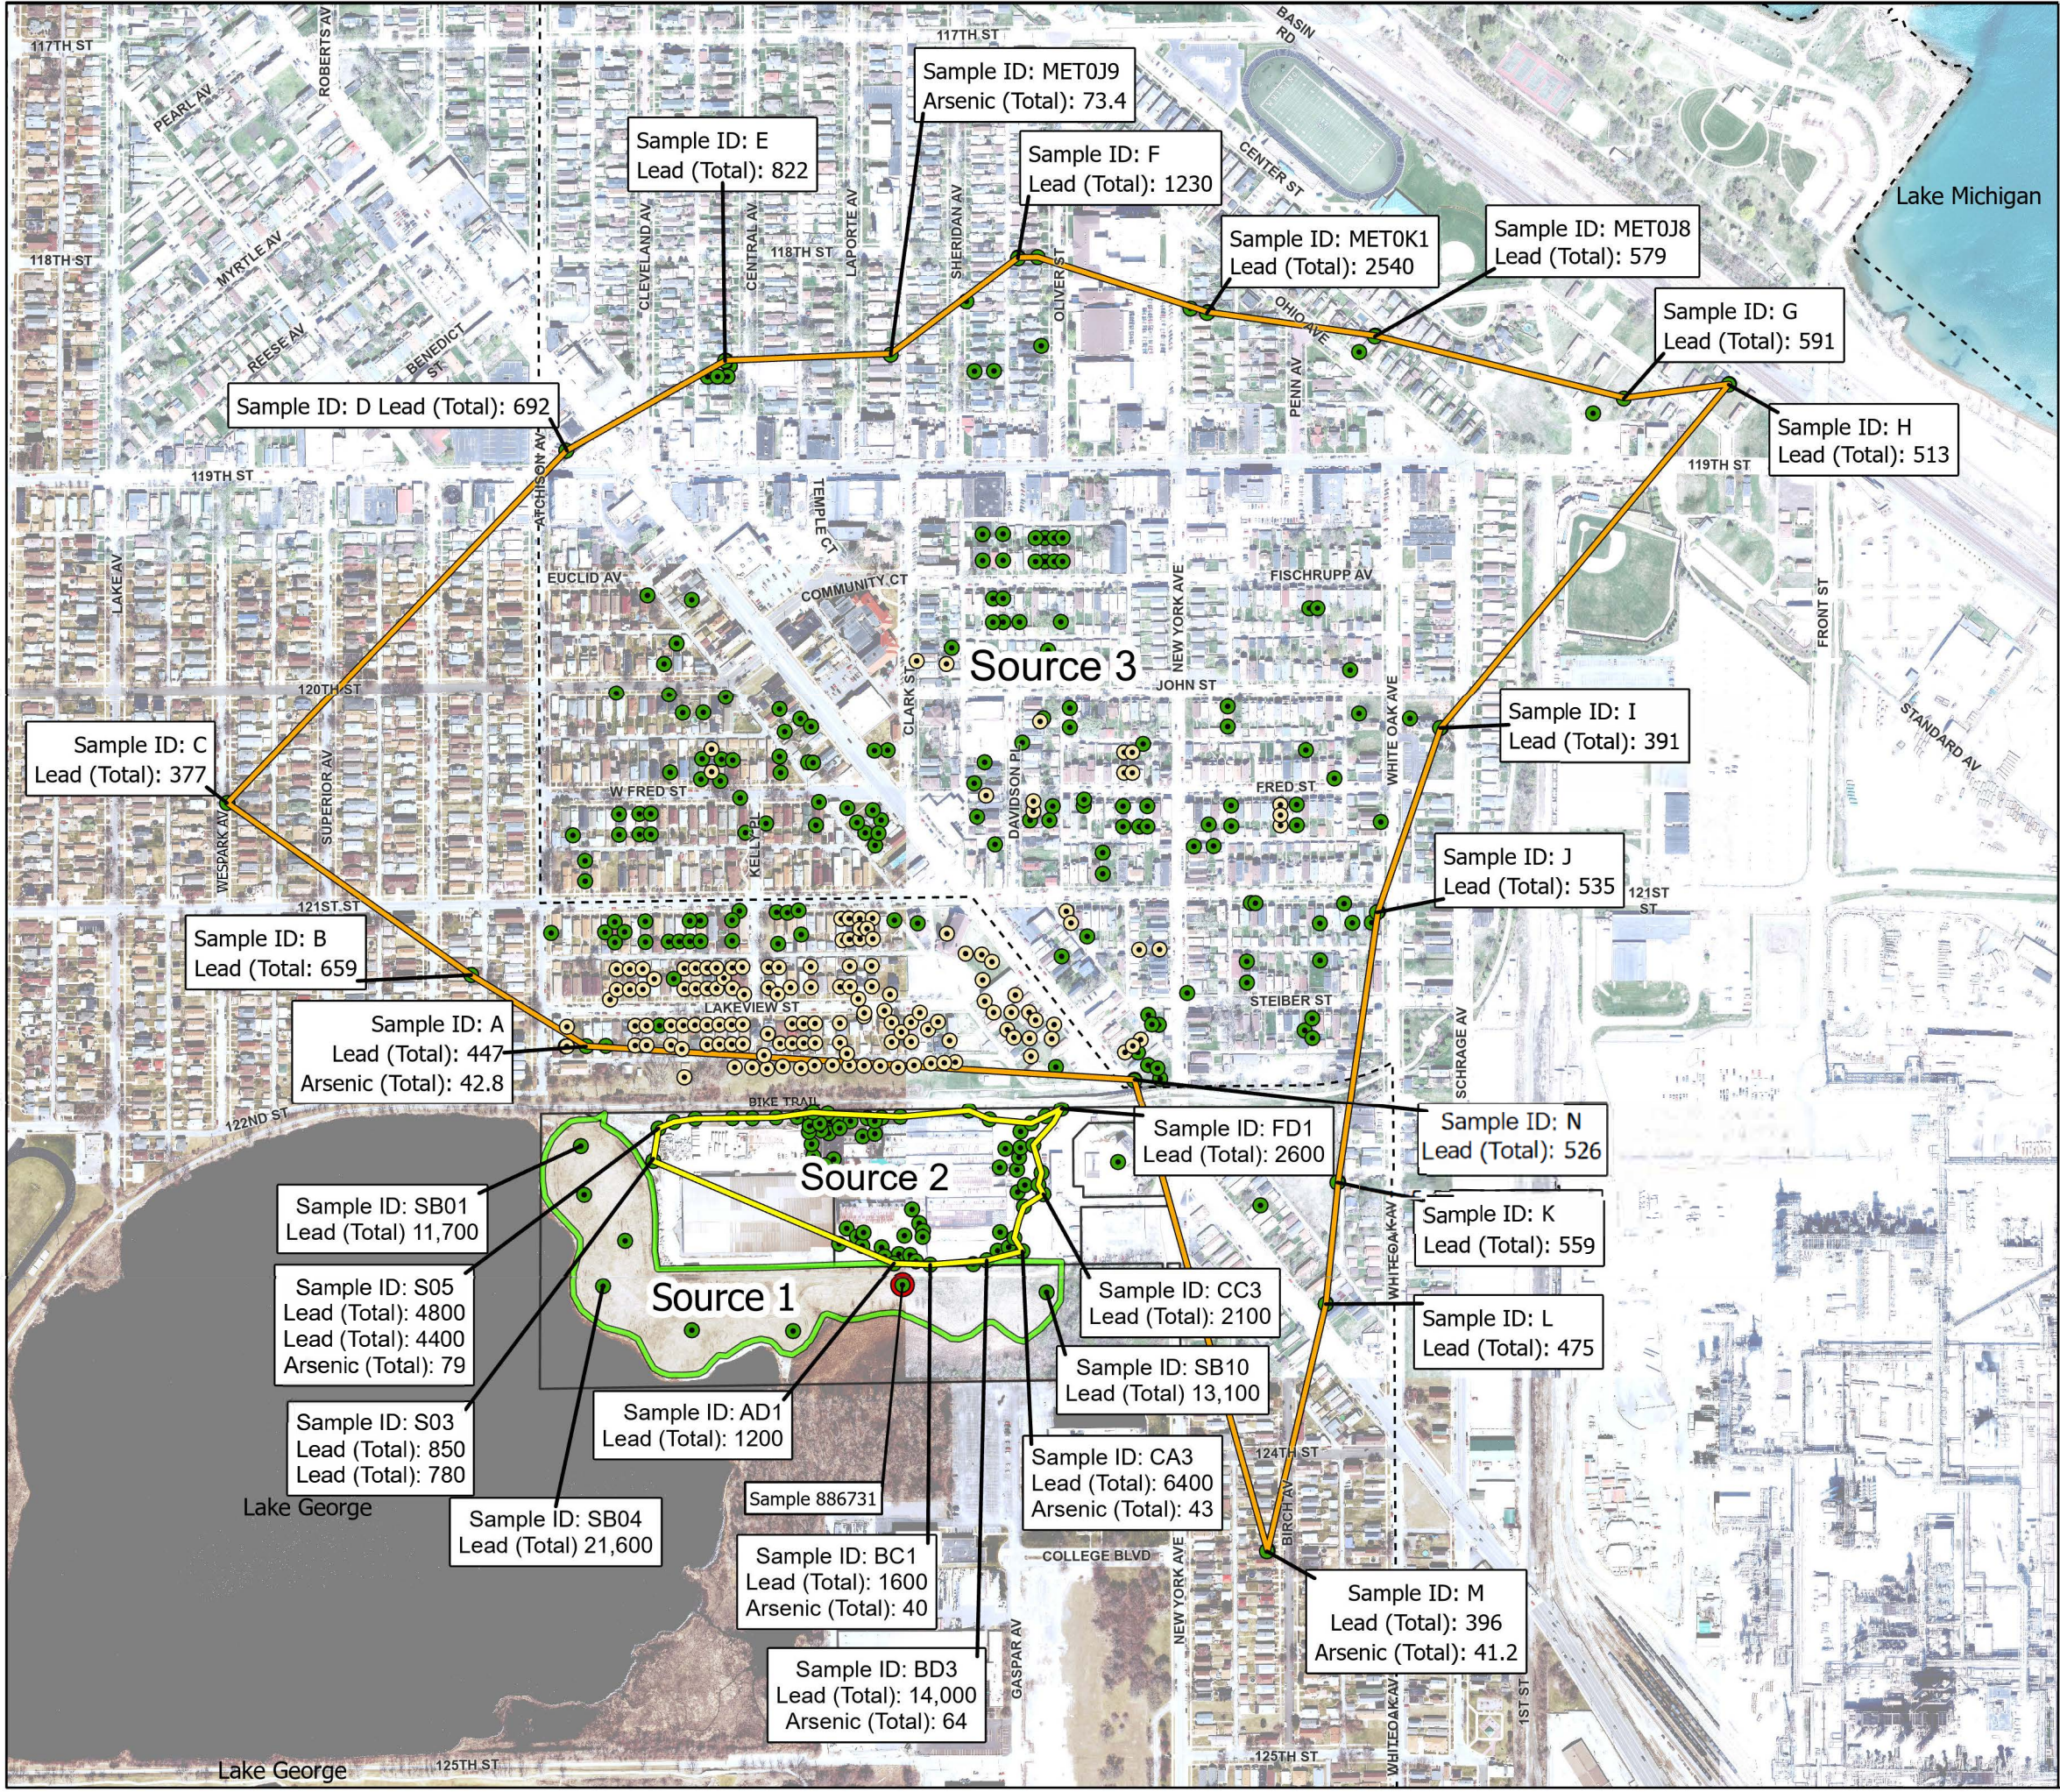
**Figure 2:**  
**Federated Metals Corp Whiting**  
**Map Showing Source Areas**

- For references to the related laboratory reports for results on this map, see Tables 3, 6, and 10 of the Federated Metals Corp Hazard Ranking System (HRS) Documentation Record

Soil contamination on the former Federated Metals property is further characterized in Section 5.0.1 of this documentation record as an area of parcels containing observed contamination (i.e., AOC B) (Figures 2 and 3 of this documentation record; Ref. 76, pg. 2).

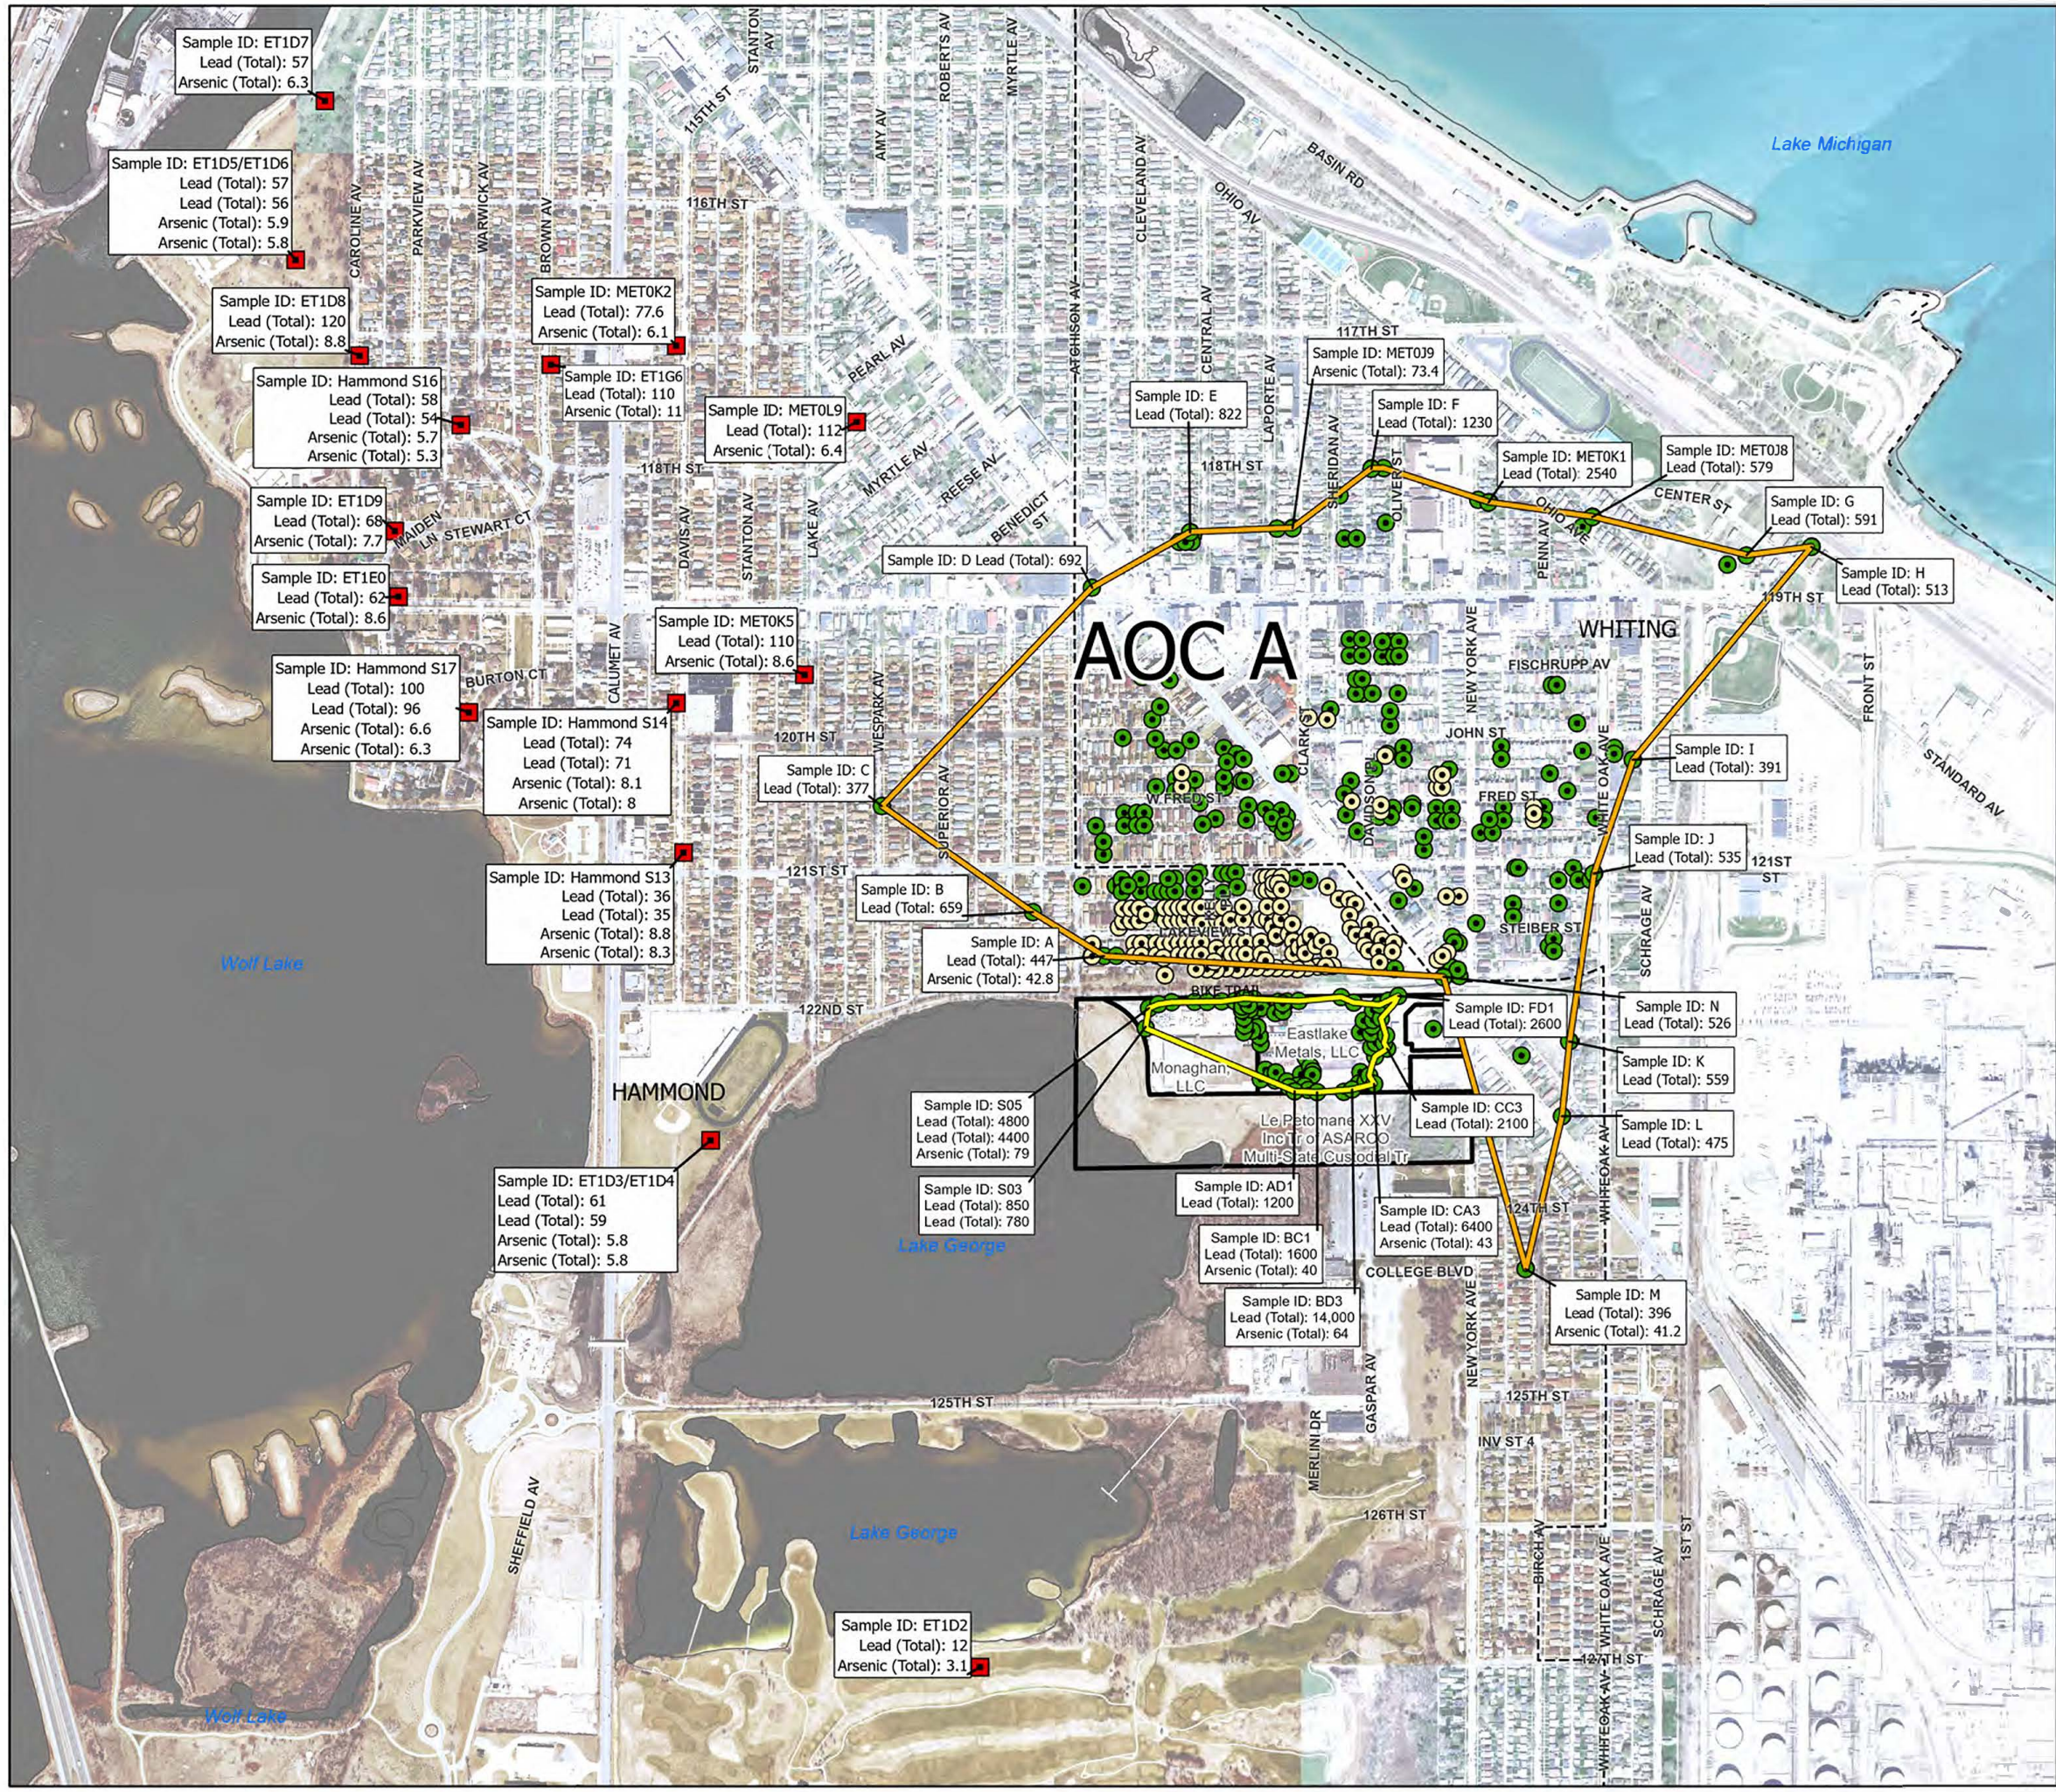
**Figure 3:**  
**Federated Metals Corp Whiting**  
**Map Showing Areas of Observed Contamination and Background Samples**

-All units are in mg/Kg.  
-Background for Arsenic (Total) is 11 mg/Kg.  
-Background for Lead (Total) is 120 mg/Kg.  
-Refer to References 54 and 57 for all sample locations and names. Polygons shown on Reference 54 indicate properties that have been inferred to be contaminated.  
-Refer to Reference 76 for a table identifying the full Sample Location ID numbers and Lab ID number for the Sample IDs.  
-Background Sample Locations and Sample Locations delineating the AOCs are labelled.  
-Eastlake Metals LLC aka Alex Gross & Eastlake Metals LLC aka Jeff Condon - Sidwell's Portico.

The coordinates above for the Federated Metals Corp Whiting site were measured from within the area of observed contamination (AOC B/Source #2) at the Federated Metals/Whiting Metals property, Whiting, Indiana (Figures 1, 2, 3).

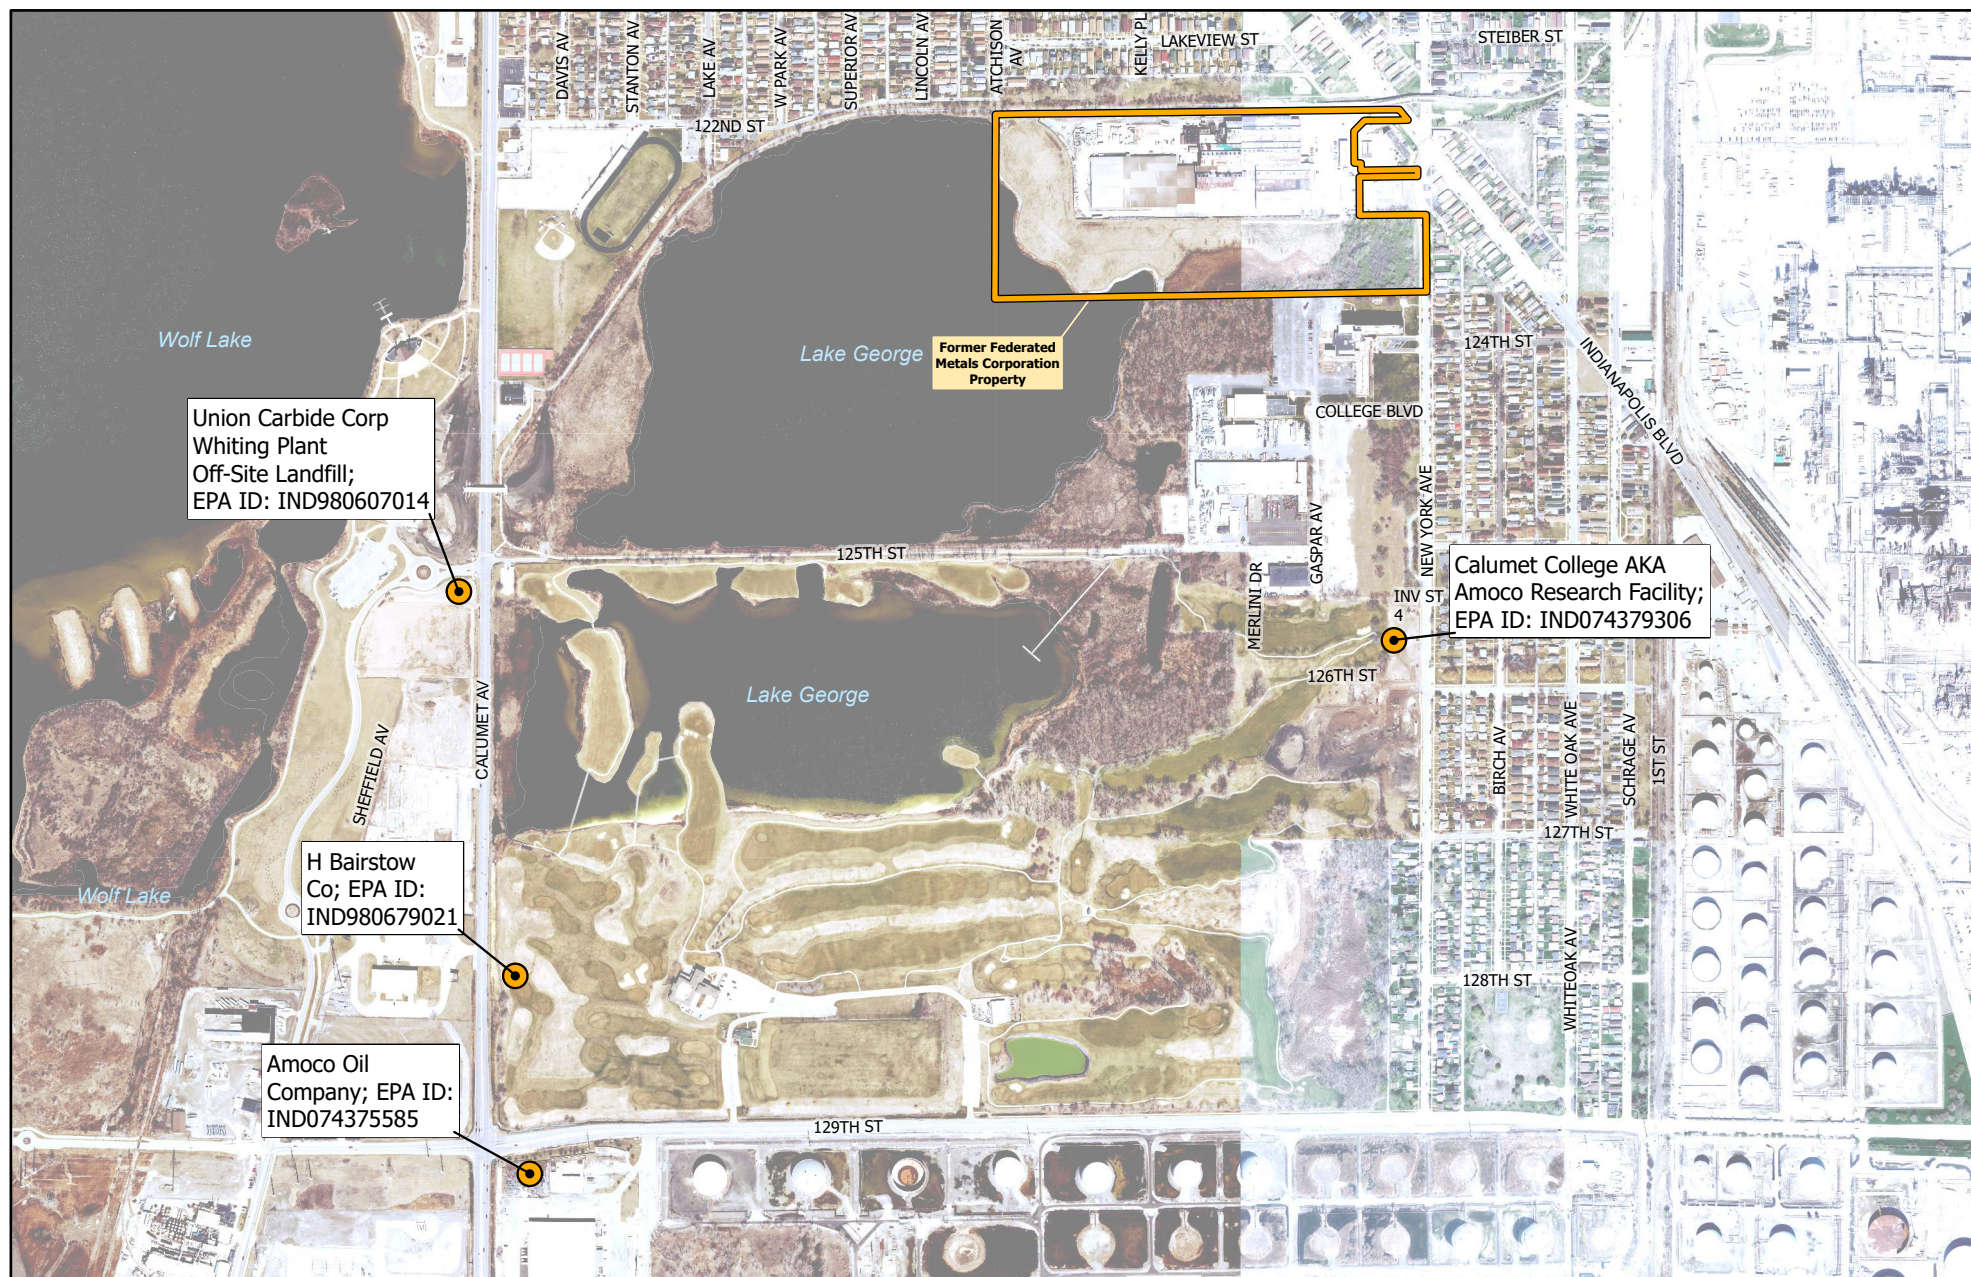
**Figure 4:**  
**Federated Metals Corp Whiting**  
**Potential Off-Site Sources**

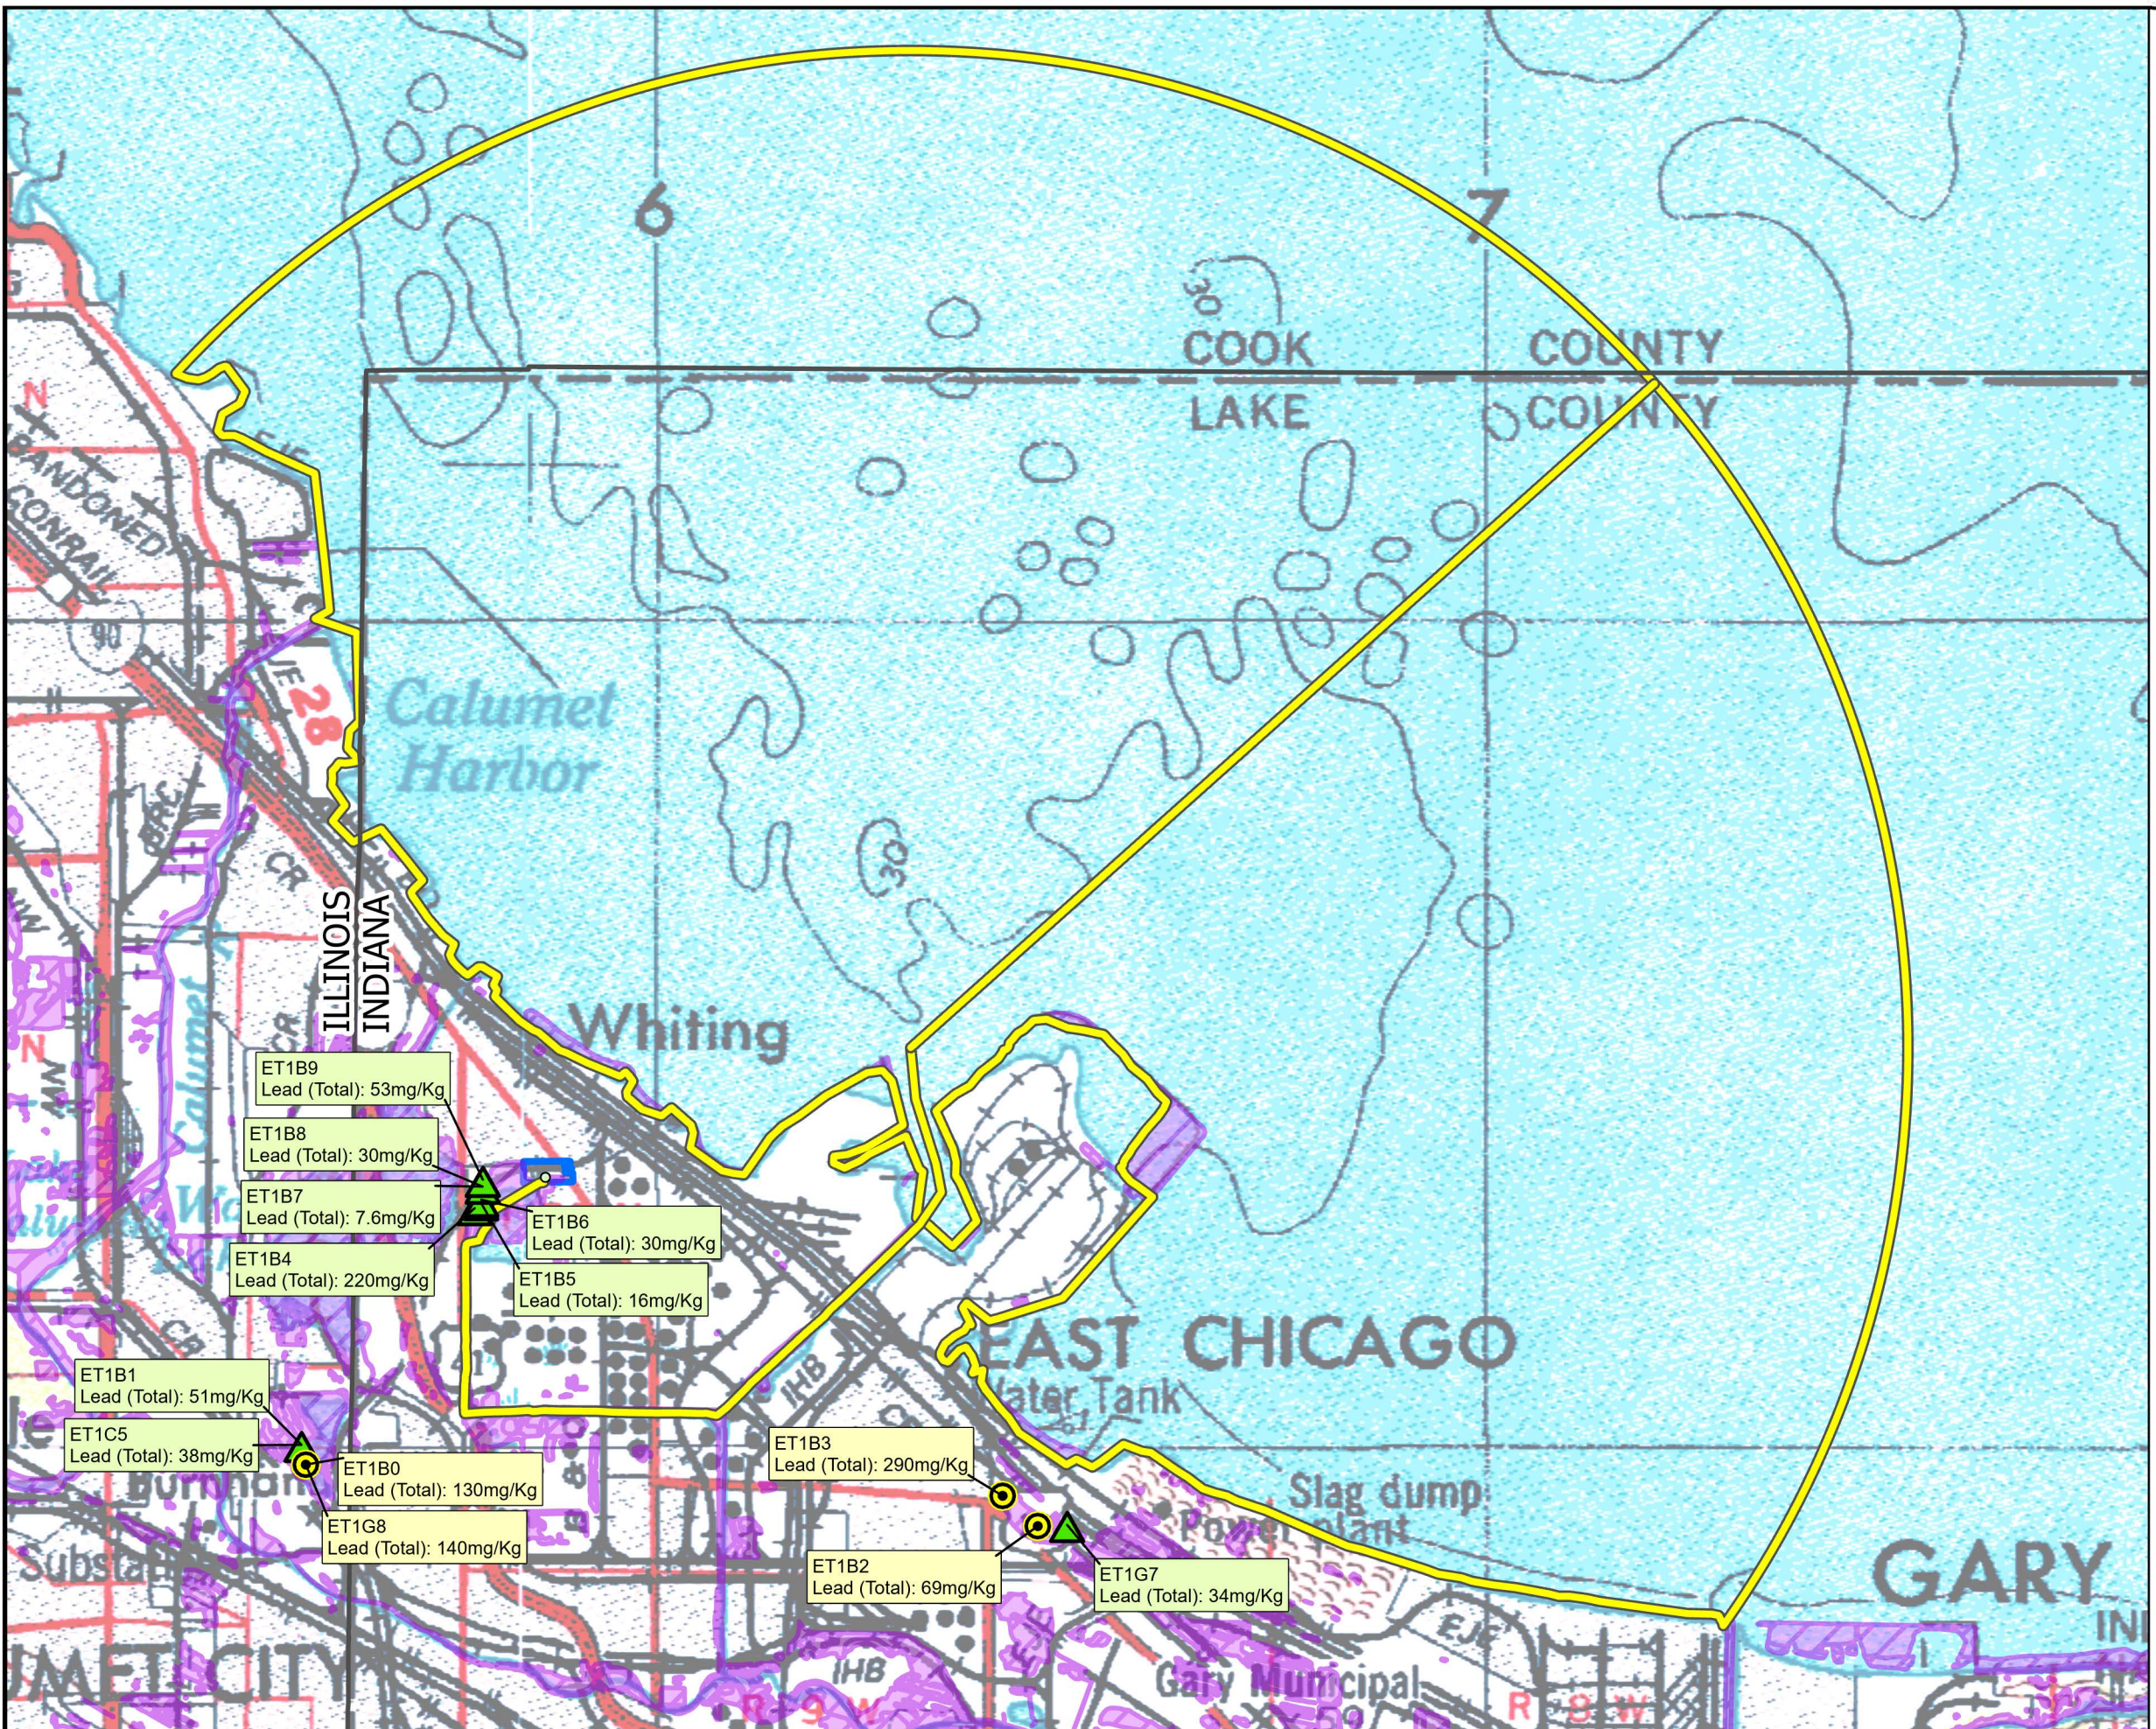
**Figure 6:  
Federated Metals Corp Whiting  
Wetland and Sediment Sample  
Location Map Showing Probable  
Point of Entry, Wetland Frontage and  
Perimeter, Background Concentrations,  
and Observed Release Concentrations  
in the Lake George Area**

- Background Wetland Sample
- Wetland Sample that meets Observed Release Criteria
- Sediment Sample that meets Observed Release Criteria
- Probable Point of Entry (PPE) End Point 1
- Probable Point of Entry (PPE) End Point 2
- Radius of Arc 1
- Radius of Arc 2
- Arc 1
- Arc 2
- OverlandFlow
- Probable Point of Entry
- Wetland Frontage
- Zone of Level II Contamination
- Wetland Perimeter
- Approximate Dredged Lake Area
- Approximate Sedge Meadow Dredged Area
- Freshwater Emergent Wetland
- Freshwater Forested/Shrub Wetland
- Freshwater Pond
- Lake
- Other
- Riverine
