## HRS DOCUMENTATION RECORD COVER SHEET

**Name of Site:** Acme Steel Coke Plant  
**EPA Identification Number:** ILN000509241 (Ref. 4, p. 1)

## HRS DOCUMENTATION RECORD

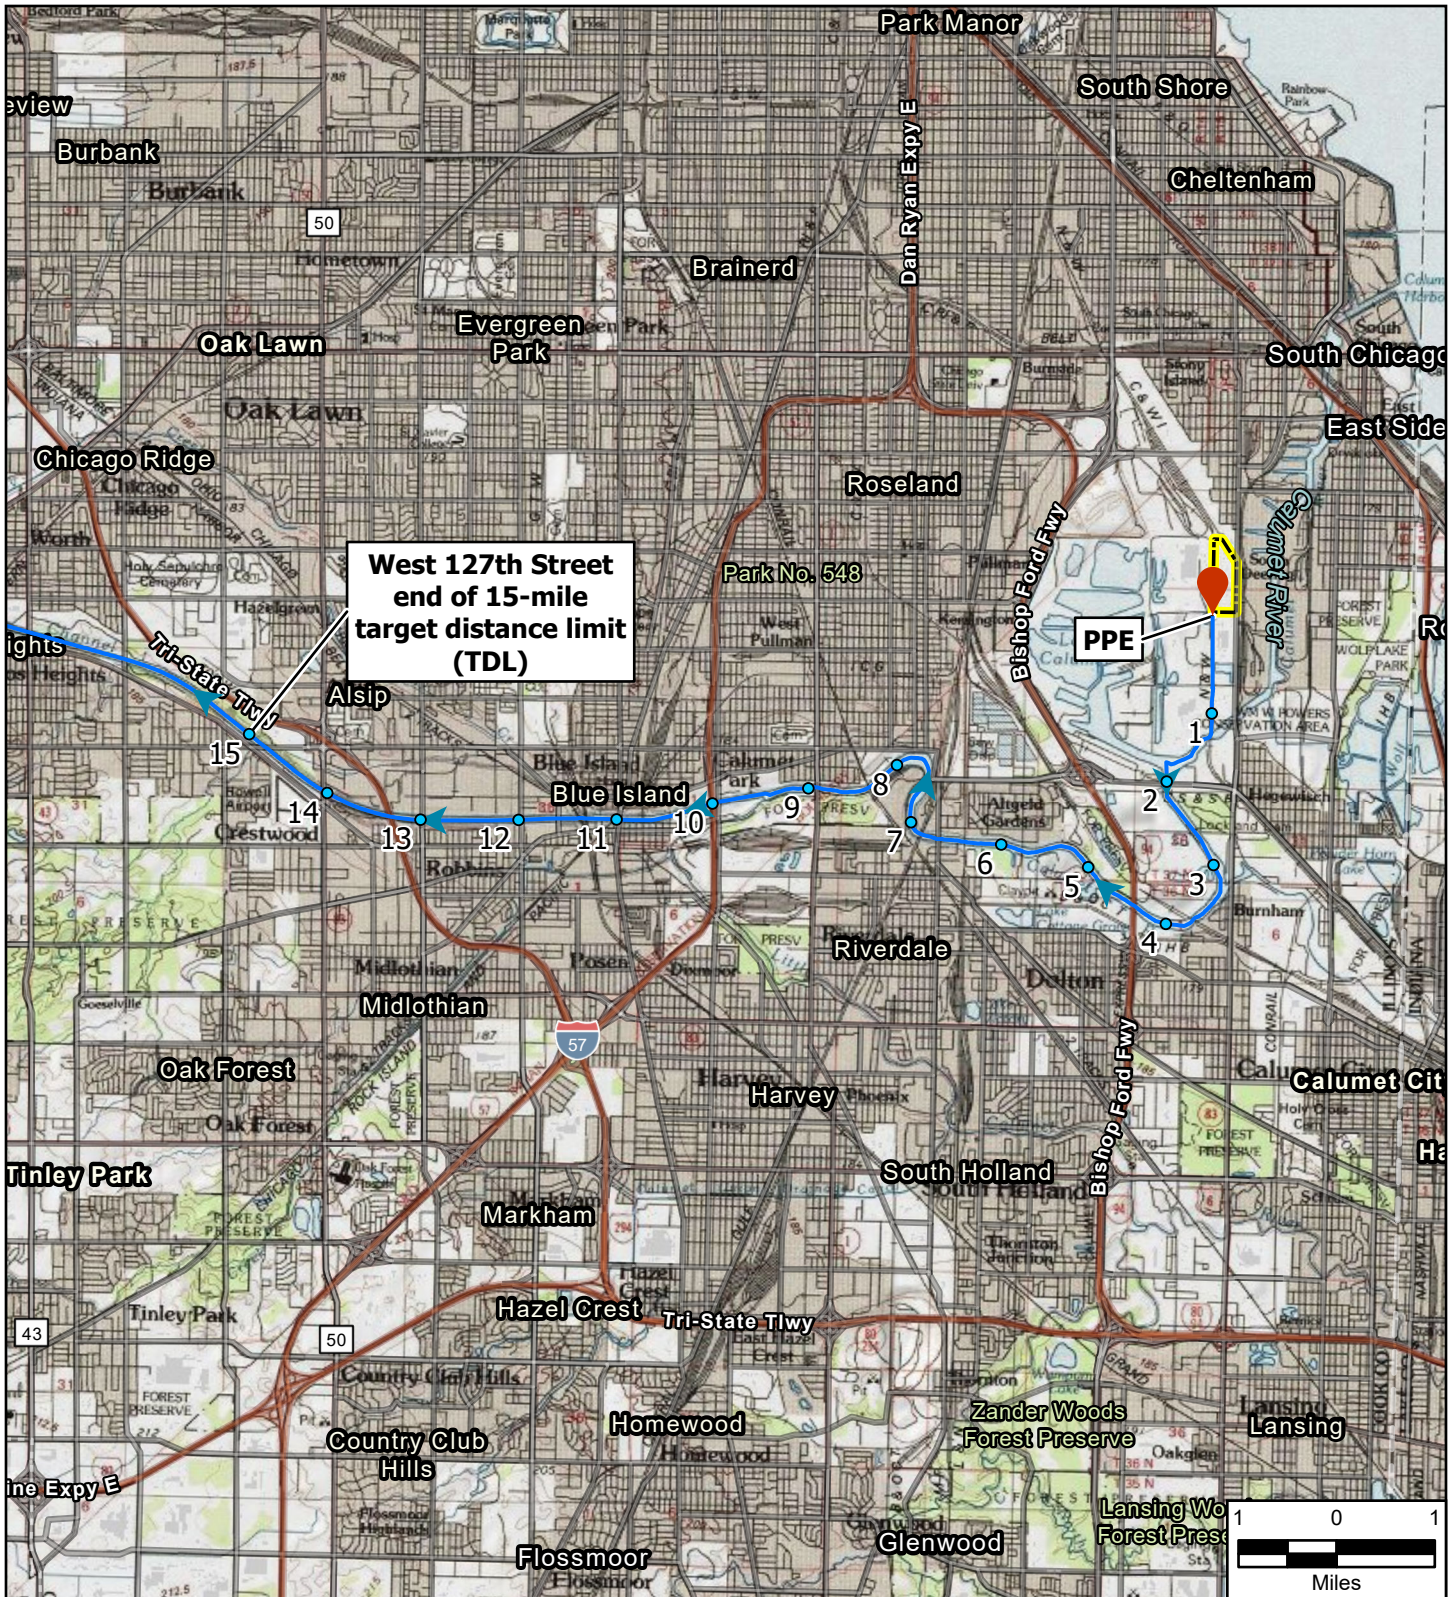
- Mile Markers along Pathways
- 📍 Probable Point of Entry (PPE)
- Surface Water Migration Pathways
- 📐 Approximate Plant Boundary
