New Bedford Harbor Superfund Site

Final Parcel 265 Intertidal After Action Report

ACE-J23-35BG2000-M17-0025

August 2018

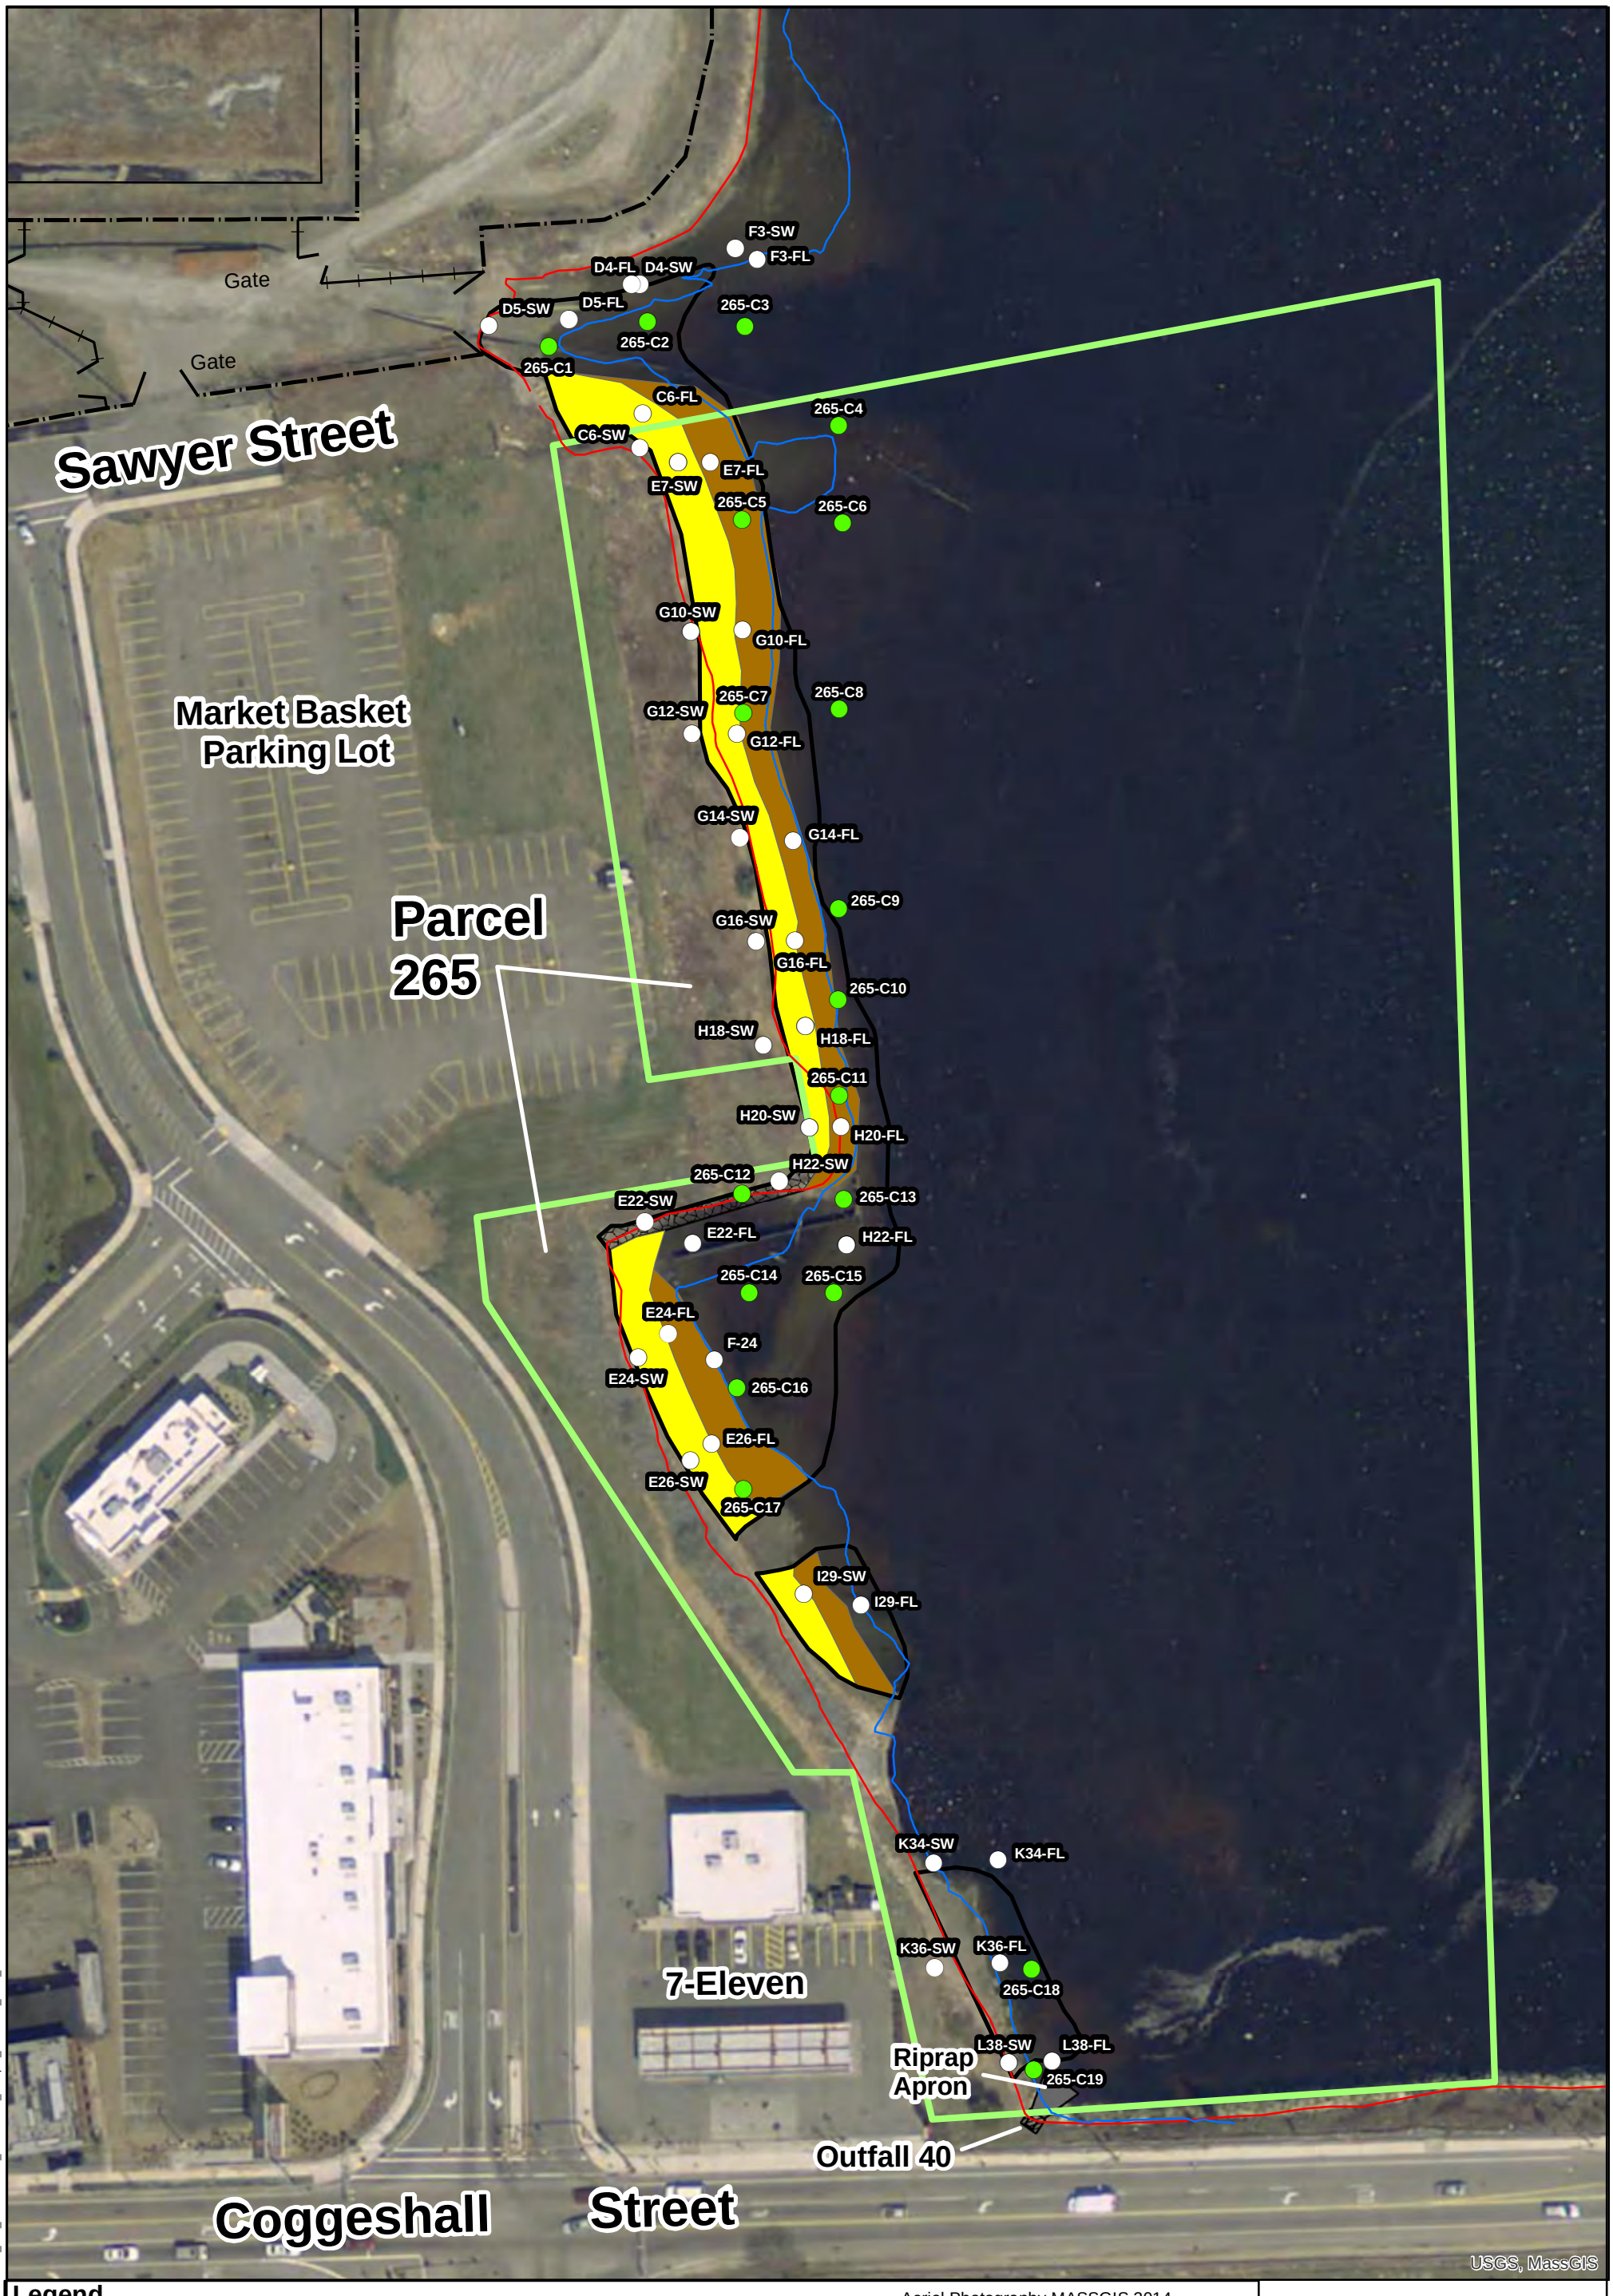
Figure 2-4

Post-excavation verification sampling was conducted by an independent party in accordance with the Field Sampling Plan (FSP) Addendum #1 to the *Revised Draft Final Confirmatory Sampling Field Sampling Plan, Lower Harbor Winter 2016 Dredge Areas and Parcel 265* (Battelle 2016a) [Confirmatory Sampling FSP] as well as the *Uniform Federal Policy- Quality Assurance Project Plan* (*QAPP) Addendum* (Battelle 2016b). Verification samples were collected on a 50-ft. grid from a pre-defined mudflat/subtidal compliance demonstration area (CDA) and a saltmarsh CDA. Jacobs screened the verification samples using immunoassay analysis to evaluate whether any further removal of contaminated sediment was required (Figure 2-4).

Confirmatory samples were collected from the area backfilled with at least 1 ft. of material. Two of these sample locations, C14 and C15, were collected from the deep excavation adjacent to the wooden structure and represent areas that have been converted to subtidal. PCB concentrations for C14 and C15 were 122 and 27.9 mg/kg, respectively. Over-excavation was conducted adjacent to the wooden structure in an effort to remove all contaminated sediment; however, excavation ceased at a depth of 14 ft. upon direction of NAE. This area was backfilled with 4 to 5 ft. of stone, and is now a subtidal area with a subaqueous cap, and therefore no longer represents an area with potential dermal contact (Figure 2-5).

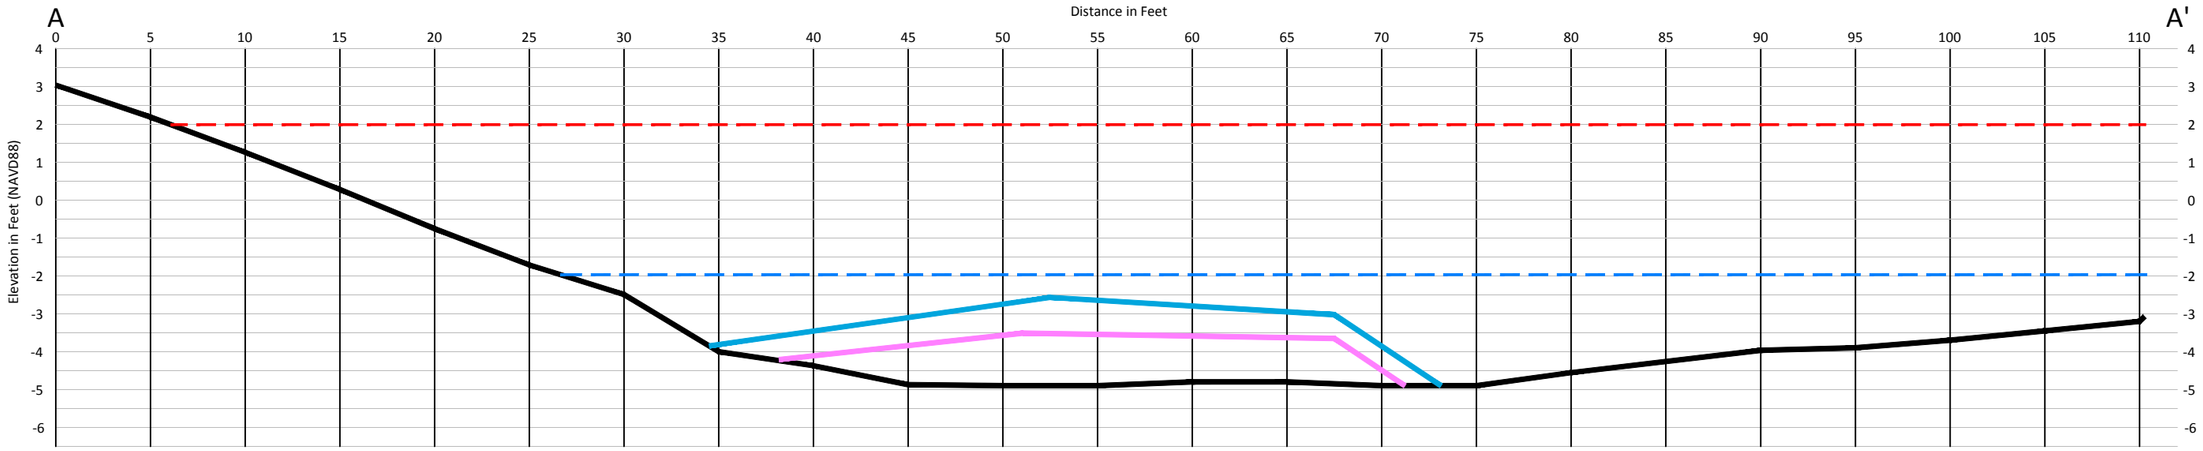
Figure 2-6

Site restoration activities were completed following the removal of contaminated sediments according to the methods defined in the Work Plan. Restoration activities included backfill, revegetation, and removal of security fencing and an access road. Backfill of excavated areas was performed by Sevenson using fill material from an uncontaminated virgin source as specified in the Work Plan (Figures 2-5 and 2-6).
