First Five-Year Review Report
For
North Carolina State University Lot 86 Site
Raleigh
Wake County, North Carolina

September 2003

U.S. Army Corps of Engineers
Wilmington District
Wilmington, North Carolina

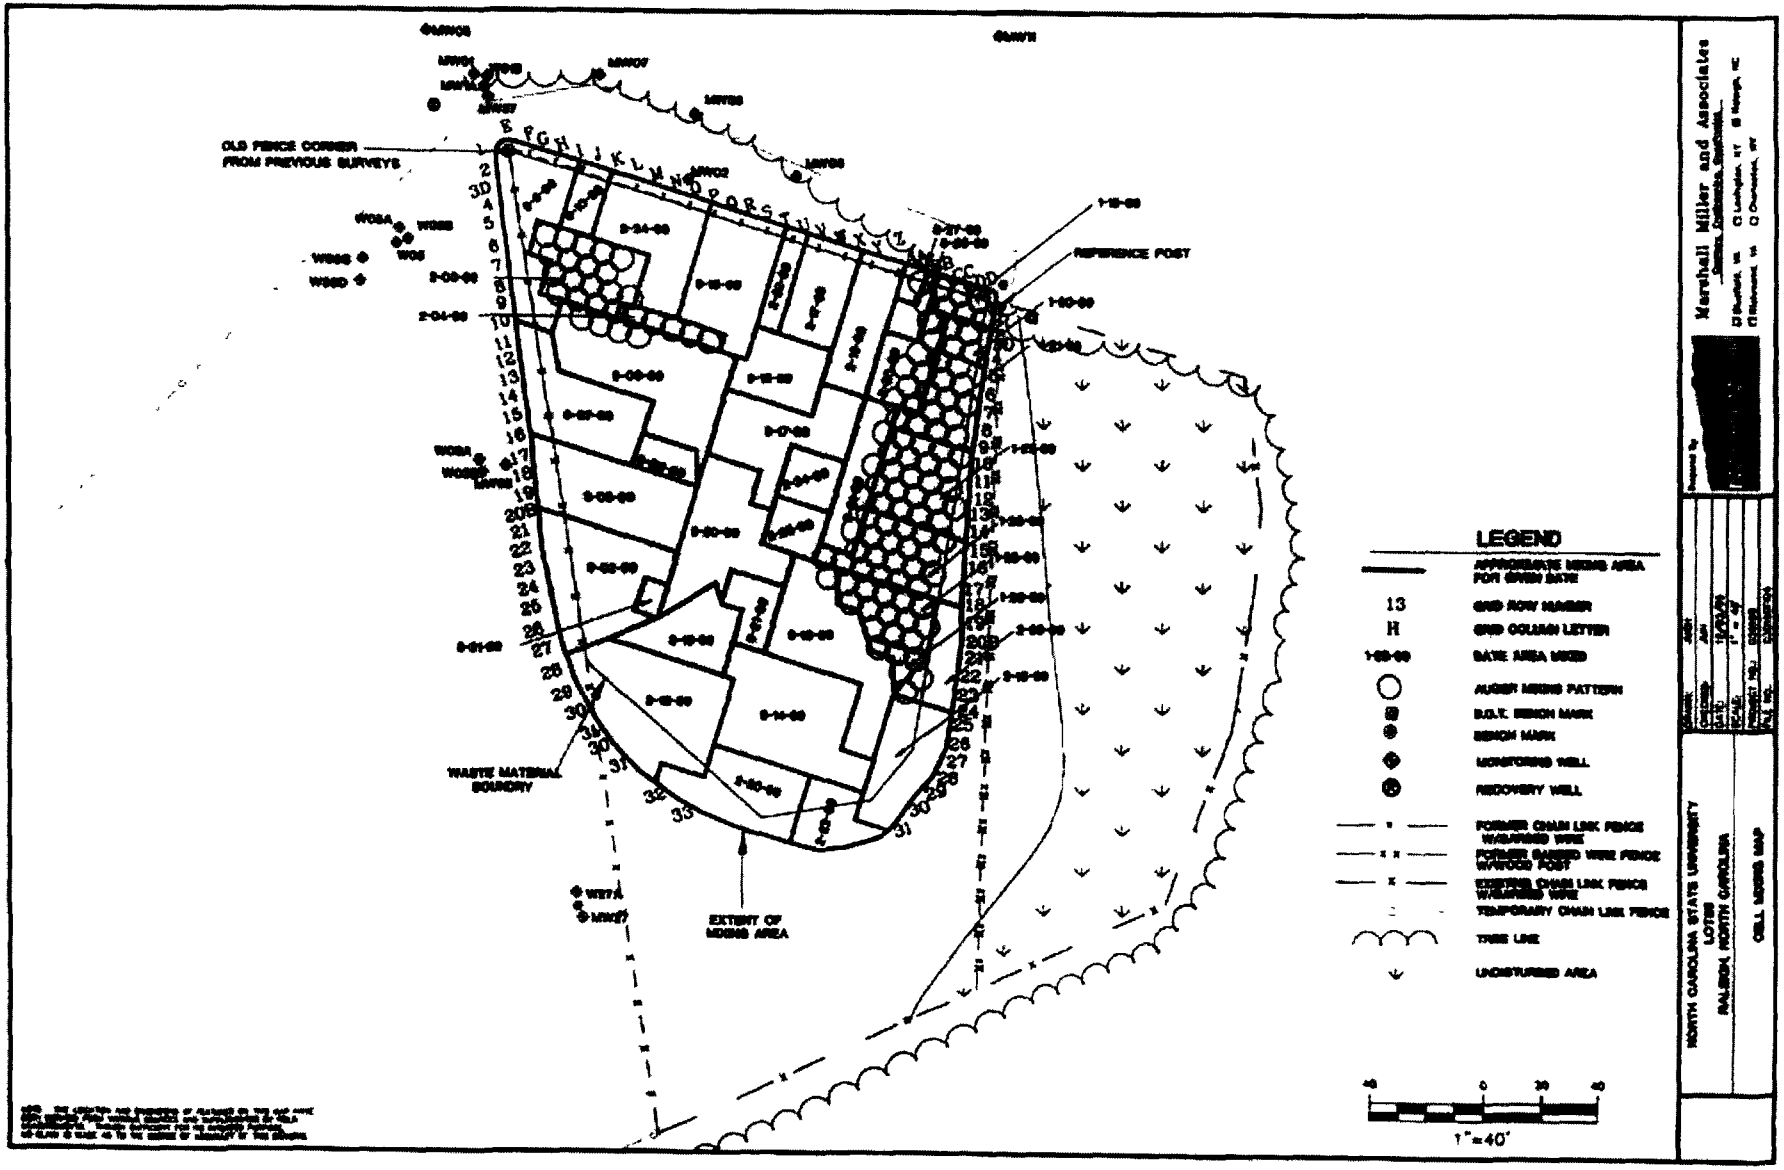
Figure 10. Mixing Cell Map

procedures. The trackhoe bucket was used to mix the contaminated soil and grout into a homogeneous blend in individual cells. The cells were the width of the bucket (four feet) by twelve feet long by ten feet deep or two feet past the depth of the visible waste material. The use of the trackhoe allowed for visual inspection to determine at what depth the waste material was present. Addendums to the Remedial Action Work Plan, Performance Standards Verification Plan, and Construction Health and Safety/Contingency Plan were submitted to incorporate the changes to the remedy. Once these addendums were approved, trackhoe-mixing operations commenced on August 27, 1999. Mixing operations were completed on September 21, 1999 and Figure 10 is provided to illustrate the mixing cells conducted during the RA.

Two of the 113 samples failed the unconfined compressive strength testing criteria due to not following the sampling protocol. After remixing and resampling, two additional samples from the failed sample columns passed the unconfined compressive strength criteria.

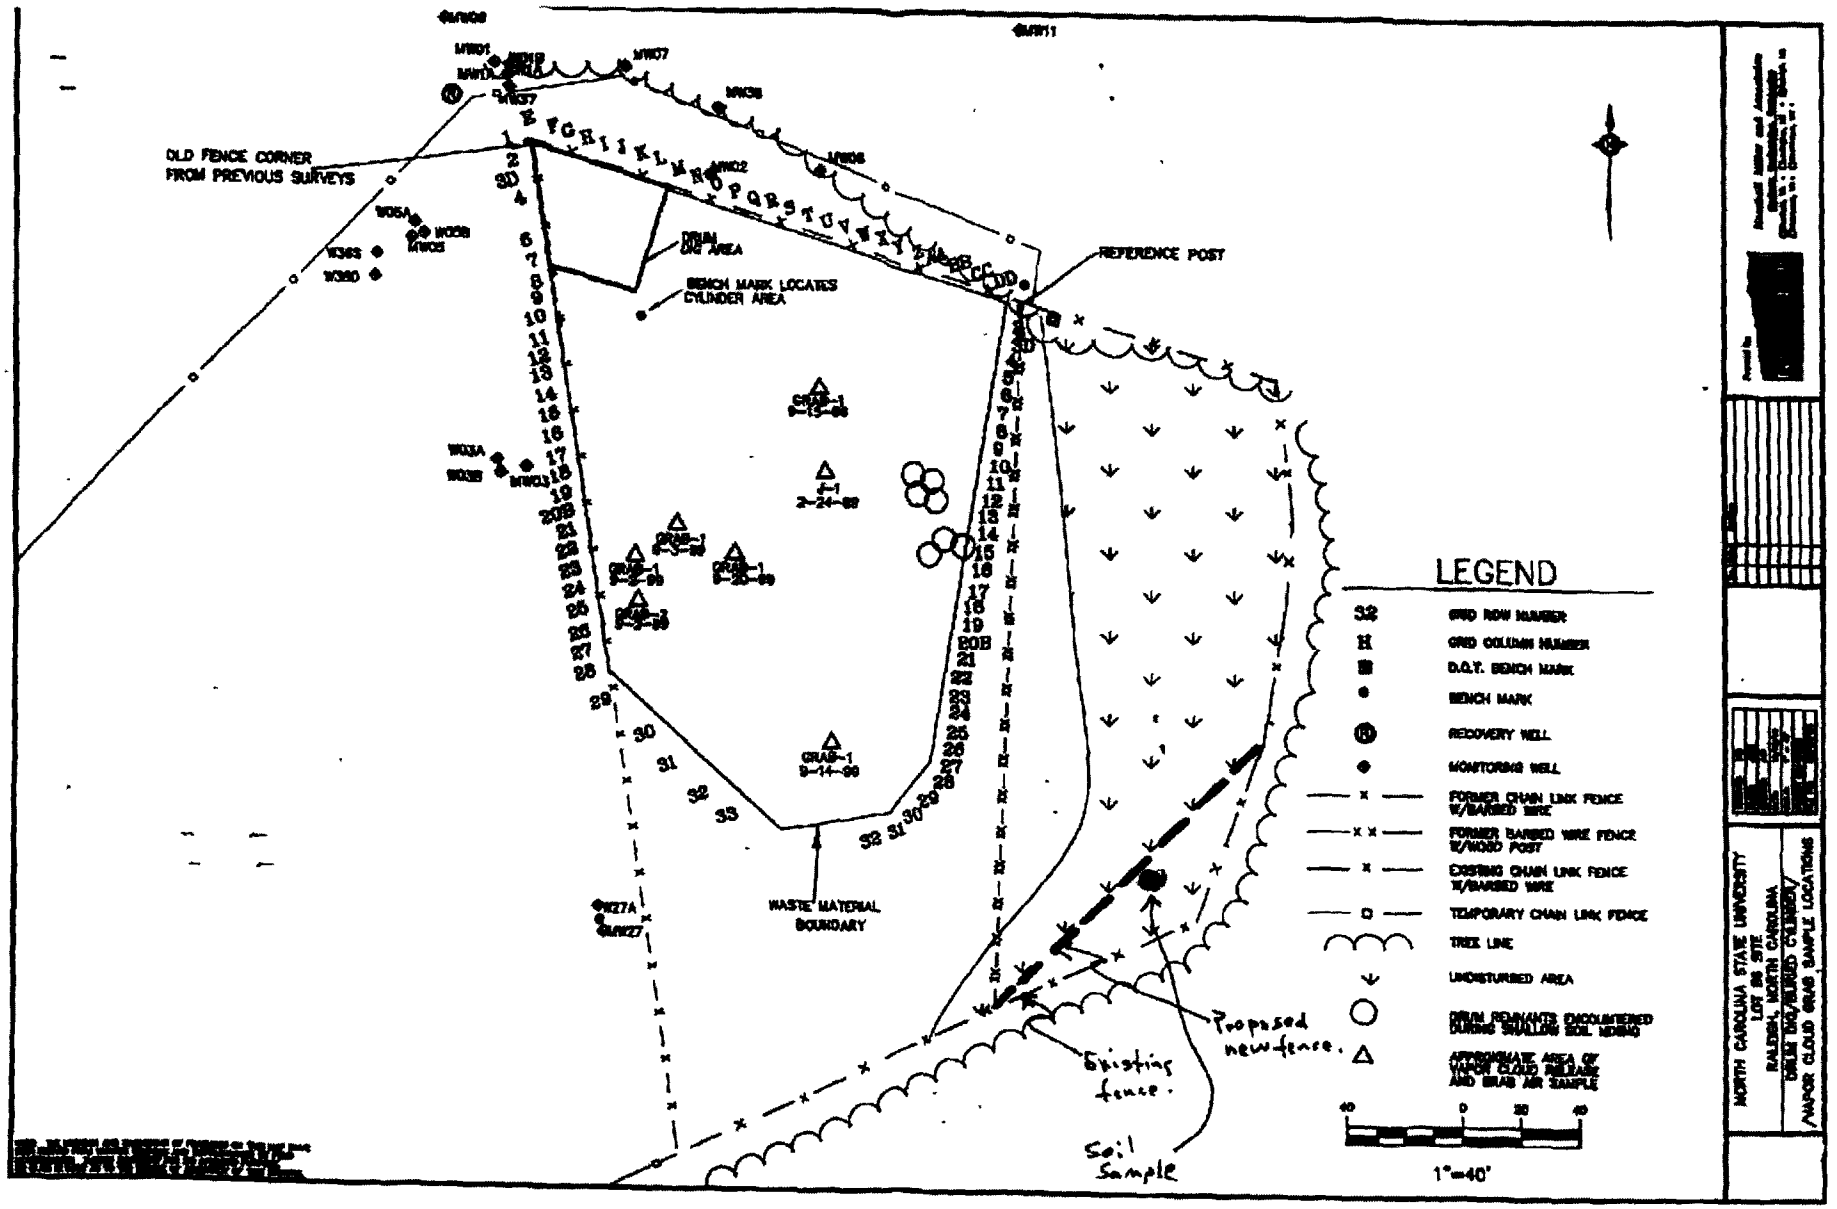
Figure 11. Soil Sample Location for Perimeter Fence Relocation

In April 2002 a soil sample was collected in order to relocate a small portion of the perimeter fence to allow for easier maintenance of the perimeter and for installation of a football practice field light. This area was identified as having no history of chemical contamination. The soil sample was collected from 1.5 to 2 feet bgs from the location shown in Figure 11. The sample was analyzed for volatile organics and radiological parameters. The results indicated all constituents were non-detect except bromoform. Bromoform was detected at 26 parts per million (ppm), which was less than the North Carolina action limit of 62 ppm (NCSU 2002).

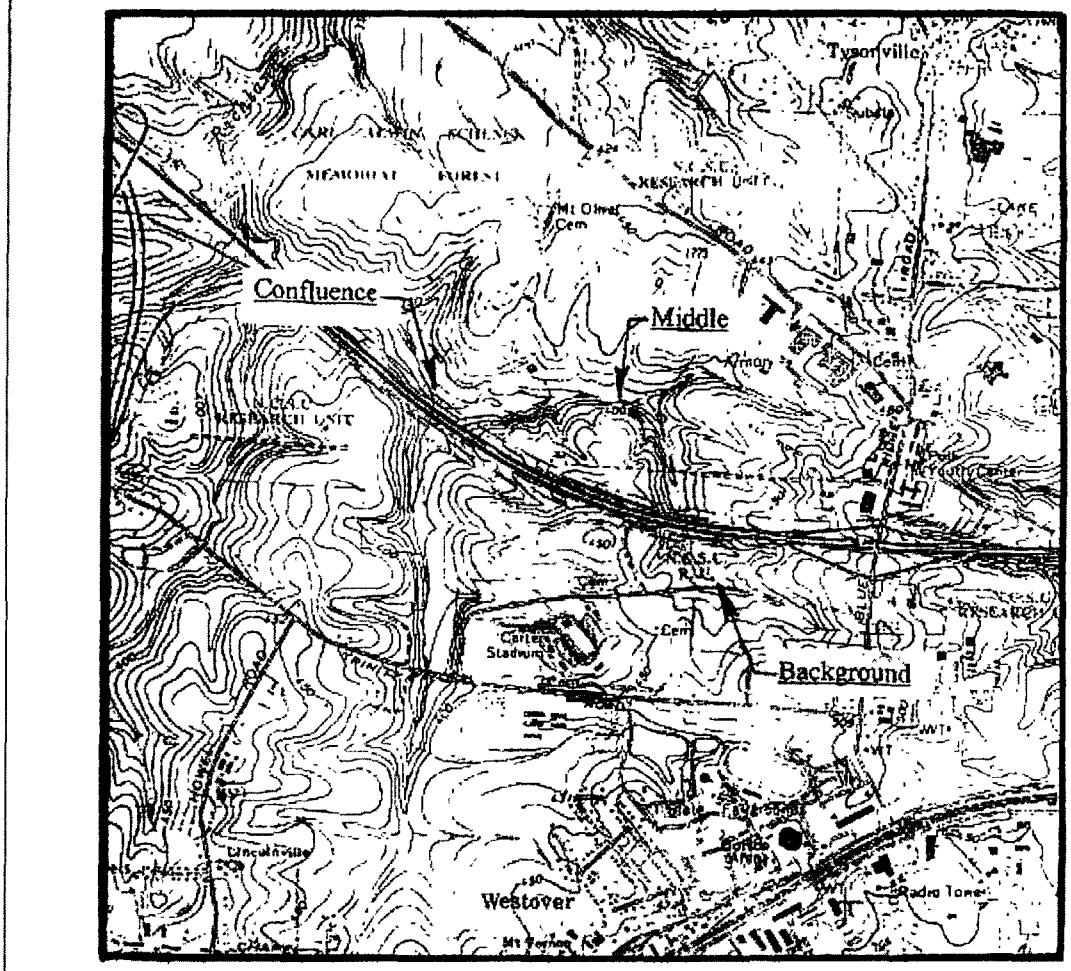
Figure 17. Sediment and Surface Water Sample Locations for Richlands Creek

In April 2001, surface water and sediment samples were collected from three locations near the site. The locations included a background location, from the middle of Richland Creek and from the confluence of Richland Creek and an unnamed tributary and are shown on Figure 17. The samples were analyzed for VOCs and the results indicated VOCs were not detected above the detection limits in any sample.
