Memorandum

May 12, 2020

Re: San Jacinto River Waste Pits TCRA Armored Cap
Post-Tropical Storm Imelda Channel Maintenance Completion Report

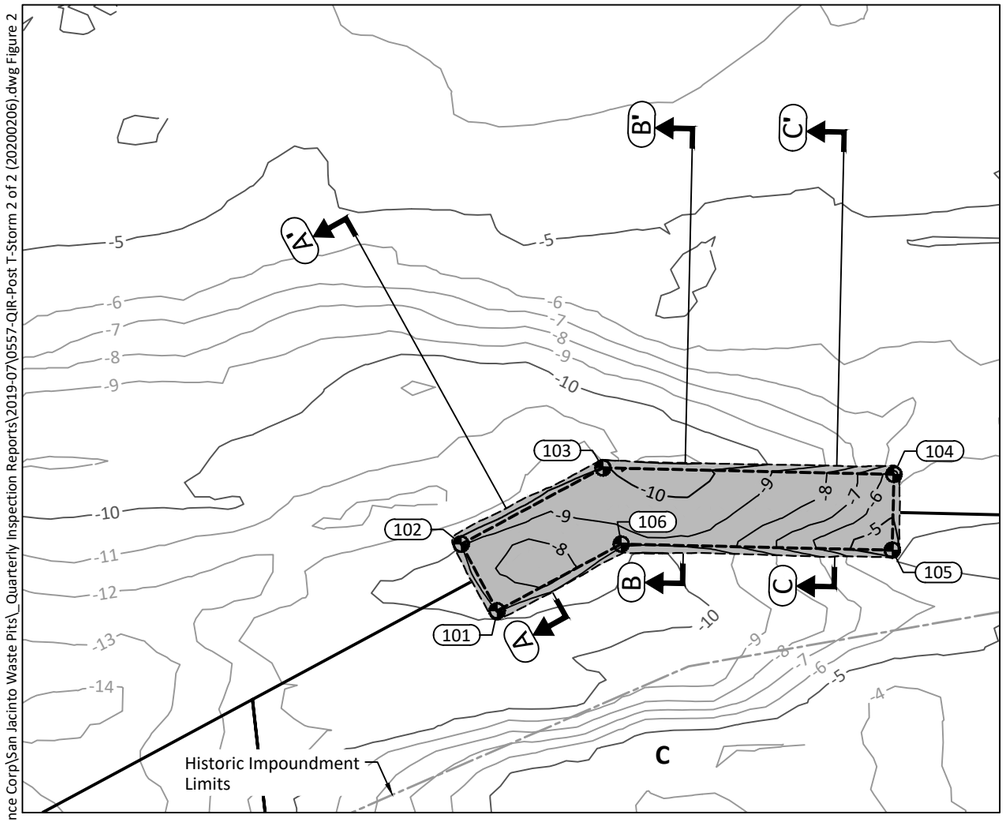
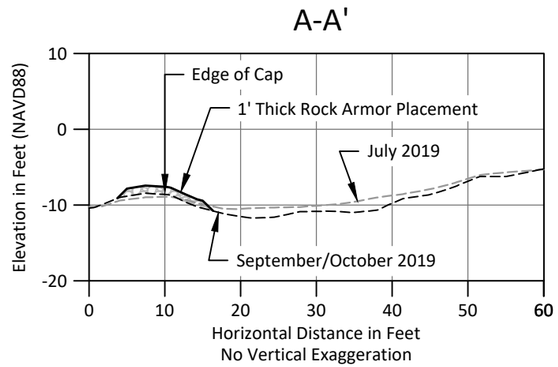
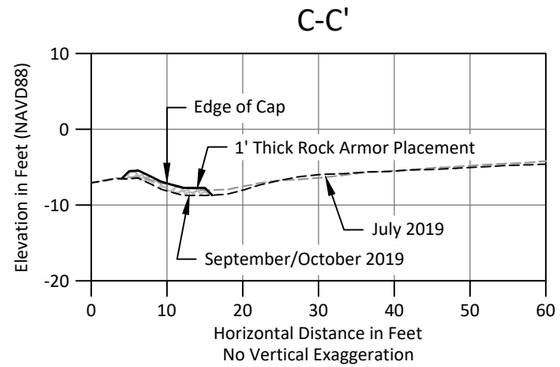
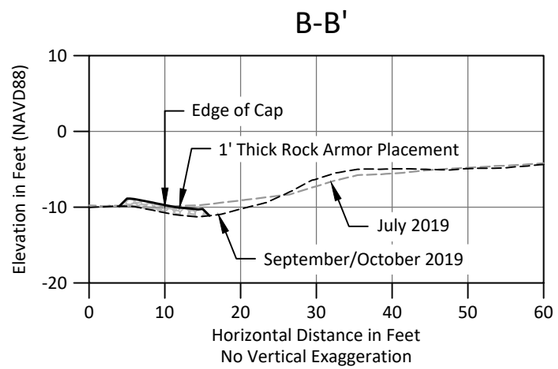
Figure 1
Site-Wide Post-Flood Plan View
Post-Tropical Storm Imelda Work Plan
San Jacinto River Waste Pits Superfund Site

The post-storm bathymetric survey revealed two areas (Channel Areas) outside the footprint of the Armored Cap, in the river channel adjacent to the Armored Cap where riverbed elevations had decreased, relative to the July 2019 quarterly inspection survey (Figure 1). The Channel Areas are located in the vicinity of where the barge was grounded.

The proposed work involves placing additional rock in the three areas shown on Figures 1 through 3 (Placement Areas) to further protect the edge of the Armored Cap by providing additional slope stabilization and scour protection at those locations. Placement Areas 2 and 3, located along the southern edges of the two Channel Areas, were the areas originally proposed for maintenance in the November 26, 2019 submittal of this plan. Placement Area 1 is a new area incorporated into this revised plan in response to a request by USEPA. Final Removal Action Work Plan (Anchor QEA 2011) Type D[3] rock will be placed within the Placement Areas to provide slope stabilization and scour protection.

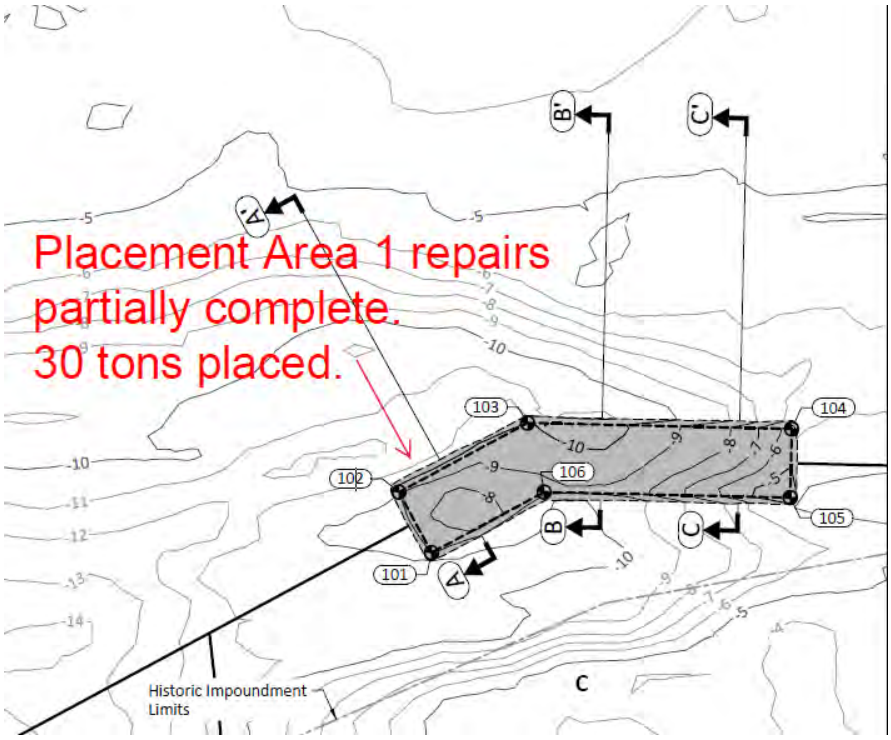
Figure 1 – CAD Detail of Placement Area 1

Photograph 4 – Rock being placed at Placement Area 1 with Dynamic Excavator.

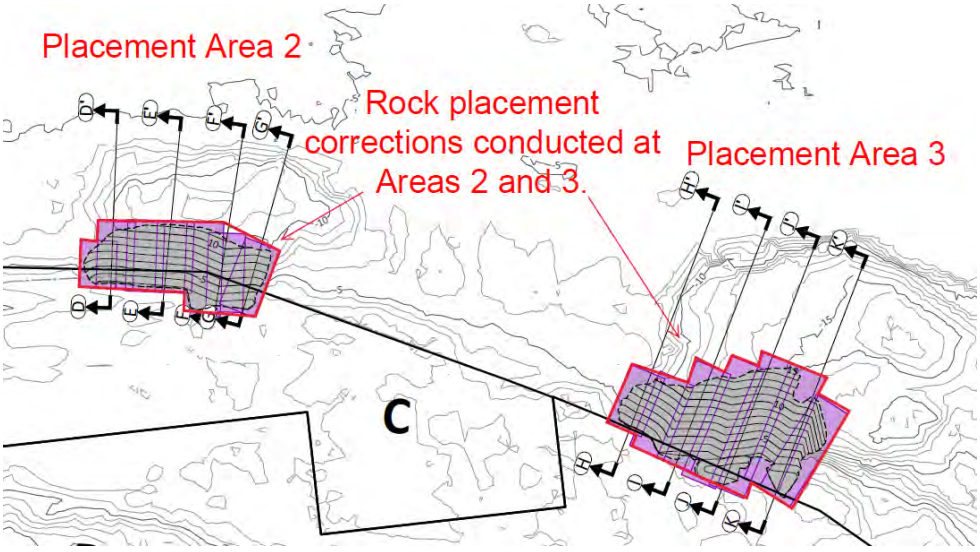
Figure 1 – CAD Detail of Placement Areas 2 and 3

Photograph 1 – Bathymetric survey and rock placement corrections being conducted at Placement Areas 2 and 3.

On April 6, 2020, the Contractor began rock placement corrections in Placement Areas based on quality control survey results.

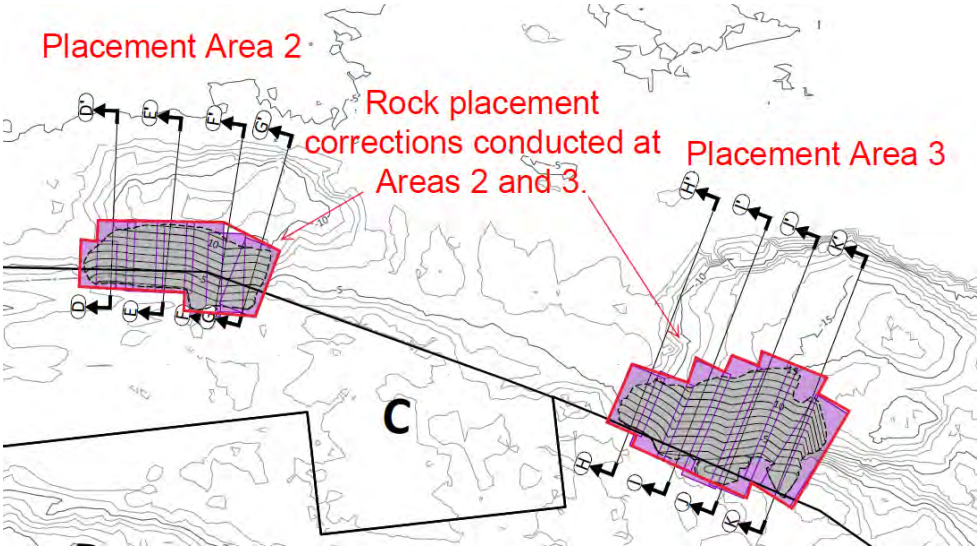
Figure 1 – CAD Detail of Placement Areas 2 and 3

Photograph 1 – Rock placement corrections being conducted at Placement Areas 2 and 3 with assistance from surveyors.

On April 7, 2020, the Contractor continued rock placement corrections in Placement Areas.

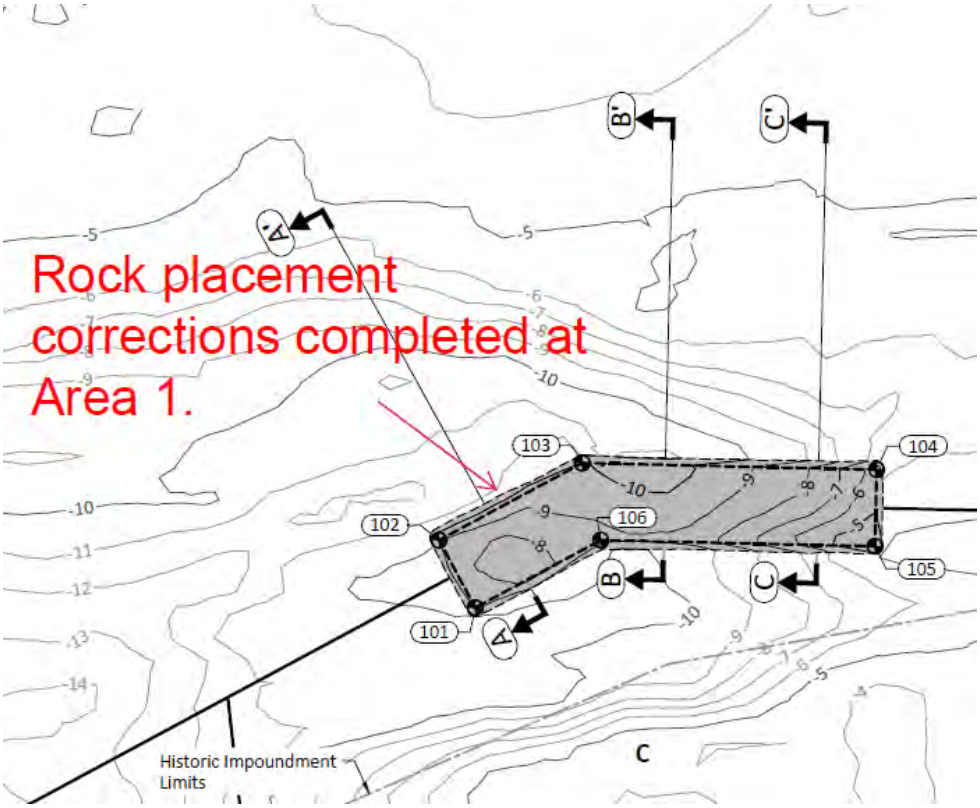
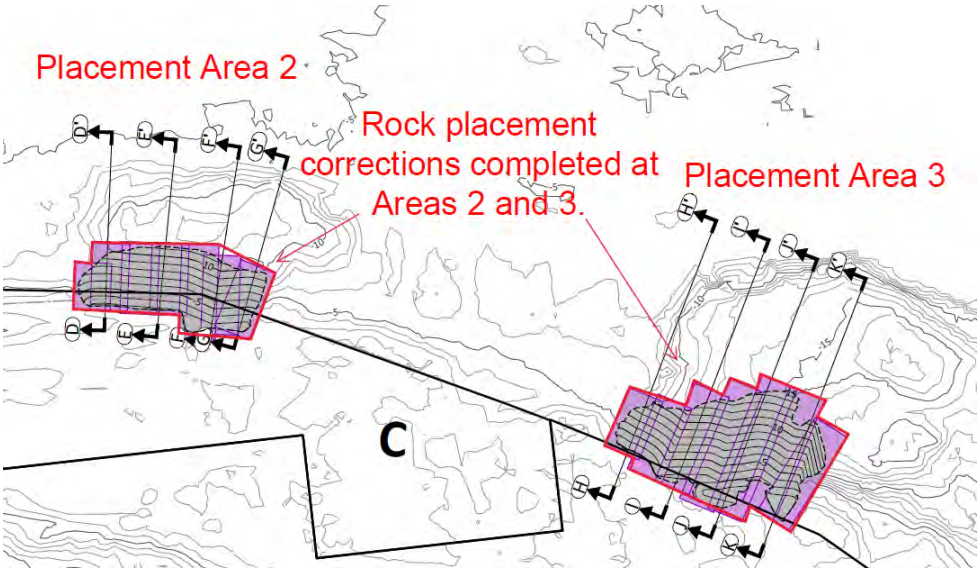
Figure 1 – CAD Detail of Placement Area 1

Photograph 2 – Rock placement corrections being conducted at Placement Areas with assistance from surveyors.

Photograph 3 – View of Placement Areas and buoys from cap after corrective measures.

Placement of armor rock was completed on Thursday, April 9, 2020. A total of 1,500 square yards of geotextile and 807 tons of armor rock were placed in the three Channel Maintenance Placement Areas.
