Third Five-Year Review Report for Silver Bow Creek/Butte Area Superfund Site

Volume 5: Rocker Timber Framing and Treating Plant Operable Unit

June 2011

Third Five-Year Review for the Silver Bow Creek/Butte Area NPL Site Butte, Montana

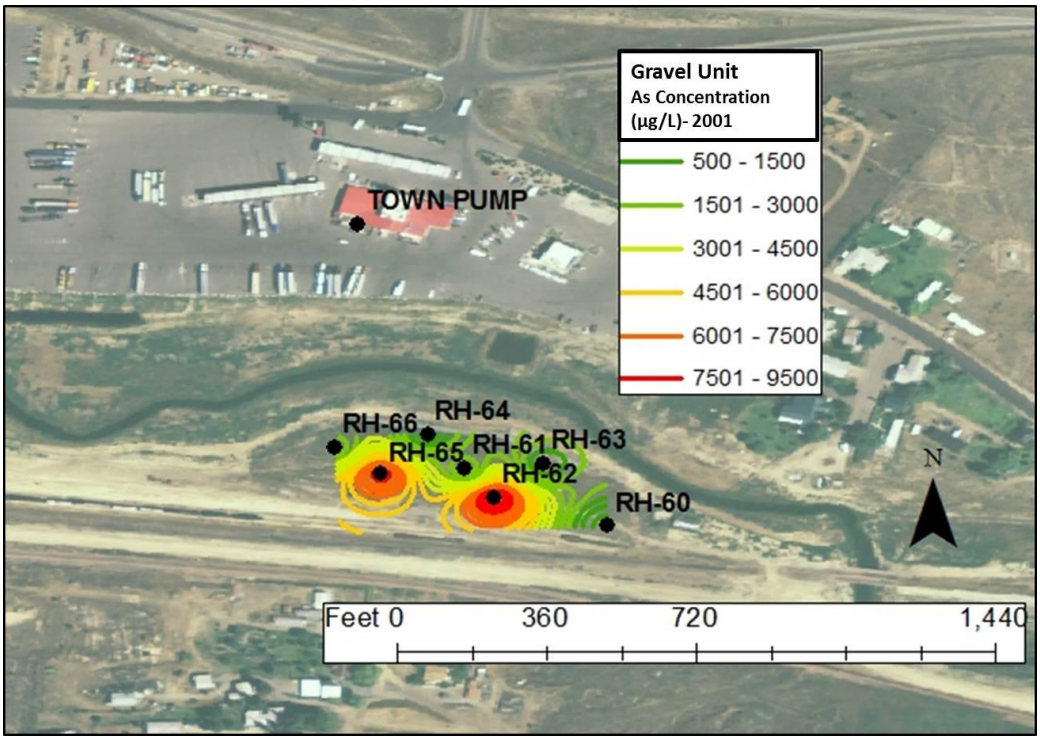
area around well RH-62, both before and after remediation. Figures 10a and 10b show the distribution of arsenic concentrations for wells in the gravel zone in 2001 and 2009, using averaged values. These figures illustrate that the general location of high arsenic concentrations in the gravel unit have not changed, but the concentrations have decreased with time. As seen in figure 6, upward vertical gradients from the shallow alluvium in this area may impact the distribution and movement of arsenic. Other gravel wells down-gradient from RH-62 have shown variable trends over time, but seem to converge around 2,000-3,000 µg/L arsenic. This suggests that arsenic is being attenuated, whether by dispersion, adsorption, or perhaps precipitation/co-precipitation as a solid phase.

Figure 10a. Water-quality contour map showing the distribution of arsenic concentrations (µg/L-2001 average) for wells completed in the gravel unit. The contour lines only extend to the spatial limit of available data, and the Town Pump well (although completed in the Tertiary aquifer) is shown for reference. The highest arsenic concentrations occurred near wells RH-62 and RH-65.

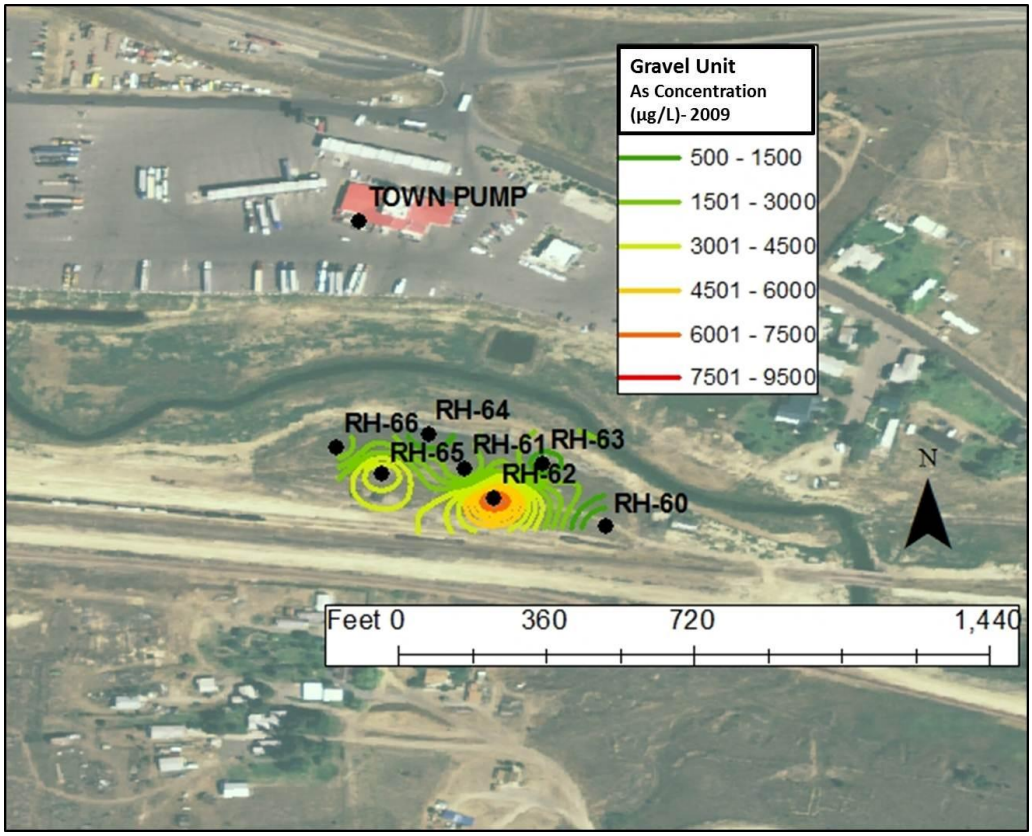
Figure 10b. Water-quality contour map showing the distribution of arsenic concentrations (µg/L- 2009 average) for wells completed in the gravel unit. The highest arsenic concentrations are shown around the same wells showing high concentrations in figure 10a, but the concentrations have decreased with time.

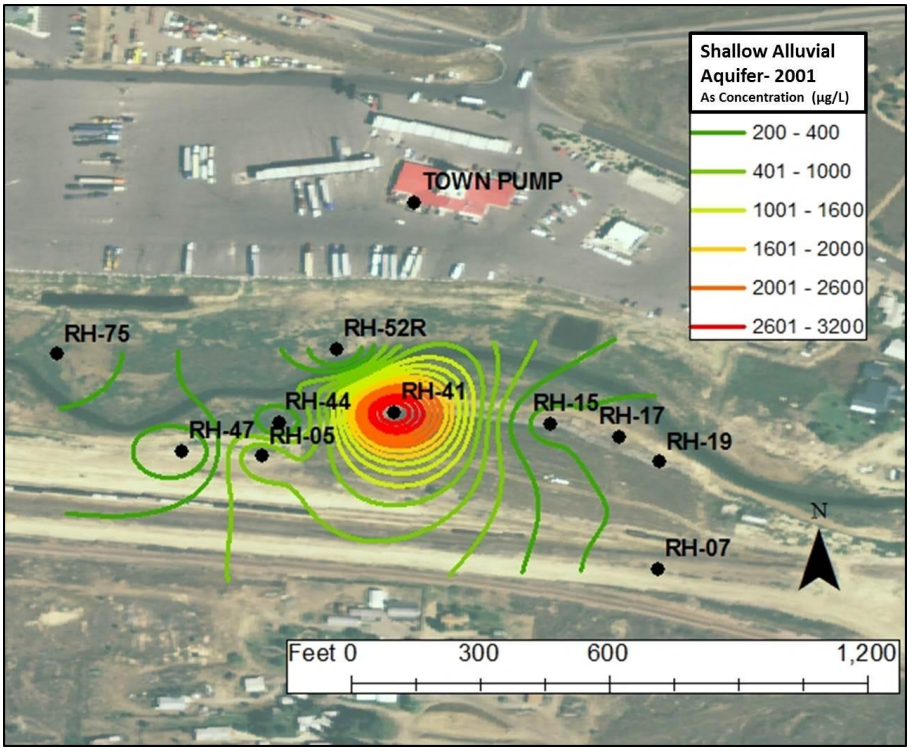
Figure 11a. Water-quality contour map showing the distribution of arsenic concentrations (µg/L-2001 average) for wells completed in the shallow alluvium. The contour lines only extend to the spatial limit of available data, and the Town Pump well (although Tertiary) is shown for reference.

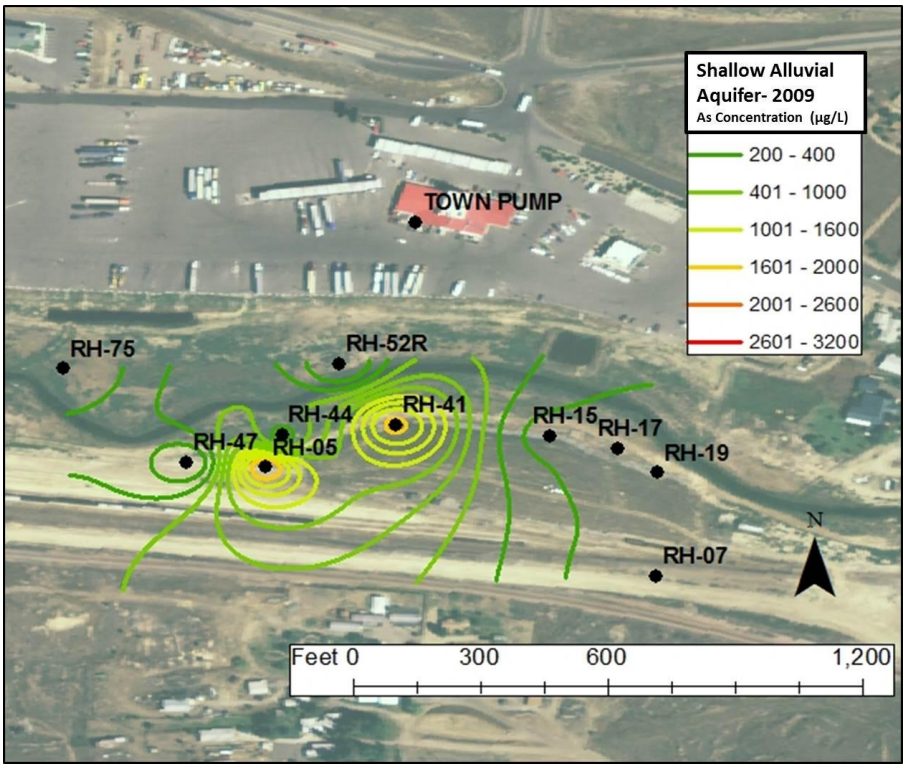
Figure 11b. Water-quality contour map showing the distribution of arsenic concentrations (µg/L-2009 average) for wells completed in the shallow alluvium. The highest arsenic concentrations are shown near RH-41 and RH-05, but generally, arsenic concentrations have decreased with time.

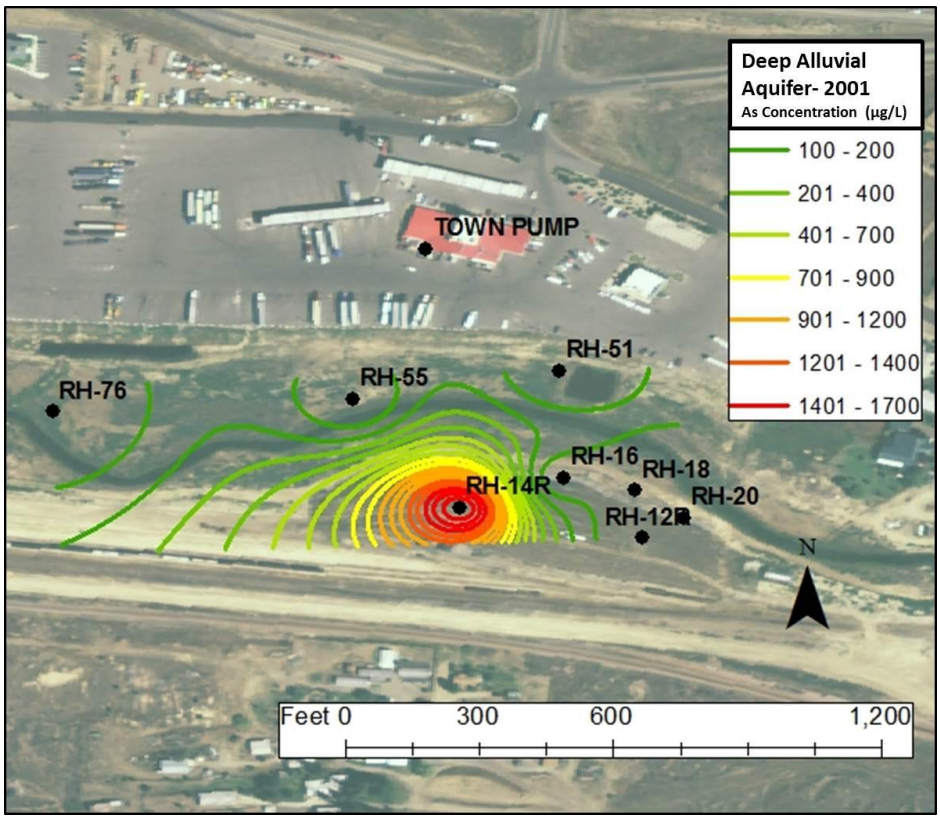
As seen in figures 12a and 12b, RH-14R consistently shows the highest arsenic concentration, which is likely because some of the highest concentrations in the gravel and shallow alluvium were situated slightly above this location. At this location, underlying the old processing area, the arsenic may have diffused or migrated deeper into the aquifer, from a zone of contamination which was not removed during remediation. In the other deep alluvial wells, arsenic concentrations remain relatively low and steady, with some wells showing slight decreases. Consistency in these arsenic concentrations and those of the contingency wells indicate that the arsenic plume is not expanding in the deep alluvial aquifer.

Figure 12a. Water-quality contour map showing the distribution of arsenic concentrations (µg/L-2001 average) for wells completed in the deep alluvium. The contour lines only extend to the spatial limit of available data, and the Town Pump well (although Tertiary) is shown for reference. The highest arsenic concentration occurred in RH-14R, which is completed just below the old processing area.

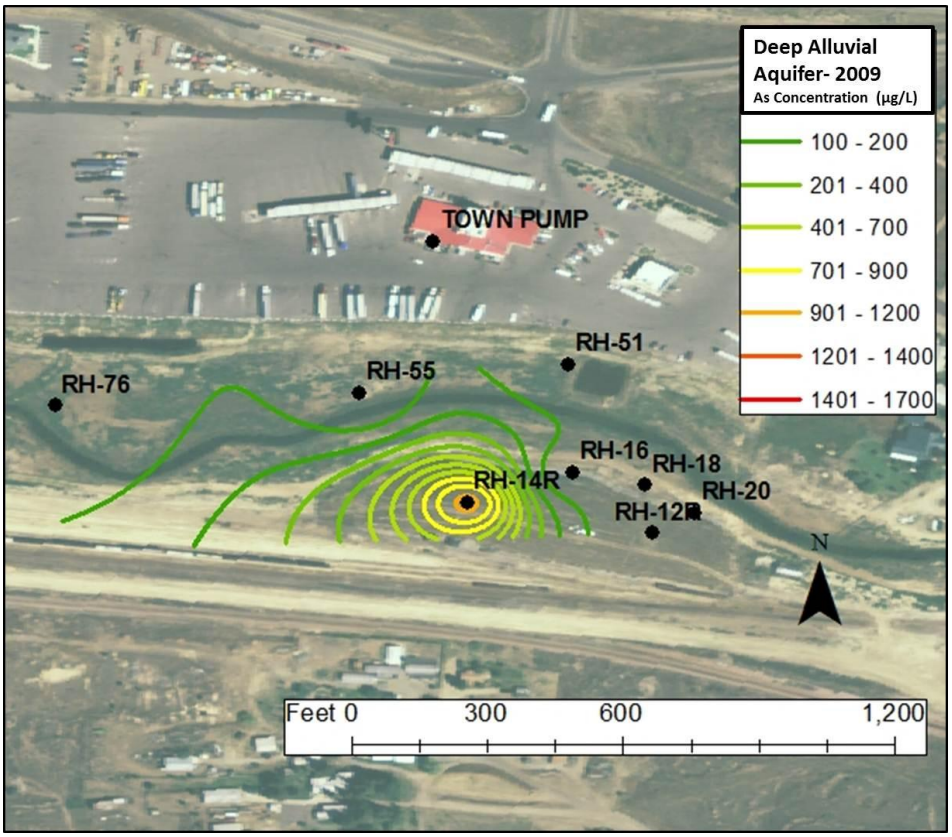
Figure 12b. Water-quality contour map showing the distribution of arsenic concentrations (µg/L-2009 average) for wells completed in the deep alluvium. The highest arsenic concentrations is found in RH-14R (like in 2001), but the concentration has decreased with time.

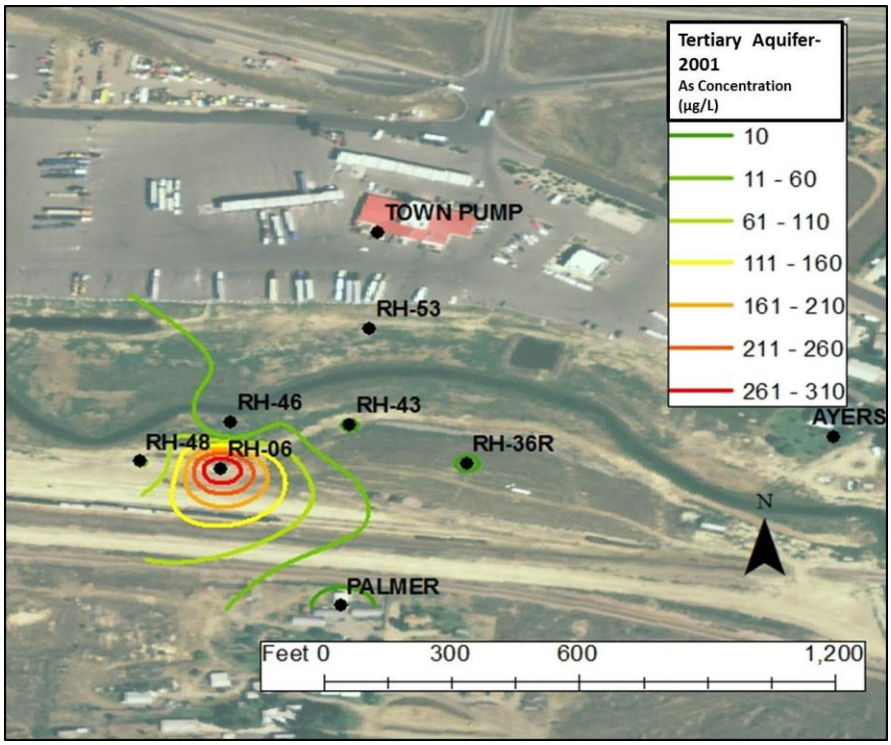
Figure 13a. Water-quality contour map showing the distribution of arsenic concentrations (µg/L-2001 average) for wells completed in the Tertiary aquifer. The contour lines only extend to the spatial limit of available data. The highest arsenic concentrations occurred near RH-06 and RH-48.

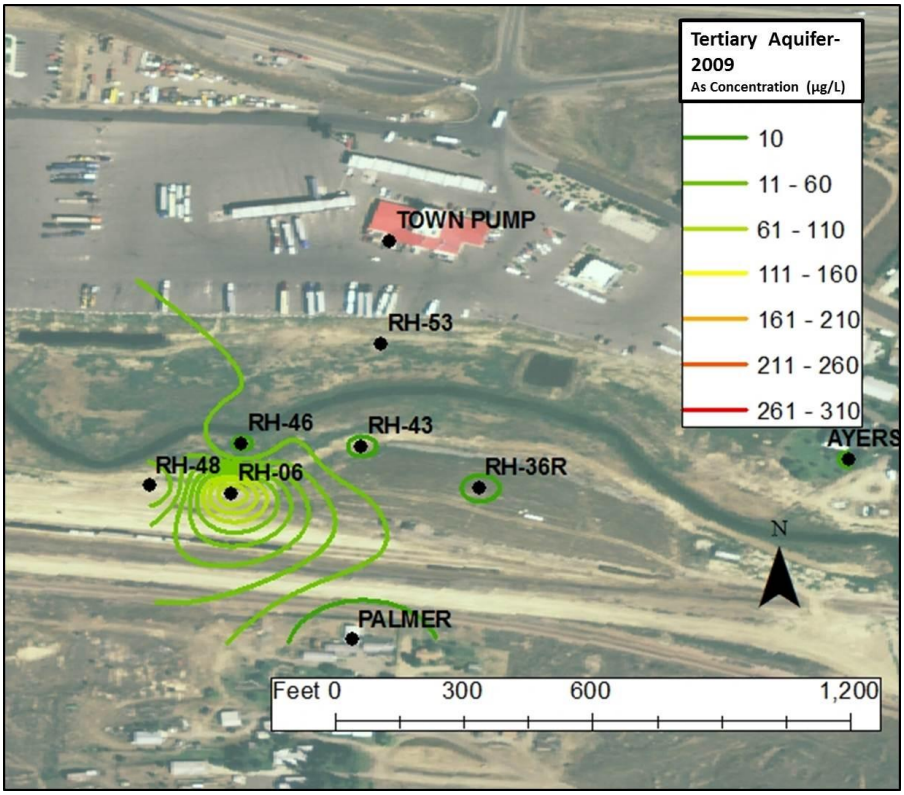
Figure 13b. Water-quality contour map showing the distribution of arsenic concentrations (µg/L-2009 average) for wells completed in the Tertiary aquifer. The highest arsenic concentrations still occur near RH-06 and RH-48, but the concentrations have decreased with time.

Concentrations of arsenic have decreased significantly for both RH-06 and RH-48 since remediation, although elevated concentrations persist in these same locations as they did prior to remedial action (average of 97 and 12 µg/L in 2009, respectively). The arsenic concentrations remain low in the other Tertiary monitoring wells, with an average of 8.9 µg/L in 2009 (range 2.7 to 11.5 µg/L). With arsenic at these concentrations, it may be difficult to determine whether the arsenic is originating from contamination at the Rocker site or from the Tertiary volcanic sediments themselves.
