Third Five-Year Review Report for Silver Bow Creek/Butte Area Superfund Site

Volume 6: Butte Priority Soils Operable Unit

June 2011

Third Five-Year Review for the Silver Bow Creek/Butte Area NPL Site Butte, Montana

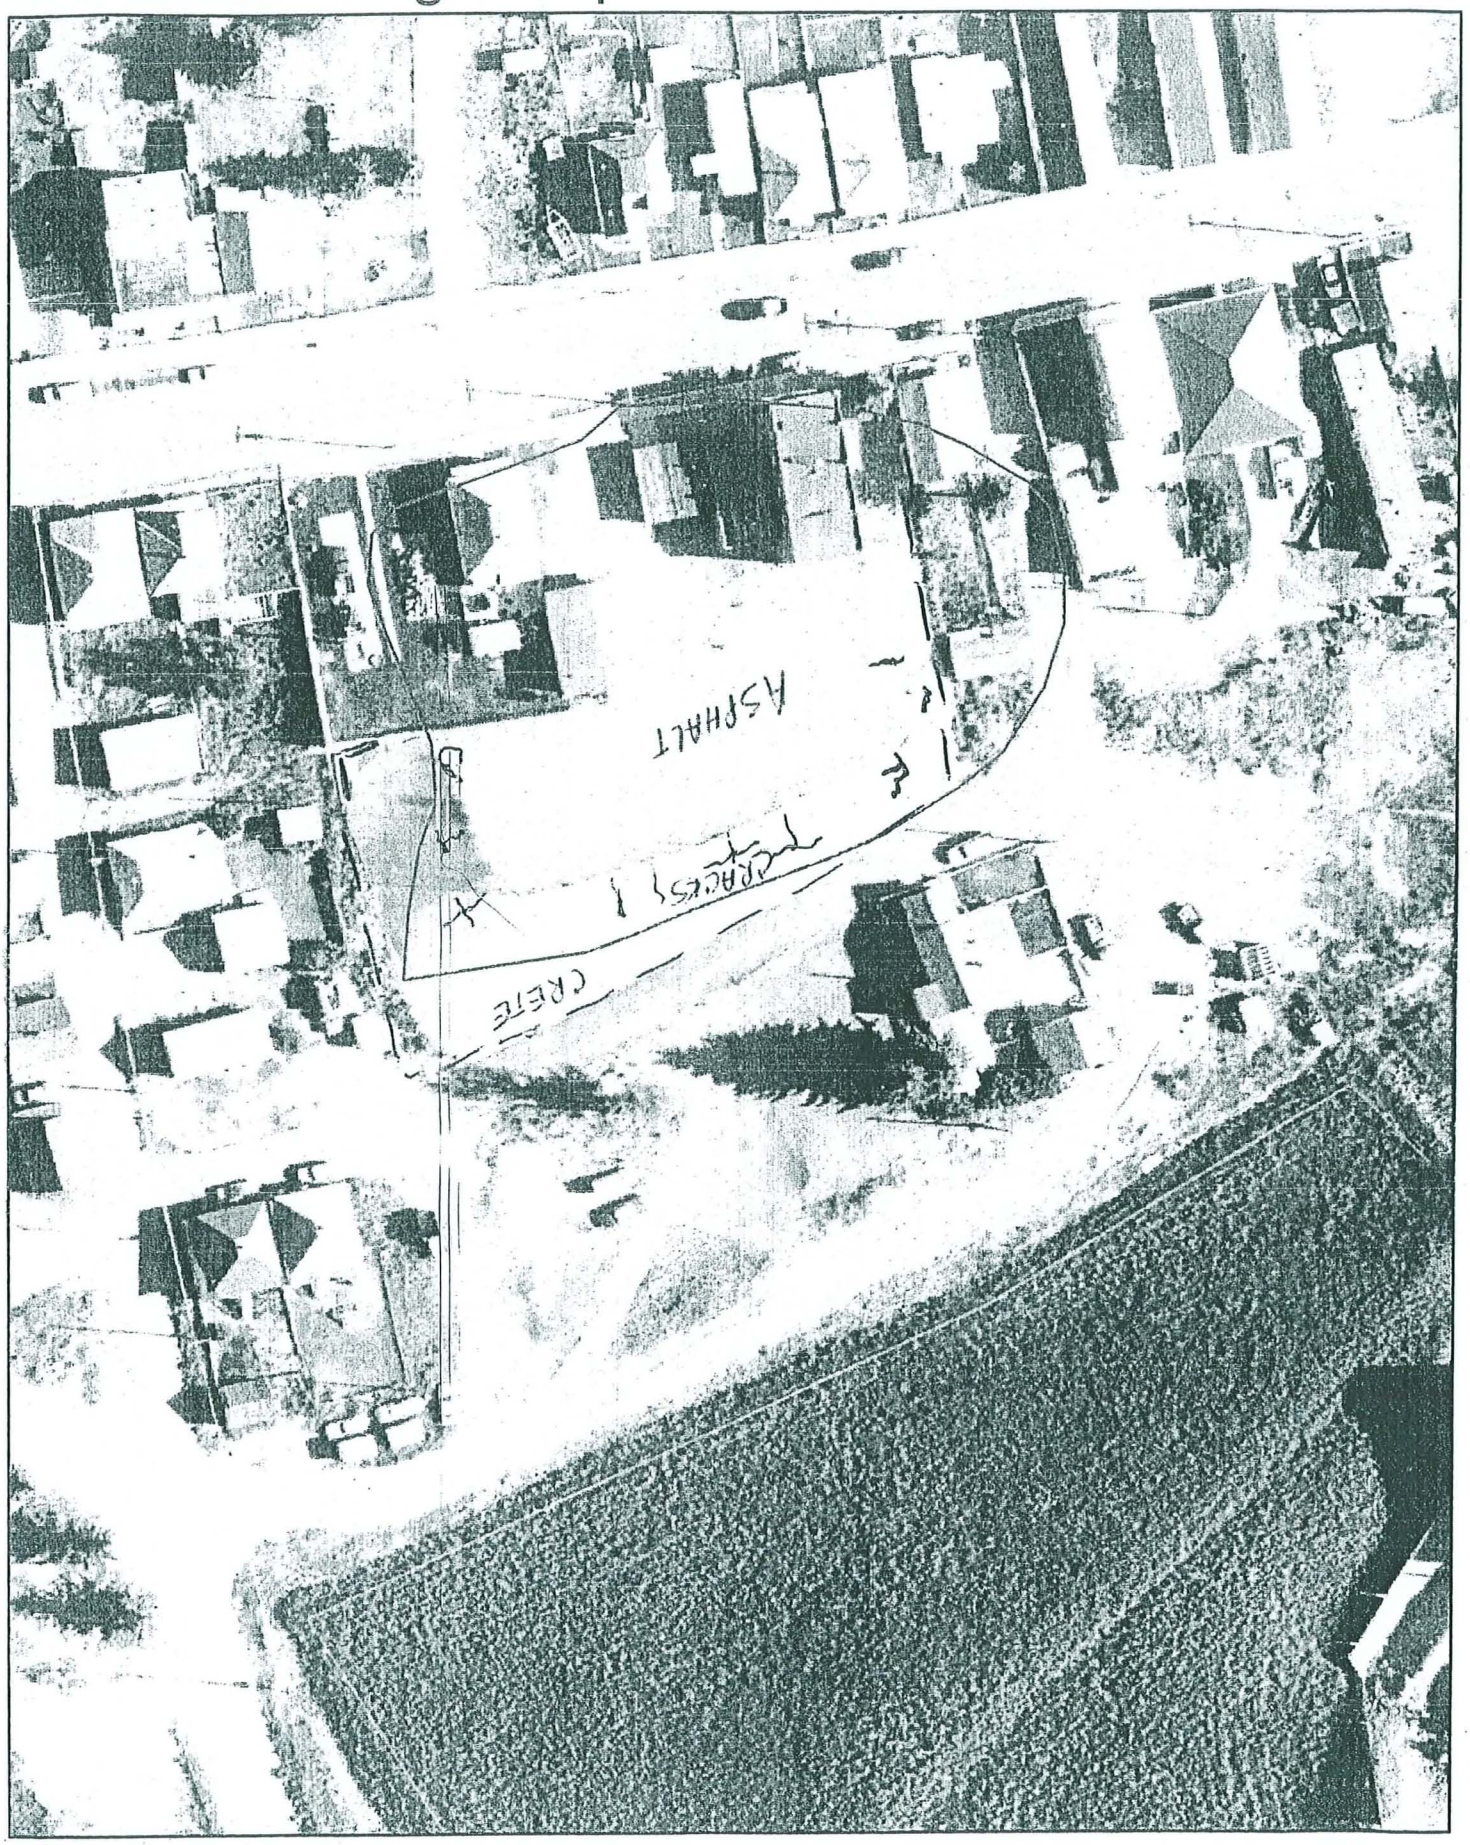
#19 - Blue Wing Dump

"~" LINES ON ASPHALT / CONCRETE INDICATE LOCATIONS OF CRACKS.

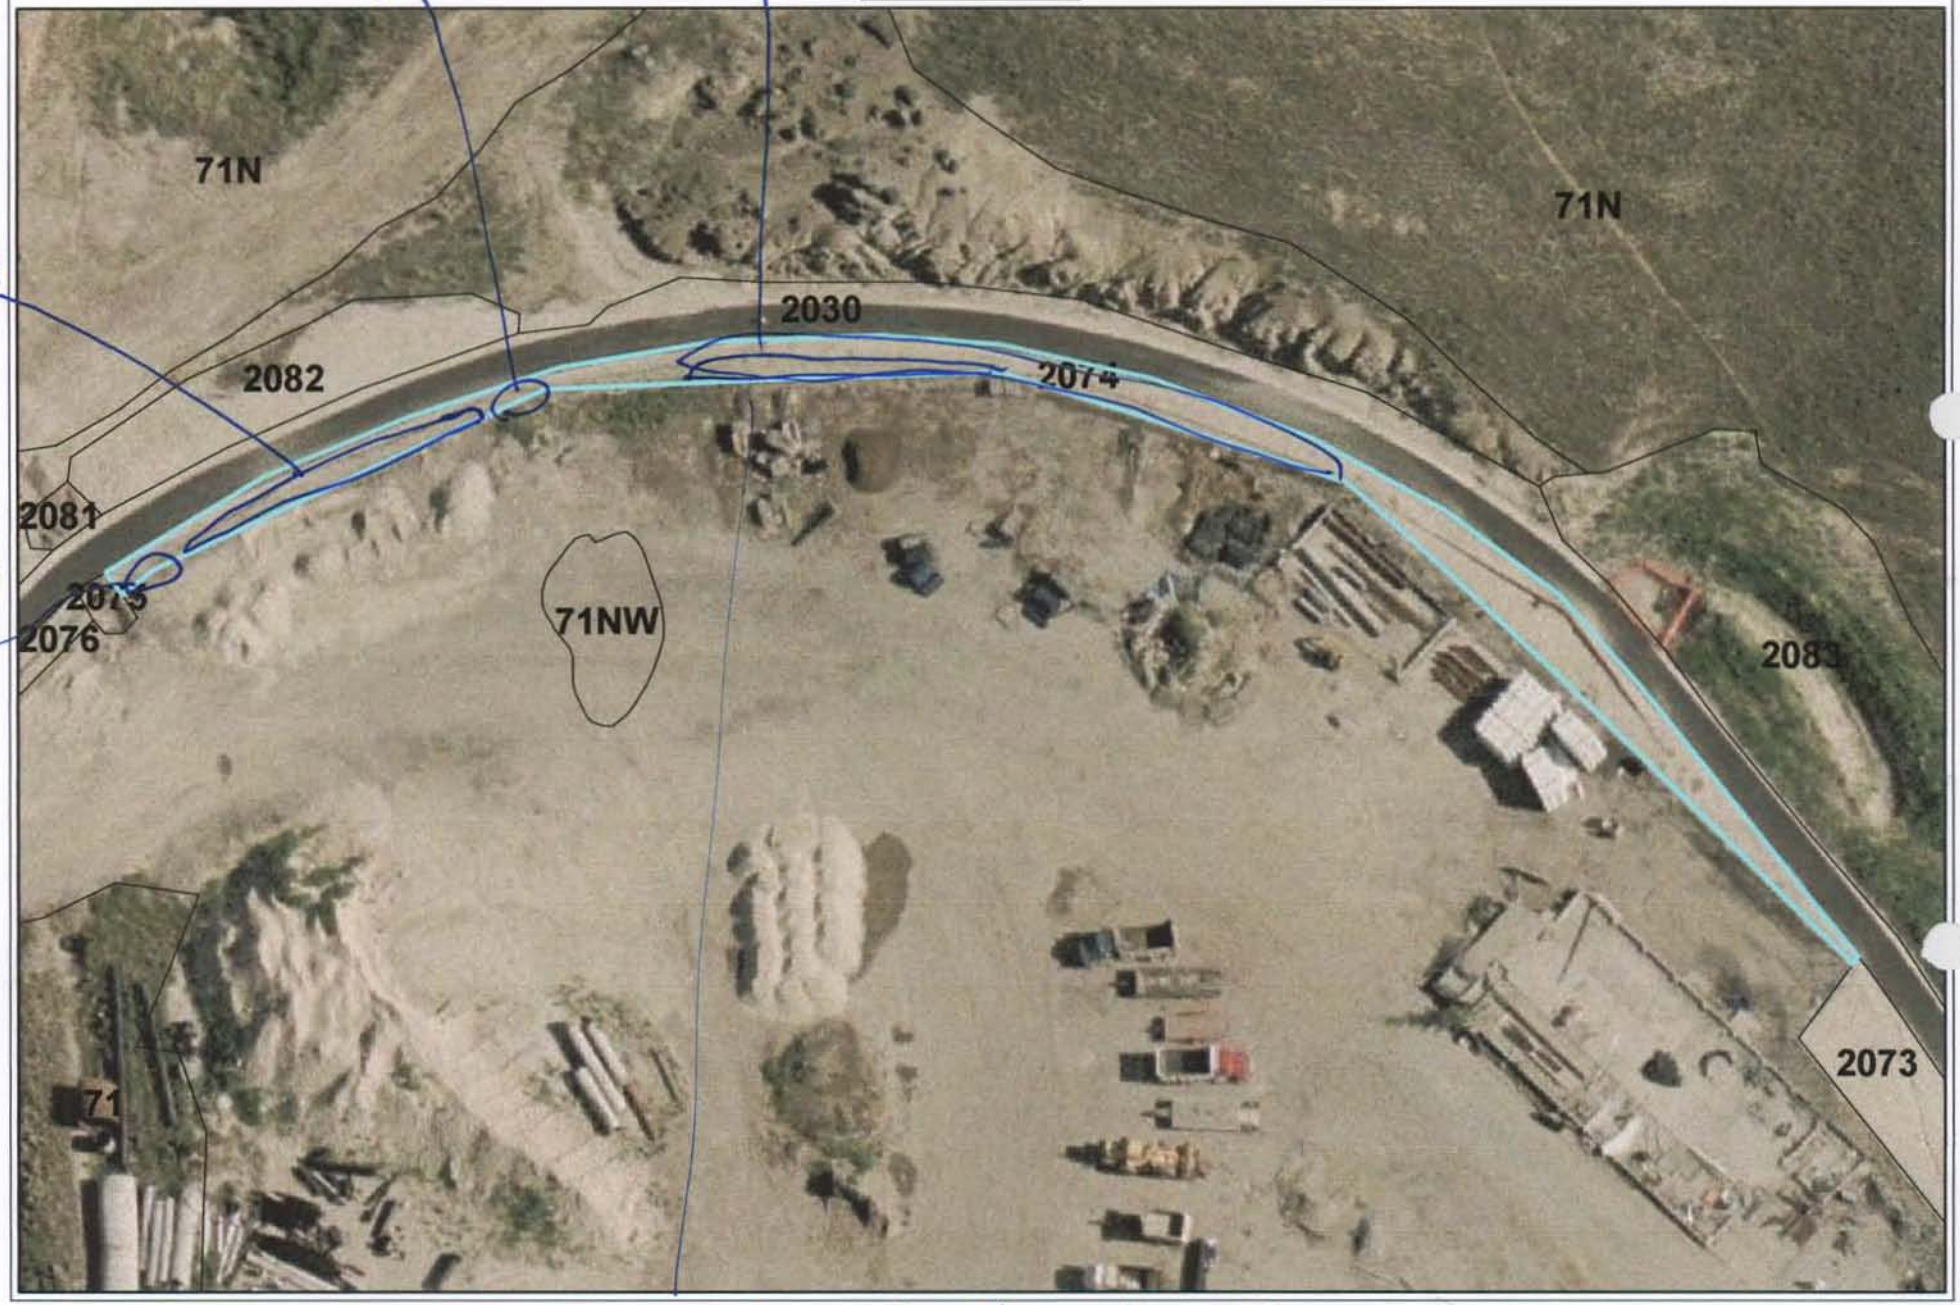
Site 2074

waste disposed through site
