Five-Year Review Report

Tutu Wellfield Site
St, Thomas
U.S. Virgin Islands

United States Environmental Protection Agency
Region 2
New York, New York

April 2009

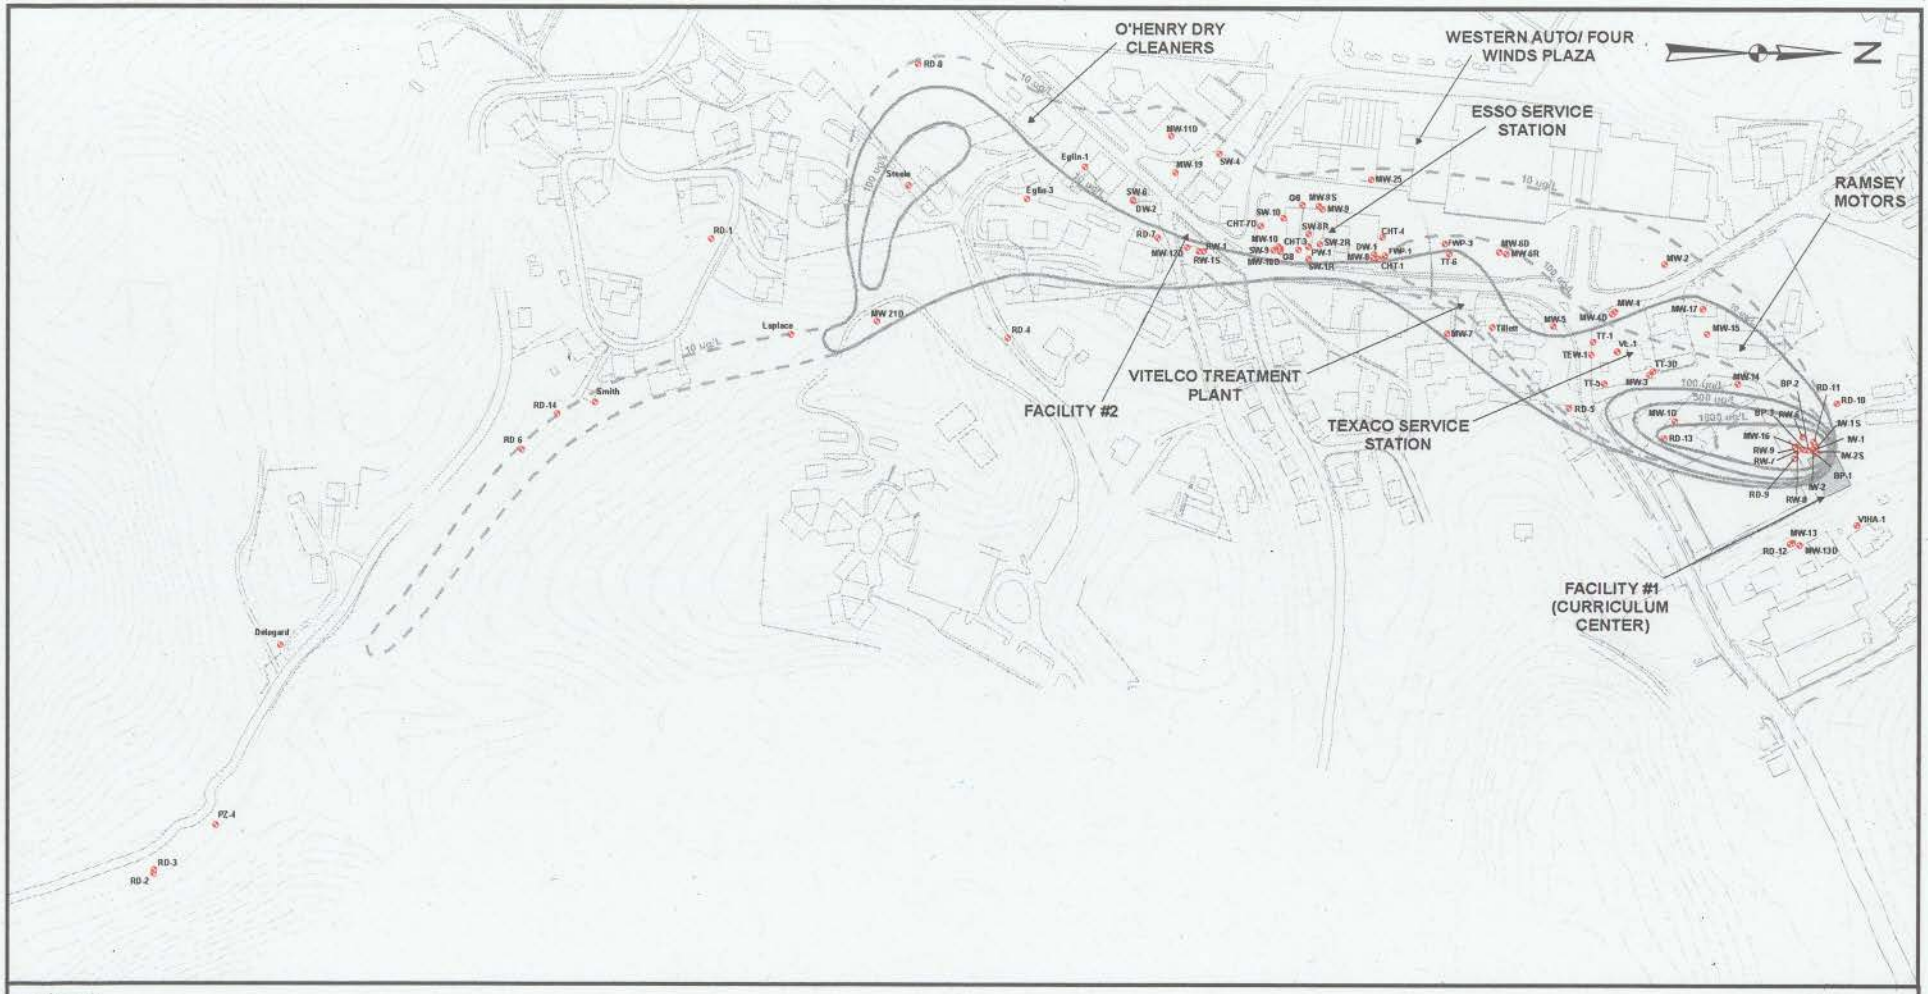
Insert Figure 3 – Site Illustration

CVOC results from samples collected during the site-wide groundwater monitoring events are summarized in Table 3. The monitoring well locations are shown on Figure 3. In general, concentrations of total CVOCs in Site groundwater have decreased compared to the baseline levels measured in March 2004. Water quality samples from monitoring wells measured during the March 2004 to April 2008 period show various decreasing trends with several wells showing increasing trends and other wells showing unchanging levels for the past few years. Fluctuations in concentrations are observed along the trend lines, which probably reflect periodic changes in the groundwater flow regime in response to recharge and unaccounted-for extraction.
