Five-Year Review Report

Fifth Five-Year Review Report
for
Uravan Uranium Project (Union Carbide)
EPA ID COD007063274

Uravan
Montrose County, Colorado

September 2015

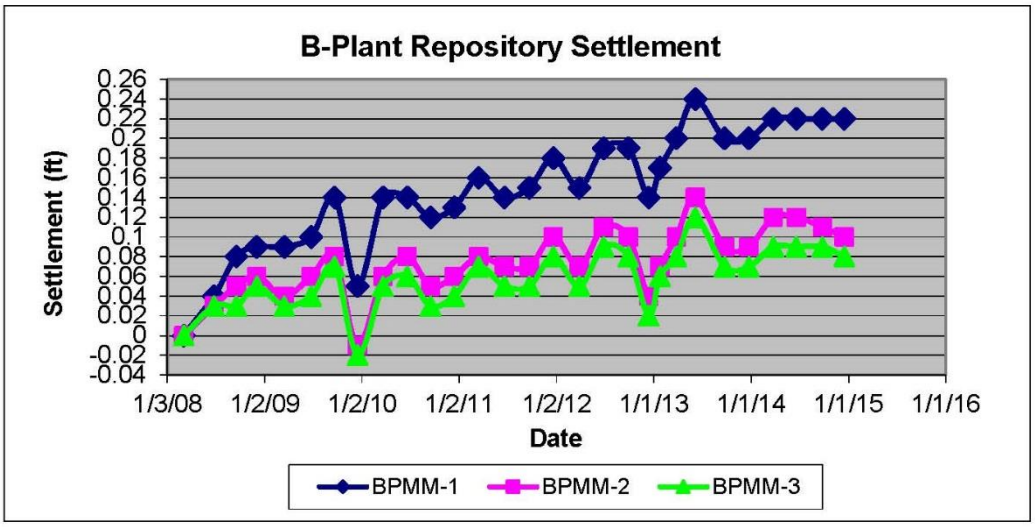
Figure 5: B-Plant Repository Settlement, 2008 to 2015

On November 28, 2007, three surface settlement monuments were installed on the completed top surface of the B-Plant Repository. The 2010 and 2011 reports noted that small amounts of incremental/total settlement were measured. The 2012-2014 annual reports indicated that "inconsequential amounts of incremental/total settlement" were measured. However, a graph in the 2014 report demonstrates a gradual increase in settlement since 2008.

OU(s): Sitewide	Issue Category: Remedy Performance			
	Issue: There has been a slight, steady increase in settlement since 2008 at the three surface settlement monuments installed on the completed top surface of the B-Plant Repository.			
	Recommendation: Determine if settlement at the B-Plant Repository is affecting the cap.			
Affect Current Protectiveness	**Affect Future Protectiveness**	**Implementing Party**	**Oversight Party**	**Milestone Date**
No	Yes	EPA/State	EPA	09/30/2016
