DRAFT
FOURTH FIVE-YEAR REVIEW

HUNTERS POINT NAVAL SHIPYARD, SAN FRANCISCO, CA

July 2018

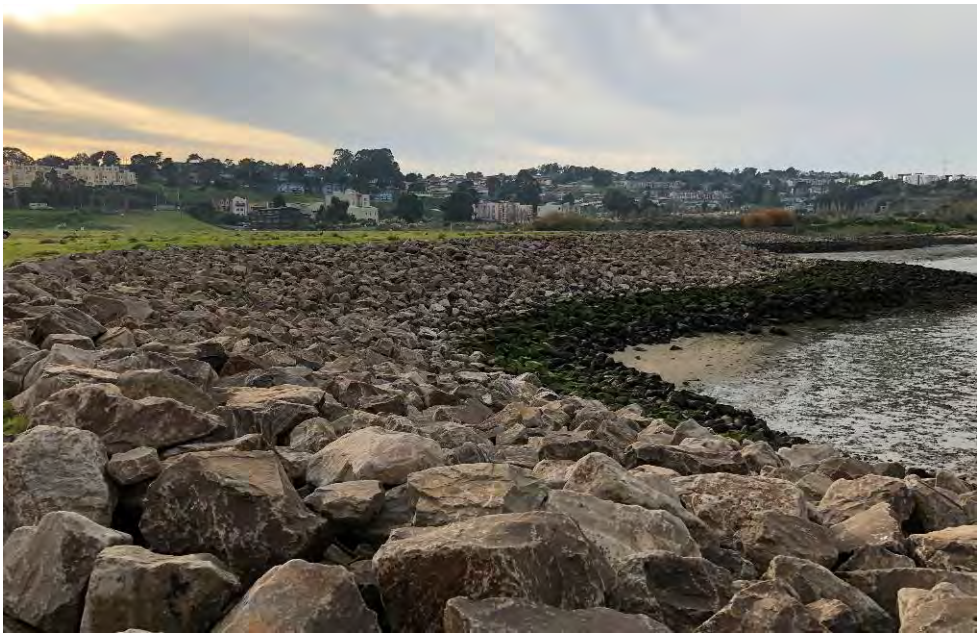
Photograph C2-10: View of shoreline revetment north of Building 117. Revetment is stable with no evidence of settlement or movement. Facing northwest.

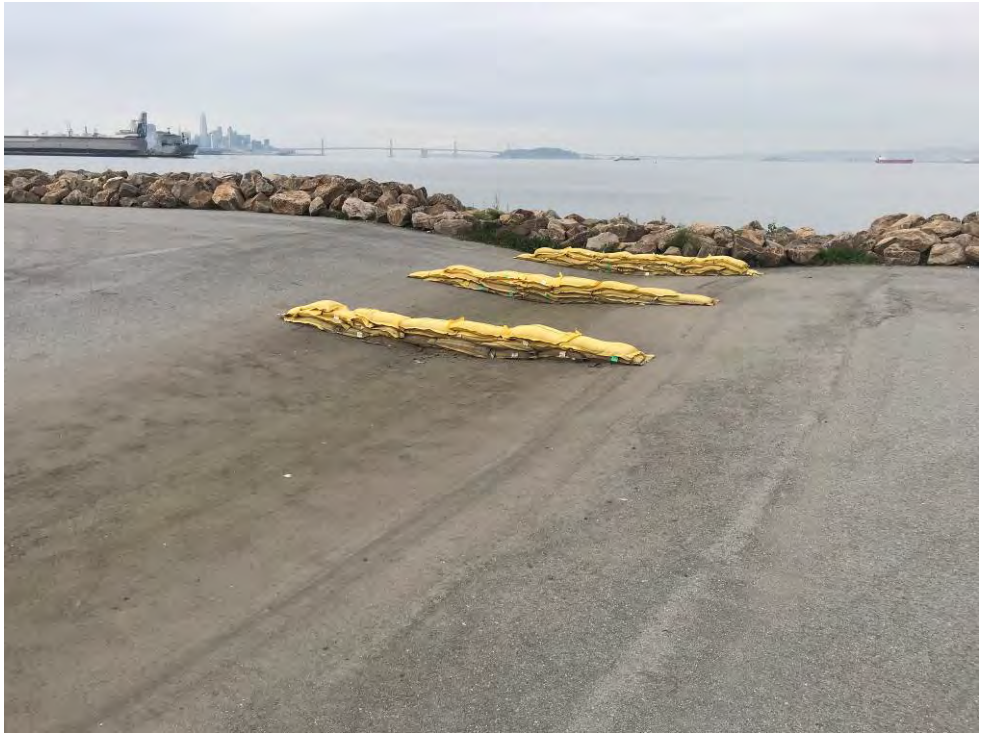
Photograph C4-6: View of swale outfall north of Building 140. Check dams are intact and functioning as intended. Facing north.

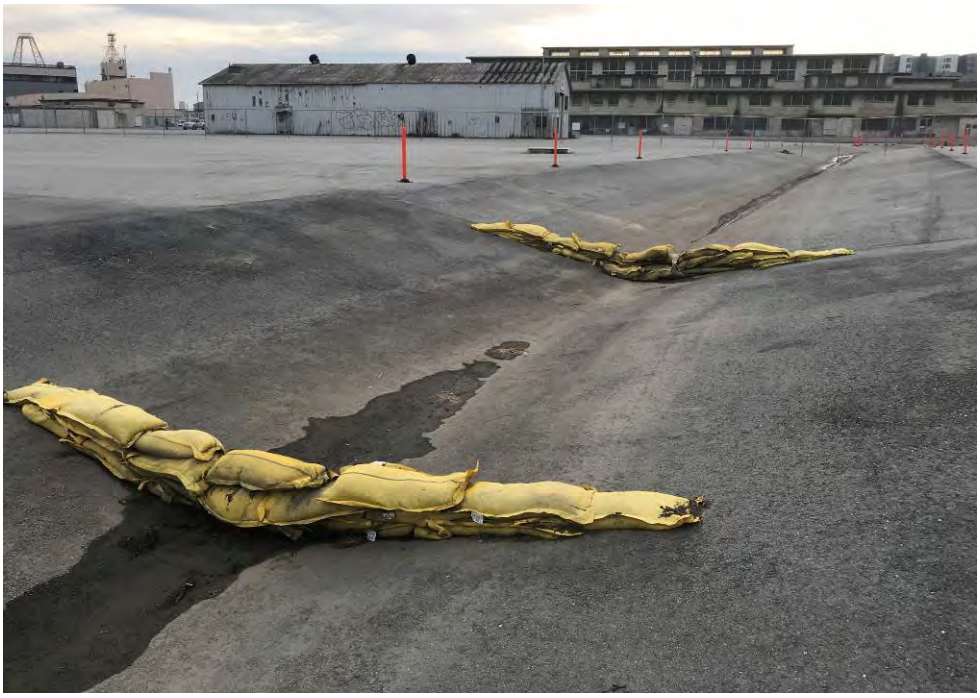
Photograph C4-7: View of swale outfall east of Building 130. Check dams are intact and functioning as intended. Facing south.

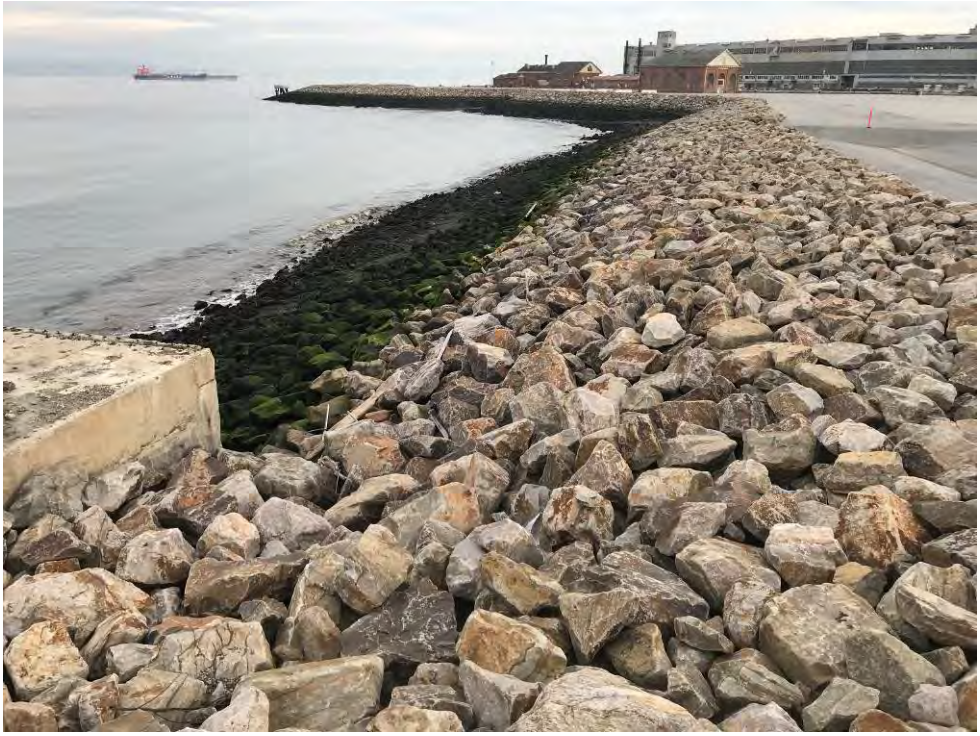
Photograph C4-8: View of shoreline revetment north of Building 130. Revetment is stable, with no evidence of settlement or movement. Facing southeast.

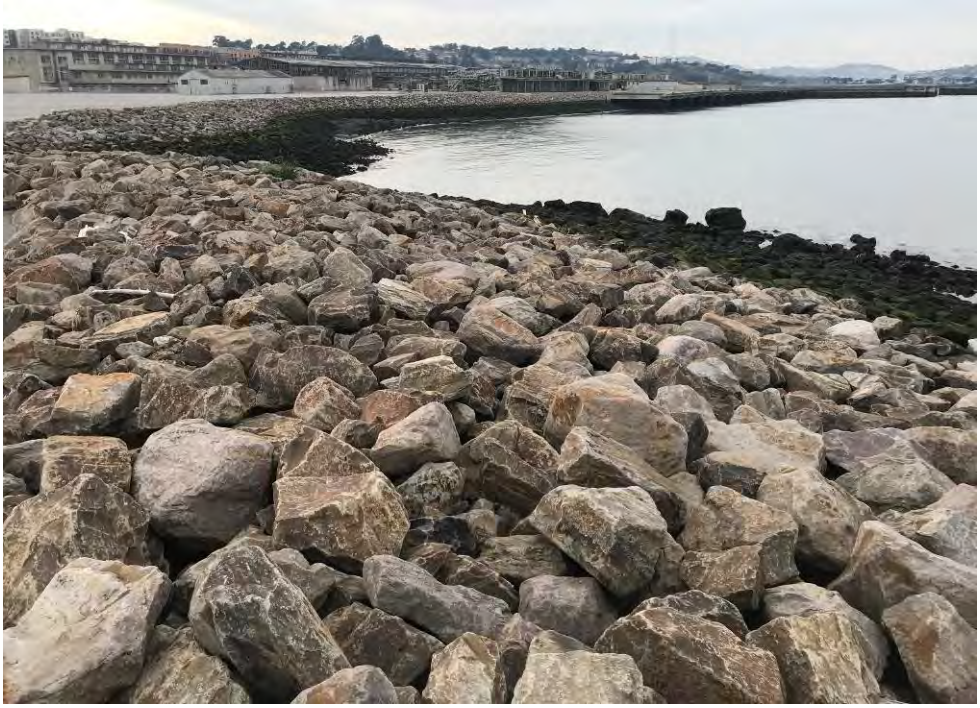
Photograph C4-9: View of shoreline revetment north of Building 140. Revetment is stable, with no evidence of settlement or movement. Facing west.

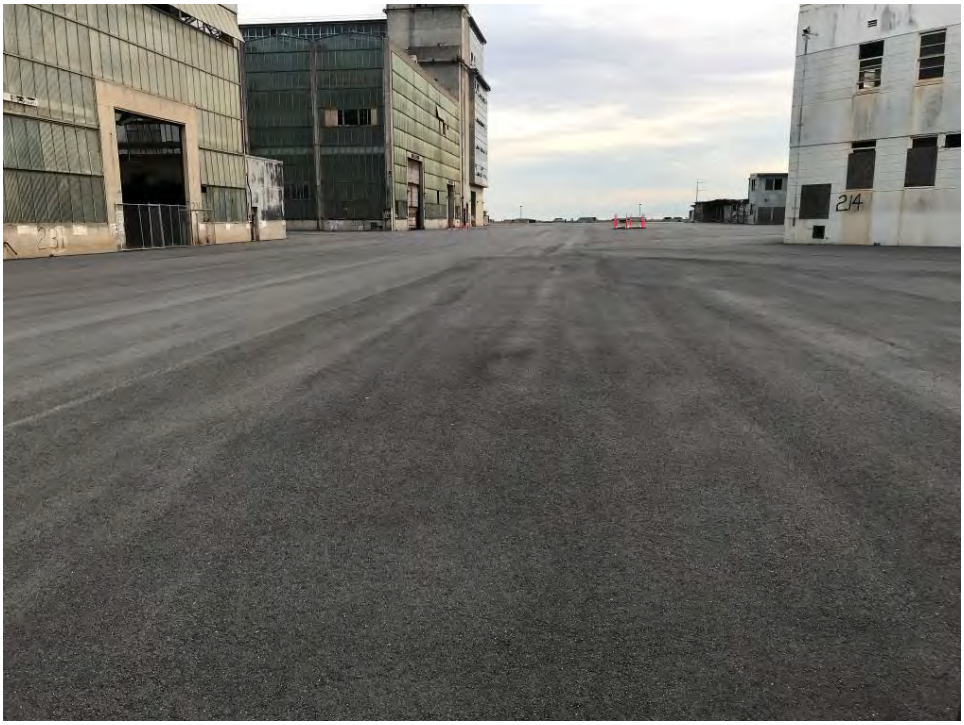
Photograph C5-2: View of durable asphaltic pavement cover west of Building 231. Cover is generally intact and in good condition. Facing south.

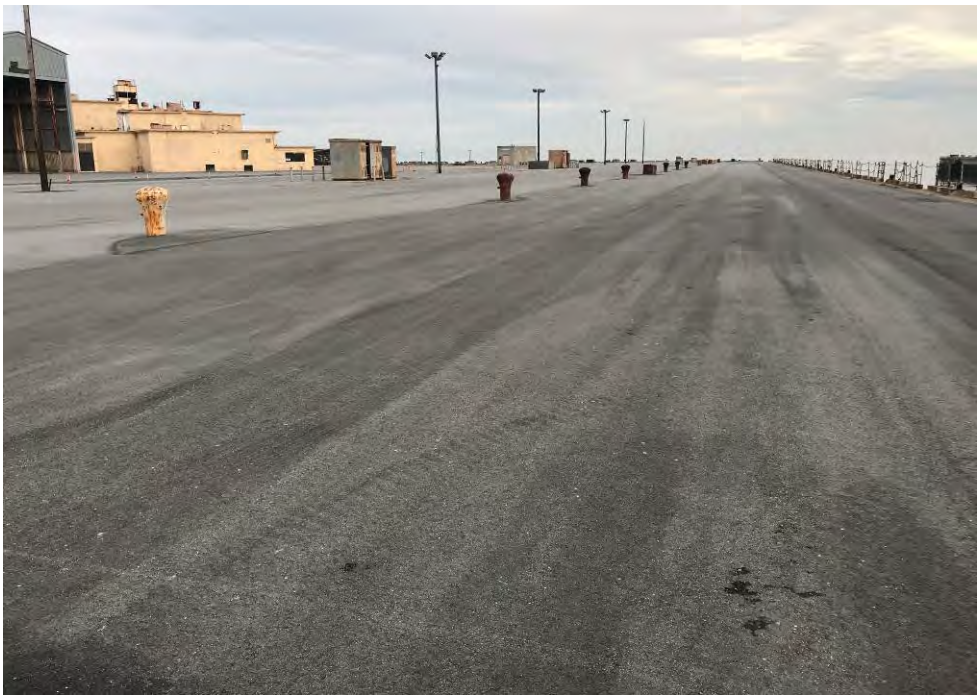
Photograph C5-3: View of durable asphaltic pavement cover north of Dry Dock 4. Cover is generally intact and in good condition. Facing southeast.

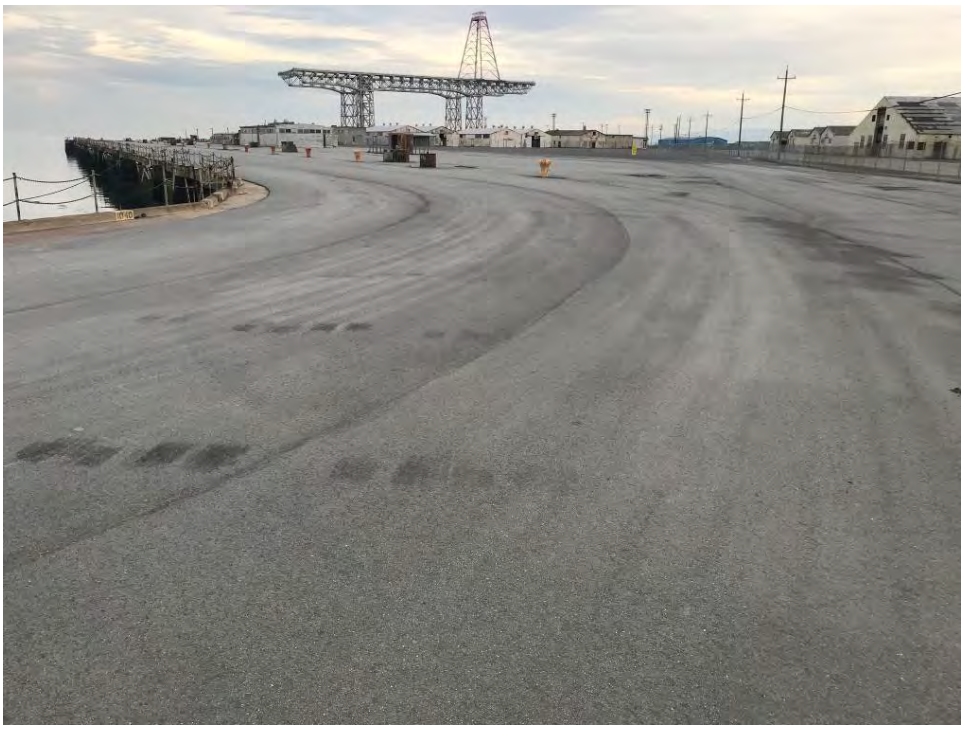
Photograph C5-5: View of durable asphaltic pavement cover south of Dry Dock 4. Cover is generally intact and in good condition. Facing south.

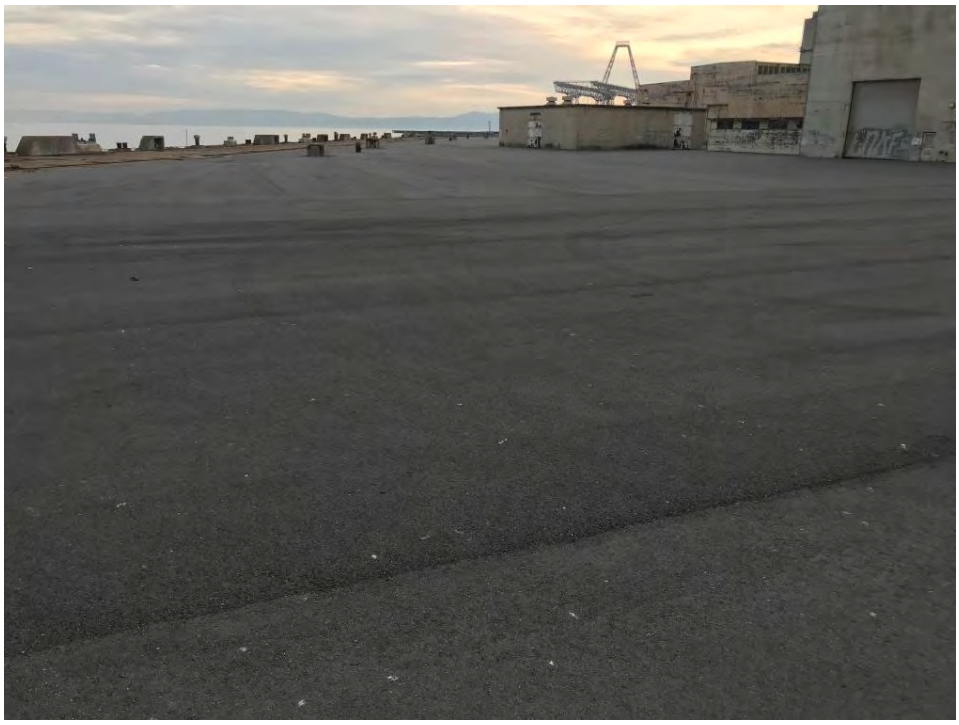
Photograph C5-6: View of durable asphaltic pavement cover at southeast end of Dry Dock 2. Cover is generally intact and in good condition. Facing south.

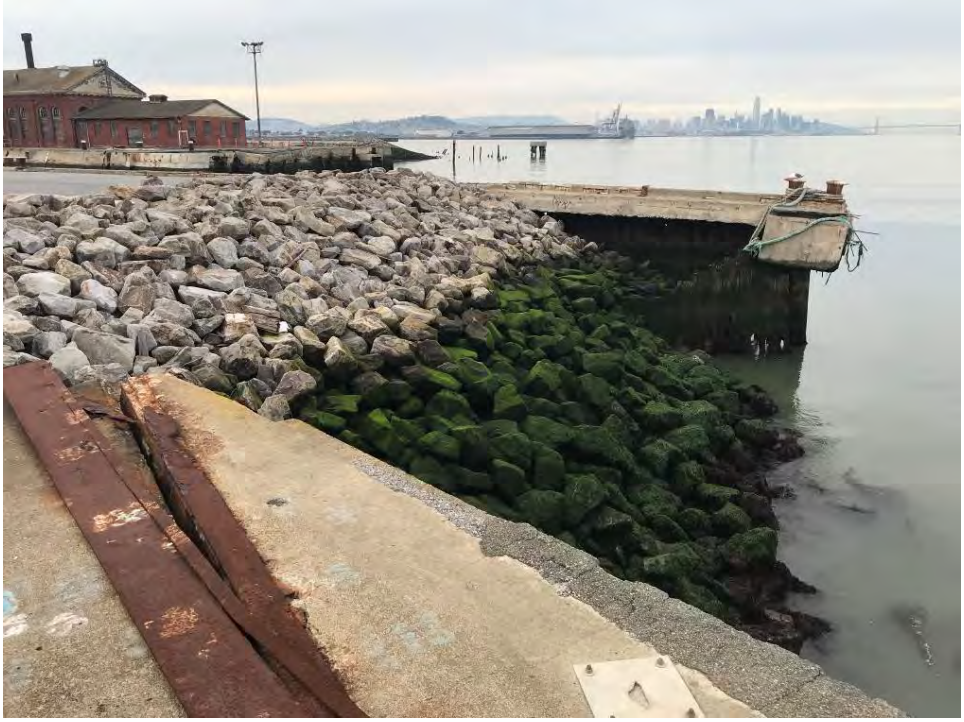
Photograph C5-11: View of shoreline armoring northeast of Building 231. Riprap armoring is stable, with no evidence of settlement or movement. Facing northwest.

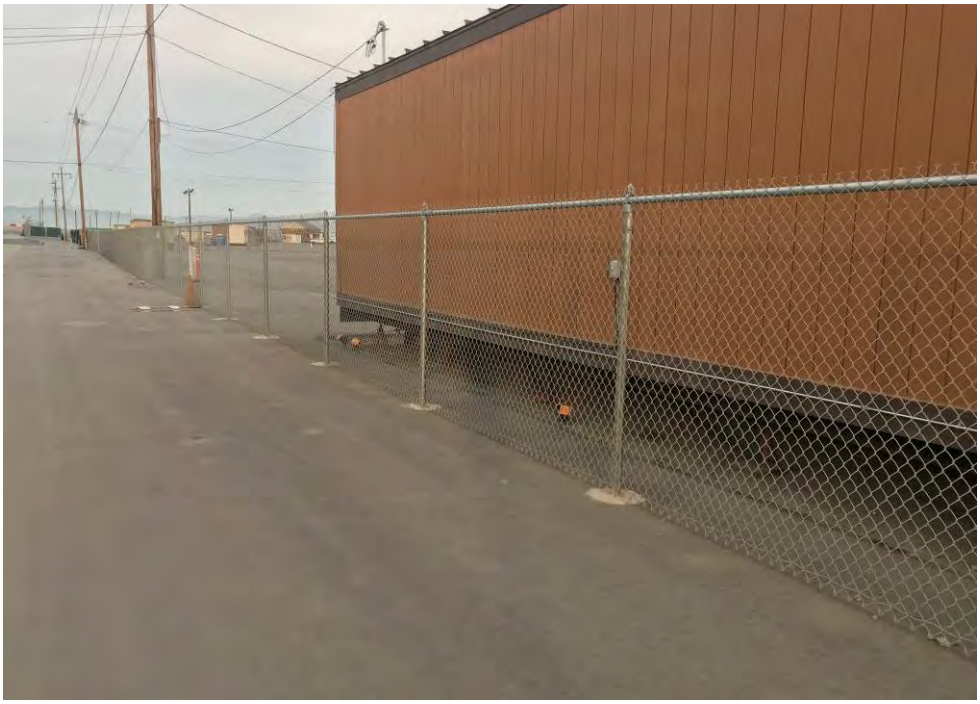
Photograph C5-19: Chain-link fence along Fisher Avenue is intact and in good condition. Facing northeast.

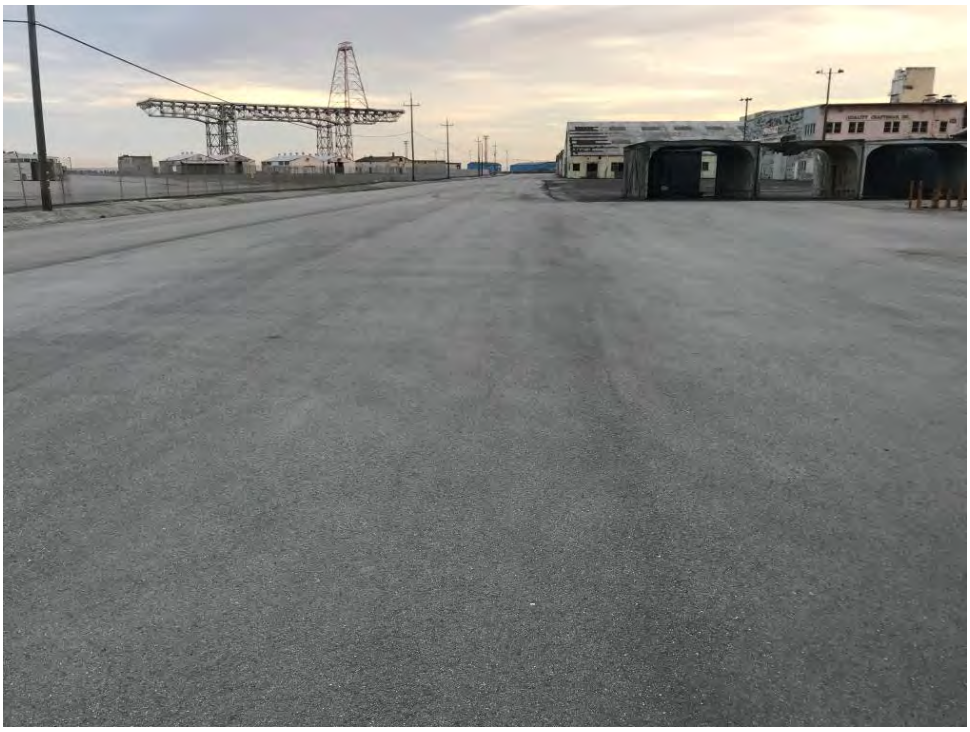
Photograph C6-1: View of durable asphaltic pavement cover east of Building 302. Cover is generally intact and in good condition. Facing south.
