First Five-Year Review Report

Pemaco Superfund Site

Maywood, California

September 2010

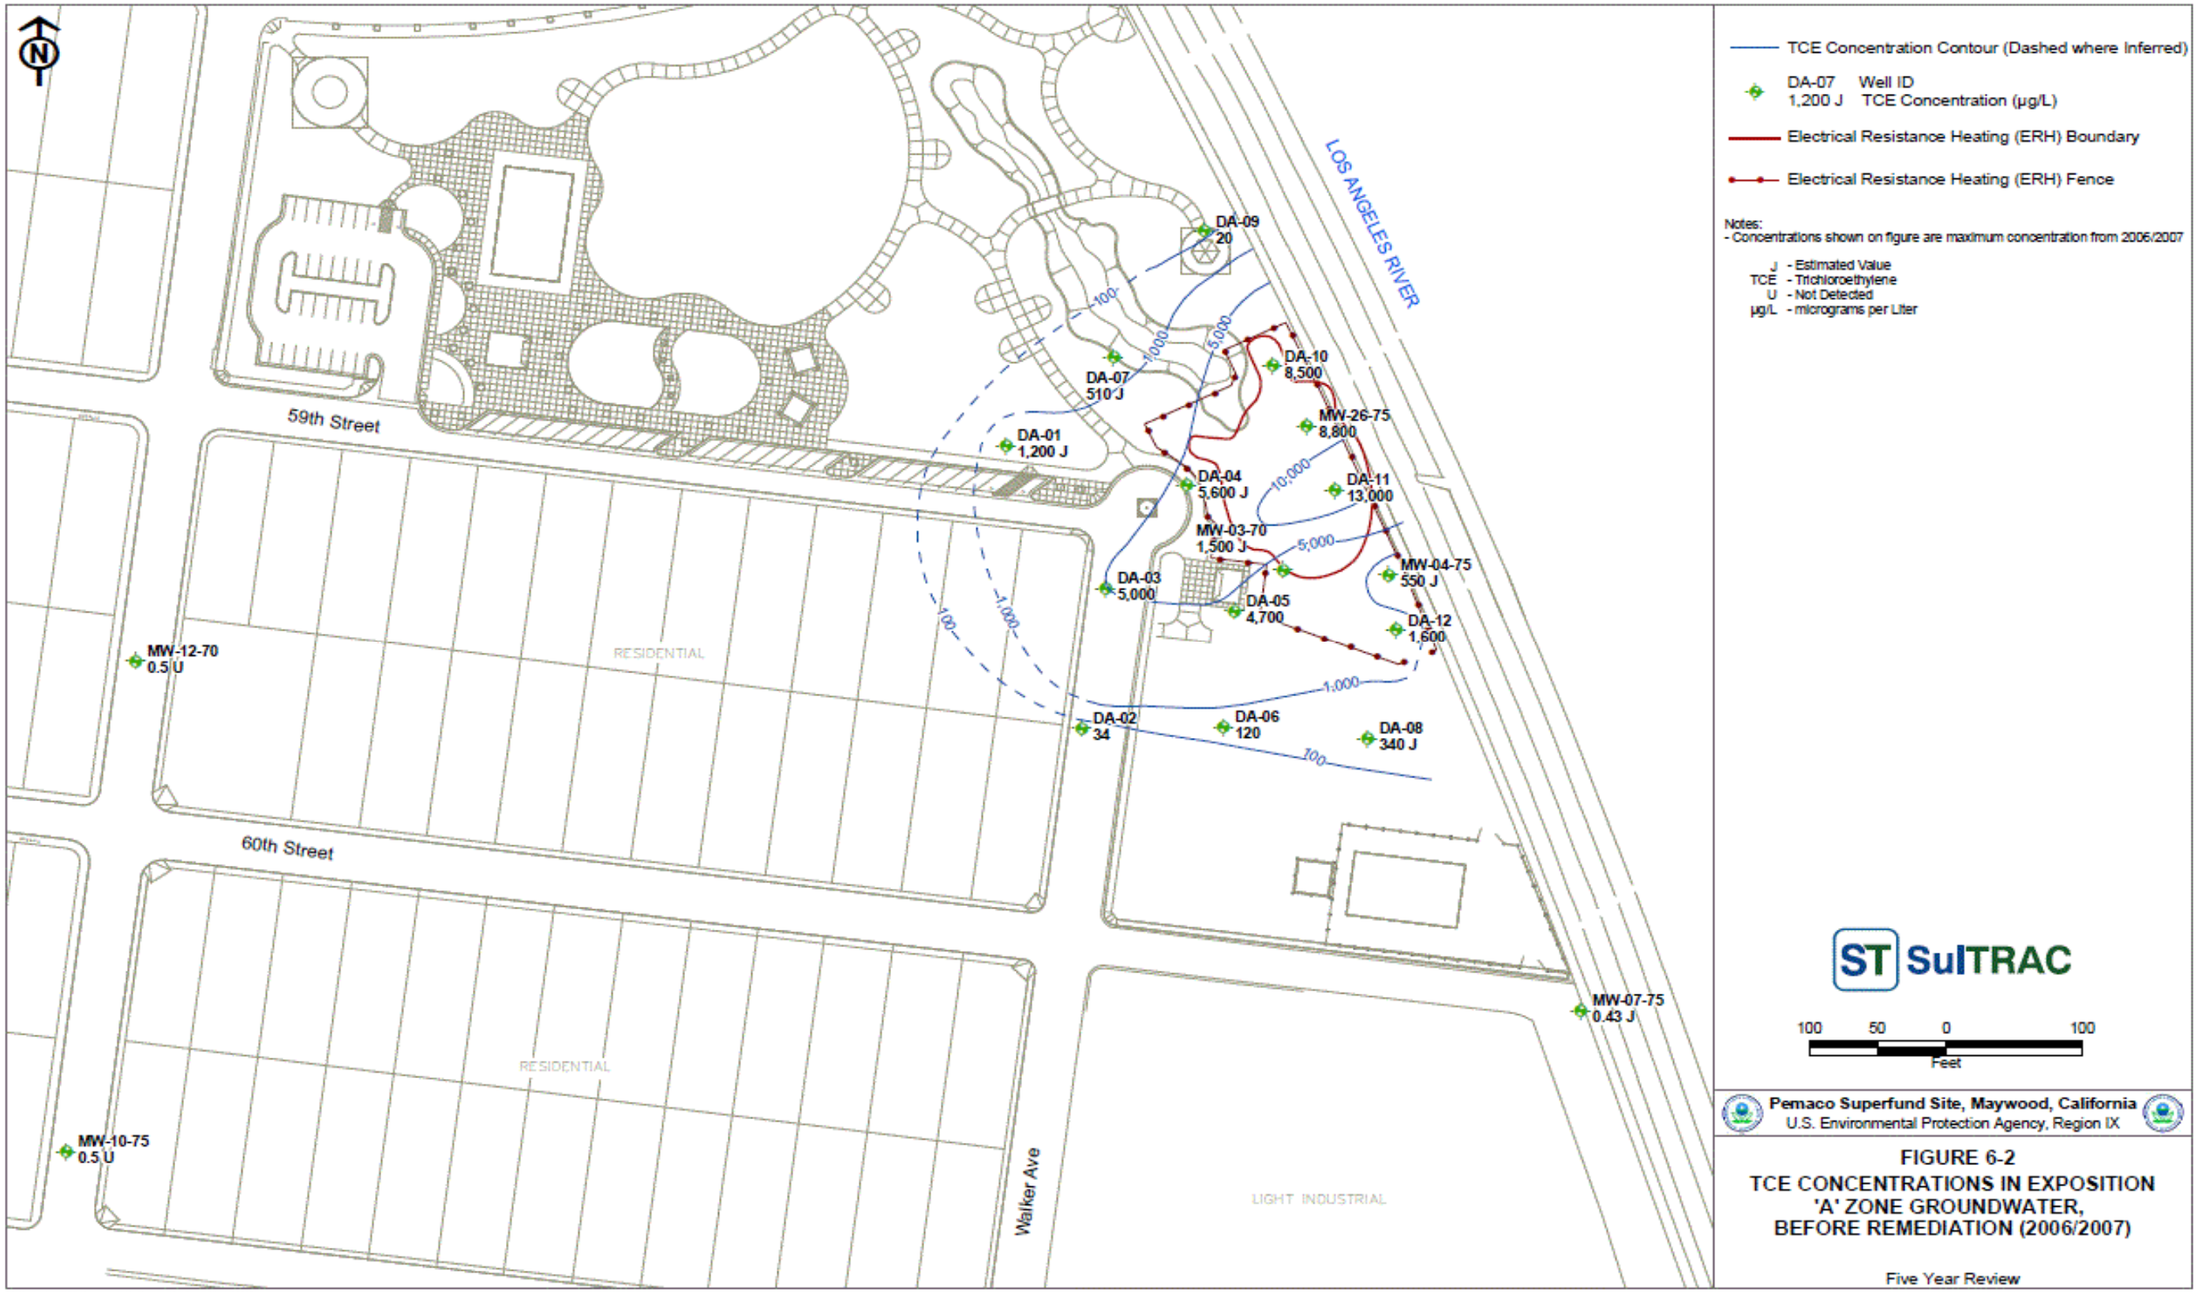
Figure 6-2 Pre-HVDPE Maximum Concentrations of TCE in Exposition 'A' Zone Groundwater, Pemaco Superfund Site, Maywood CA

The most common contaminants found in the 'A' Zone are TCE, PCE, cis-1,2-DCE, trans-1,2-DCE, 1,1-DCE, VC, and benzene. COC concentrations, especially those of TCE and cis-1,2-DCE, have decreased significantly since the ERH remedy and groundwater pump-and-treat system were implemented. Figure 6-2 shows the maximum TCE concentrations in 'A' Zone groundwater between the signing of the ROD in January 2005 and the implementation of the HVDPE system in May 2007. Figure 6-3 shows the maximum concentration of TCE in 'A' Zone groundwater in 2009. Within the ERH Area, groundwater samples from 'A' Zone wells have not exceeded SSRLs since 2008, except for one detection of TCE at 39 µg/L in MW03-70 (5/20/09). EPA conducted bio-treatment in an area of TCE contaminated groundwater located adjacent to the ERH Area prior to the start of heating. Extraction wells DA-01, DA-03, and DA-05 now contain TCE concentrations of approximately 100 µg/L in October 2009. EPA may follow-up with additional bio-remediation treatment sometime in the future.

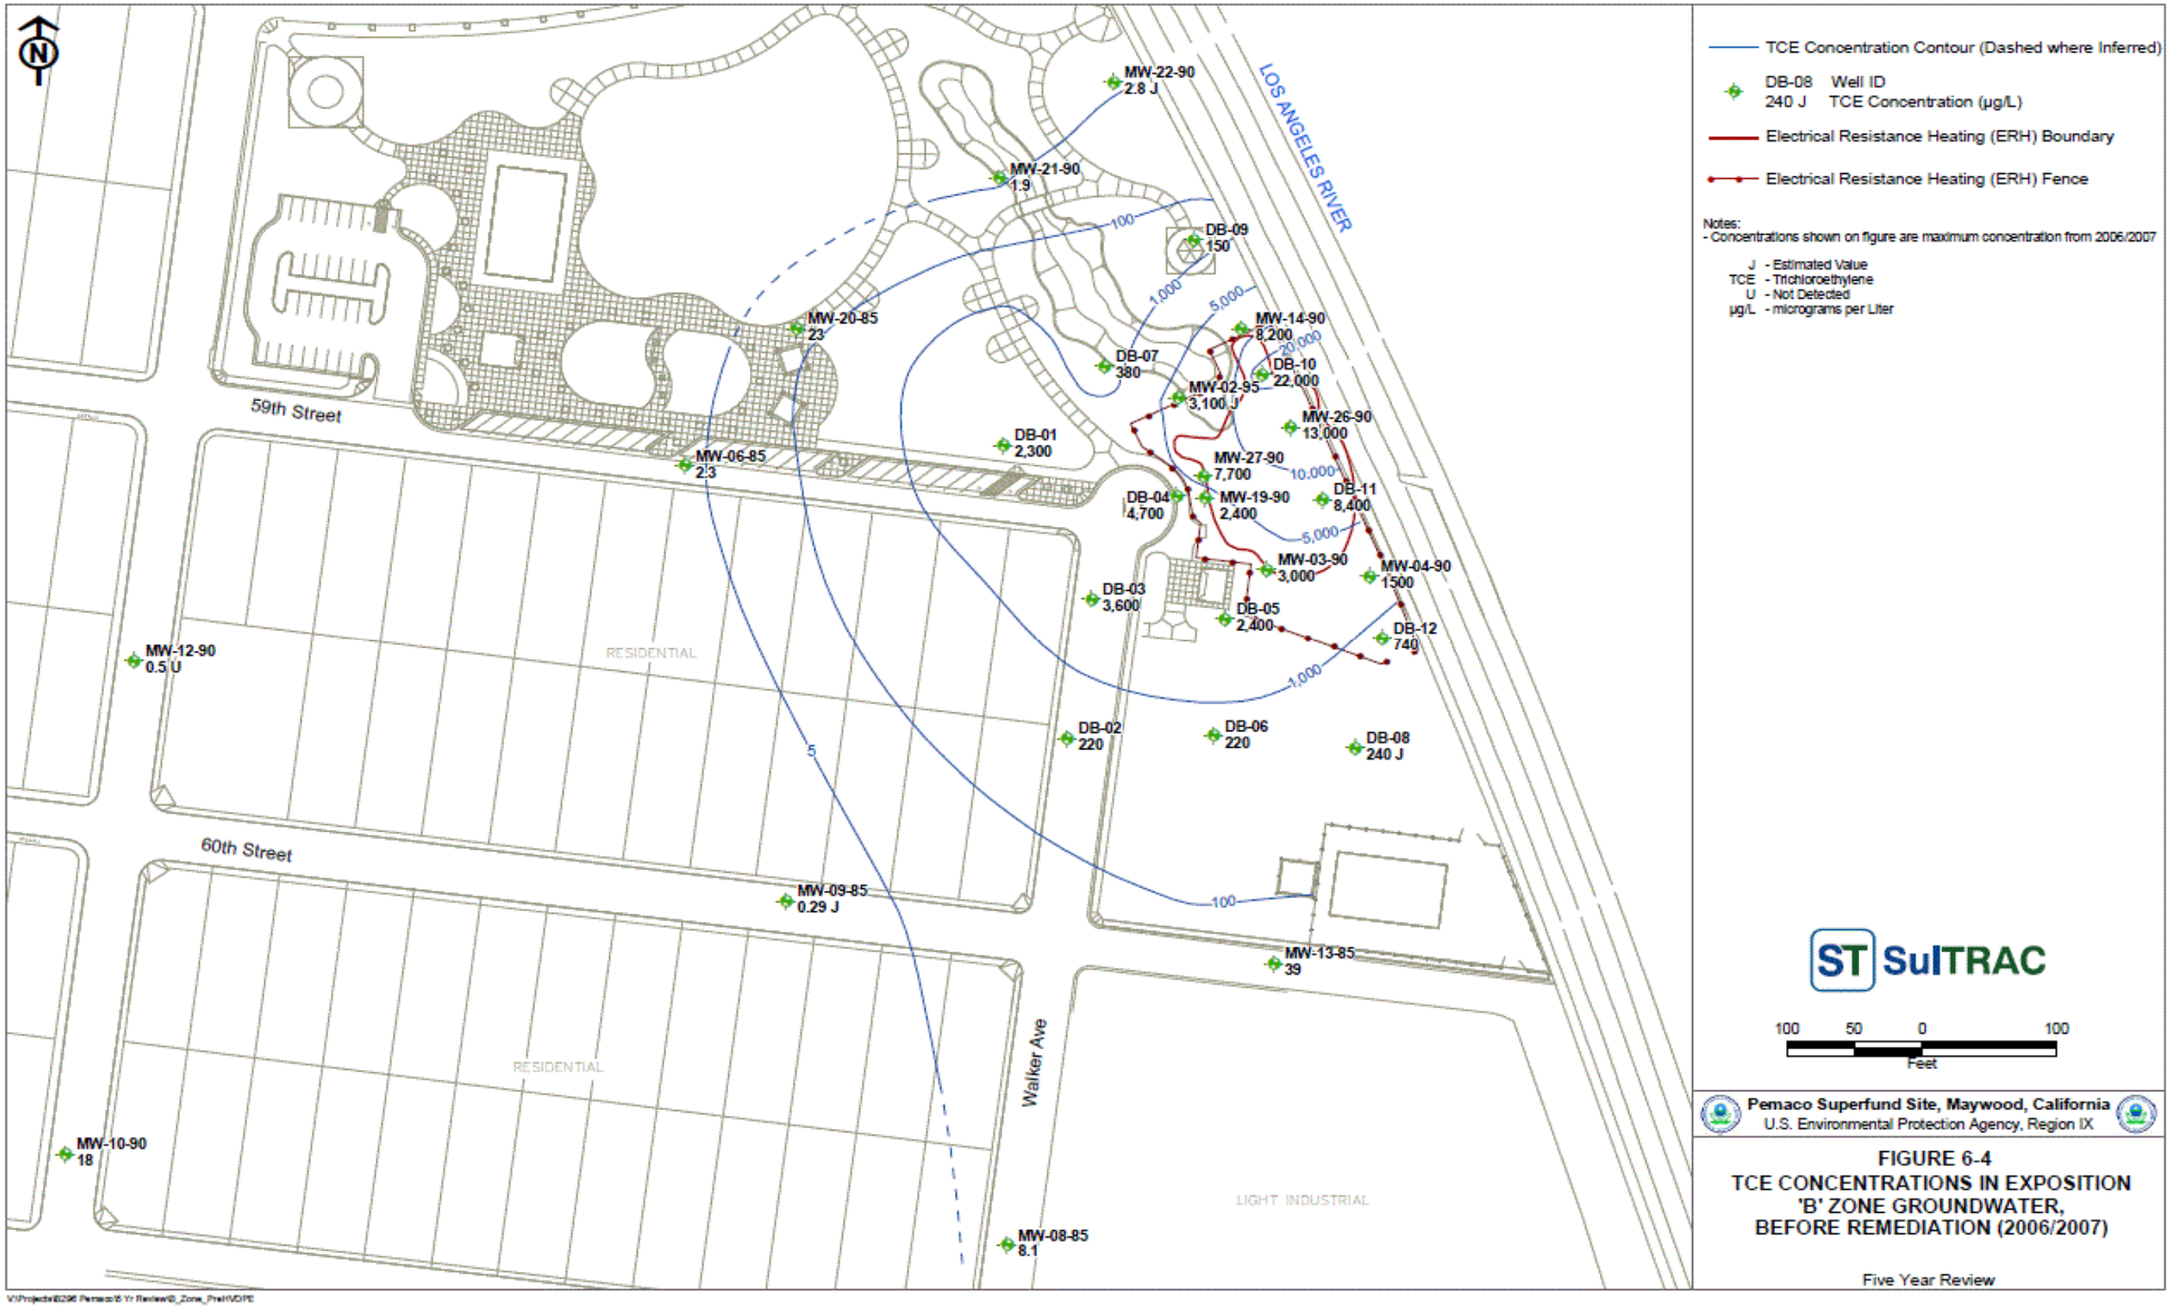
Figure 6-4 Pre-HVDPE Maximum Concentrations of TCE in Exposition 'B' Zone Groundwater, Pemaco Superfund Site, Maywood CA

The most common contaminants in the 'B' Zone are benzene and the chlorinated solvents TCE, PCE, cis-1,2-DCE, trans-1,2-DCE, 1,1-DCE, and VC. TCE is the primary contaminant in the 'B' Zone. TCE concentrations decreased significantly after the ERH remedy and the groundwater extraction system were implemented. Figure 6-4 shows the maximum TCE concentrations in 'B' Zone groundwater between the signing of the ROD in January 2005 and the implementation of the HVDPE system in May 2007. Figure 6-5 shows the maximum concentration of TCE in 'B' Zone groundwater in 2009. The surface area of the plume was 4.56 acres in December 2007. Post-ERH sampling in October 2009 showed that TCE concentrations exceeded the SSRL in an area of 2.66 acres, a 42% decrease. TCE and cis-1,2-DCE continue to be detected in 'B' Zone extraction wells and select monitoring wells above their respective SSRLs. In 2009, TCE concentrations in the 'B' Zone ranged from 0.56 µg/L (MW30-90, 10/12/09) to 720 µg/L (DB-08, 5/19/09), and cis-1,2-DCE concentrations ranged from 0.28J µg/L (MW28-90, 7/22/09) to 130 µg/L (MW02-95, 3/17/09). In the ERH Area and immediate surroundings, TCE concentrations in 'B' Zone wells have decreased 97%. Wells that recently had detections of TCE and cis-1,2-DCE above 25 µg/L are depicted in Figure 6-1. The maximum concentrations of select COCs in 'B' Zone groundwater before HVDPE began in April 2007 and post-ERH remedy in 2009 are presented in Table 6-3.

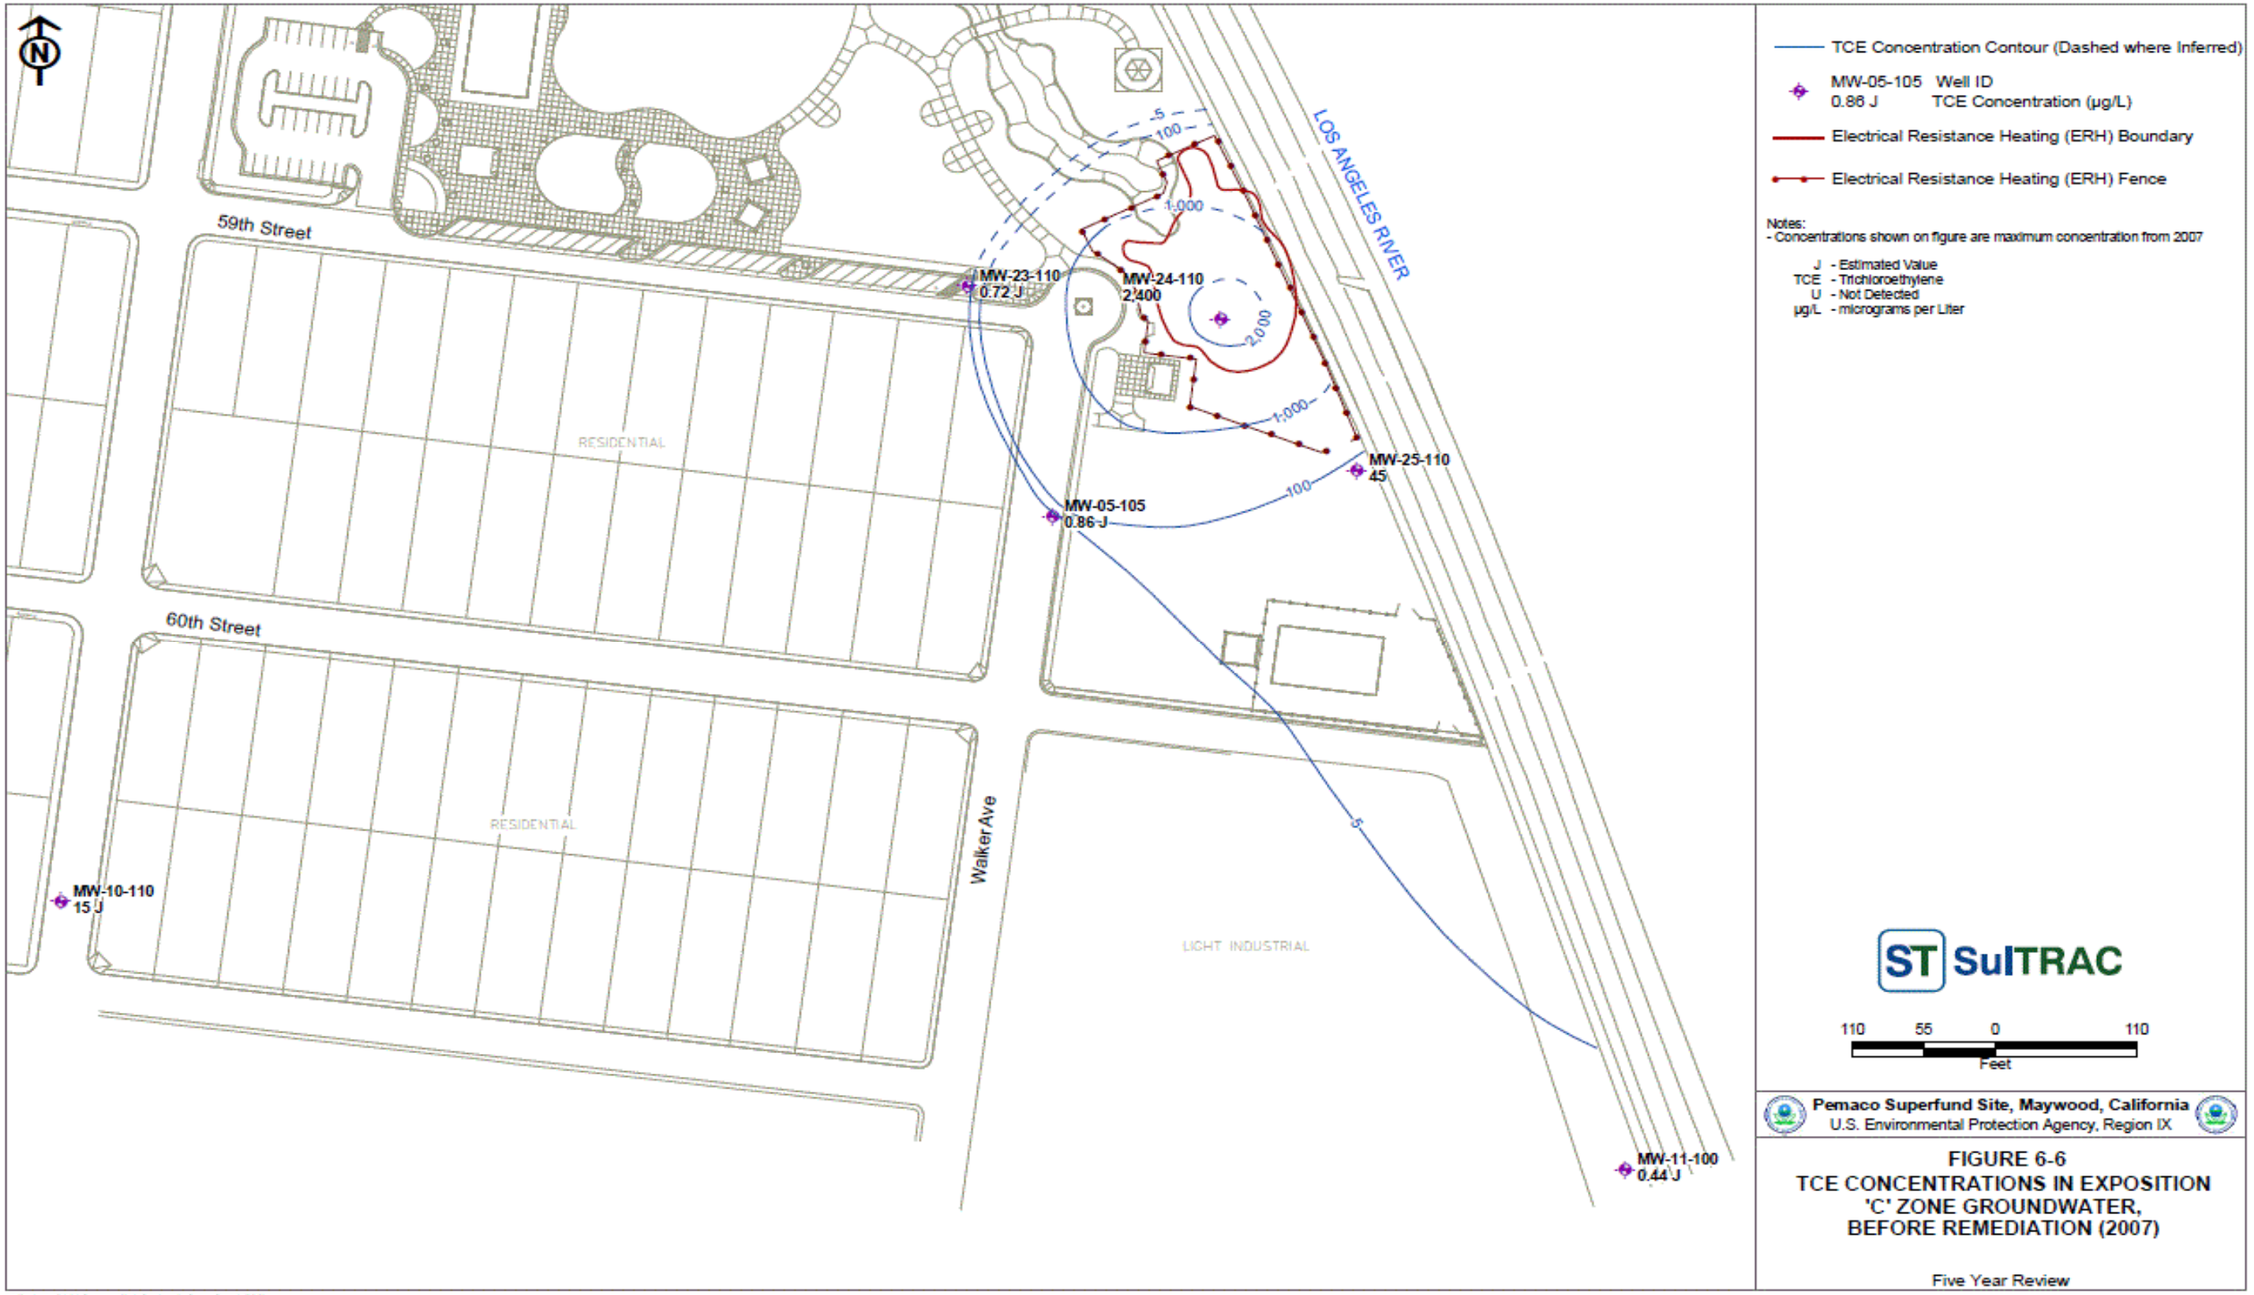
Figure 6-6 Pre-HVDPE Maximum Concentrations of TCE in Exposition 'C' Zone Groundwater, Pemaco Superfund Site, Maywood CA

The most prevalent contaminants in 'C' Zone groundwater are TCE, cis-1,2-DCE, VC, and benzene. Historical data indicate that 'C' Zone contamination, although present at low levels before ERH construction activities, increased significantly following the installation of TMPs and ERH electrodes in 2006. Figure 6-6 shows the maximum TCE concentrations in 'C' Zone groundwater between the signing of the ROD in January 2005 and the implementation of the HVDPE system in May 2007. Figure 6-7 shows the maximum concentration of TCE in 'C' Zone groundwater in 2009. Before ERH construction began in September 2006, TCE was detected in 'C' Zone wells between 0.13 J µg/L (MW23-110, March 2004) and 120 µg/L (MW24-110, January 2006). After ERH construction, concentrations of TCE in well MW24-110 increased to 2,400 µg/L in February 2007. To mitigate these increases, MW24-110 was converted into an extraction well in August 2007; by November 2008, TCE concentrations had decreased to 96 µg/L. TCE concentrations in MW25-110 began to increase in the summer of 2008, from 87 µg/L in March to 650 µg/L in August. MW25-110 was converted into an extraction well in January 2009, and concentrations have decreased since. The graph below shows the trend in TCE concentrations in the 'C' Zone since monitoring began in 2003.

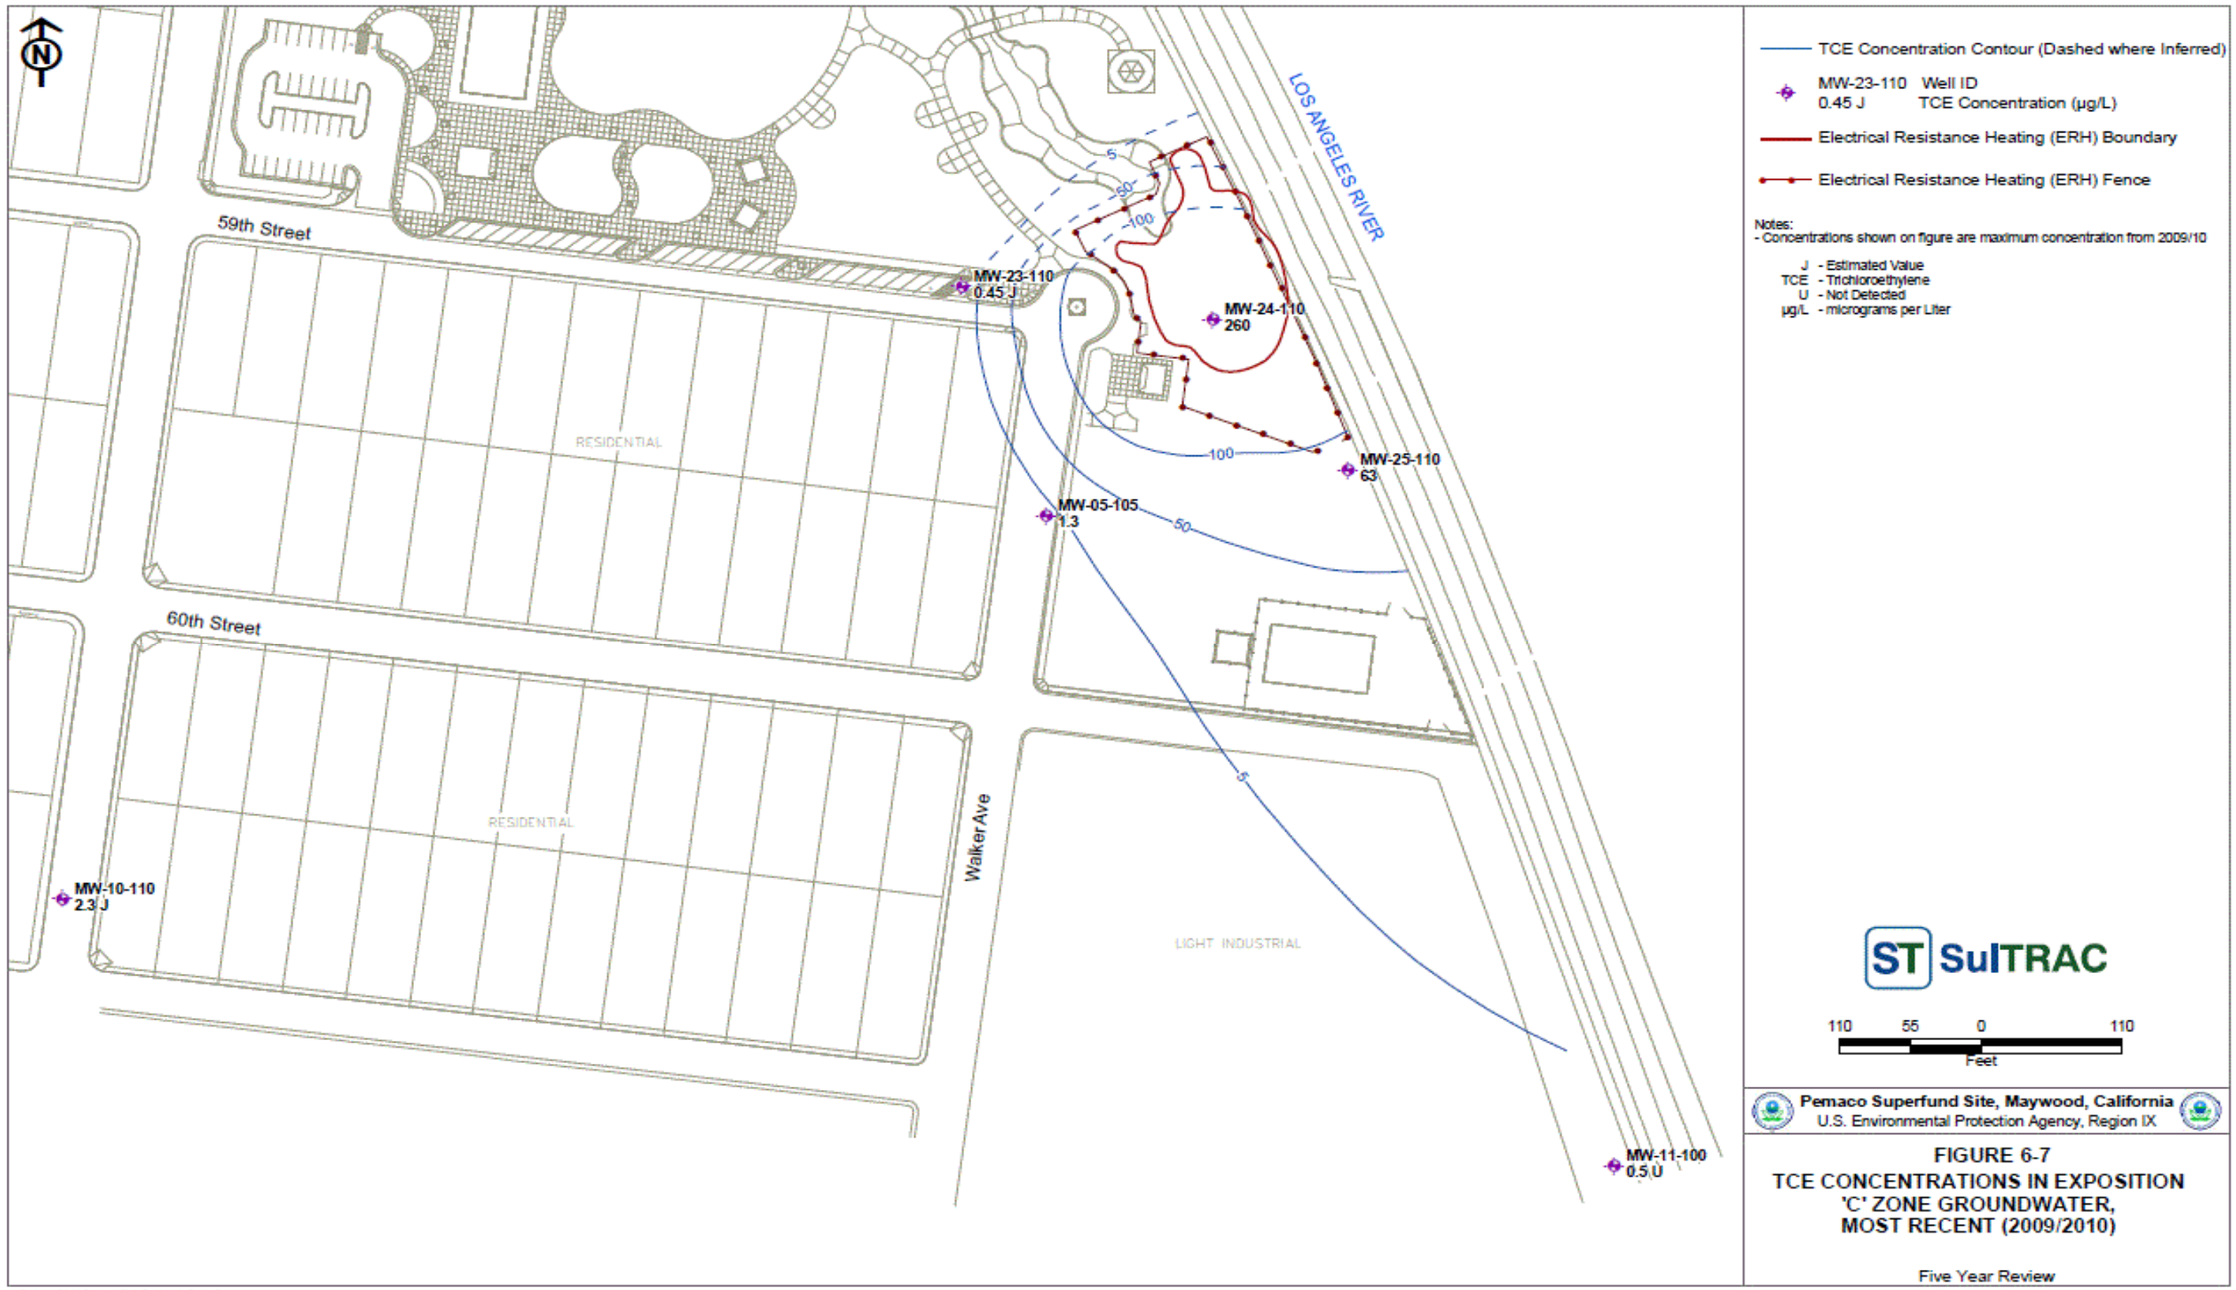
Figure 6-7 Post-ERH Maximum Concentrations of TCE in Exposition 'C' Zone Groundwater, Pemaco Superfund Site, Maywood CA

Currently, concentrations of COCs above SSRLs in the 'C' Zone are limited to TCE in wells MW24-110, MW25-110, and MW34-110; and cis-1,2-DCE in MW24-110 and MW25-110. The maximum concentrations of select COCs in 'C' Zone groundwater pre-HVDPE and post-ERH remedy in 2009 are presented in Table 6-4.

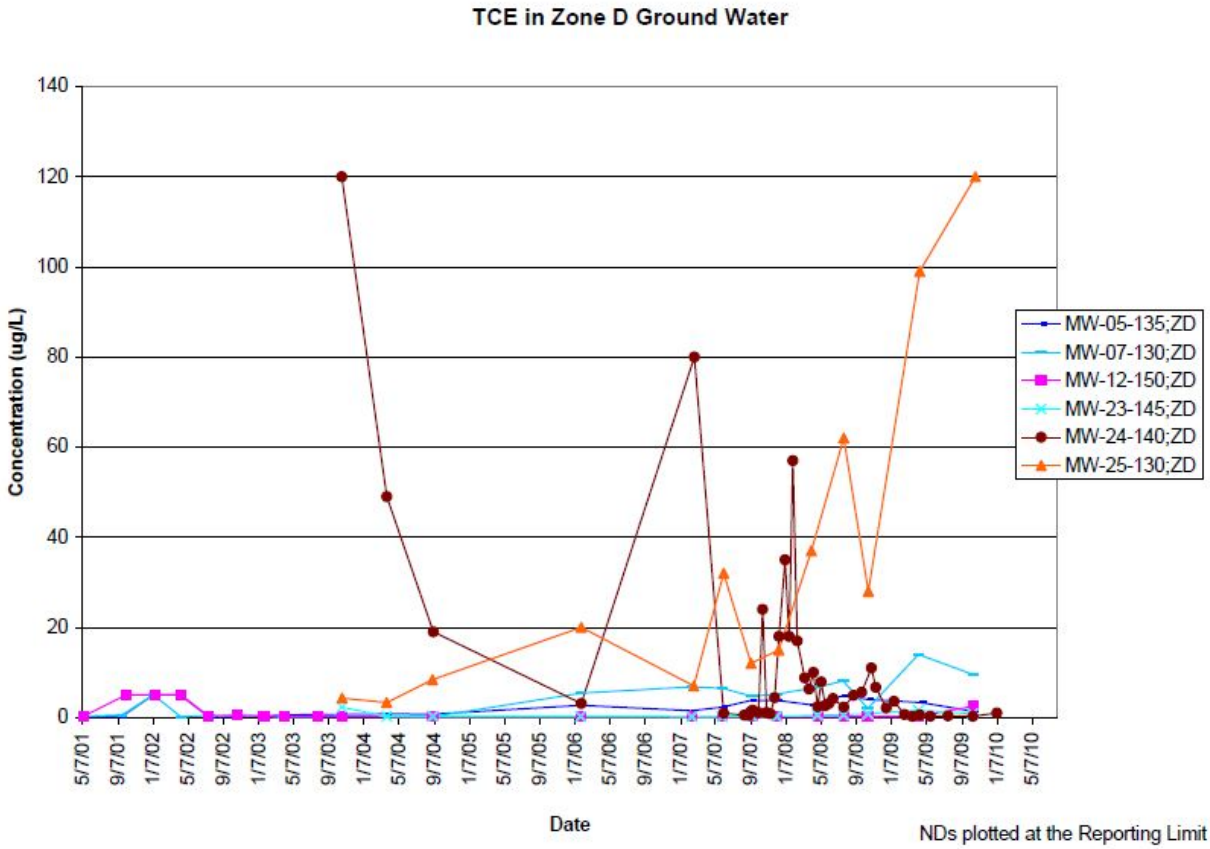
Figure 6-9: TCE in Exposition 'D' Zone Groundwater

TCE concentrations have steadily increased in well MW25-130, which is just south of MW24-140 and the ERH Area (from 4.3J µg/L in 2003 to 120 µg/L in October 2009). In January 2006, MW07-130, which is further downgradient from MW25-130, had detections of TCE in groundwater slightly above the SSRL at 5.4 µg/L, and had increased to 9.5 µg/L by October 2009. The graph below shows the trend of TCE concentrations in 'D' Zone monitoring wells, MW-07-130, , MW24-140 and MW25-130.
