Second Five-Year Review Report

Kerr-McGee Chemical Corp. (Soda Springs)
Superfund Site

Caribou County, Idaho

September 2007

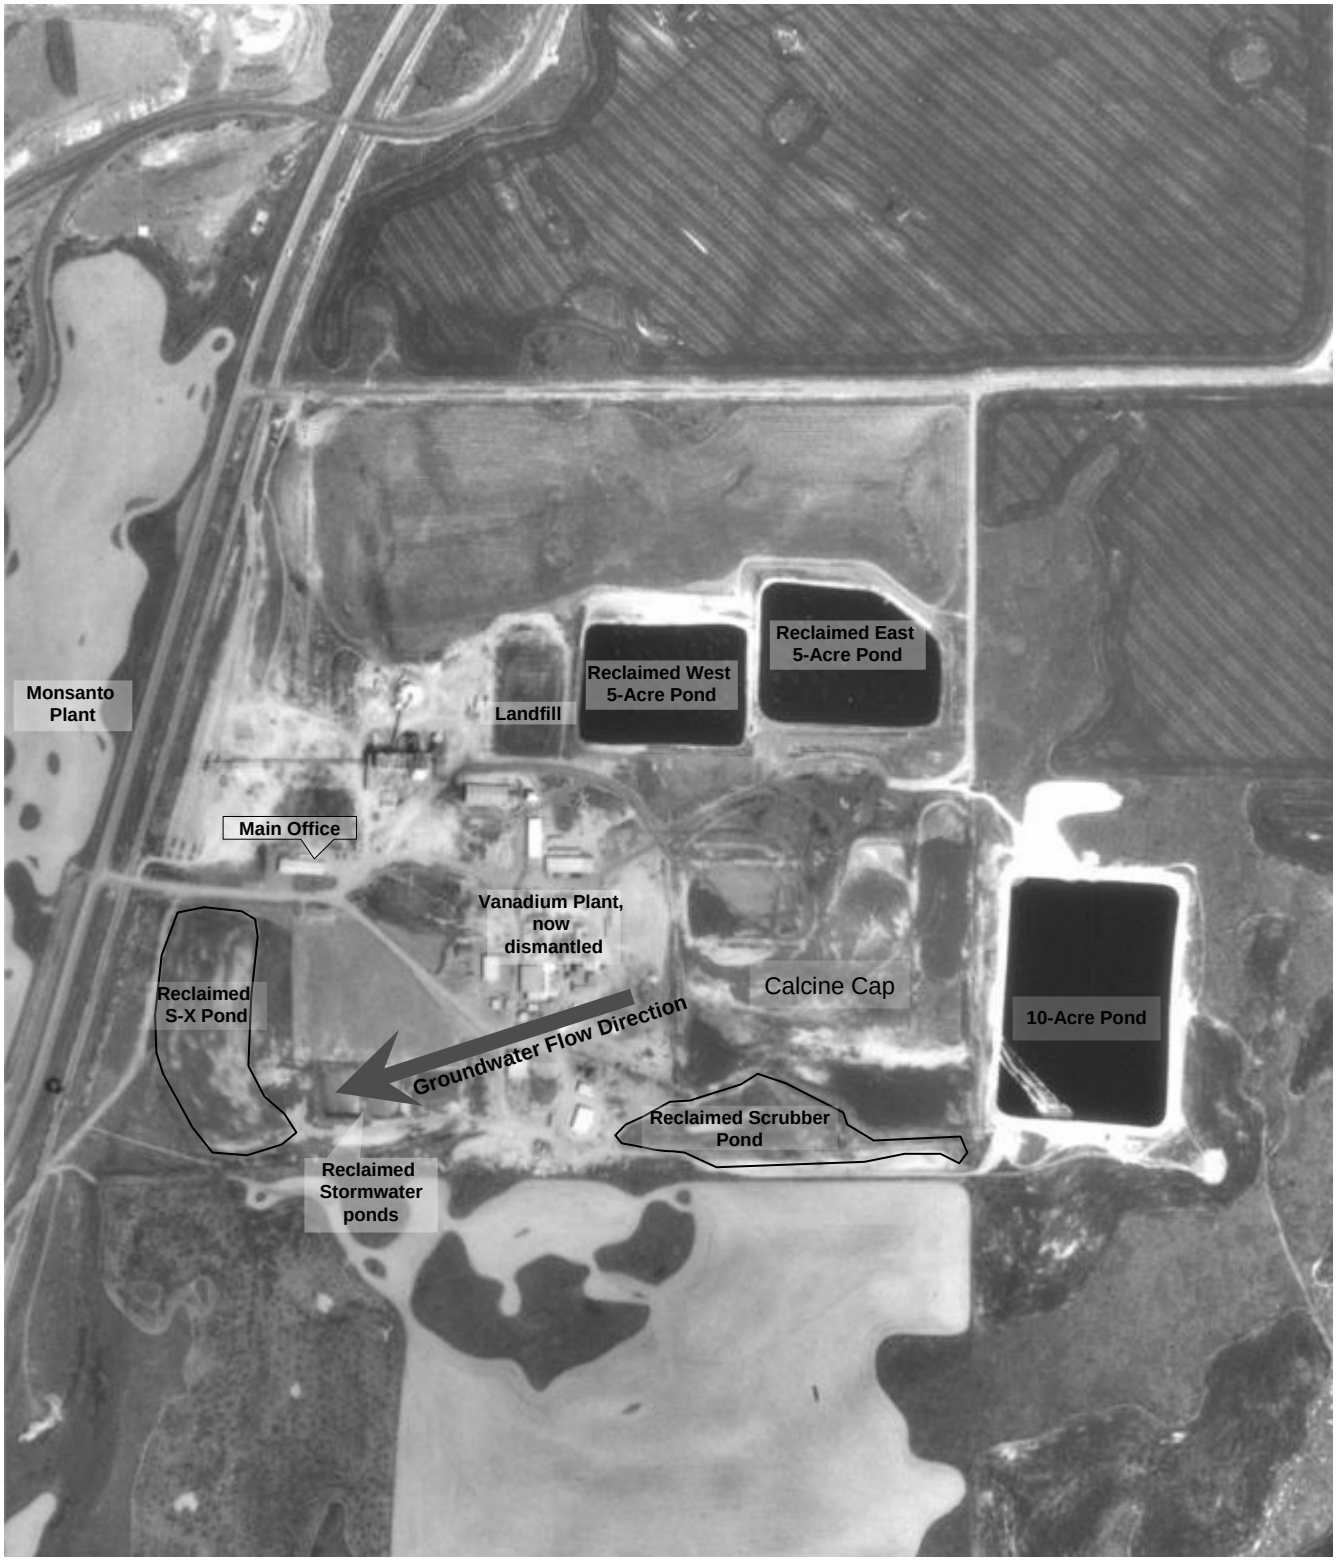
Figure 2

Photo - Sept 2000

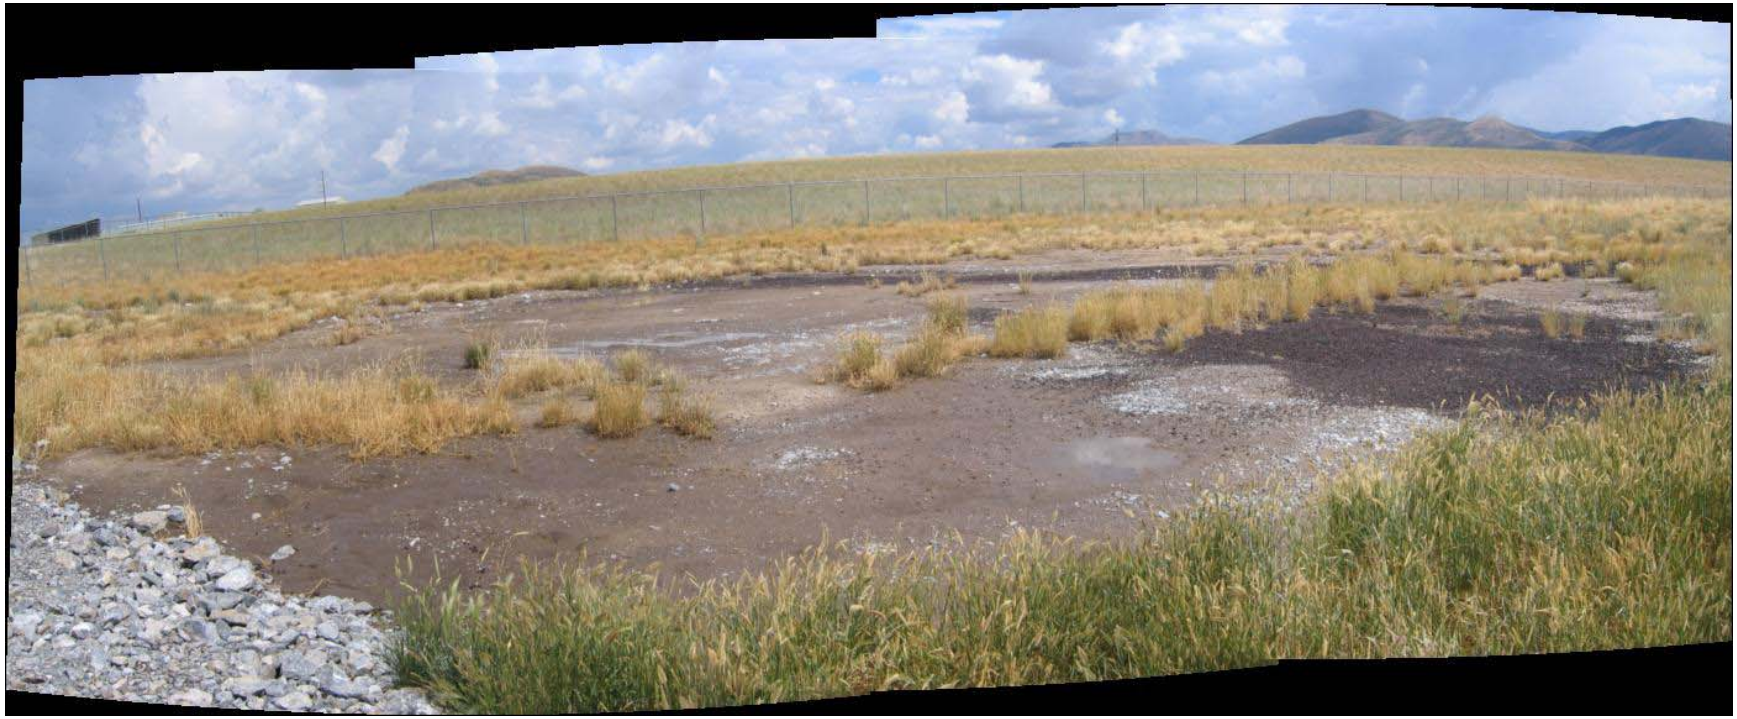
10-Acre Pond Looking North
