Second Five-Year Review Report

MIDWAY LANDFILL
Superfund Site

Kent, Washington

SEPTEMBER 2010

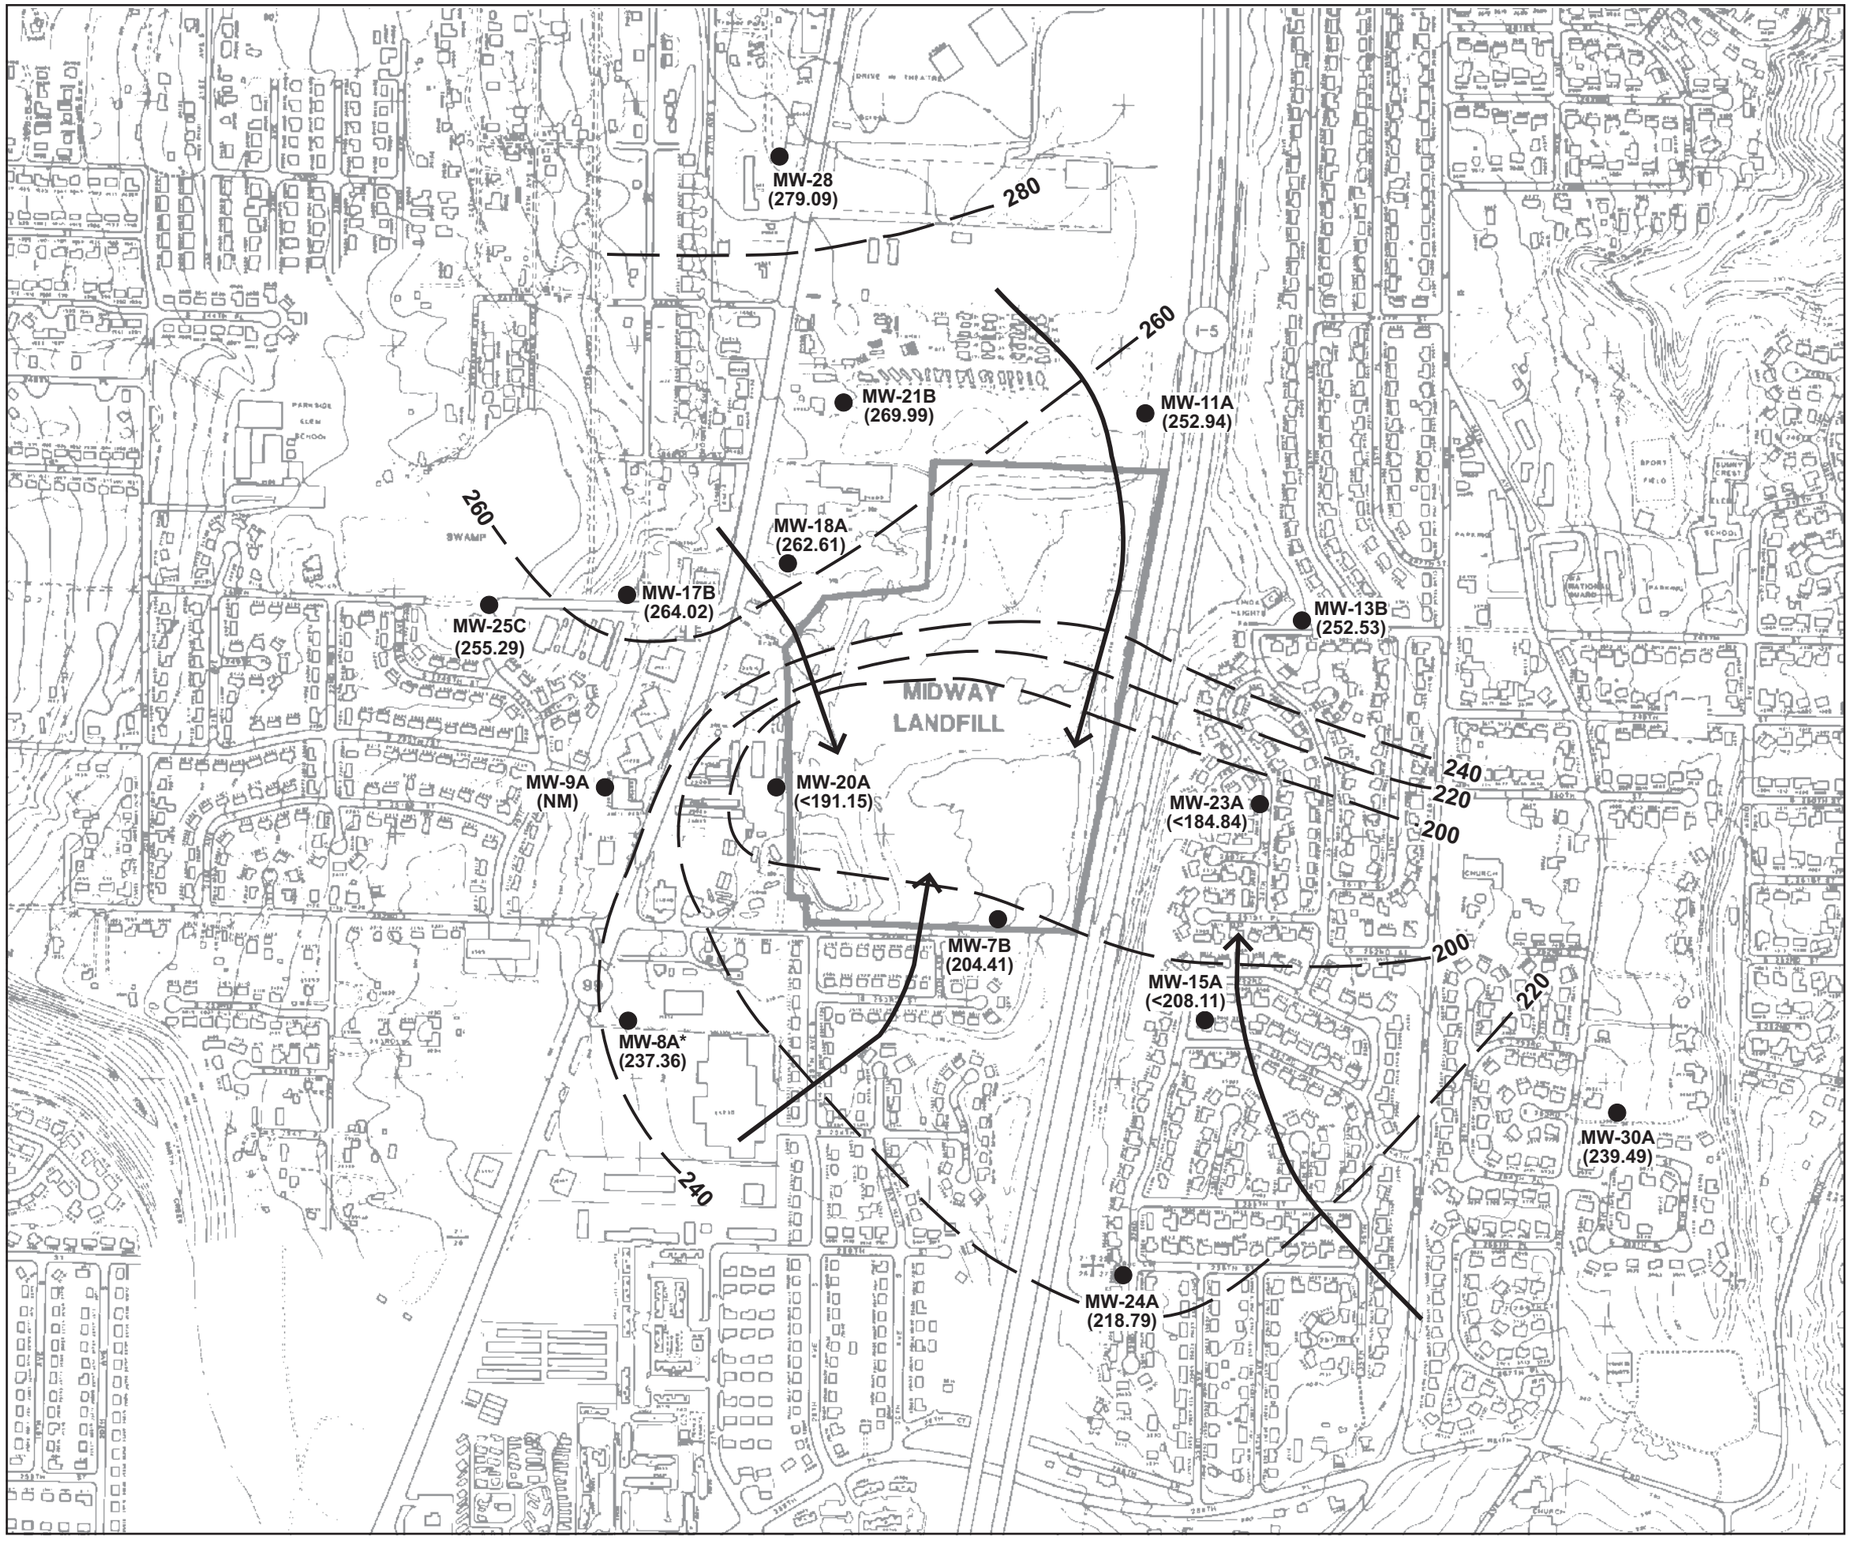
Figure 3
Generalized Sand Aquifer
Potentiometeric Surface Map, October 2008
Midway Landfill
Kent, Washington

D. Sand Aquifer (SA)
A generalized potentiometric surface map of the SA for October 2008 is presented as Figure 3. The SA occurs as a widespread deposit of interbedded sands and silts. Flow in this aquifer in the vicinity of the landfill is generally from the north and west to the southeast toward an apparent hydraulic sink. The sink occurs across a broad area beneath the southern part of the landfill and extends several hundred feet to the east. Groundwater south of this sink also flows towards the sink. Groundwater entering this sink appears to flow downward into the SGA. Some vertical flow outside the sink area also occurs from the SA downward into the SGA and NGA.

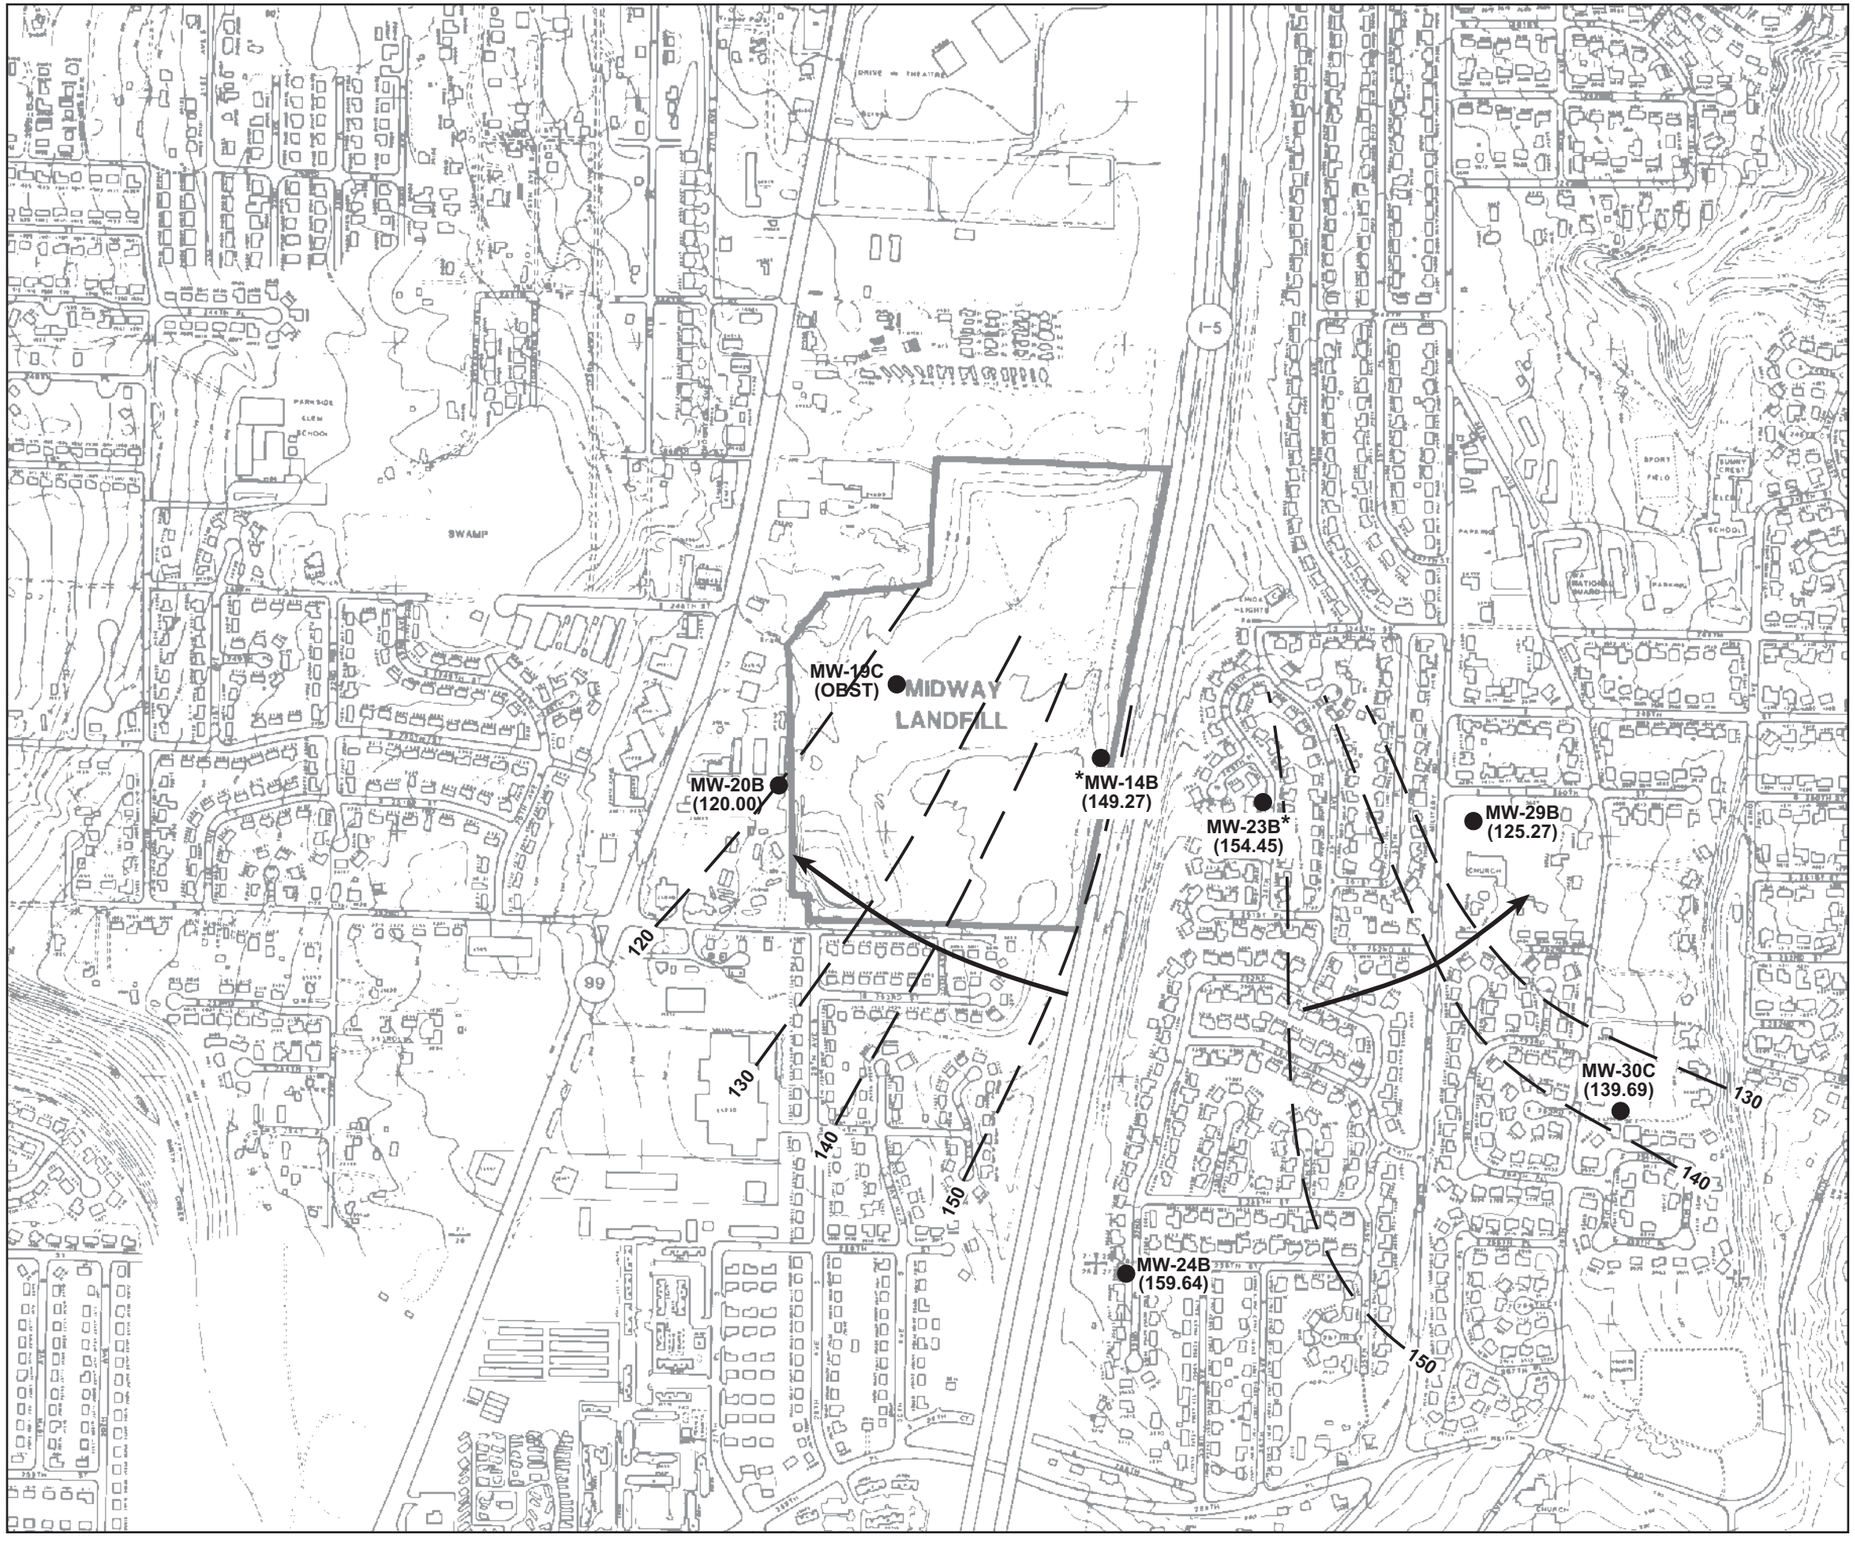
Figure 4
Generalized Southern Gravel Aquifer Potentiometric Surface Map October 2008
Midway Landfill
Kent, Washington

E. Southern Gravel Aquifer (SGA)
The SA and SGA are separated by the Lower Silt Aquitard. Like the Upper Silt Aquitard, the Lower Silt Aquitard is discontinuous and likely controls downward flow from the SA into the SGA. The deepest stratigraphic units studied are the NGA and SGA; they occur at about the same elevation, but hydraulic heads in the NGA are typically 100 ft higher than heads in the SGA. A generalized potentiometric surface map of the SGA for October 2008 is presented in Figure 4. The SGA is found beneath the southern half of the landfill and extends to the east, south, and west. It consists of permeable sands and gravel interbedded with silts and silty gravel. The SGA appears to be recharged by the SA and by lateral flow from the south. A groundwater mound in the SGA, below the hydraulic sink in the SA, is believed to be an expression of flow through the sink. Groundwater flow has changed slightly since the RI, with a more northeast/northwest direction instead of east/west. Flow to the north is blocked by higher potentiometric heads within the NGA. Groundwater in the SGA eventually discharges west to Puget Sound and east to the Green River Valley.

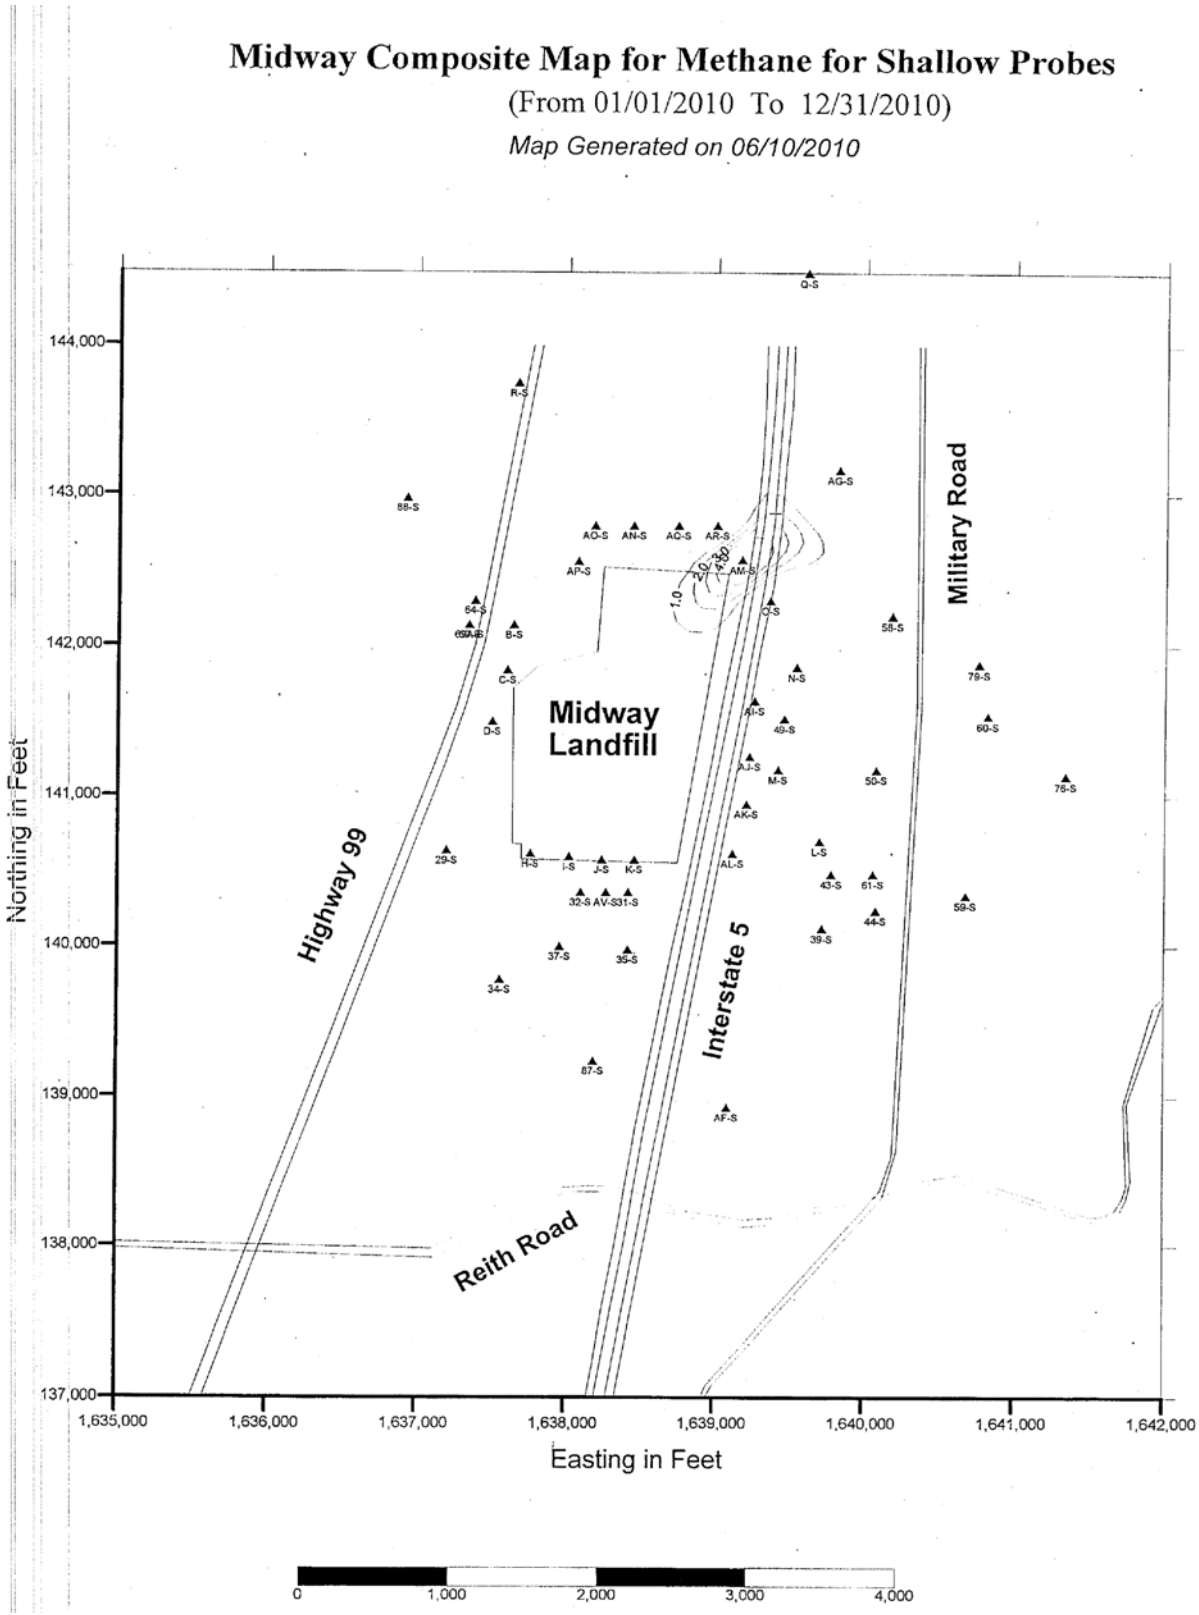
Figure 9. 2010 Methane Concentration in Shallow Gas Probes

This five-year review found that the landfill gas collection, cap, and surface water drainage systems are functioning as intended. Methane concentrations outside the landfill boundary are below the lower explosive level (LEL). The flare/blower station, landfill cap, and surface water drainage system appeared to be well maintained. Groundwater monitoring continued biannually for the past five years. Institutional controls consistent with the ROD requirements and current site conditions are in place where necessary and are functioning as intended. Contaminants of concern (COCs) are still being detected in groundwater beyond the landfill boundary, but COC concentrations are trending downwards in downgradient wells and are below or approaching the Remedial Action Goals. However, during the last five-year review, 1,4 dioxane was added to be monitored in three groundwater wells (two upgradient and one downgradient). It was detected in all three wells, but only exceeds cleanup standards in the one downgradient well. Monitoring in three wells is not enough to develop a conceptual site model for 1,4 dioxane.
