RESERVOIR HYDRAULICS AND BERM STABILITY INVESTIGATION

BoRiT ASBESTOS SUPERFUND SITE, AMBLER, PA

U.S. Army Corps of Engineers

SEPTEMBER 2013

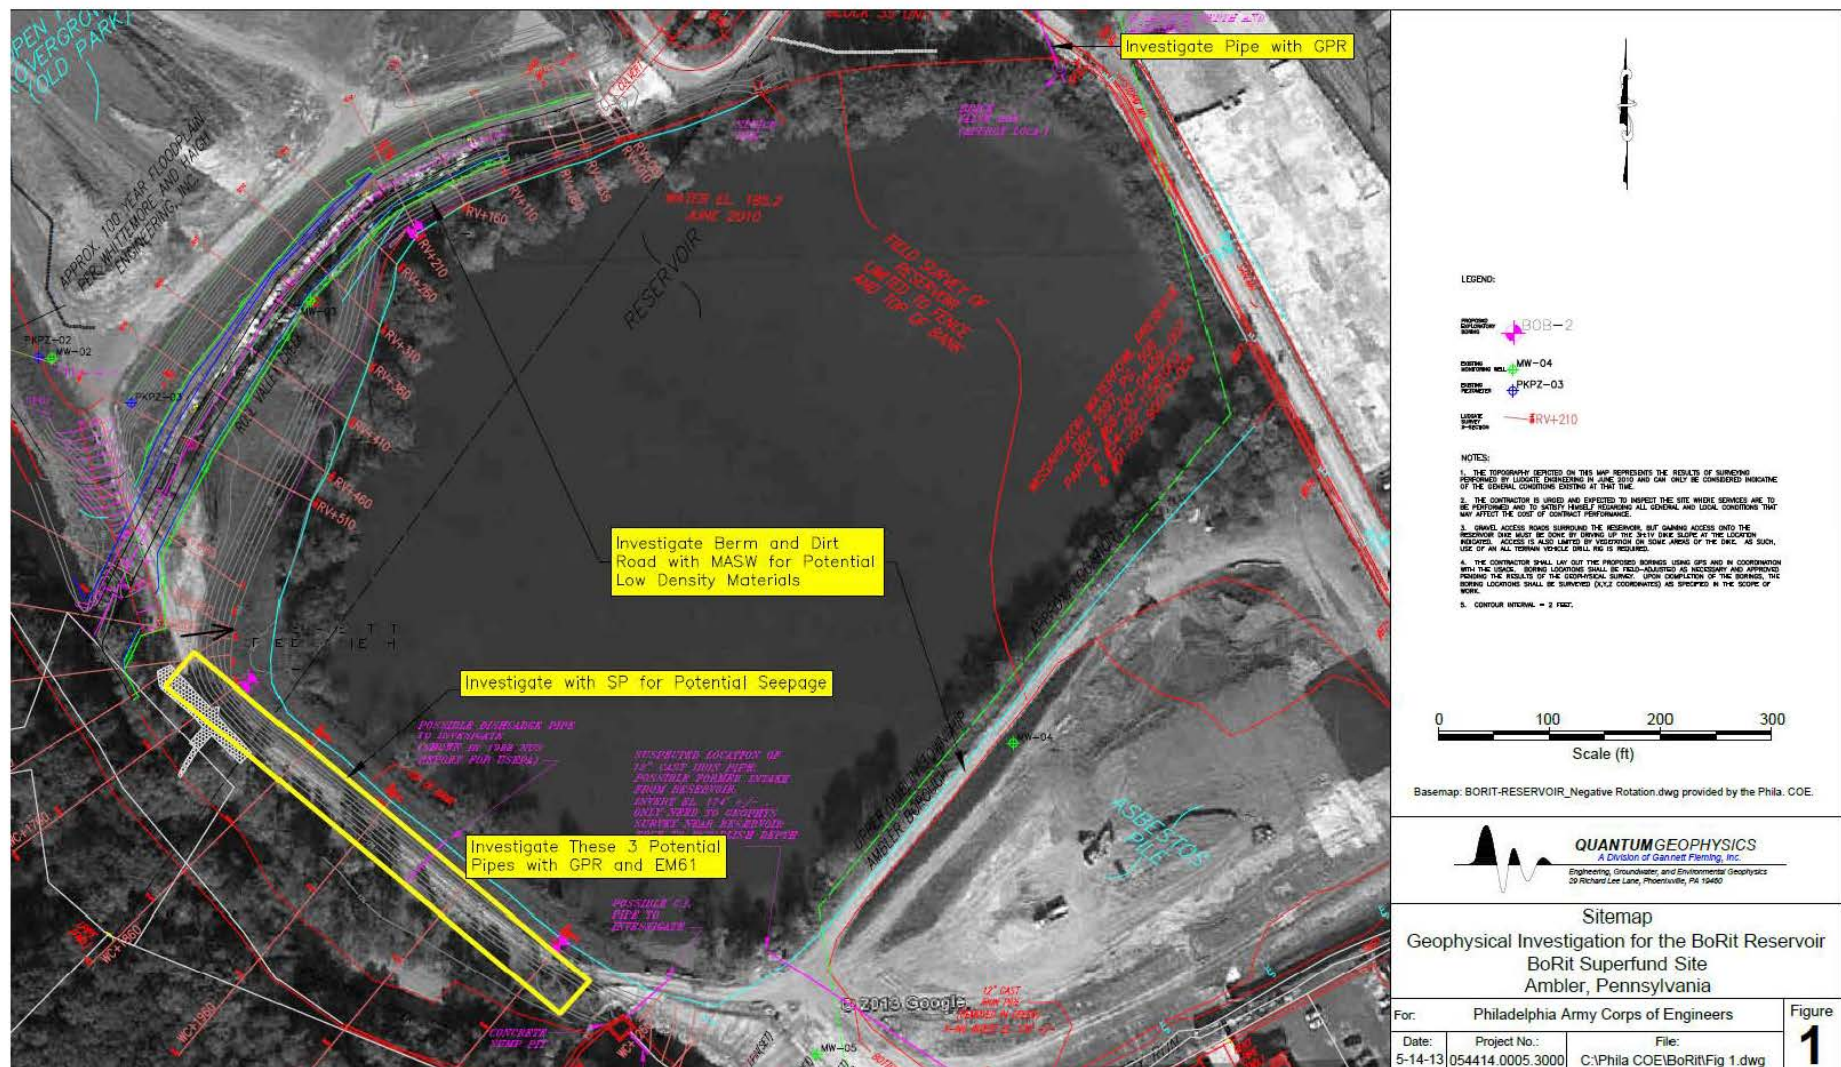
Figure 2.1

The EM61 and GPR are both tools that use electromagnetic energy to identify both metallic and non-metallic objects below the surface. These methods were used in four specific locations to verify if pipes were running into or out of the reservoir (See Figure 2.1). Any pipes found could be a conduit for groundwater traveling into the reservoir.

Locations of Geophysical Investigations

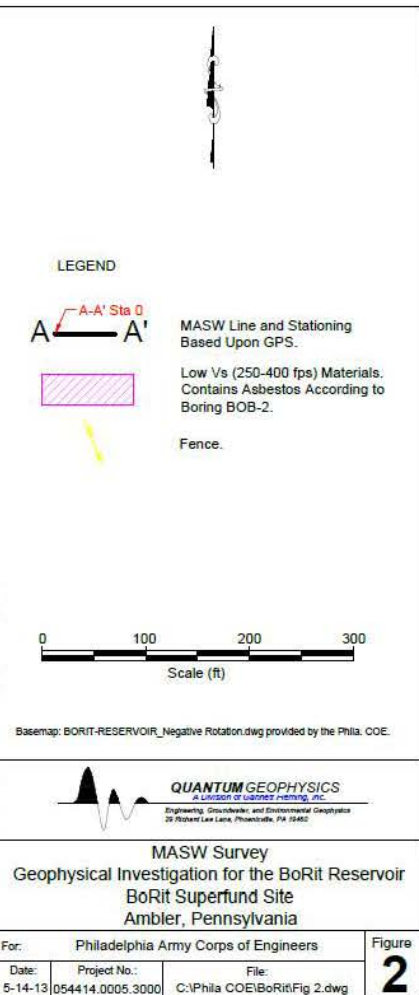
Figure 2.2

The MASW survey showed low shear wave velocities in the southwestern corner of the reservoir at the area where there has been seepage in the past (See Figure 2.2). The low velocities are indicative of soils mixed with ACM representing a loose condition, which could be a concern for slope stability. The MASW also showed a cut into the bedrock beneath the gravel road on the eastern side of the reservoir (See Figure 2.3). This square notch in the bedrock is consistent with historical accounts that suggest the site was previously used as a quarry. The geophysical investigation did not identify any previously unknown pipes leading into or out of the reservoir.

Zone of Weak Material in SW Berm BoRit Asbestos Superfund Site Ambler, PA

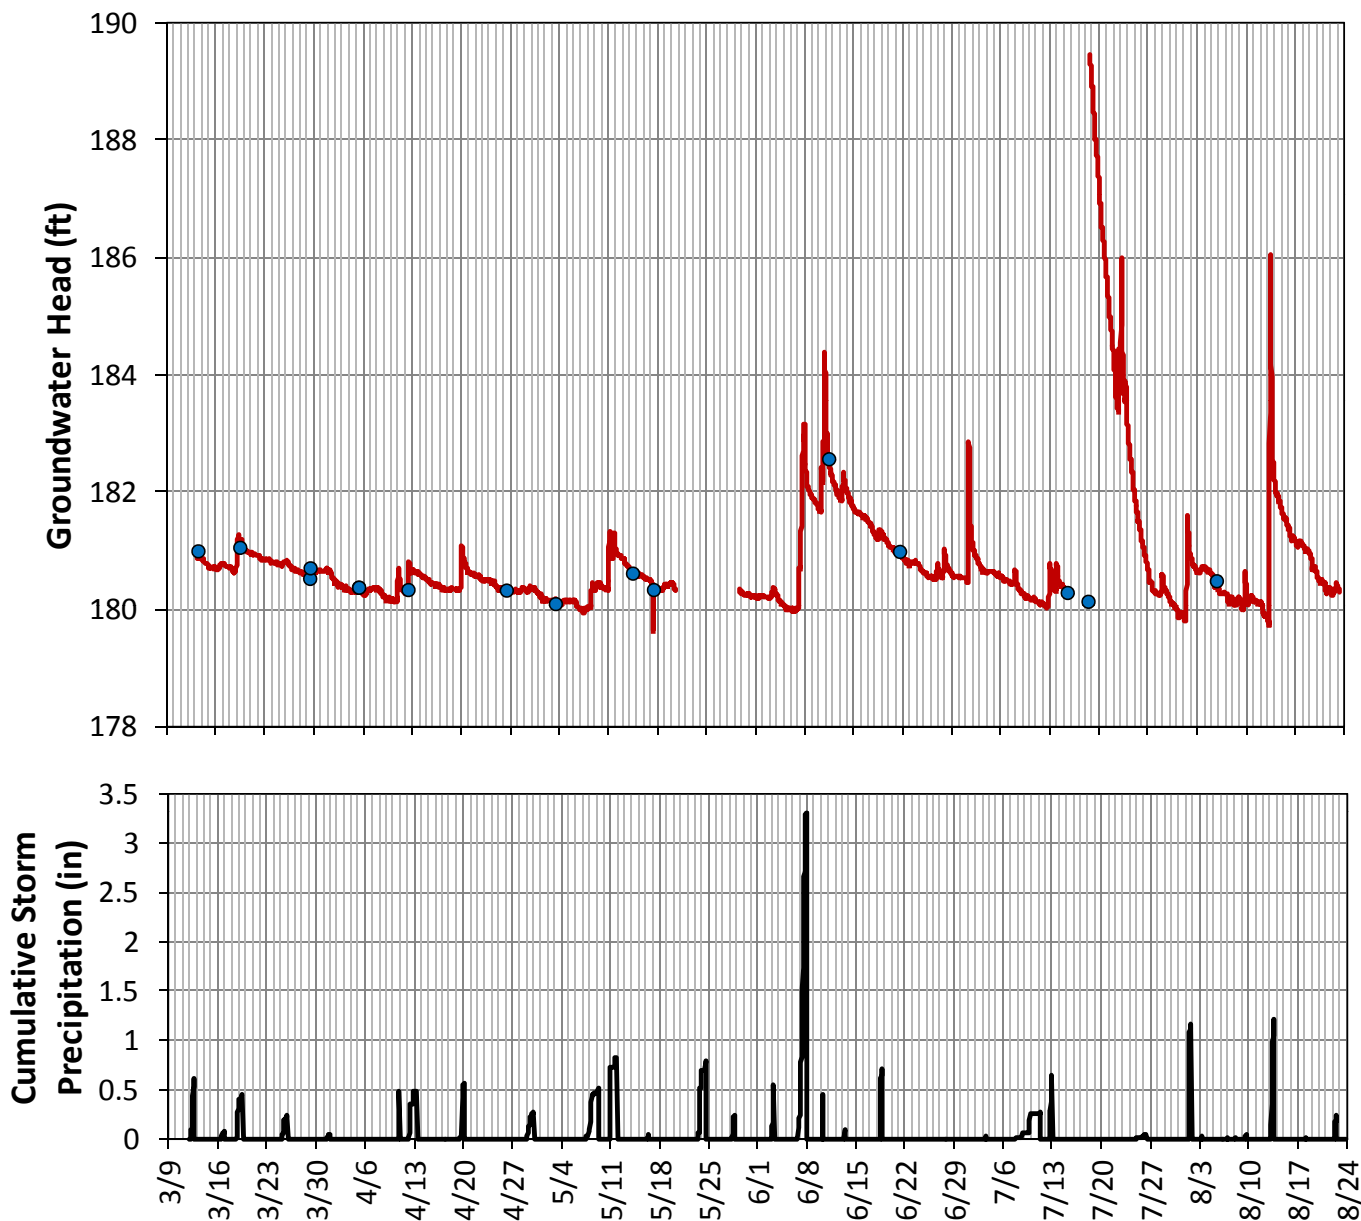
Figure 3.3

This same weekly signature can be clearly seen in the MW-07 (Figure 3.7) and, to a lesser degree, in MW-01A (Figure 3.3) and MW-02 (Figure 3.4), where the head changes are smaller and often masked by the noise of the signal. This anomaly is not, however, noted in the reservoir, although MW-03 is adjacent to the shore of the reservoir. The cause of this anomaly is most likely two nearby upgradient industrial wells associated with a business in Ambler. Pumped volumes are high (about 16 million gallons per year together) and generally they are reported to be pumping for around 20 days per month.

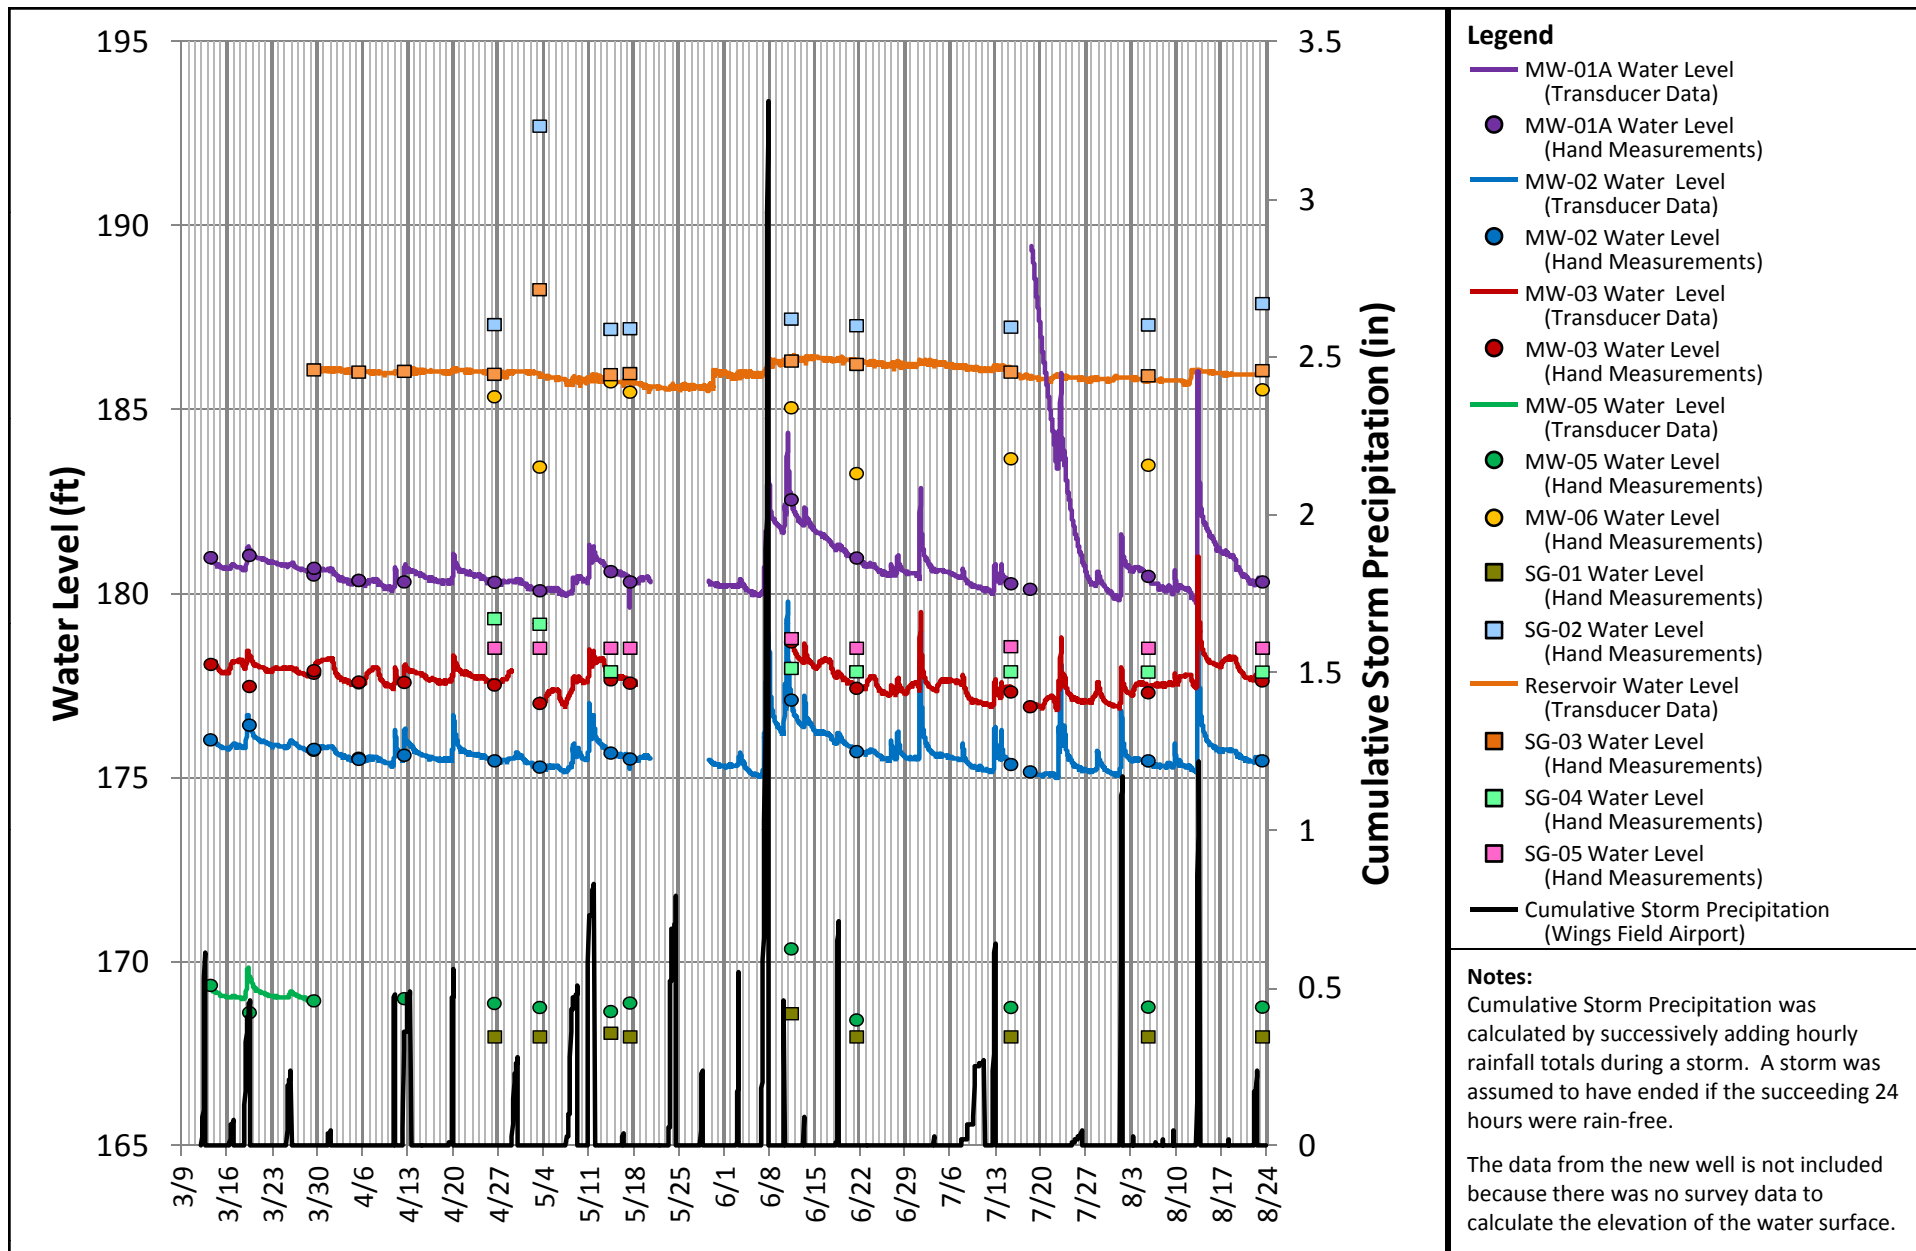
Figure 3.9

All Measured Water Levels
 BoRit Asbestos Superfund Site
 Ambler, PA

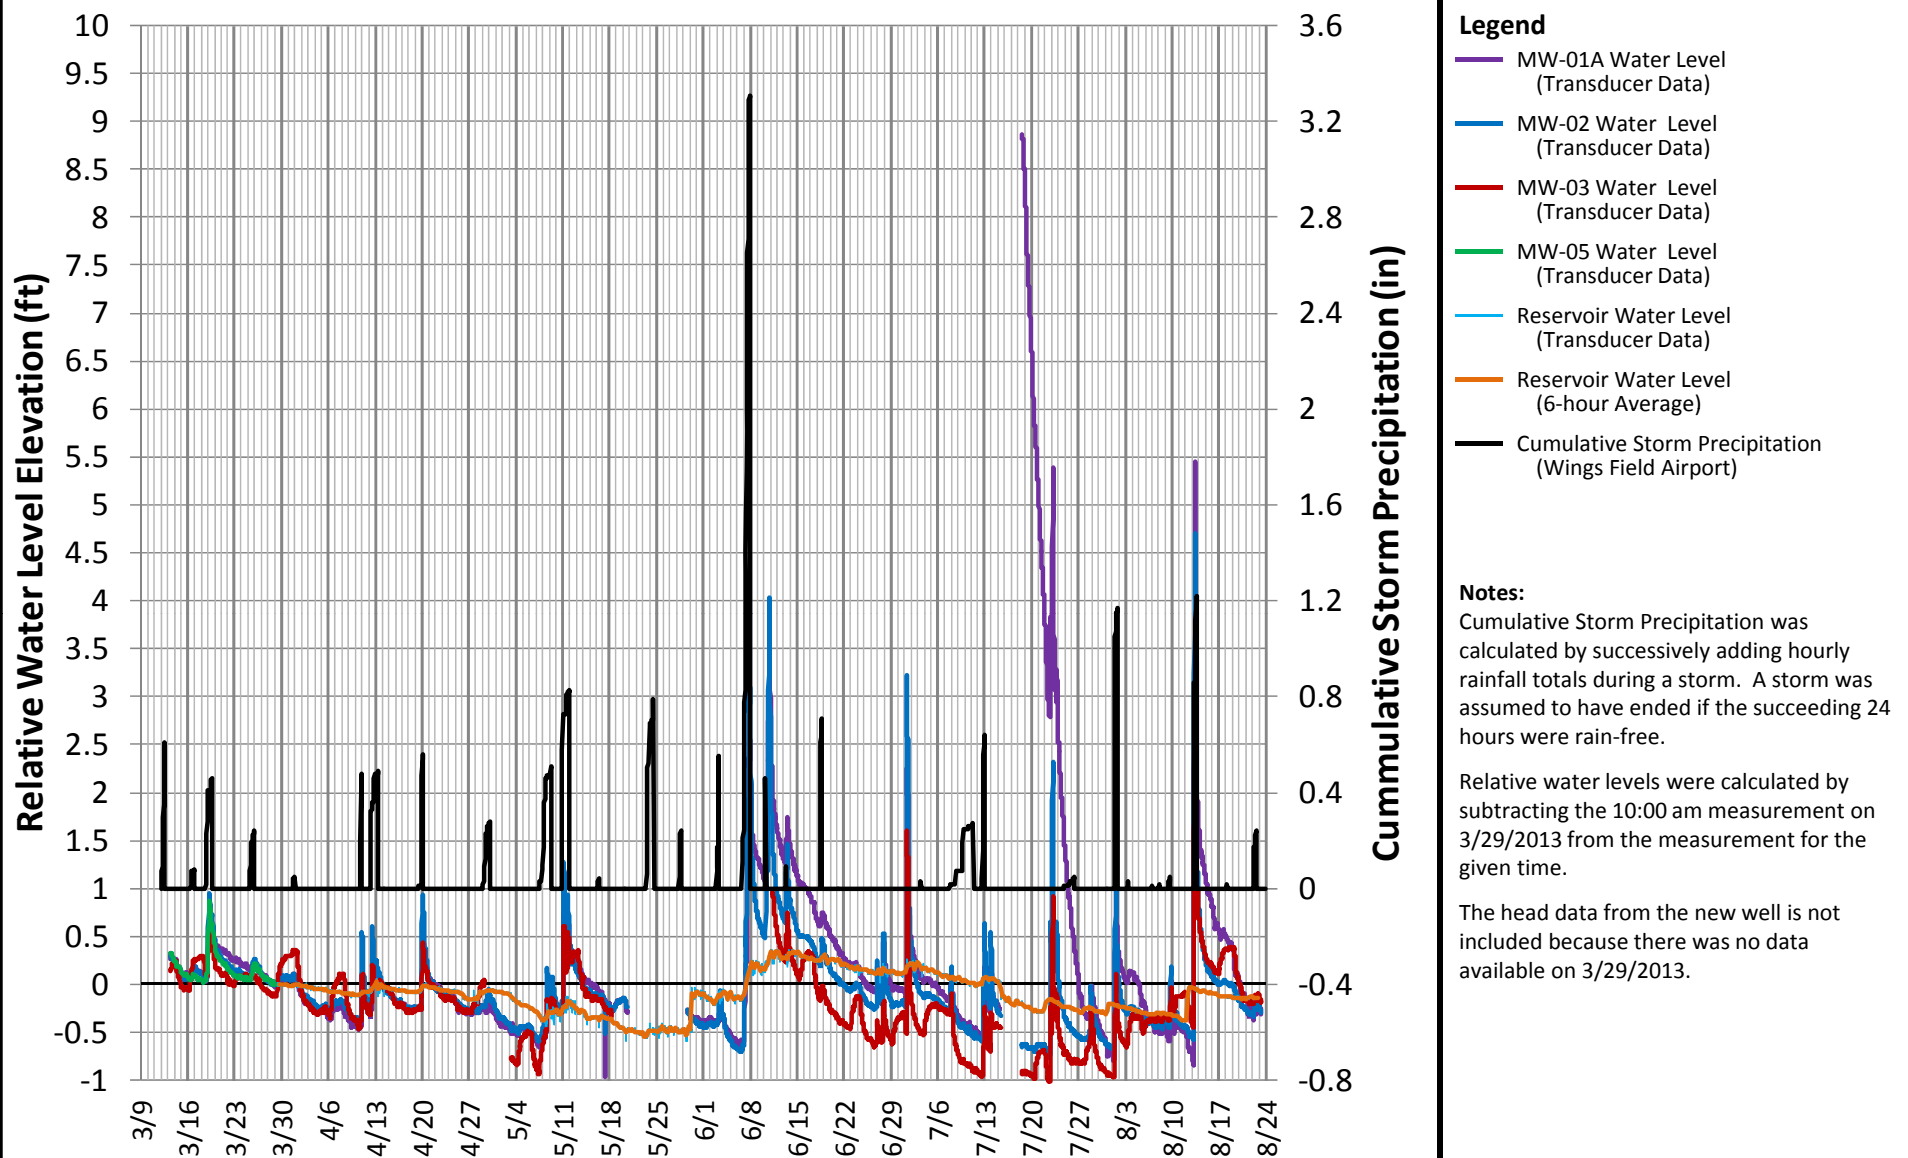
Figures 3.3 through 3.8 show the water level data and the precipitation data at each location with a transducer. The precipitation data is presented as cumulative inches for each storm. The storm was assumed to have ended if the succeeding 24 hours were dry and the precipitation data collection was restarted. Note the sudden impacts from rainfall in each of the wells and in the reservoir. All wells have a 9-day break in data at the end of May and a 3-day break during July when the transducers were removed for a sampling event performed by CDM as part of the Phase III field investigations of the BoRit site. A larger break in data during May and June occurred at MW-03 due to condensation on the transducer. Note that the reservoir water level is 5 to 10 feet higher than the measured groundwater at most of the wells other than MW-06. At MW-06, the typical measured groundwater elevation was similar to the reservoir water level. Figure 3.10 shows all of the transducer data, zeroed out on March 29th to show relative water level changes.

Relative Water Levels BoRit Asbestos Superfund Site Ambler, PA
