THIRD FIVE-YEAR REVIEW REPORT FOR  
Moyer's Landfill Superfund Site  
Montgomery County, Pennsylvania

U.S. Environmental Protection Agency  
Region III  
Philadelphia, Pennsylvania

JUN 27 2017

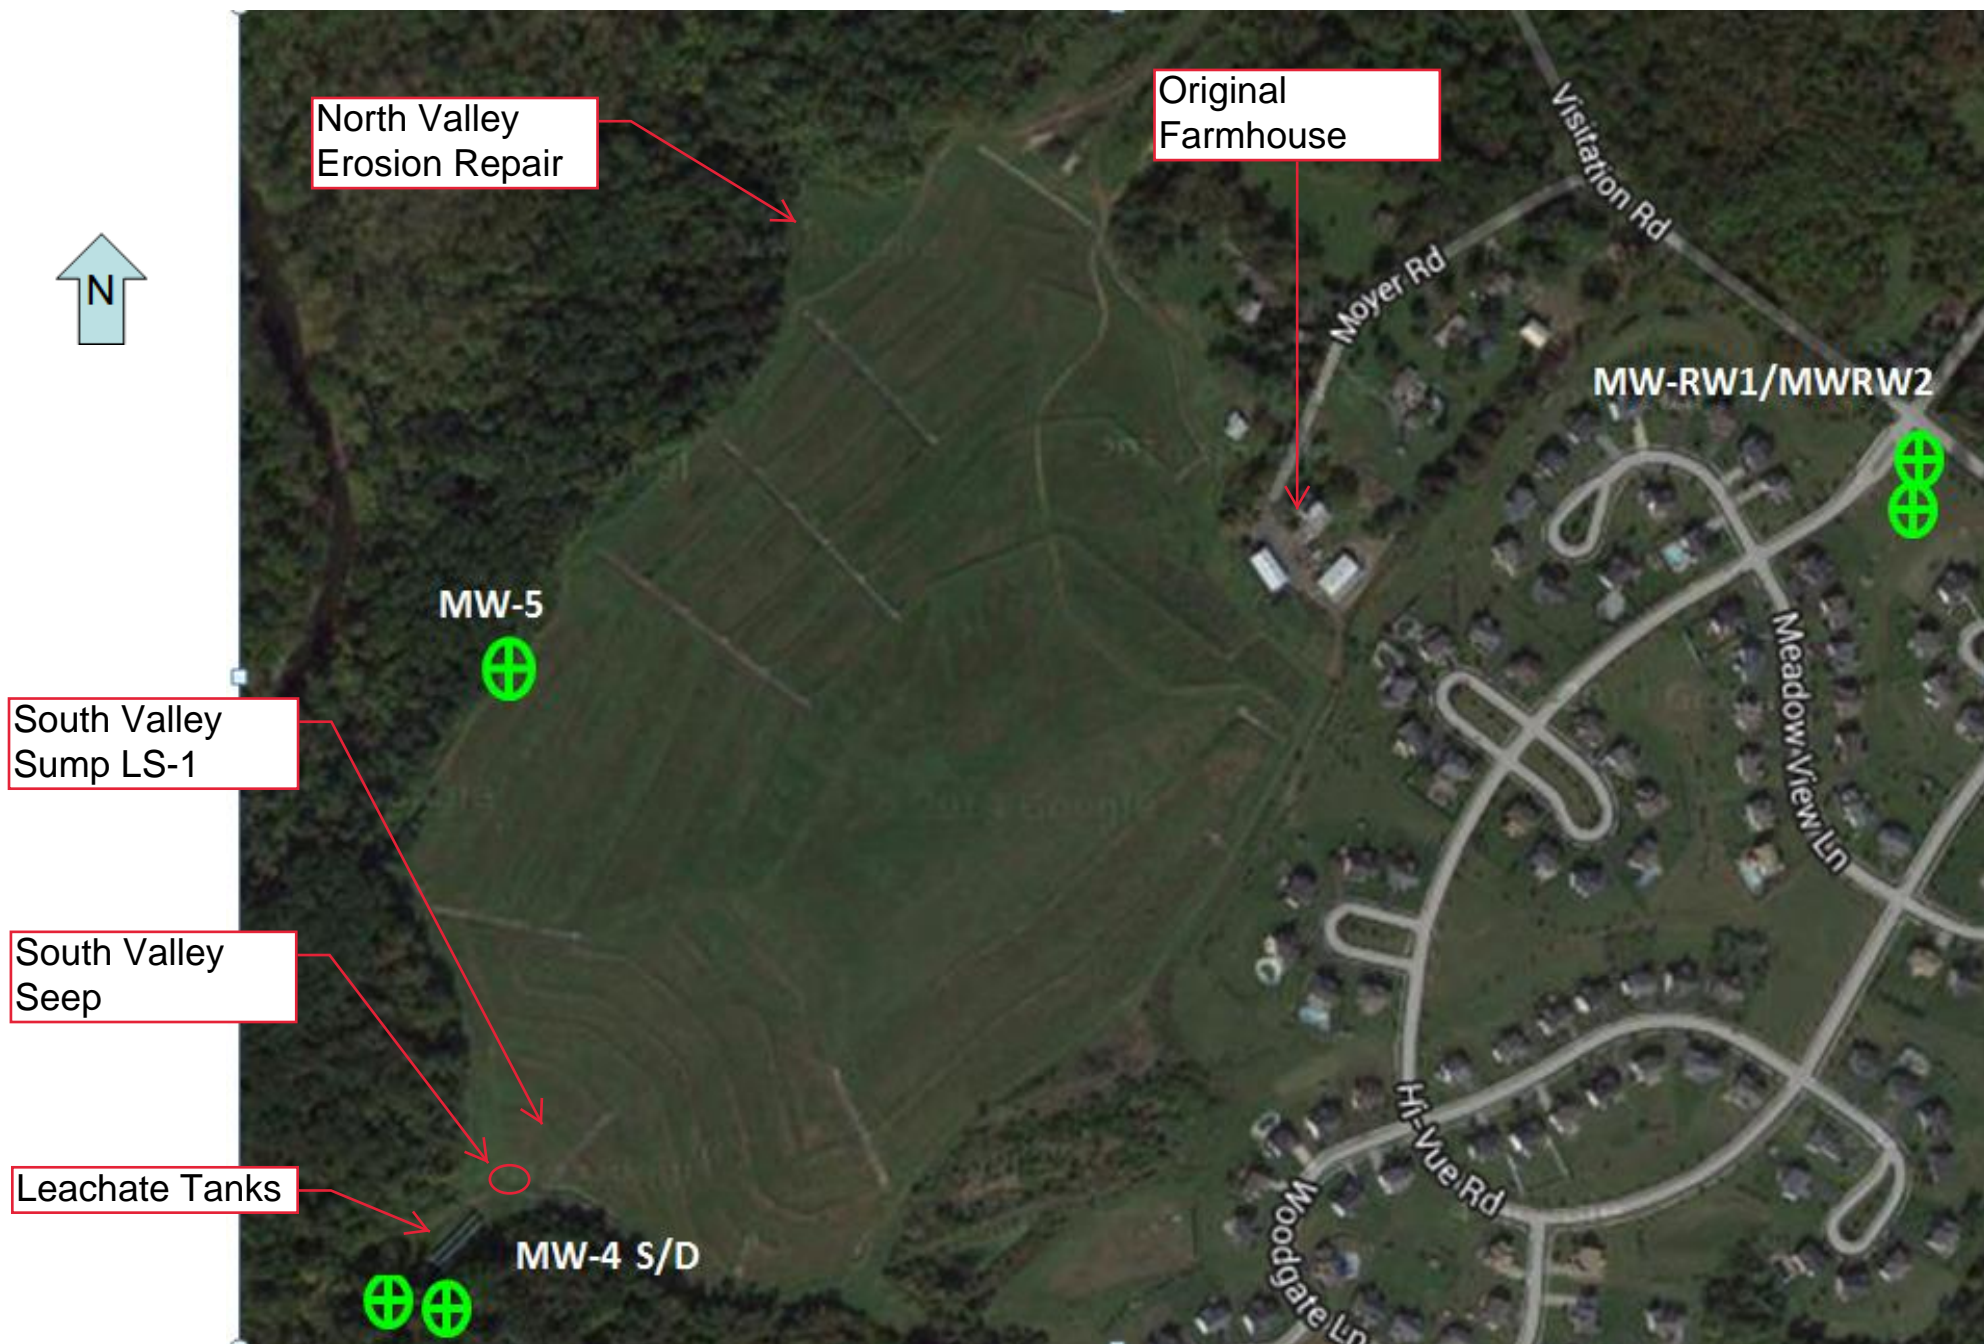
Figure 2  
Site Layout Map, Well Locations and Site Features  
Moyers Landfill Superfund Site

Figure 2 is a map showing the on-site groundwater well locations and site features. Groundwater flows toward Skippack Creek such that wells MW-4S, MW-4D and MW-5 are on the downgradient edge of the plume, and wells MW-R1 and MW-R2 are upgradient. Most residents in the area receive water from the local public water supply, and no residential wells exist between the landfill and the downgradient monitoring wells.

In 2016, the groundwater monitoring wells were analyzed for VOCs. A seep in the South Valley (Figure 2), and the leachate discharge at the South Valley manhole (LS-1) were also analyzed for VOCs, metals, cyanide, oil & grease and general chemistry. As in 2014, all wells were non-detect for all VOCs, except MW-5. At MW-5, cis-1,2 DCE was detected at a concentration of 3 ug/l, below the MCL of 70 ug/L and trichloroethene (TCE) was detected at a concentration of 2.3 ug/l, below the MCL of 5 ug/L. Table 3 summarizes the VOCs that were detected during groundwater sampling and compares the results to MCLs. No VOCs were detected in the groundwater monitoring wells, seep, or leachate during the 2016 monitoring event above MCLs.

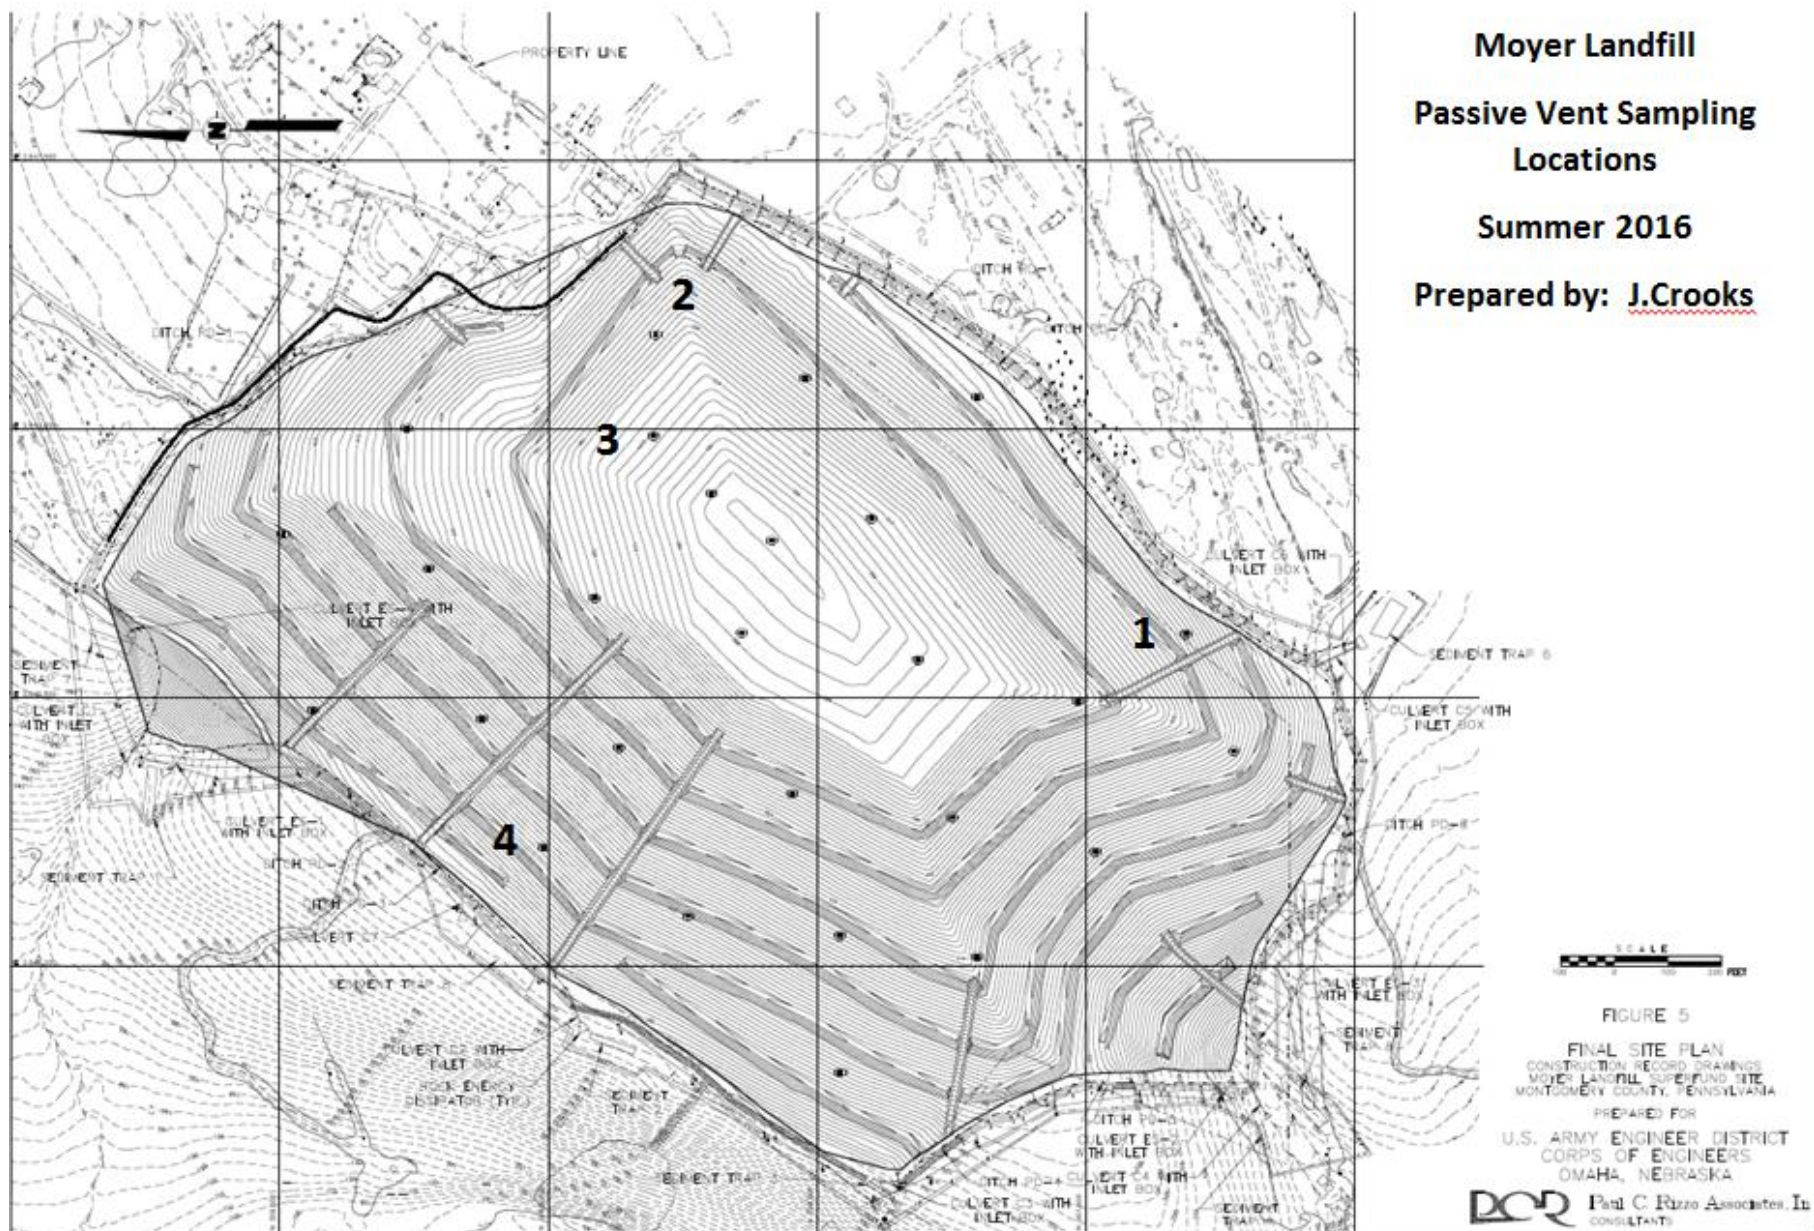
Figure 5  
Gas Vent Sampling Locations 2016  
Moyers Landfill Superfund Site

On April 22, 2014, PADEP collected vapor samples directly from three passive gas vents on the site (GV-1, GV-2, and GV-3) at the locations marked on Figure 4. On June 13, 2016, PADEP collected vapor samples directly from four passive gas vents on the site (GV-12, GV-20, GV-30, and GV-50) as marked on Figure 5. The passive gas vent samples were analyzed for EPA Method TO-15 VOCs in Air.
