SYOSSET LANDFILL

2017 ANNUAL POST-CLOSURE SUMMARY REPORT

TOWN OF OYSTER BAY

SYOSSET LANDFILL
2017 ANNUAL POST-CLOSURE
SUMMARY REPORT

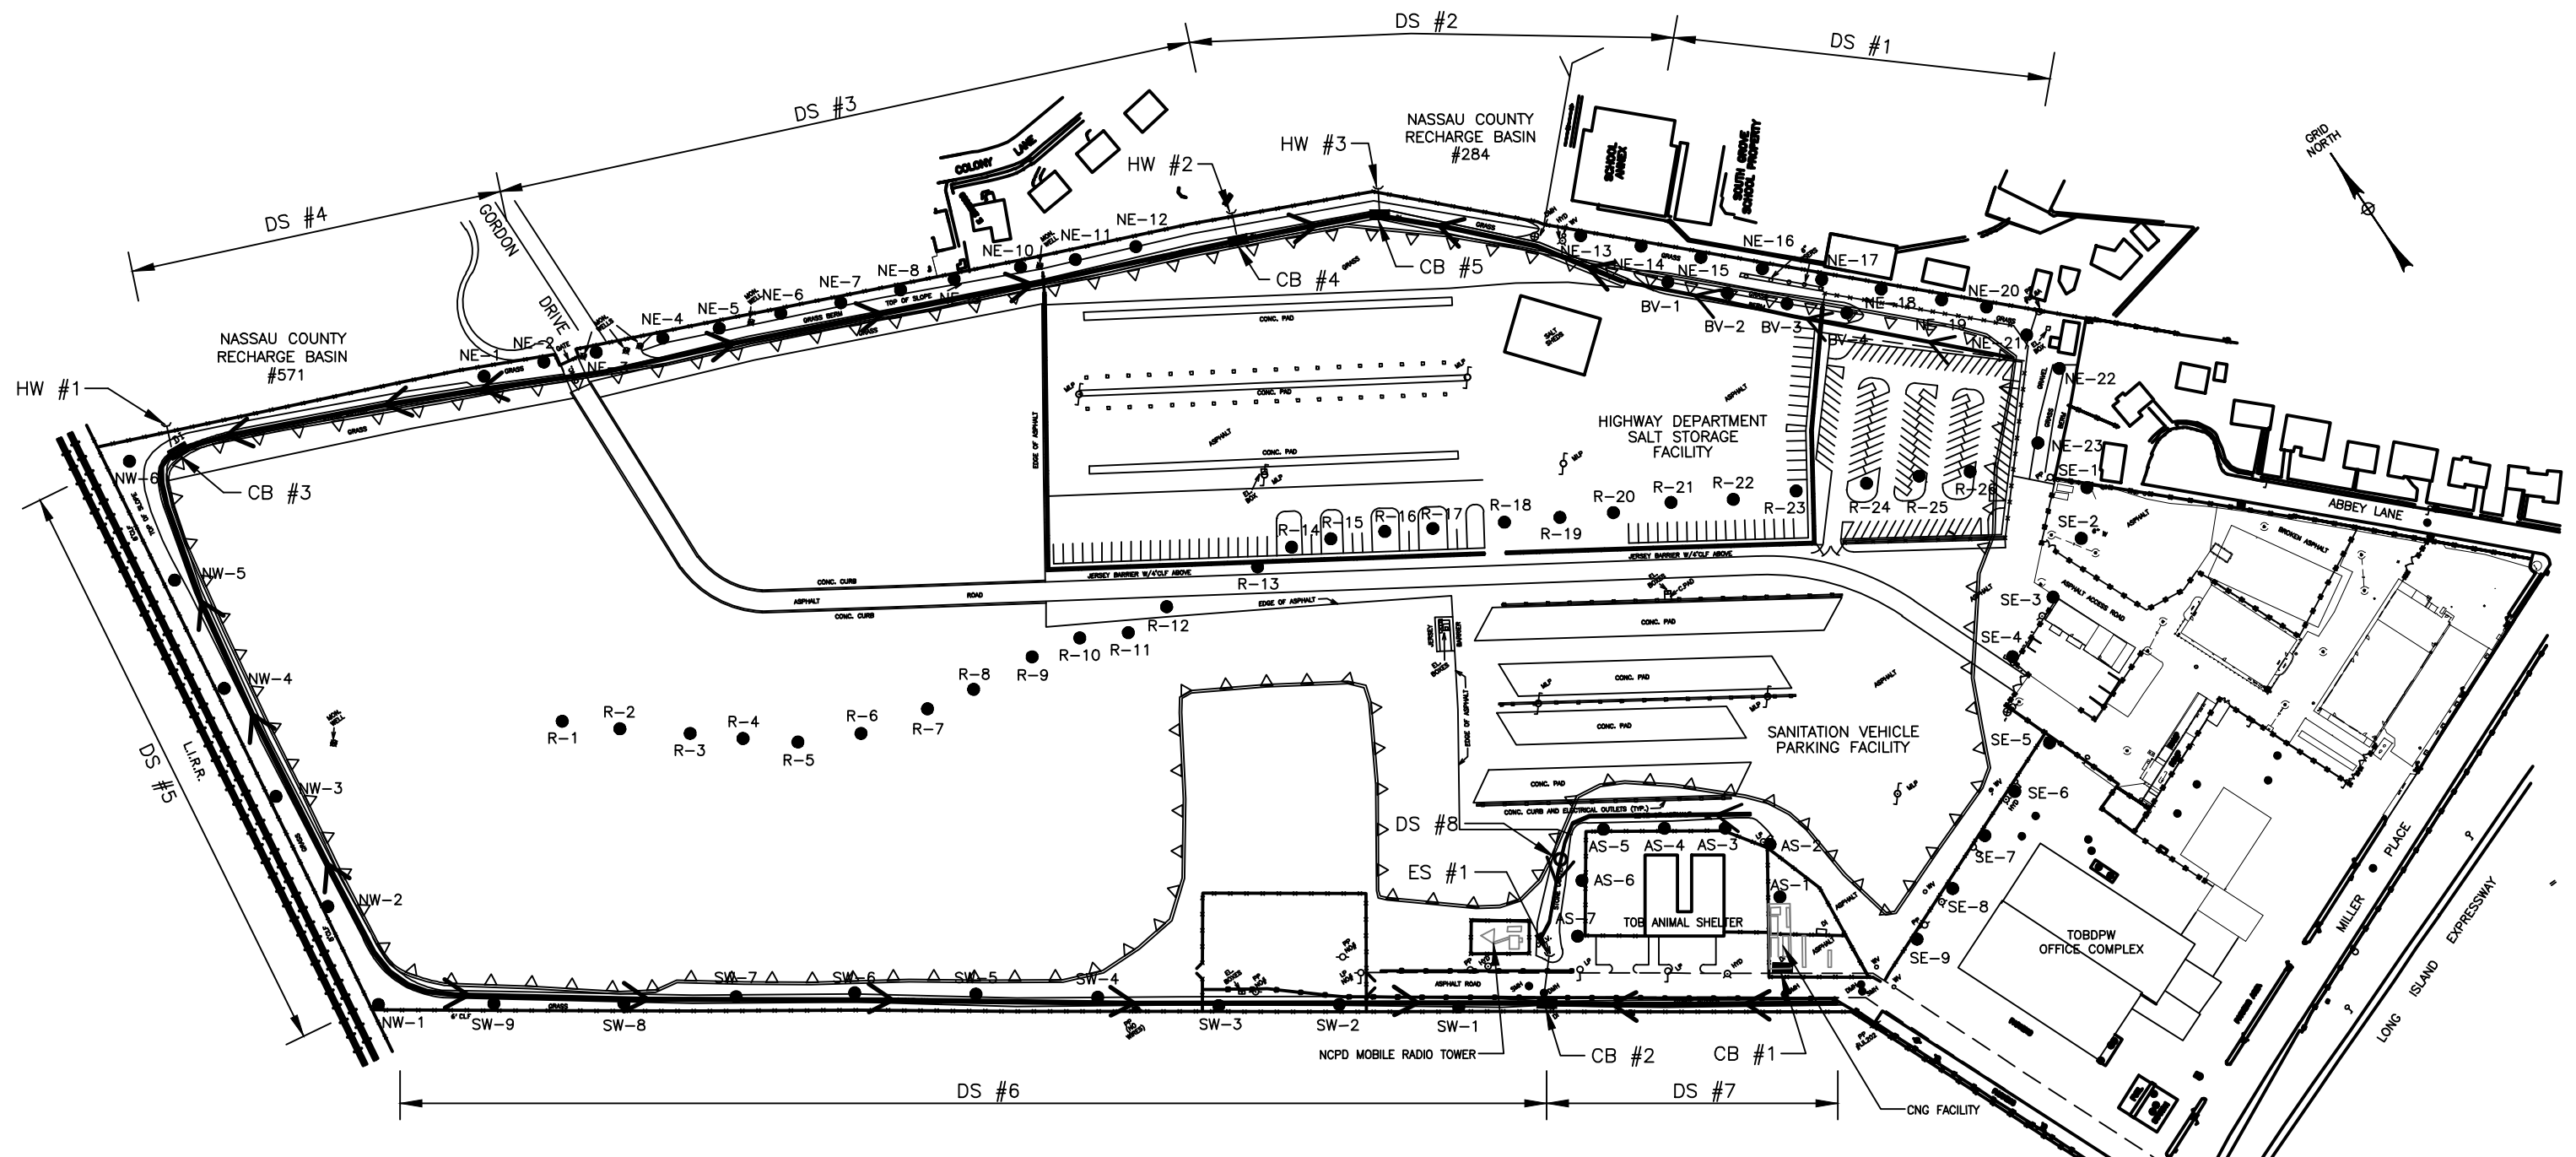
FIGURE 2
SYOSSET LANDFILL
DRAINAGE SYSTEM LOCATION PLAN

The storm drainage pipes were inspected at the drainage structure locations and only minimal sedimentation and some vegetative growth were noted at the entrance to the end section located adjacent to the Animal Shelter (ES #1, see Figure 2) during the 2017 reporting period.
